Joshua Young  
Air Safety Investigator  
AS-ERA

**Date:** October 27, 2024  
**Subject:** ERA25LA023, FAA On-site Examination  
**Contact:** Nick Anderson, Aviation Safety Inspector, FAA

Inspector Anderson was the FAA IIC for this accident, and the following are excerpts from a report he sent the NTSB IIC after completing his onsite examination.

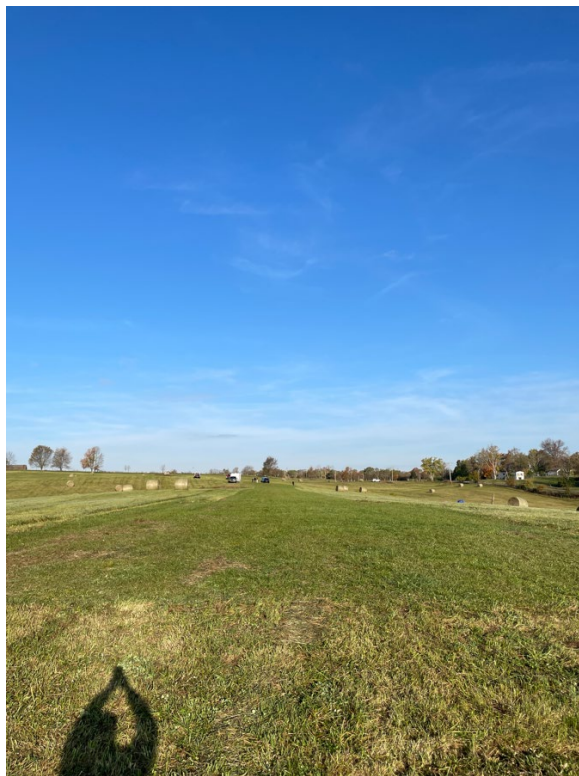
*Photo 1: View looking SW 215°. (Courtesy of FAA)*

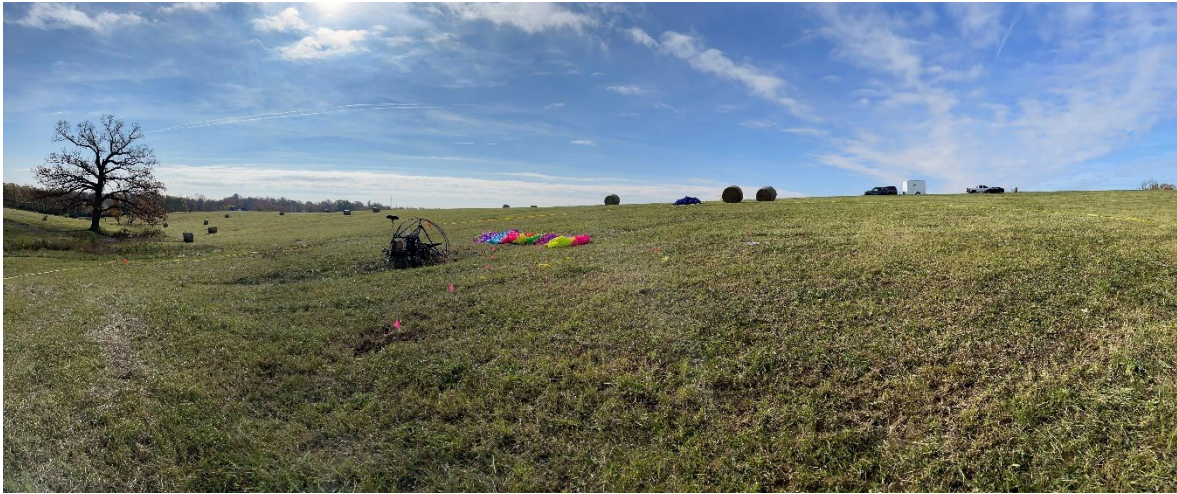
*Photo 2: Overview of the accident site. (Courtesy of FAA)*

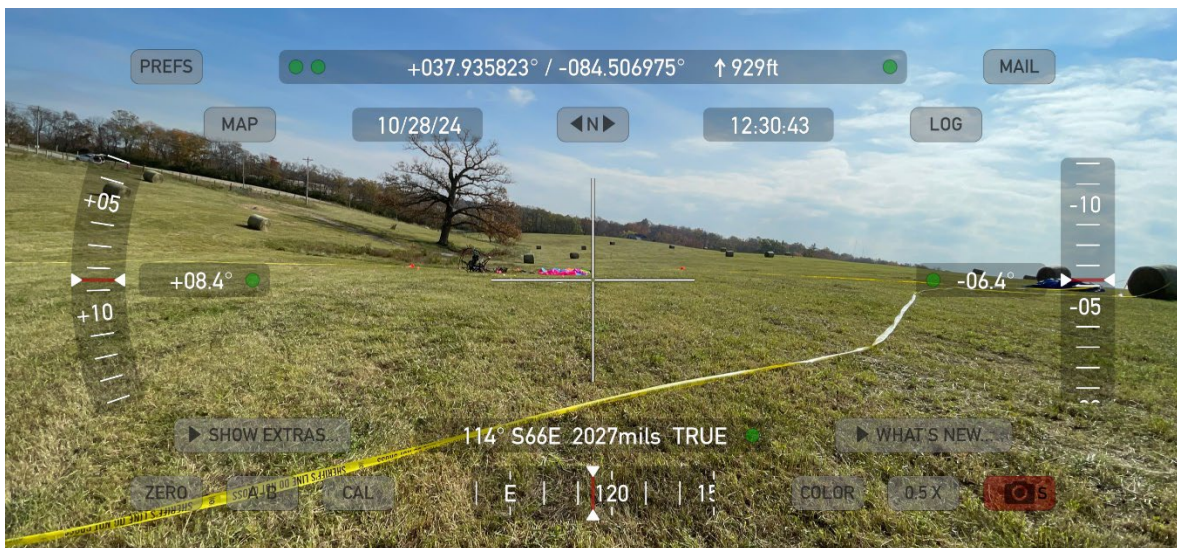
*Photo 3: Overview of the accident site. (Courtesy of FAA)*

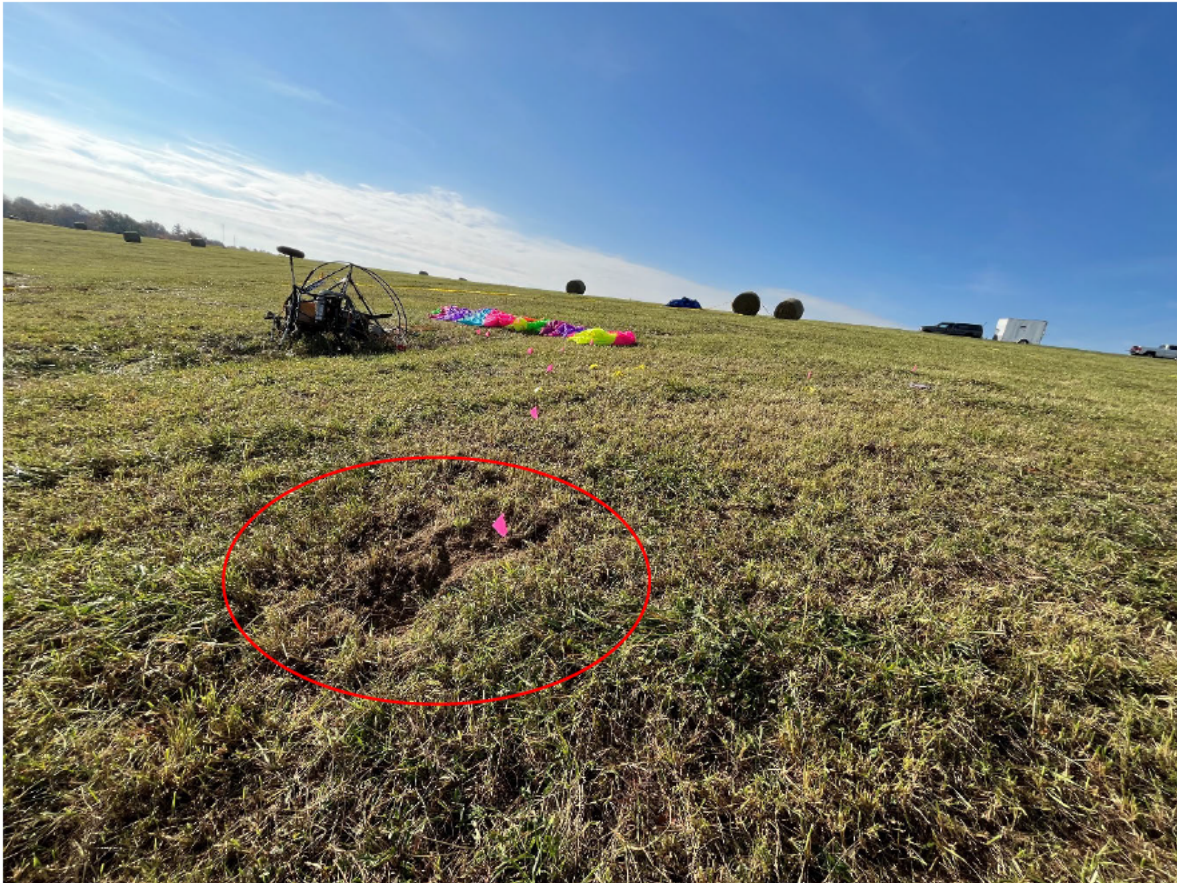
*Photo 4: Initial impact area marked by flag in forefront. (Courtesy of FAA)*

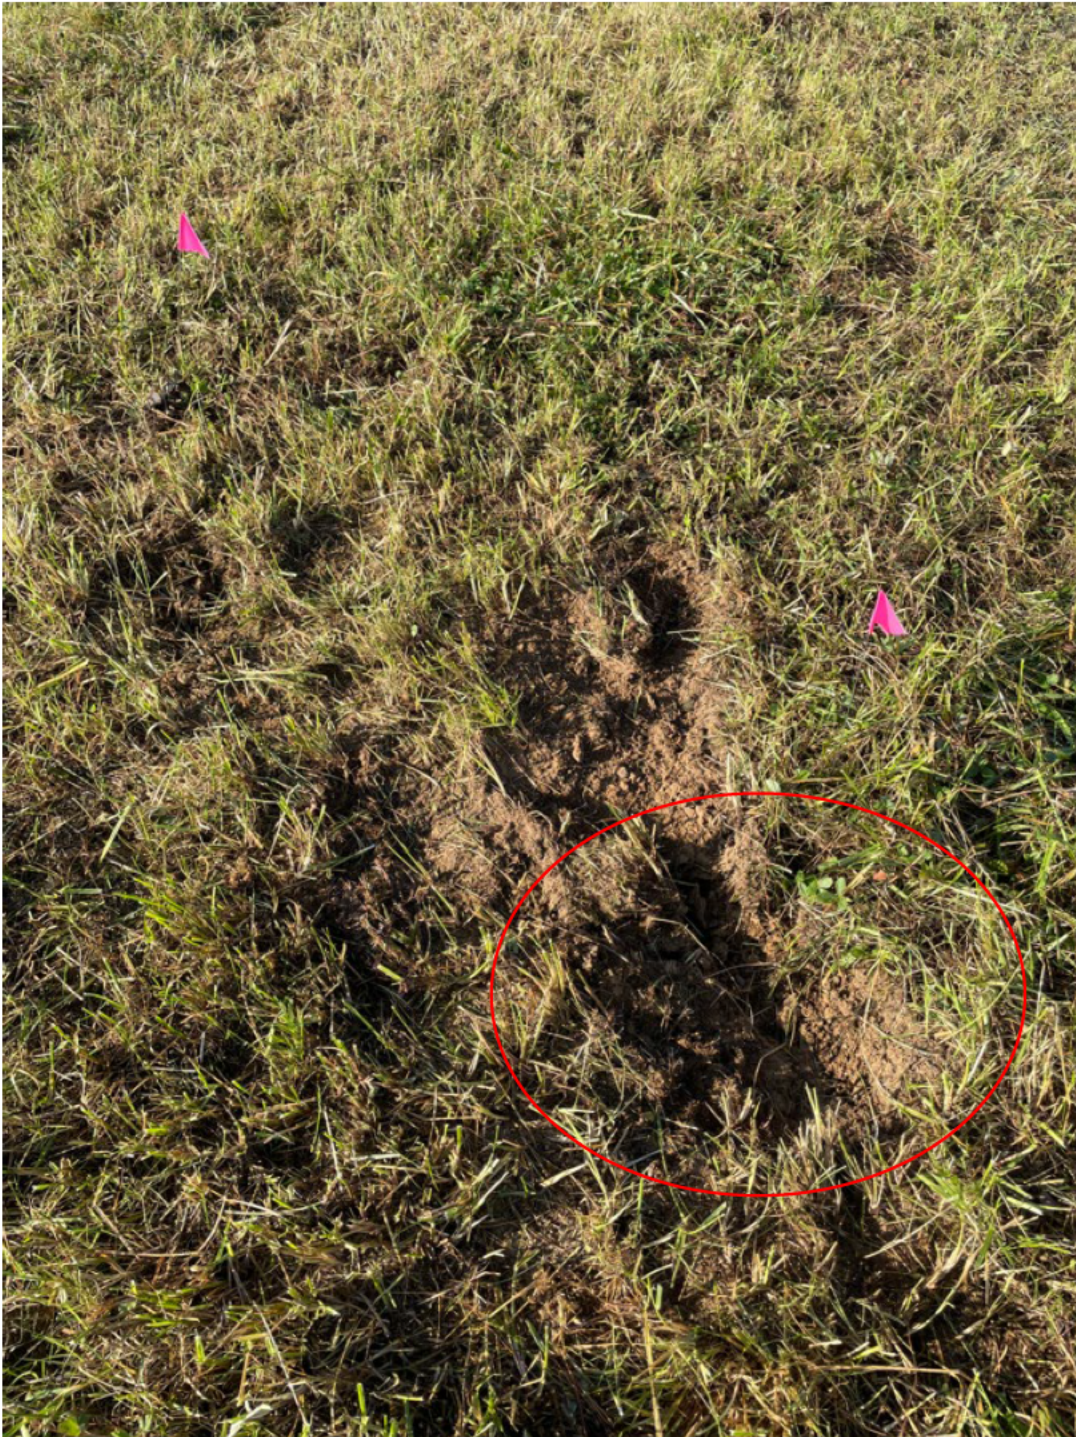
*Photo 5: Nose gear impact ground scar (circled). (Courtesy of FAA)*

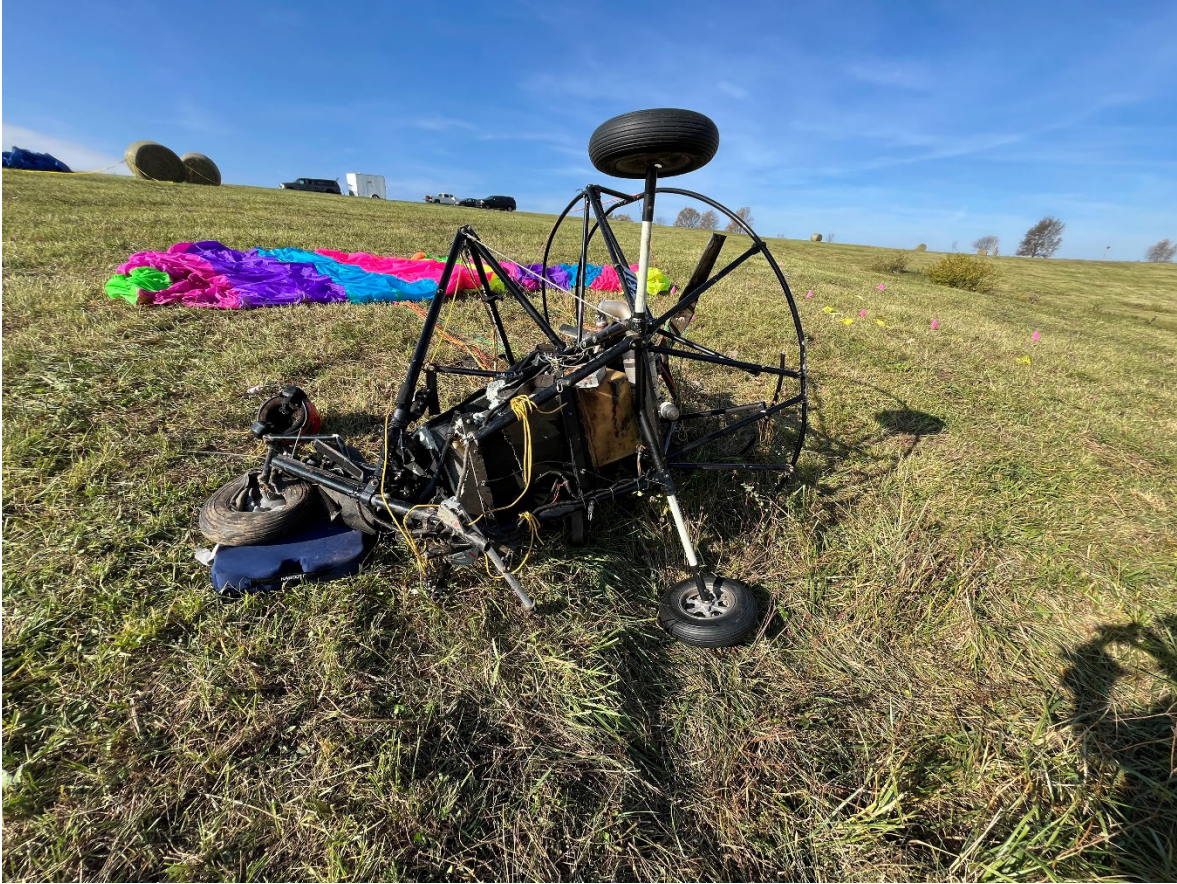
*Photo 6: Overview of the wreckage. (Courtesy of FAA)*

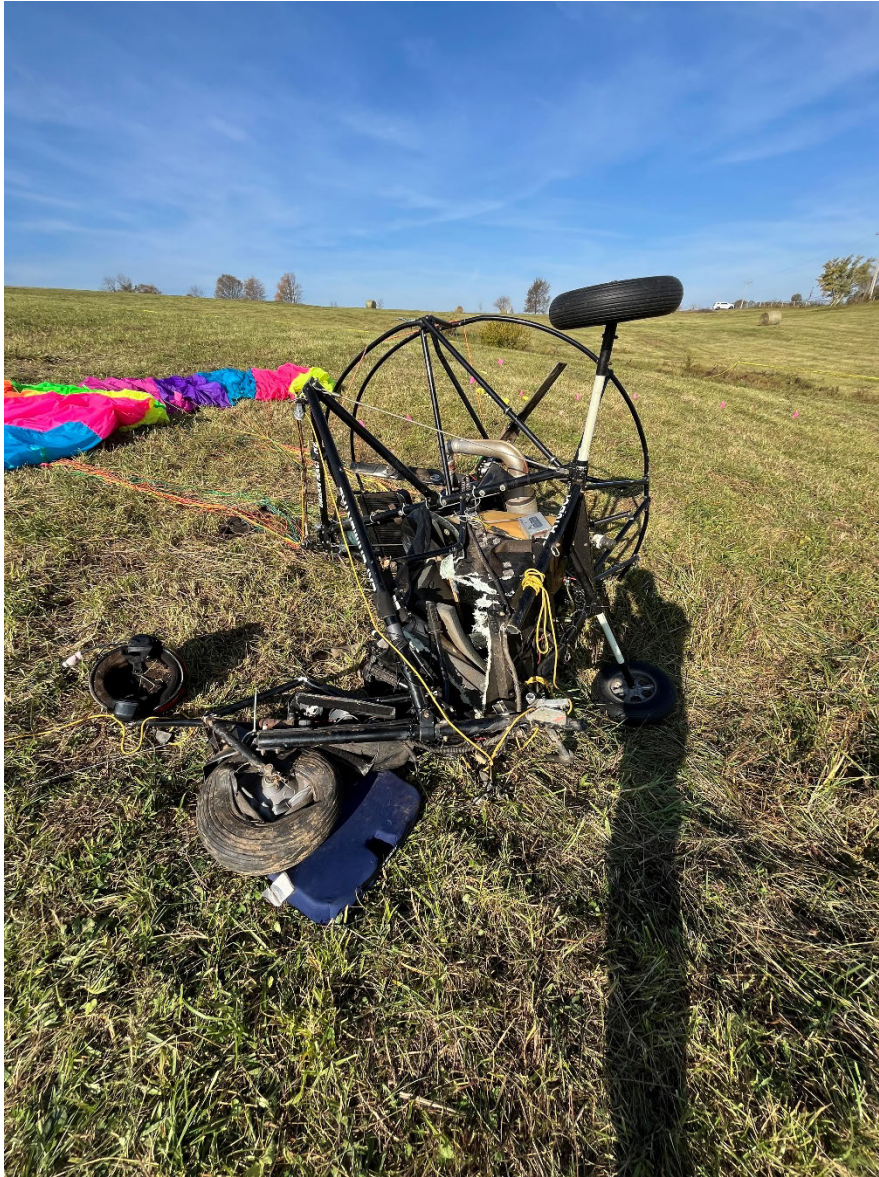
*Photo 7: Overview of the wreckage. (Courtesy of FAA)*

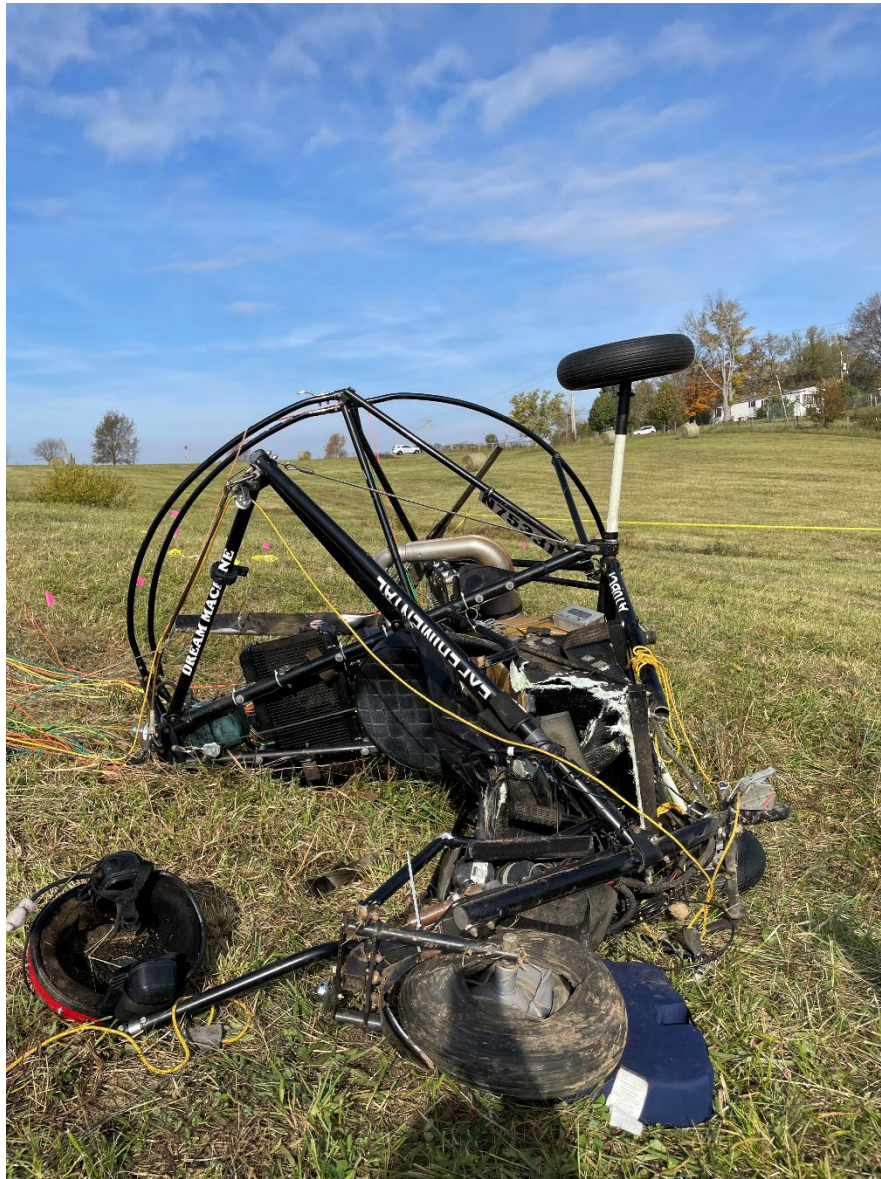
*Photo 8: Overview of the wreckage. (Courtesy of FAA)*

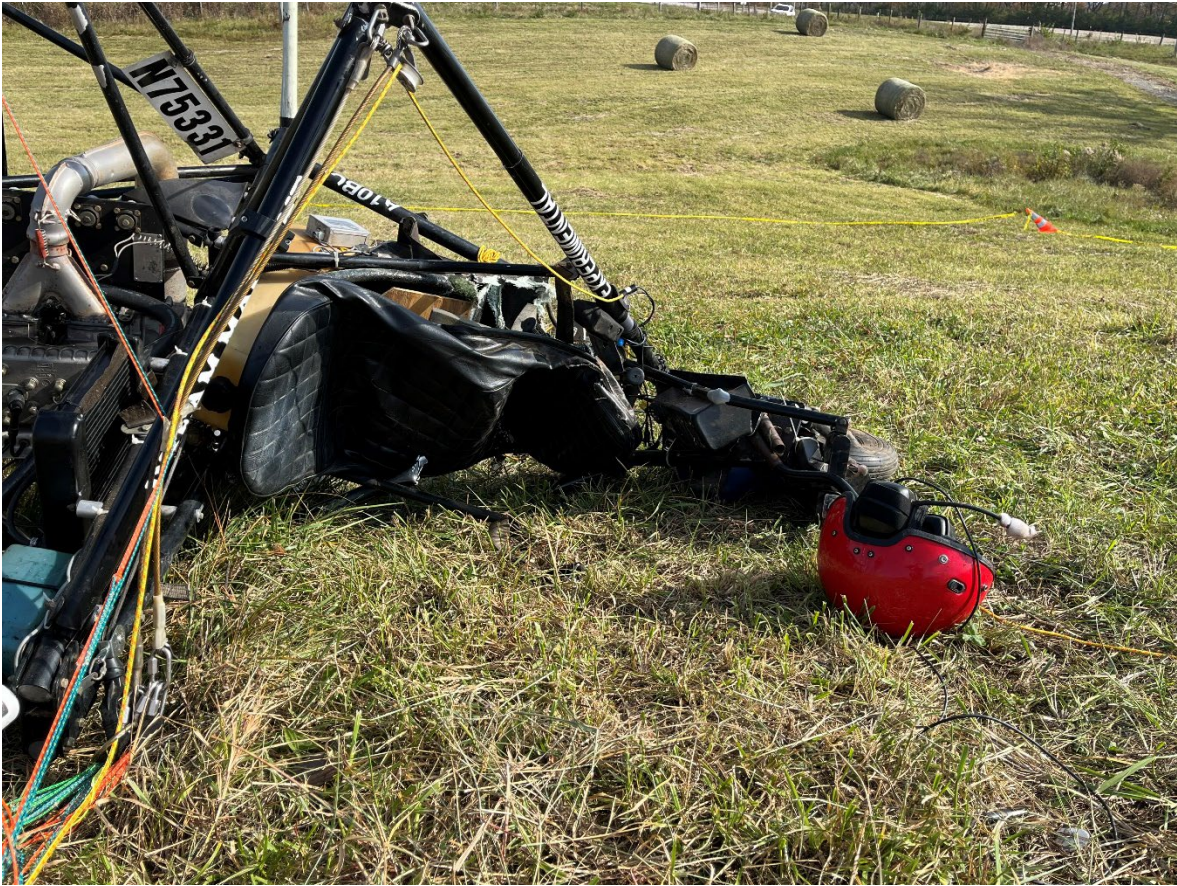
*Photo 9: Overview of the wreckage. (Courtesy of FAA)*

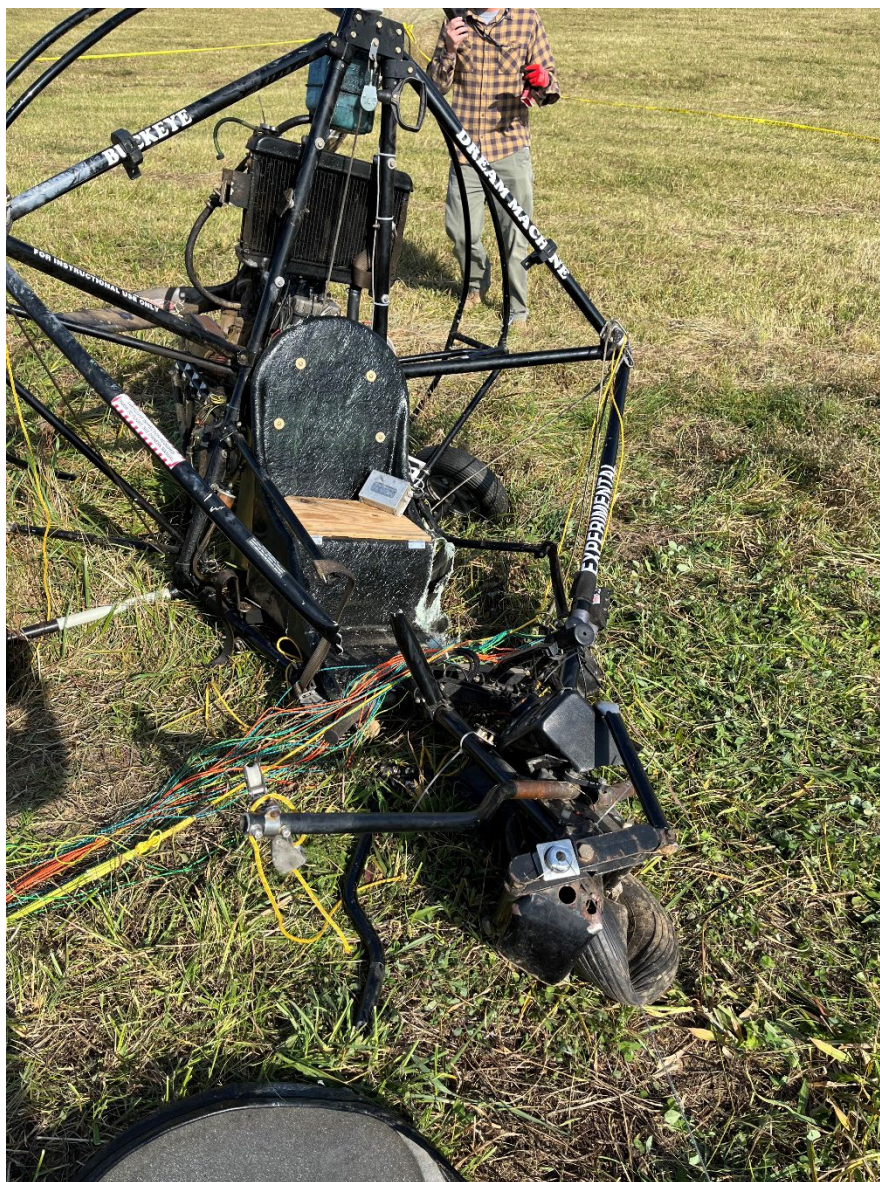
*Photo 10: Overview of the wreckage. (Courtesy of FAA)*

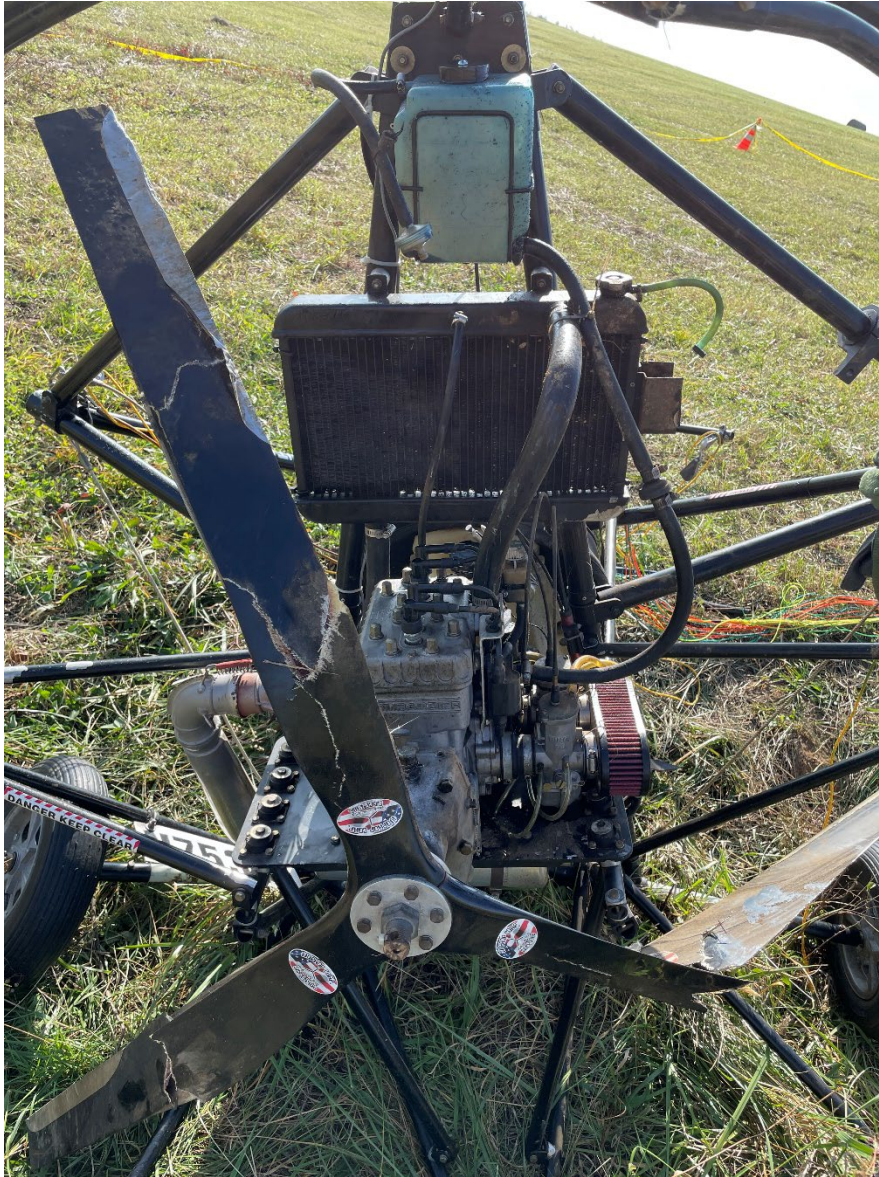
*Photo 11: View of propeller. (Courtesy of FAA)*

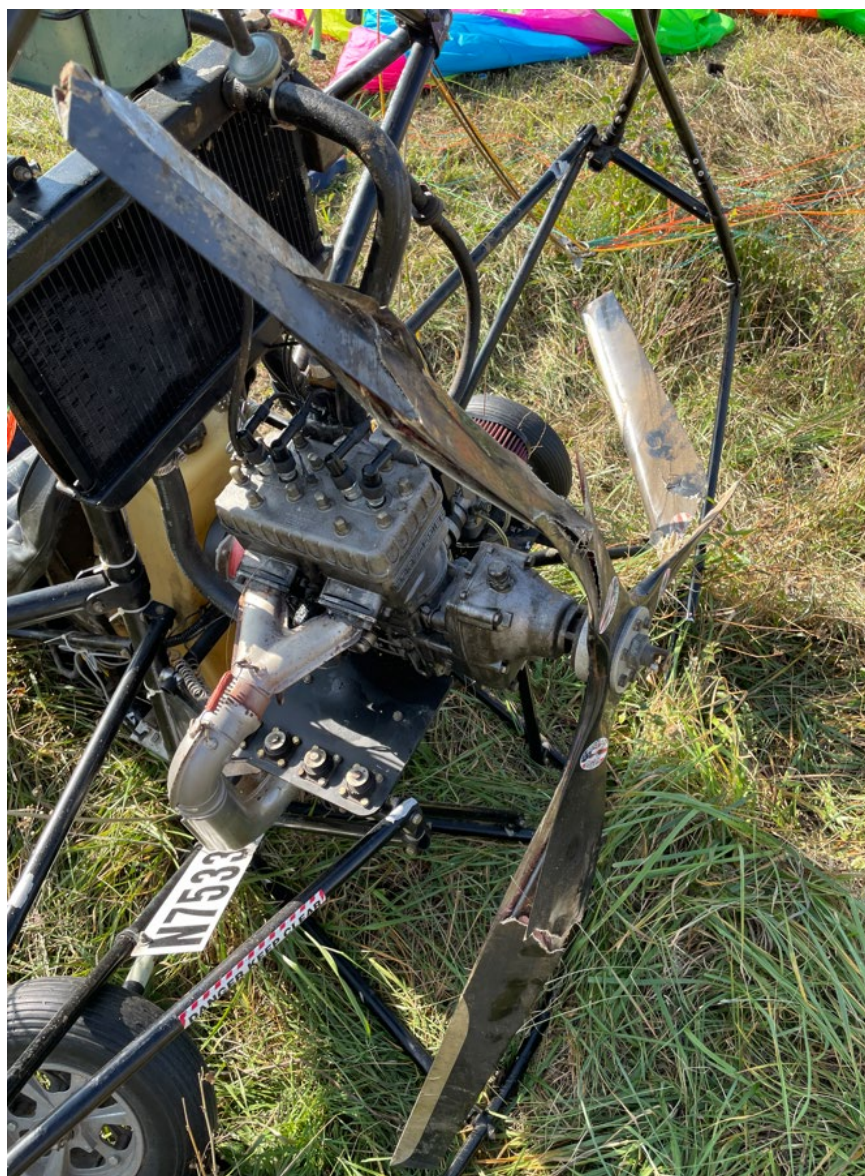
*Photo 12: View of propeller. (Courtesy of FAA)*

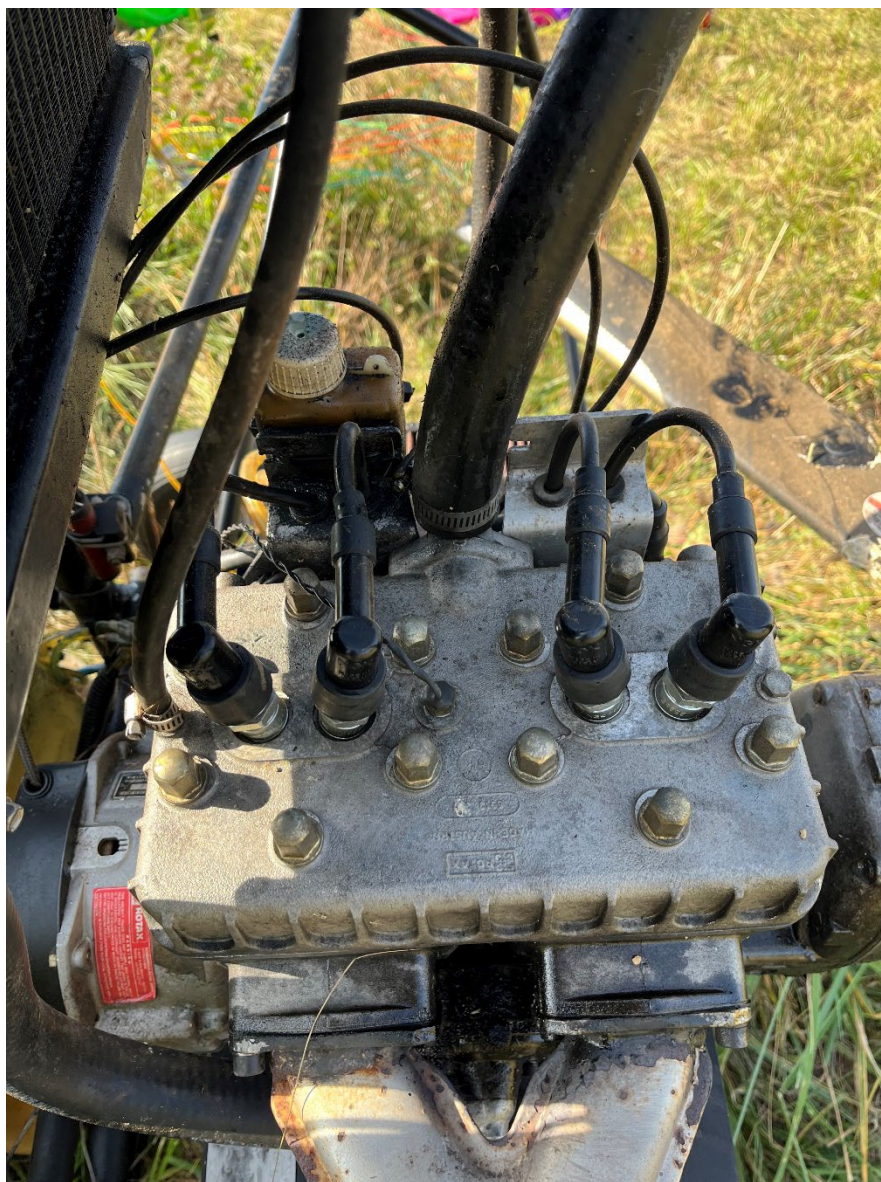
*Photo 13: Overview of the engine. (Courtesy of FAA)*

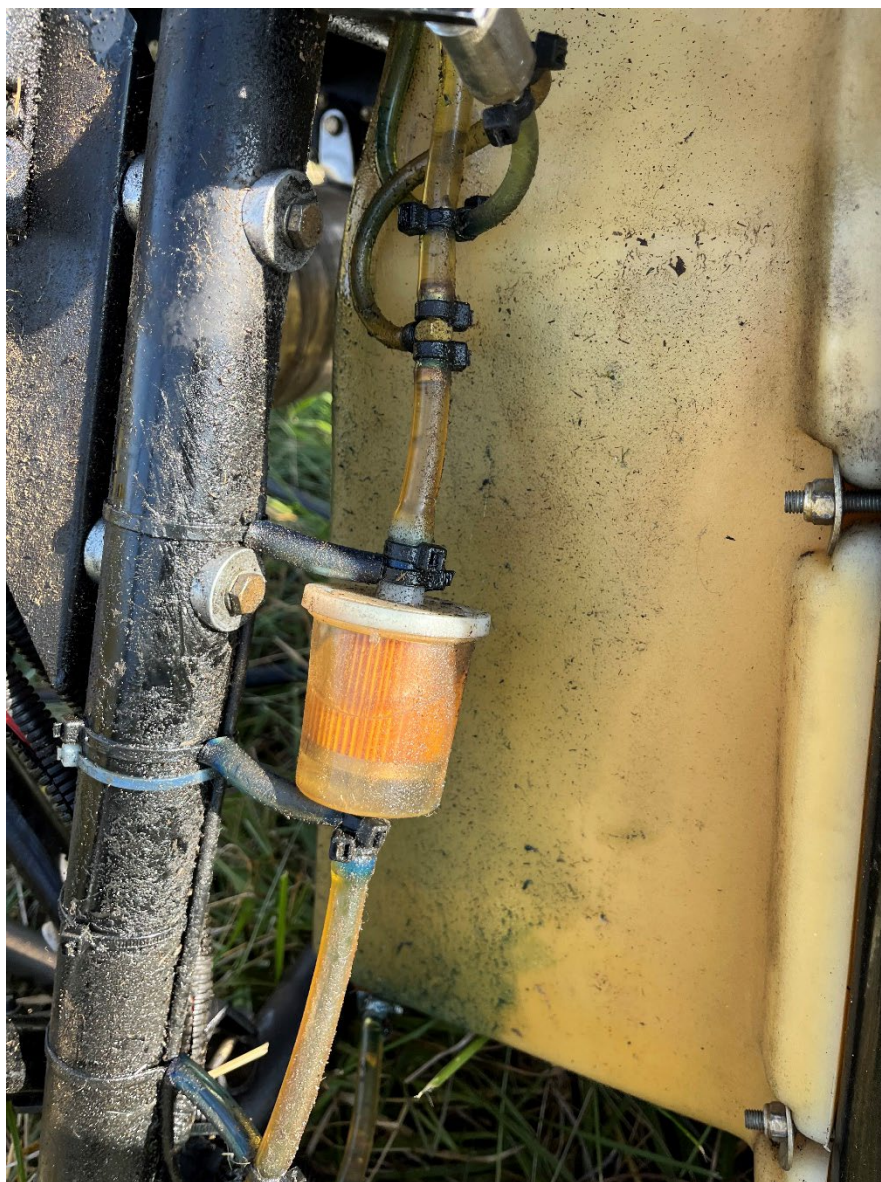
*Photo 14: View of the inline fuel filter with fuel still in the bowl and line. (Courtesy of FAA)*

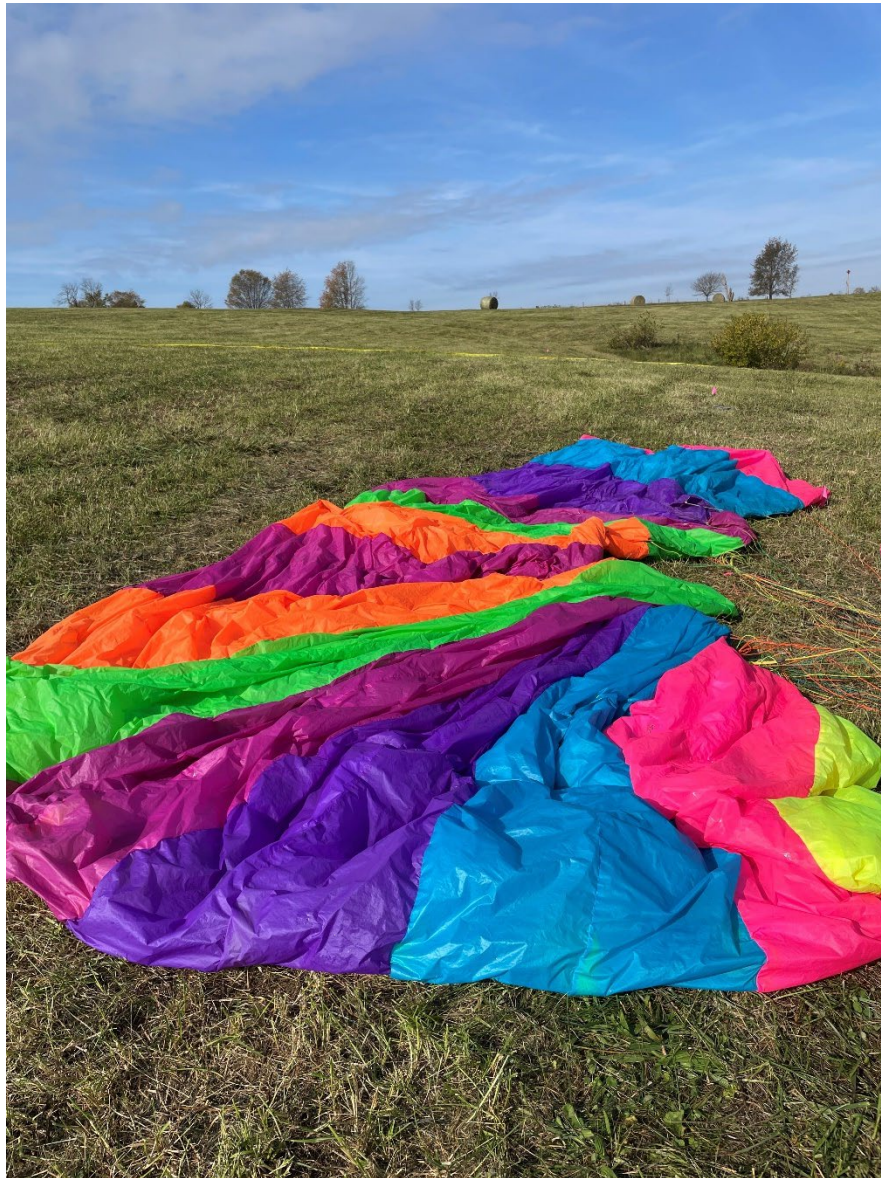
Parachute risers appeared to not be frayed or damaged. No missing panels or damage to canopy.

*Photo 15: Overview of the canopy/wing. (Courtesy of FAA)*

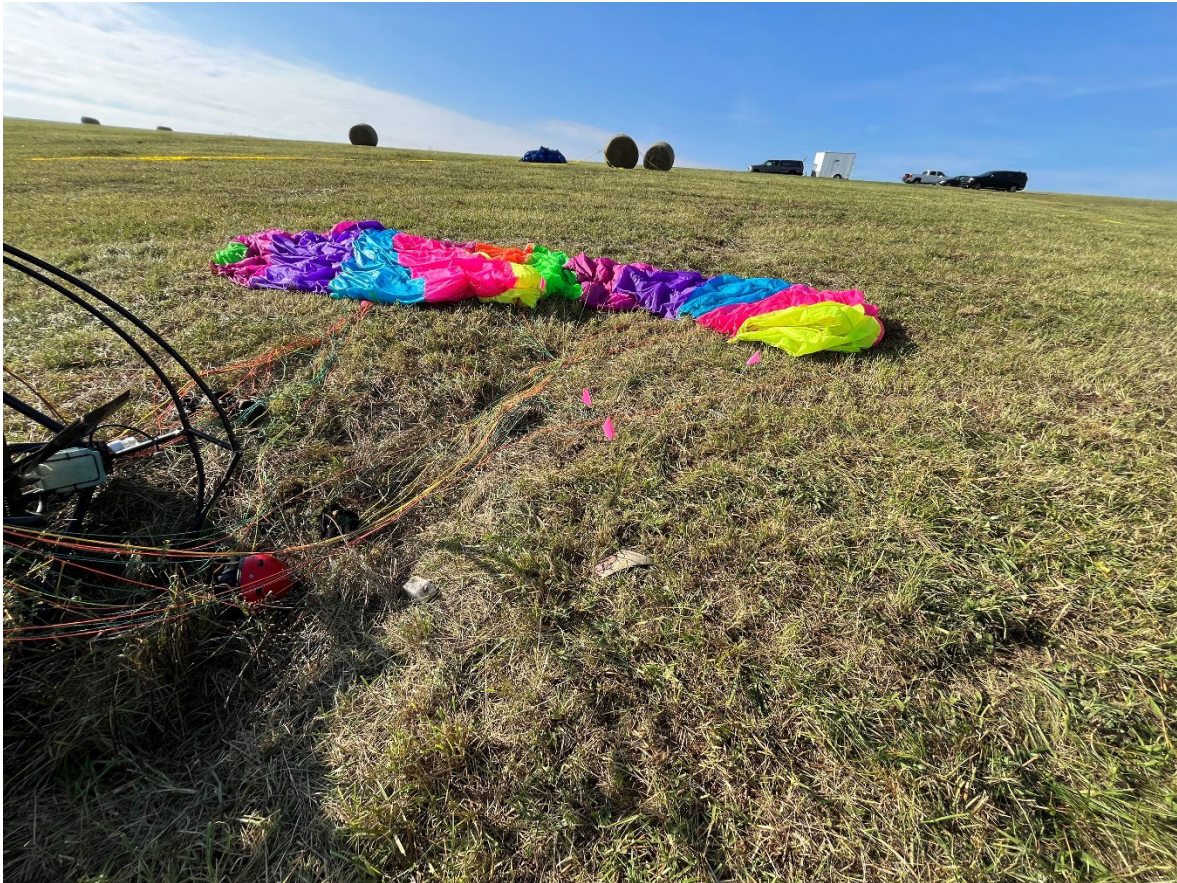
*Photo 16: Overview of the canopy/wing and risers. (Courtesy of FAA)*

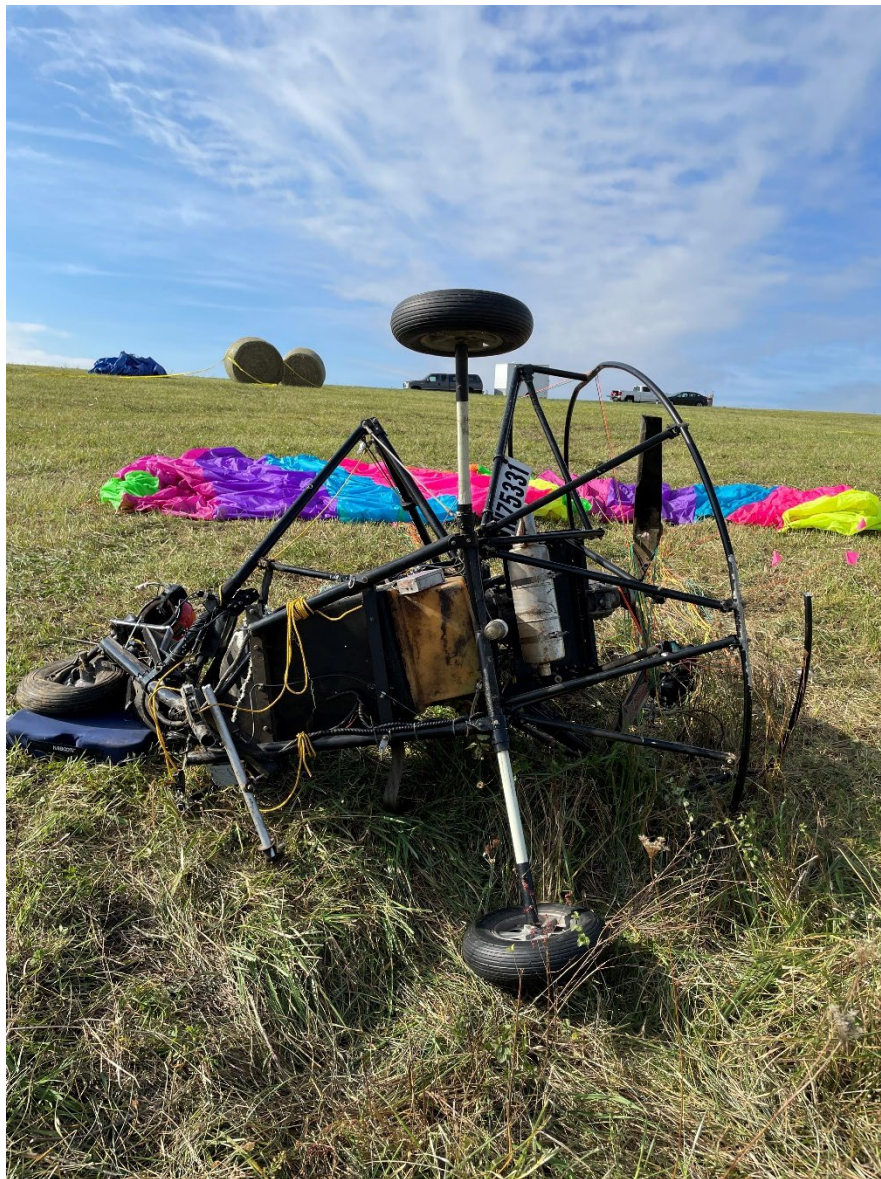
*Photo 17: View of the bottom of the powered parachute. (Courtesy of FAA)*

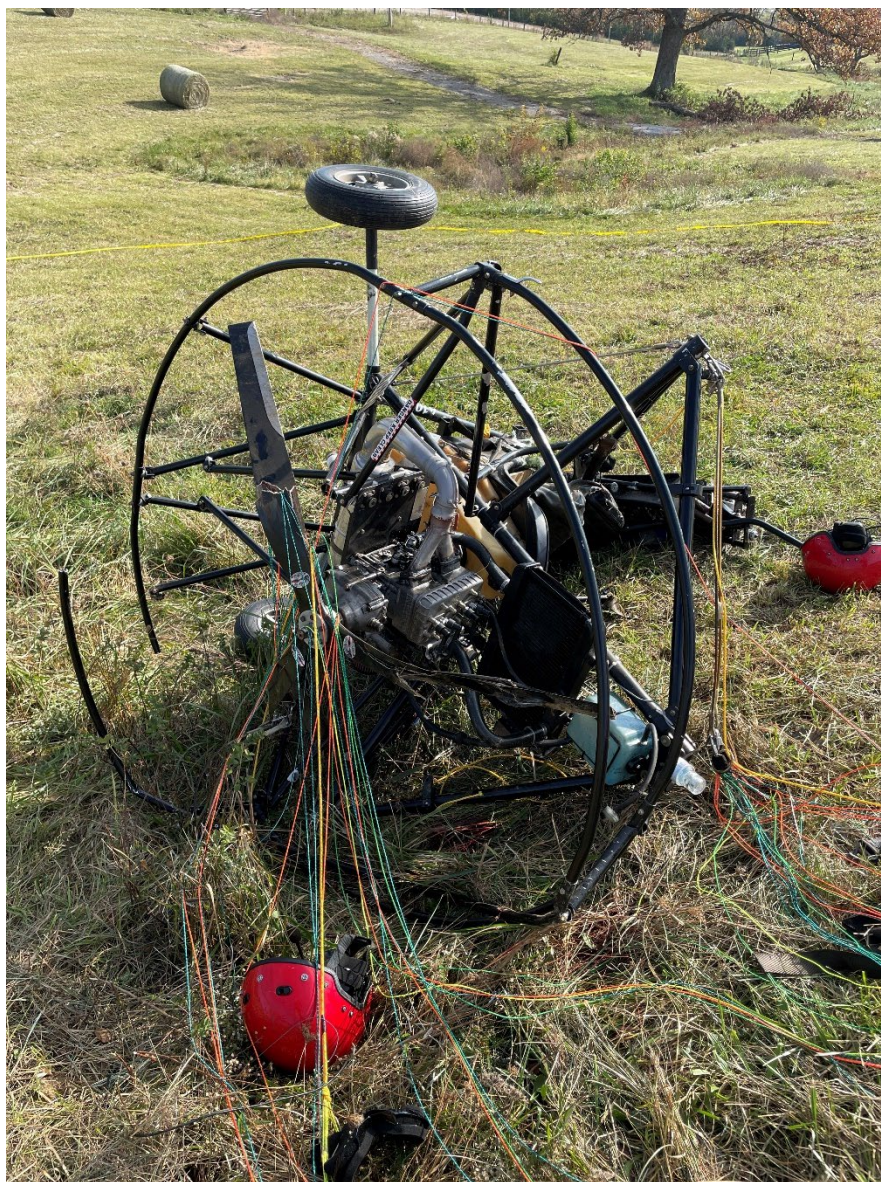
*Photo 18: view of one of the riser attach points. (Courtesy of FAA)*

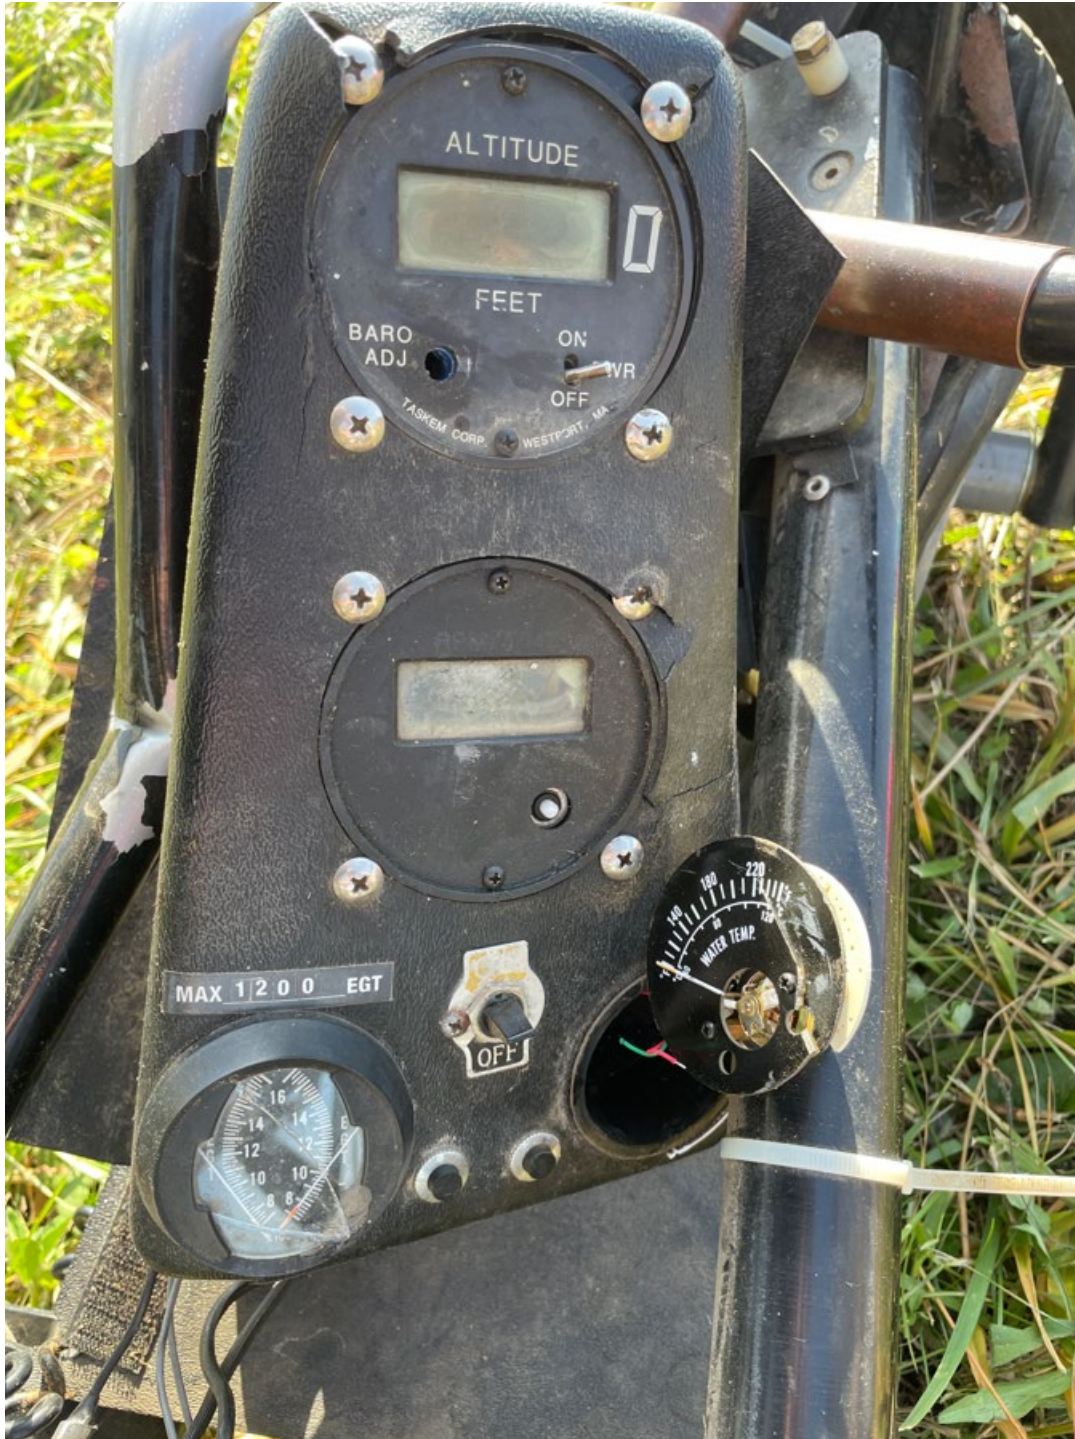
*Photo 19: Overview of the cockpit instrument panel. (Courtesy of FAA)*
