ERA25LA030

## INVESTIGATION PHOTOGRAPHS

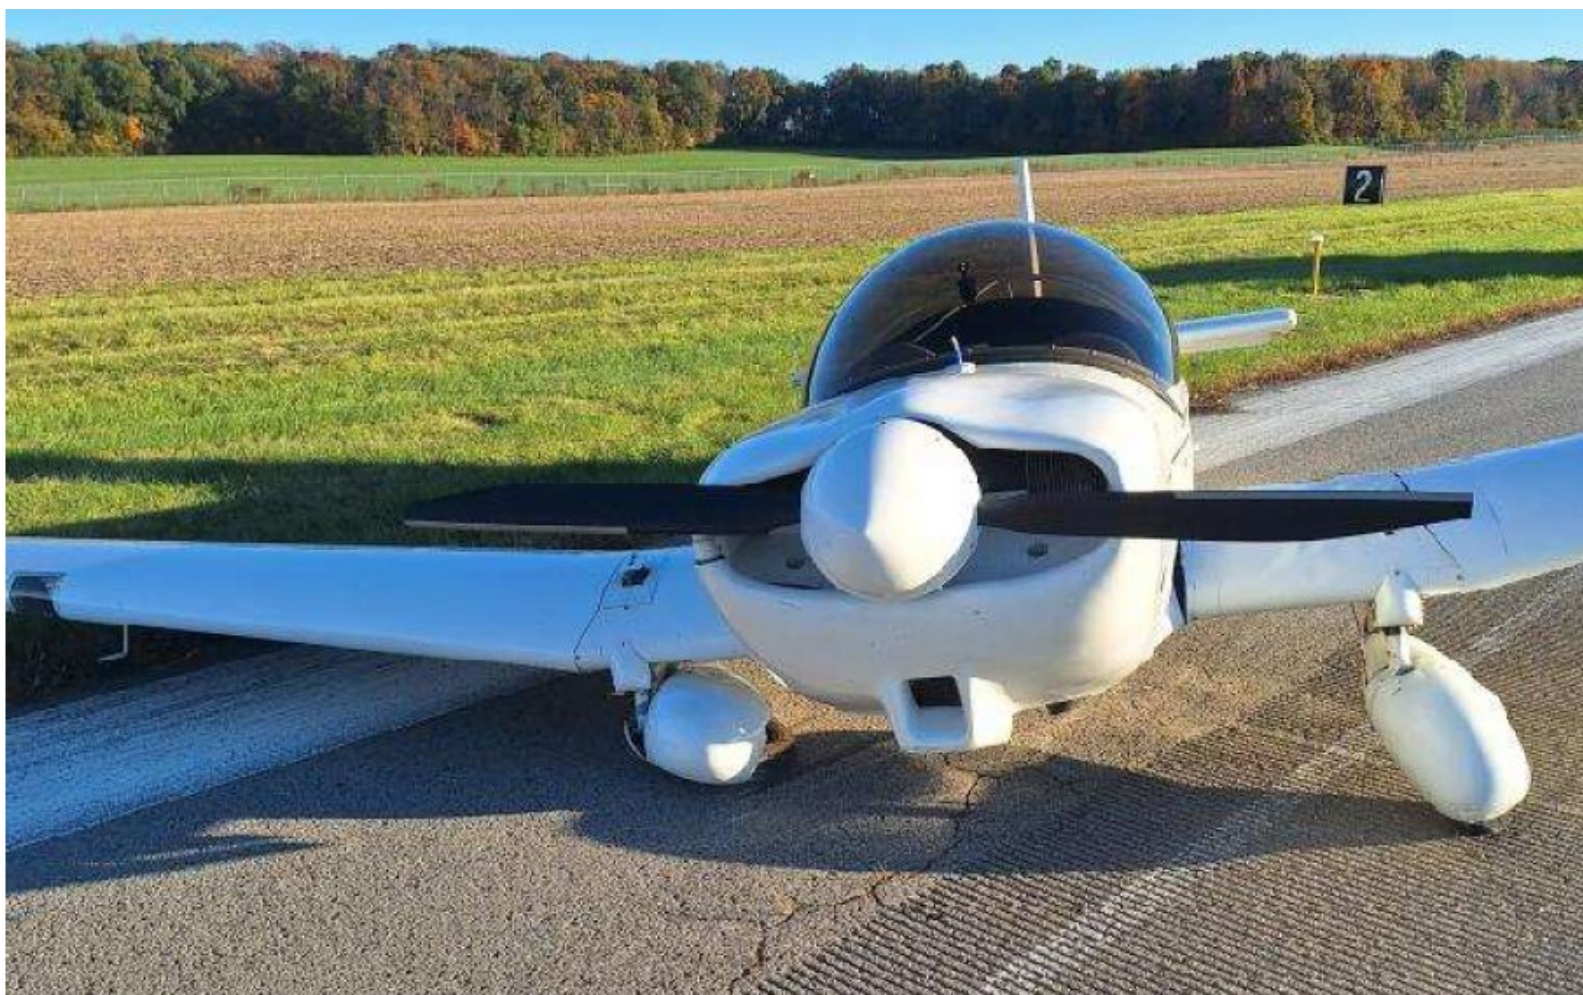
**Photograph 1 - View of airplane looking aft showing damage to landing gear and airframe.  
(Courtesy of FAA)**

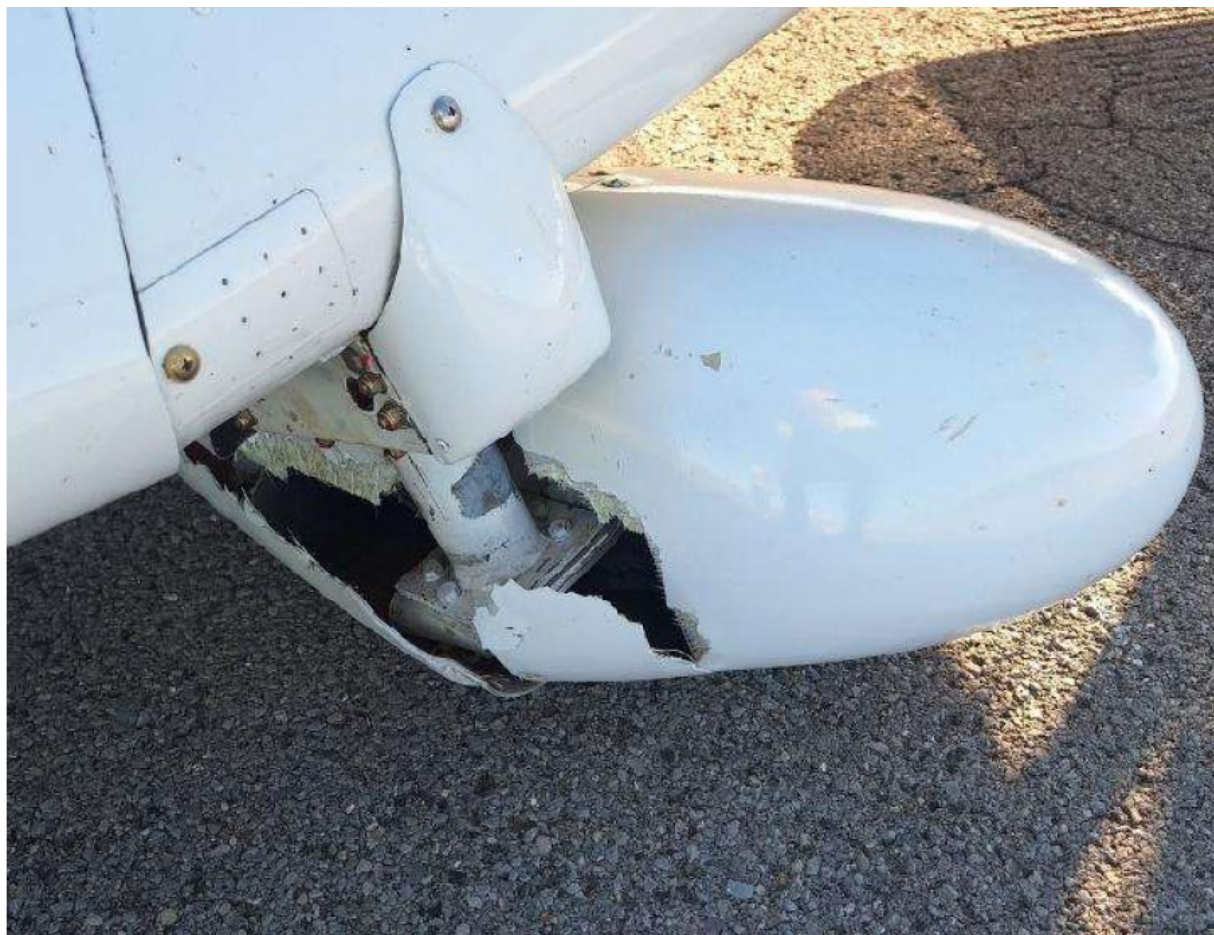
**Photograph 2 - Right landing gear damage. (Courtesy of FAA)**
