Aaron McCarter  
Aviation Accident Investigator  
Eastern

**Date:** October 31, 2024

**Subject:** ERA25LA030; N511JG

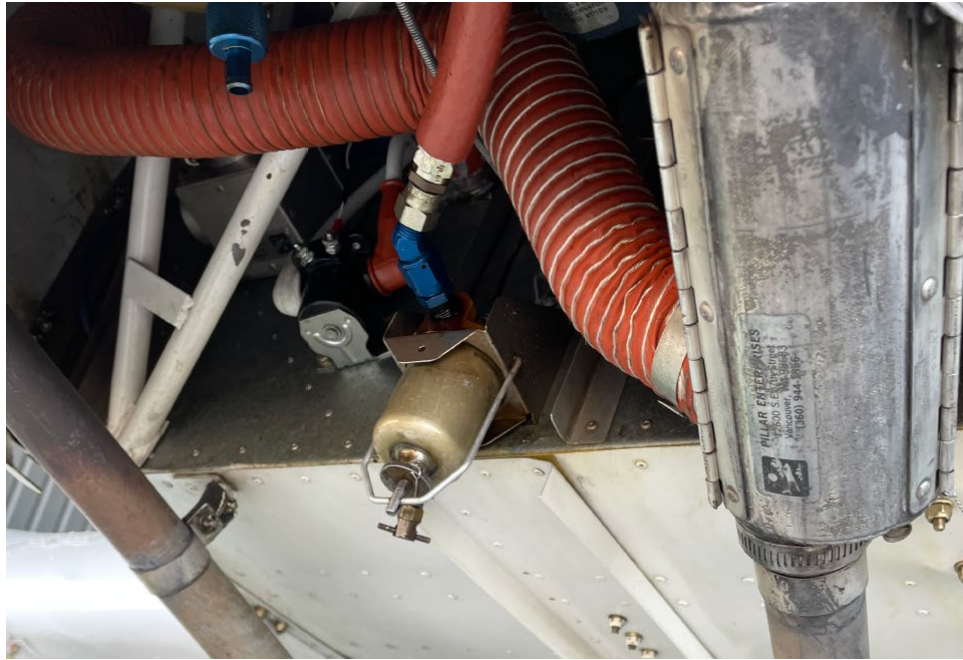
Engine/crankshaft continuity was confirmed. The magnetos produced spark and there was compression on each cylinder. The fuel filter bowl (gascolator) was installed partially outside of the engine compartment and hung below the cowling in the slipstream. (Figure 1) When it was examined, fuel started leaking substantially when light finger pressure was applied in an aft direction. Upon further examination, the gasket was stiff and had a crack in it which allowed fuel to escape. (Figure 2)

*Figure 1 Gascolator/fuel bowl installed as discovered was installed partially outside of the engine compartment.*

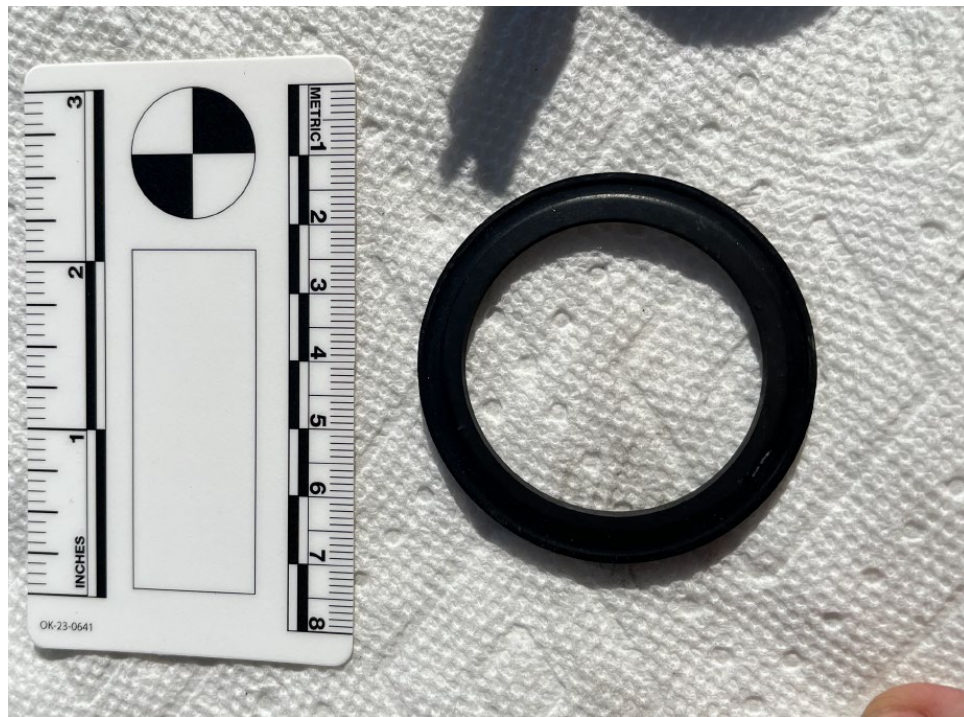
*Figure 2 After removal and examination of the gascolator; Gasket seal was stiff and cracked.*
