ERA25LA031

## INVESTIGATION PHOTOGRAPHS

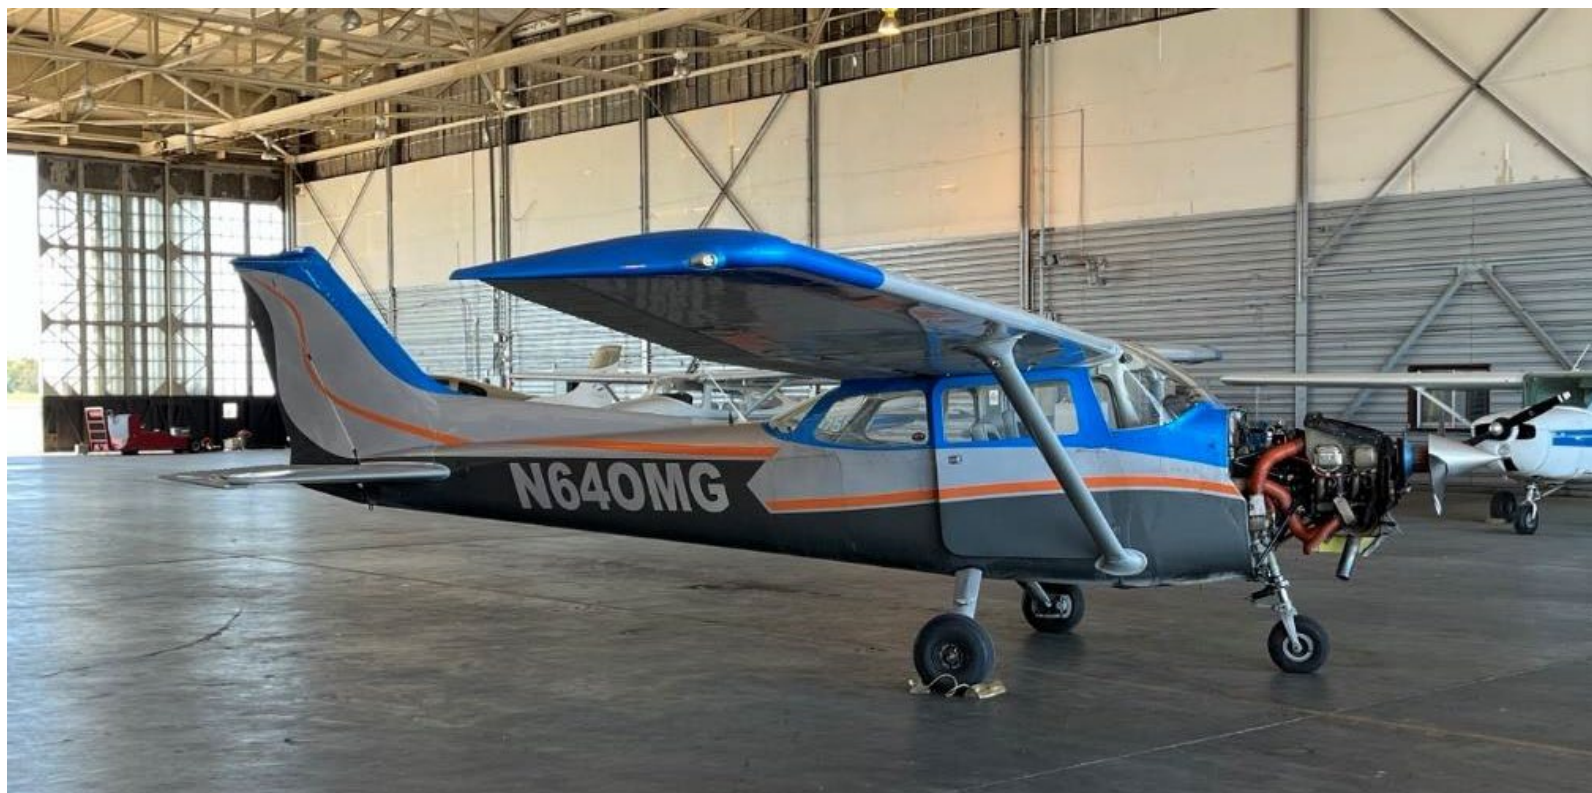
**Photograph 1 - Airplane postaccident (Courtesy of FAA)**

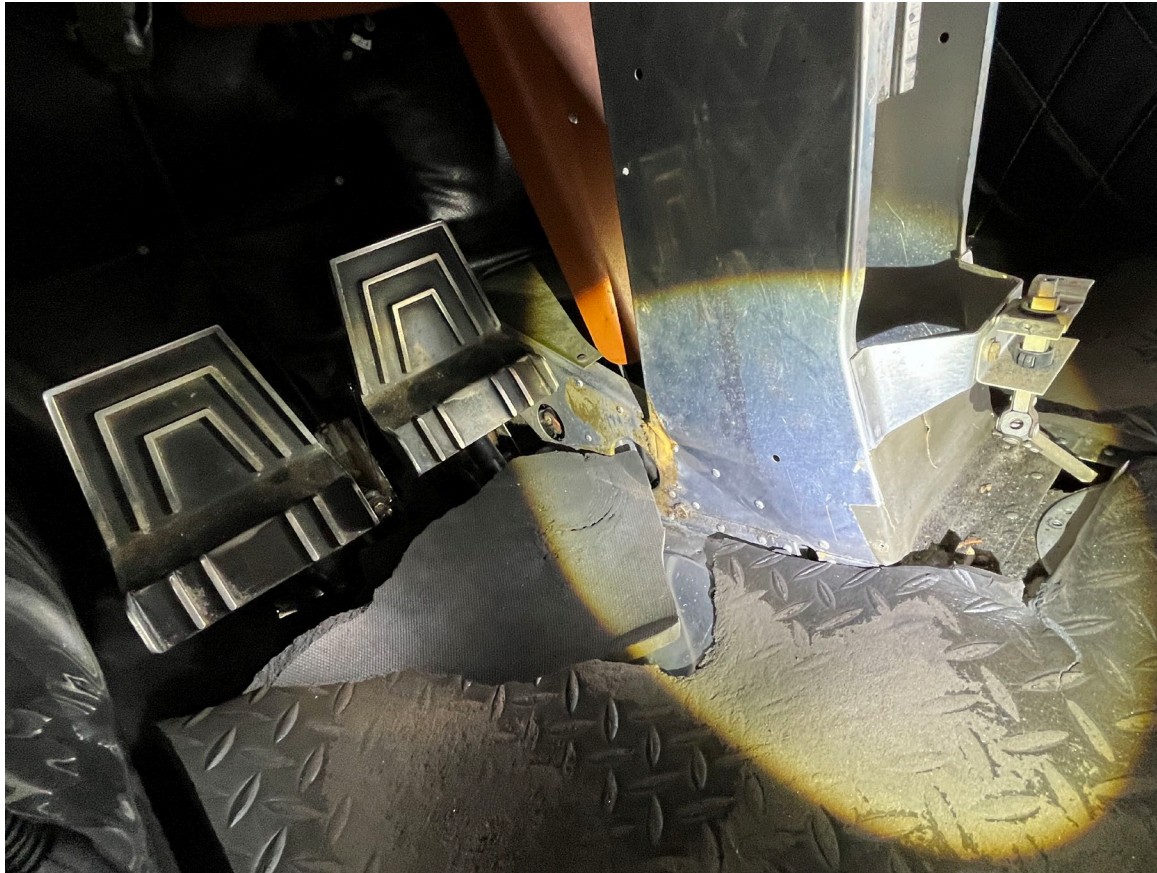
**Photograph 2 - Structure wrinkling (Courtesy of FAA)**

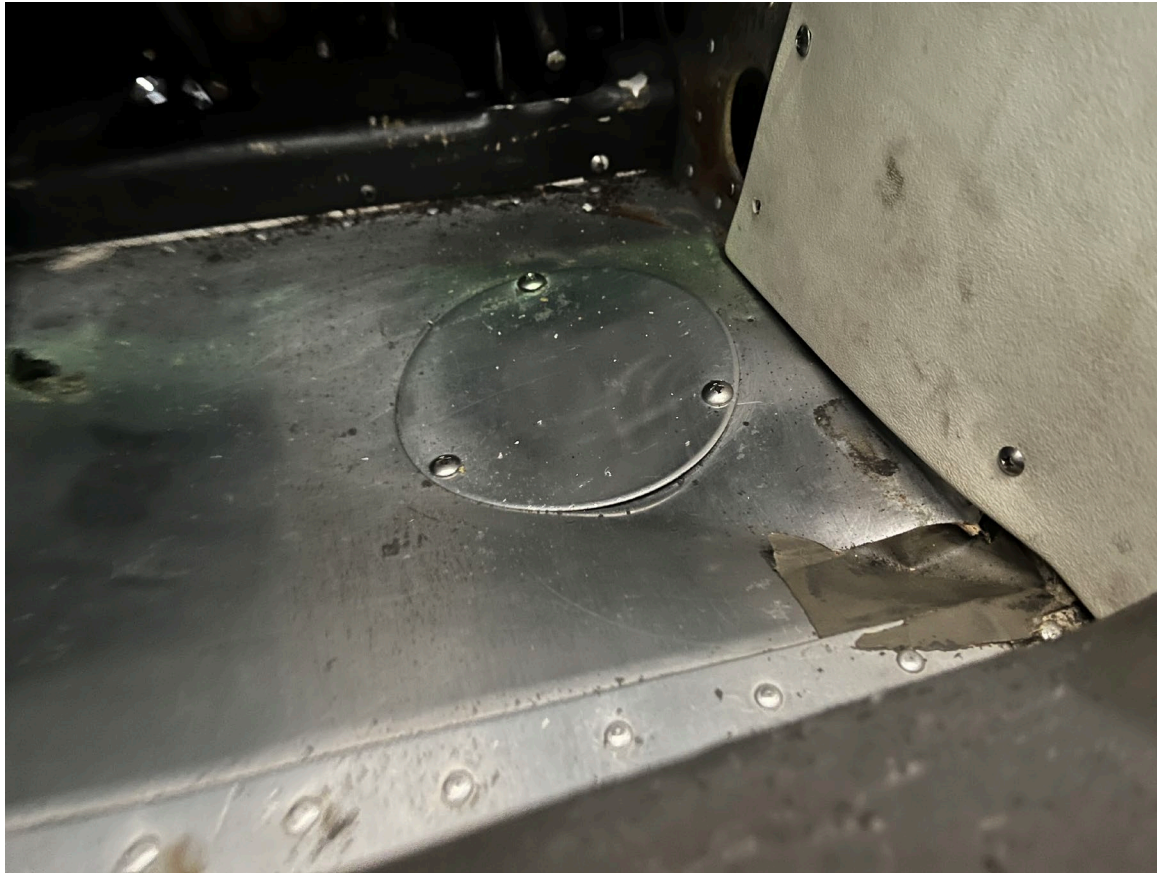
**Photograph 3 - Floorboard wrinkling (Courtesy of FAA)**

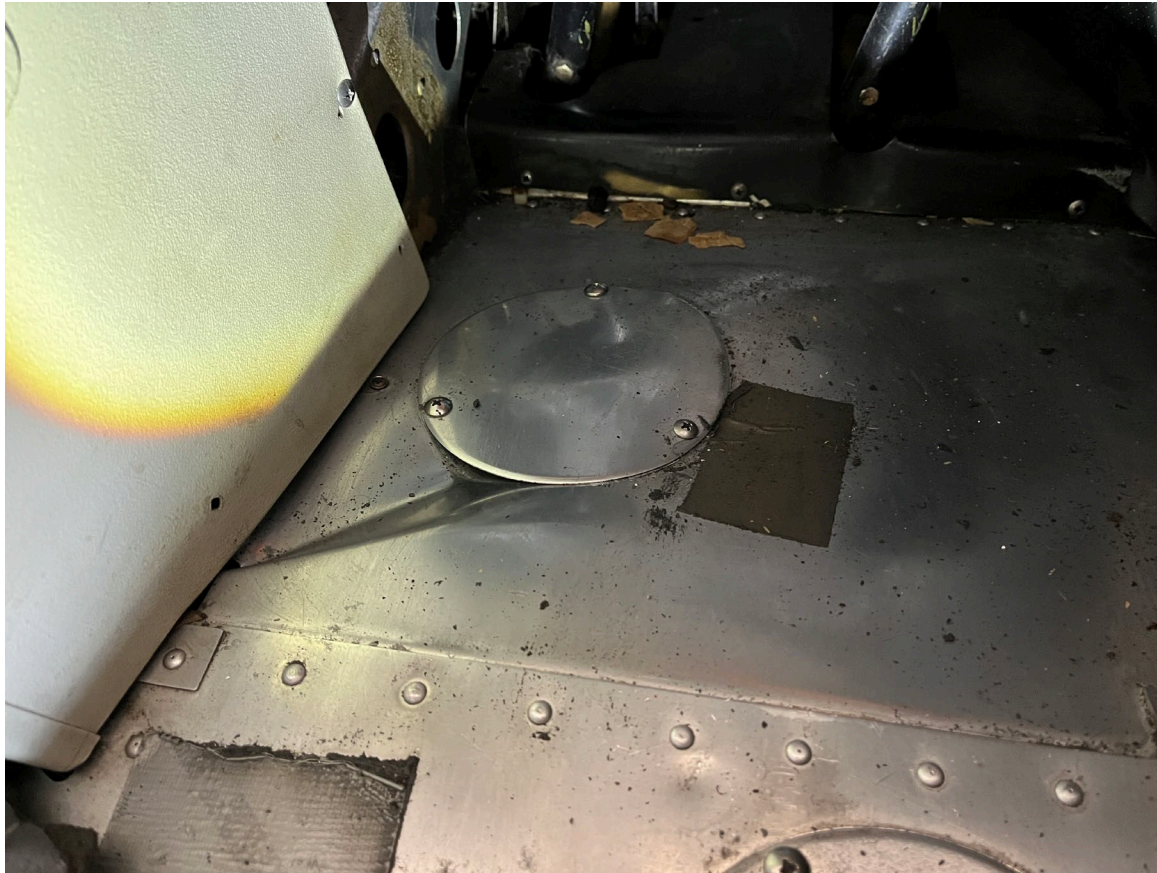
**Photograph 4 - Floorboard wrinkling (Courtesy of FAA)**
