## N620GA Mishap

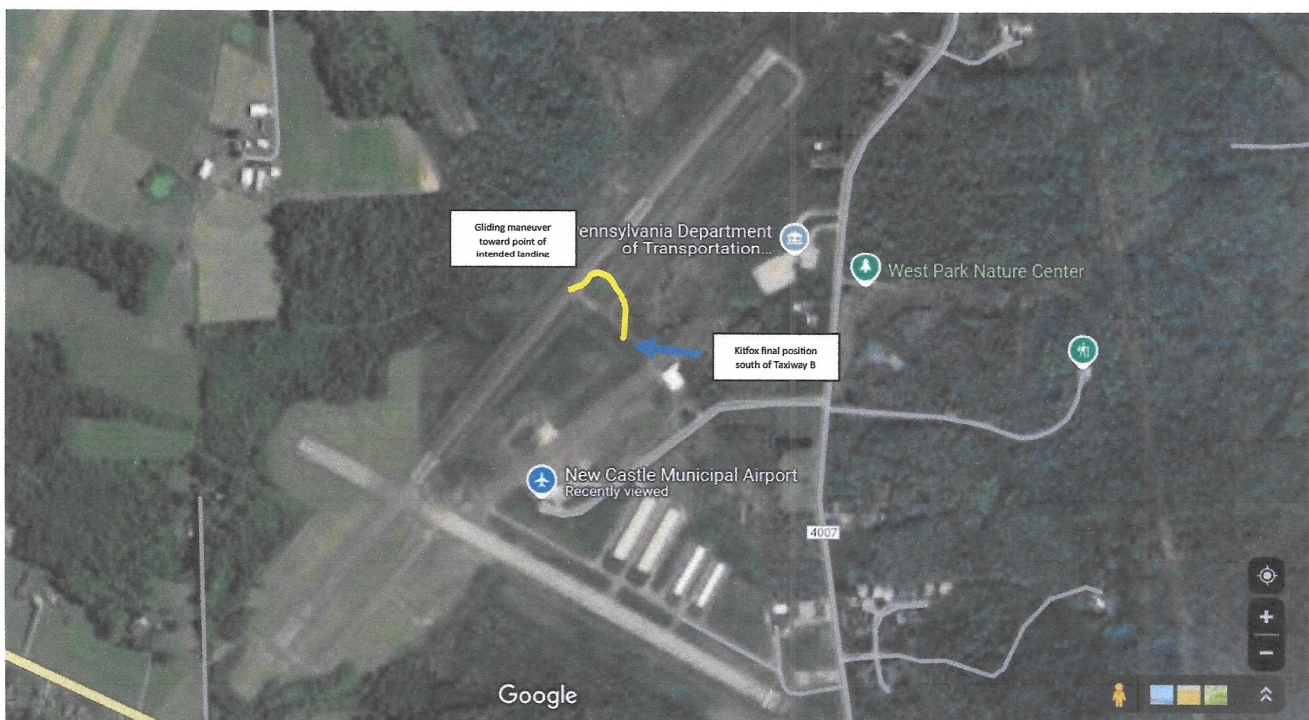
During the third and final take-off (appr 1015 hrs), Rick performed a normal takeoff with rotation between 45-50 mph. Upon reaching 250'-300' about ½ way down the runway, I noticed a clear reduction in engine RPM (less engine noise). I asked Rick if he had reduced the throttle to which he promptly answered "no." I immediately assumed all the flight controls, verified that the throttle was in the full-forward position, and confirmed a major loss of engine power. I input forward stick to establish a

glide then assessed the available landing options. Doubting that I could get the aircraft to touch-down and stop on Runway 05 without going off the steep embankment on the departure end of the Runway or off the down sloping sides of the runway, I selected one of the few smooth and grassy areas south of Taxiway B as my best landing option. Both the runway and taxiway are down sloping on the north end of Runway 05. Entering a banking right turn toward Taxiway B, we touched down just north of Taxiway B with the nose gear and the right main collapsing. The aircraft crossed Taxiway B and stopped just to the east in the grassy field where I had desired to have executed a "more controlled landing". One taxiway light was demolished as part of our landing. From initial recognition of power loss to aircraft coming to rest was about 6-8 seconds. With one or two minutes of the mishap, we were met on site by one of the KUCP grounds maintenance personnel.
