ERA25LA041

## INVESTIGATION PHOTOGRAPHS

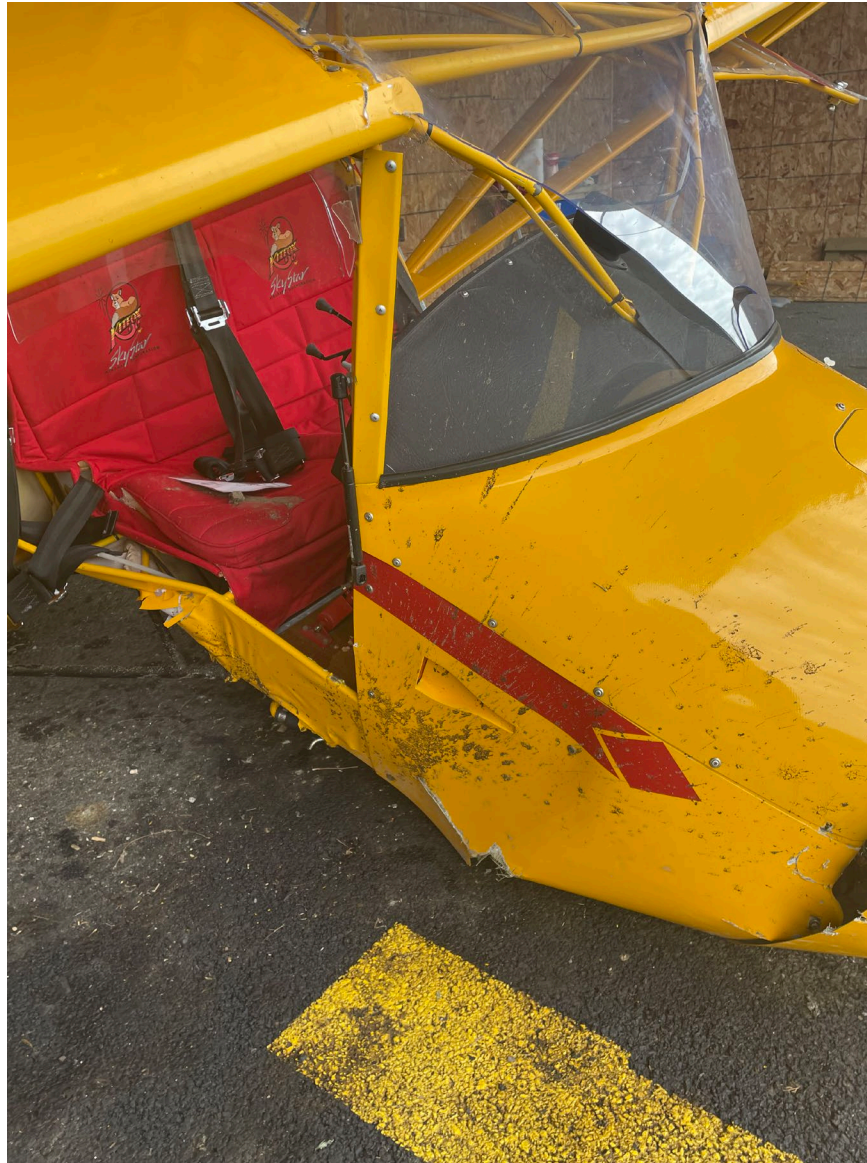
**Photograph 1 - Deformation noted to fuselage tubular structure (Courtesy of FAA)**

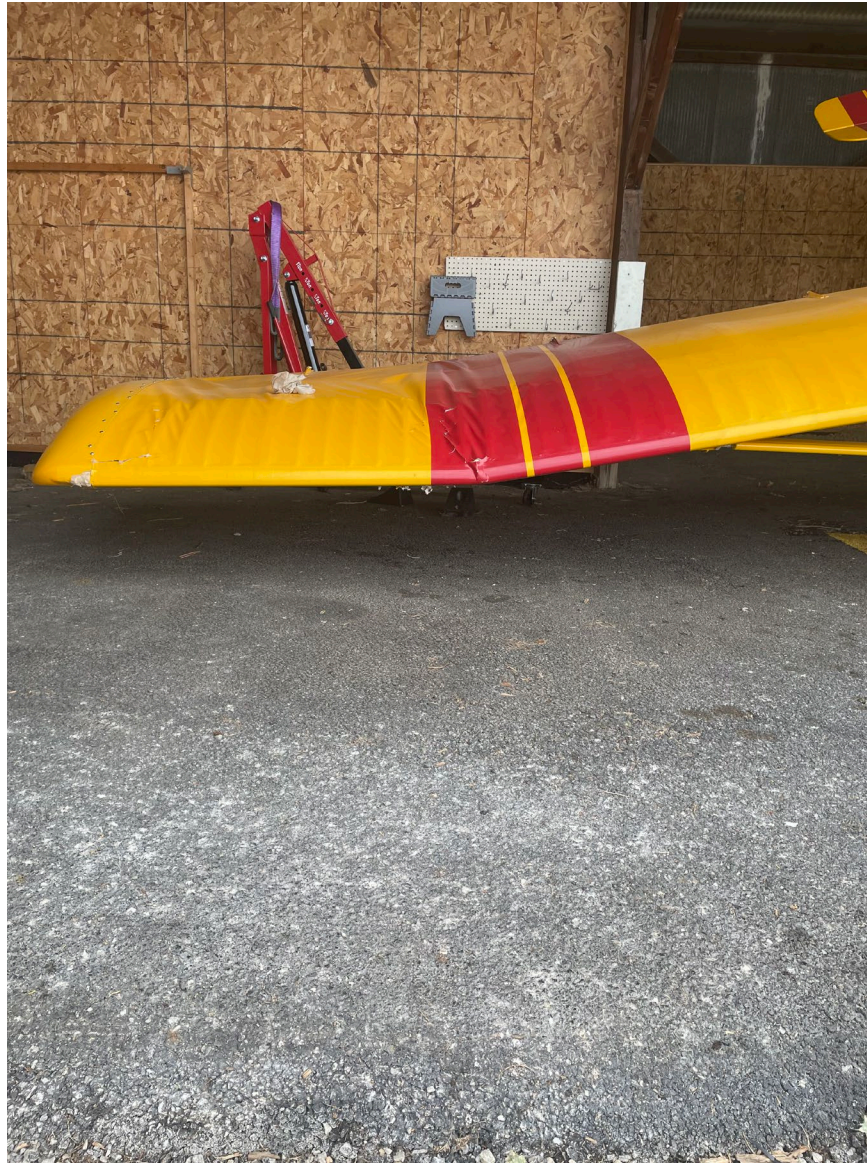
**Photograph 2 - Deformation noted to right wing (Courtesy of FAA)**

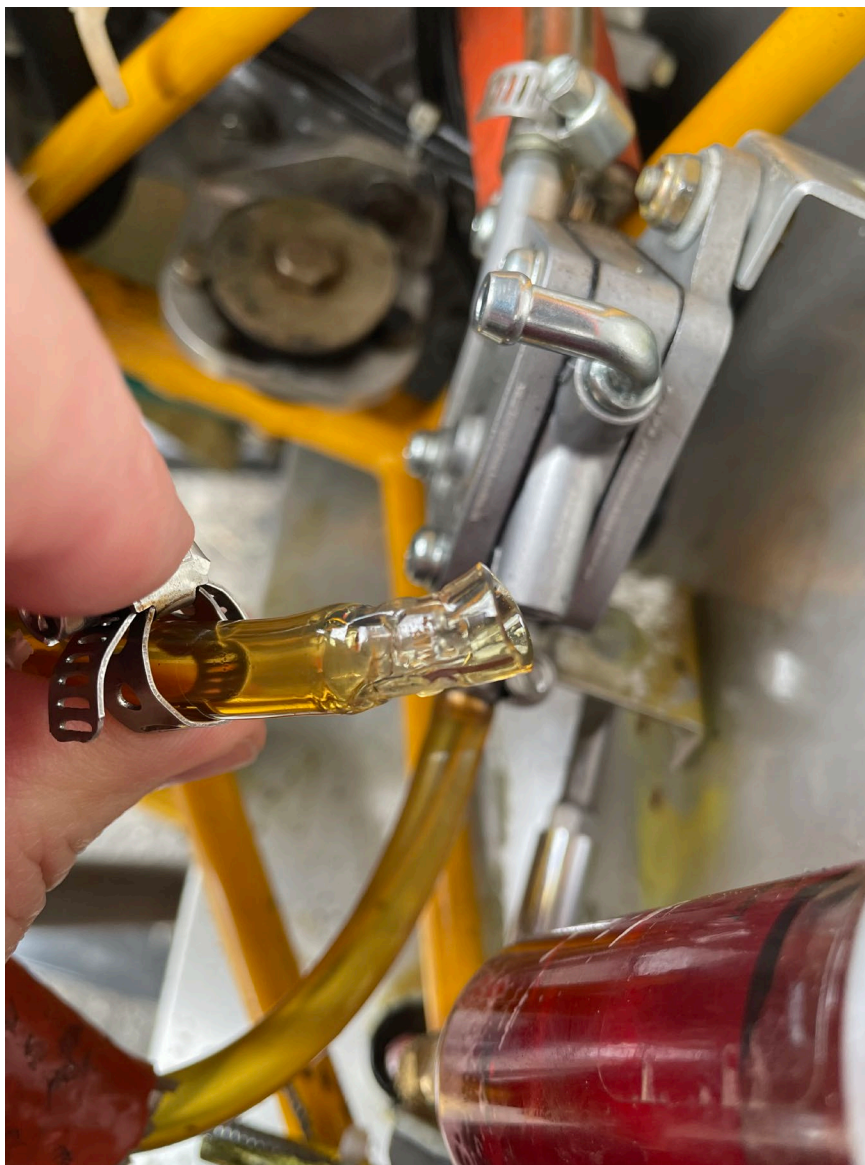
**Photograph 3 - Split noted to fuel line (Courtesy of FAA)**
