# Inspector Statement

## Accident of N143MG, October 9<sup>th</sup>, 2024, KTYS

Phoebe E. Gordon, Aviation Safety Inspector, Operations

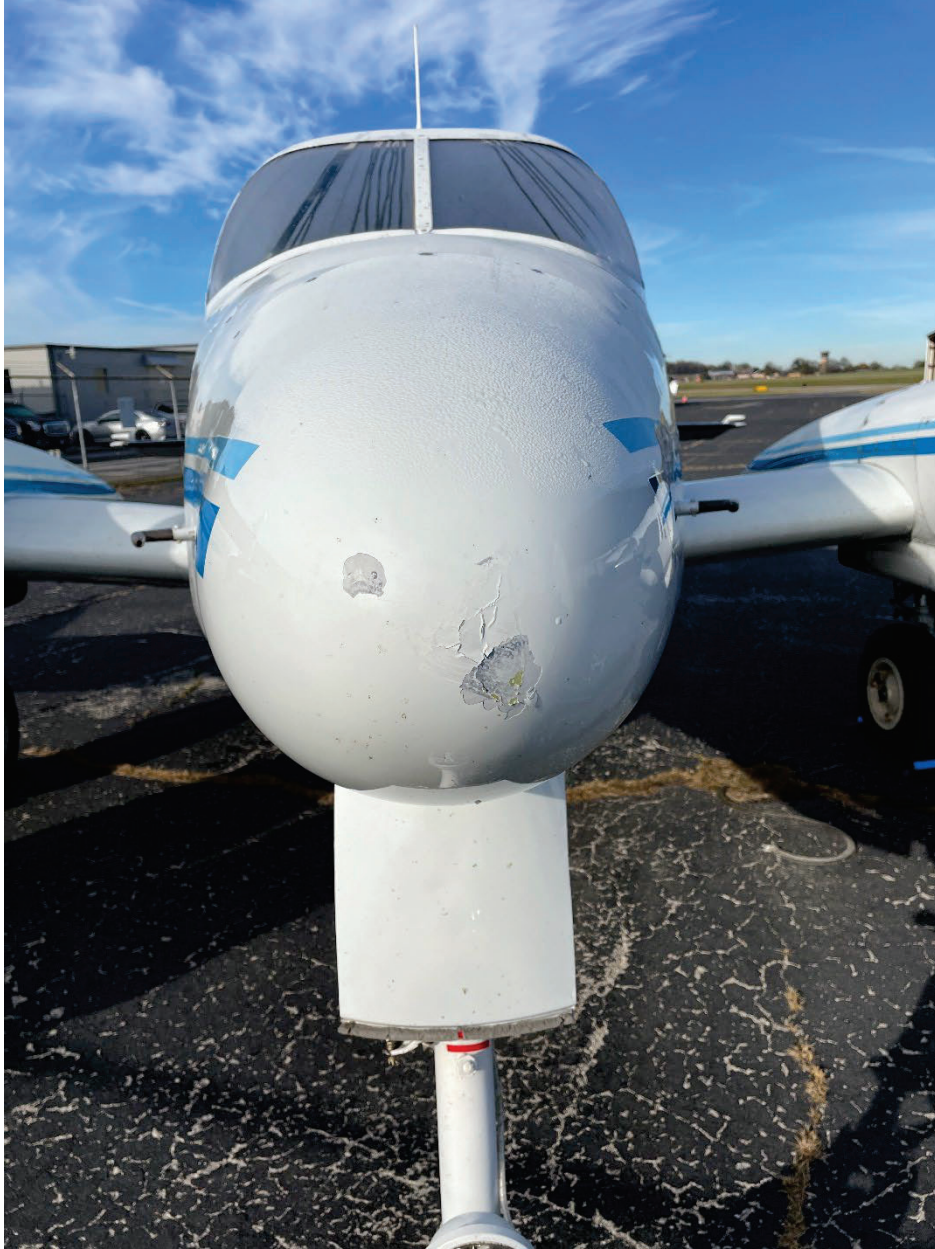
*Fuselage.* The fuselage and body of the aircraft had no noted damage except to the nose of the aircraft that showed paint chipping to the skin and minor impact damage.

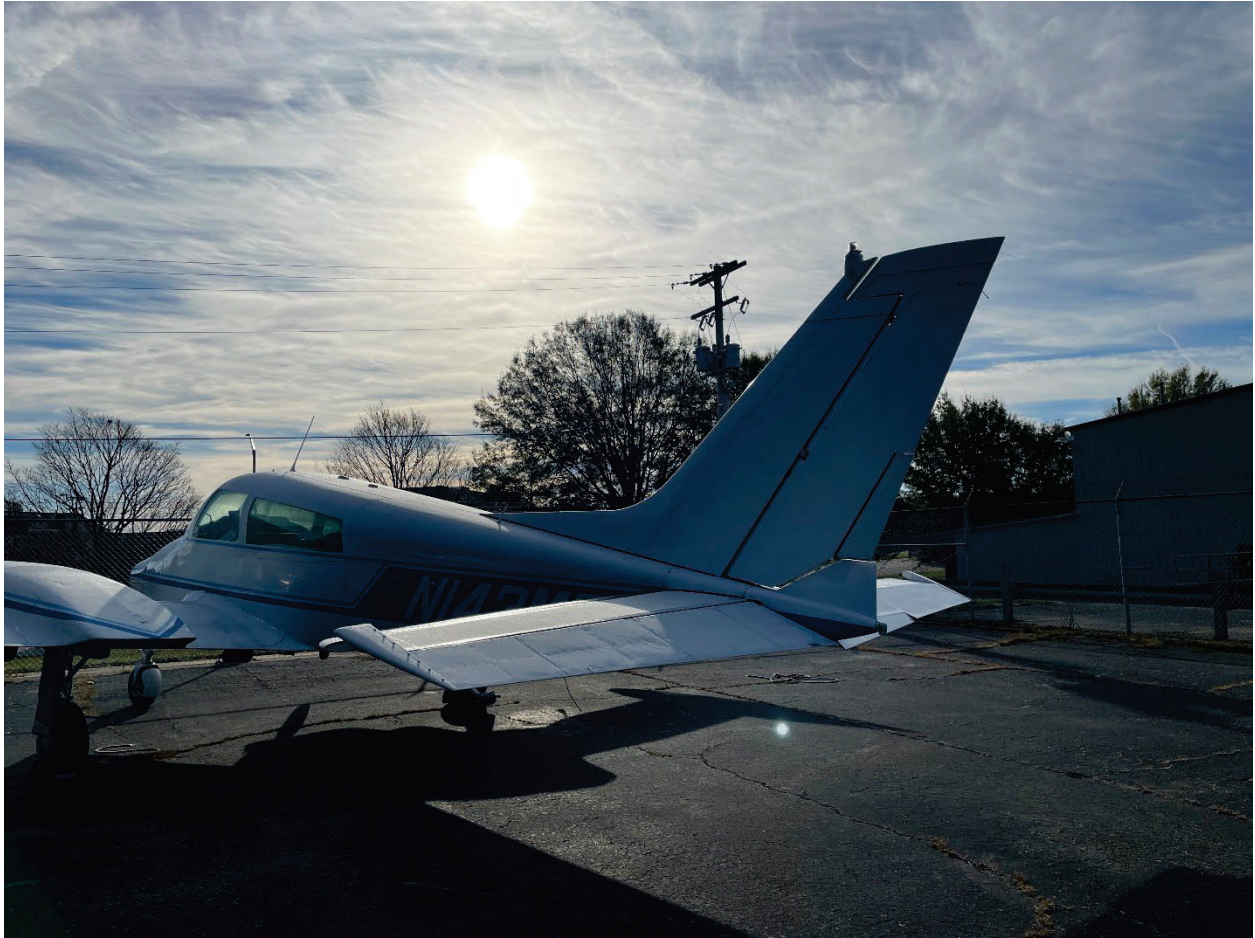
*Empennage.* The empennage of the aircraft had no noted damage albeit minor hangar rash on the rudder.

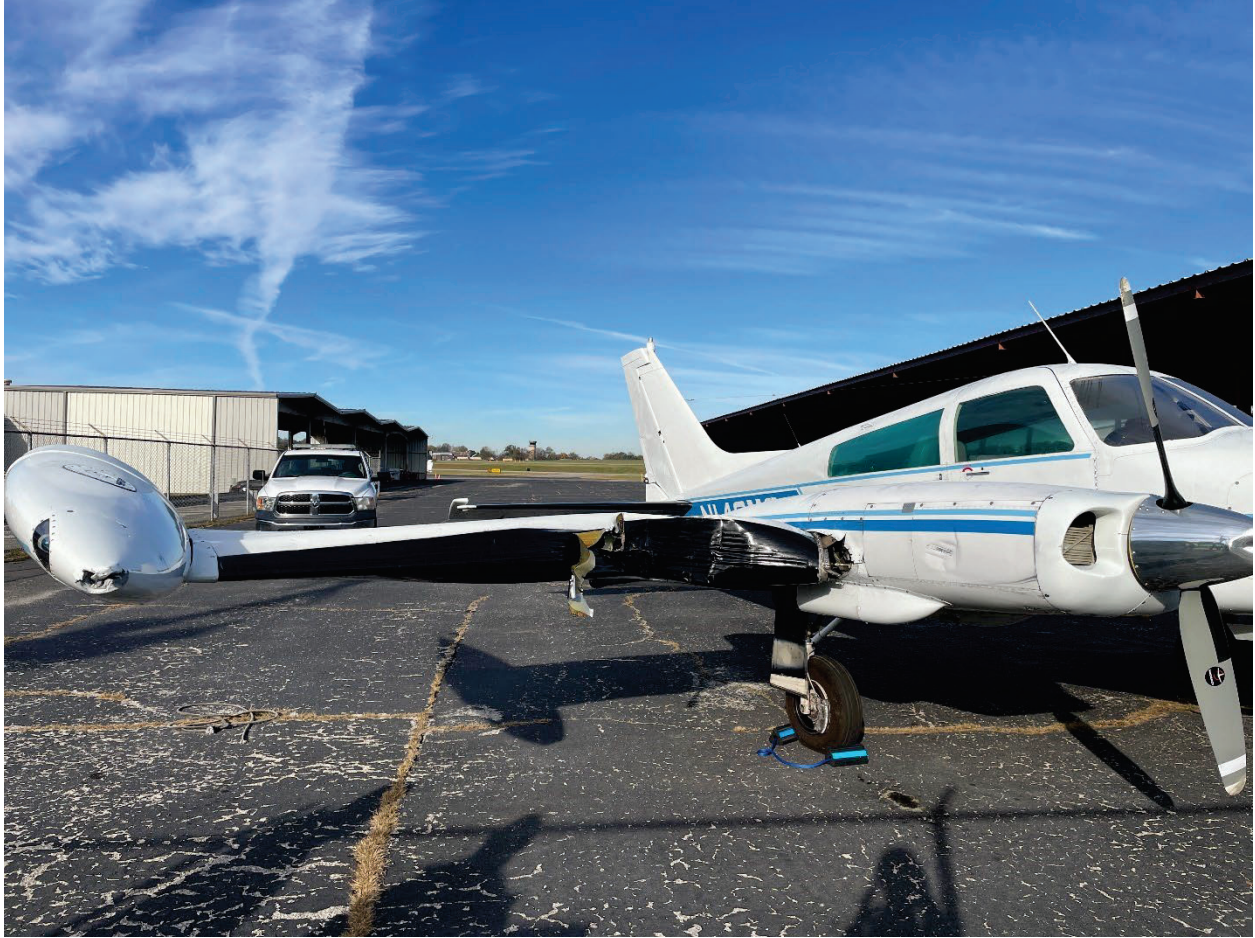
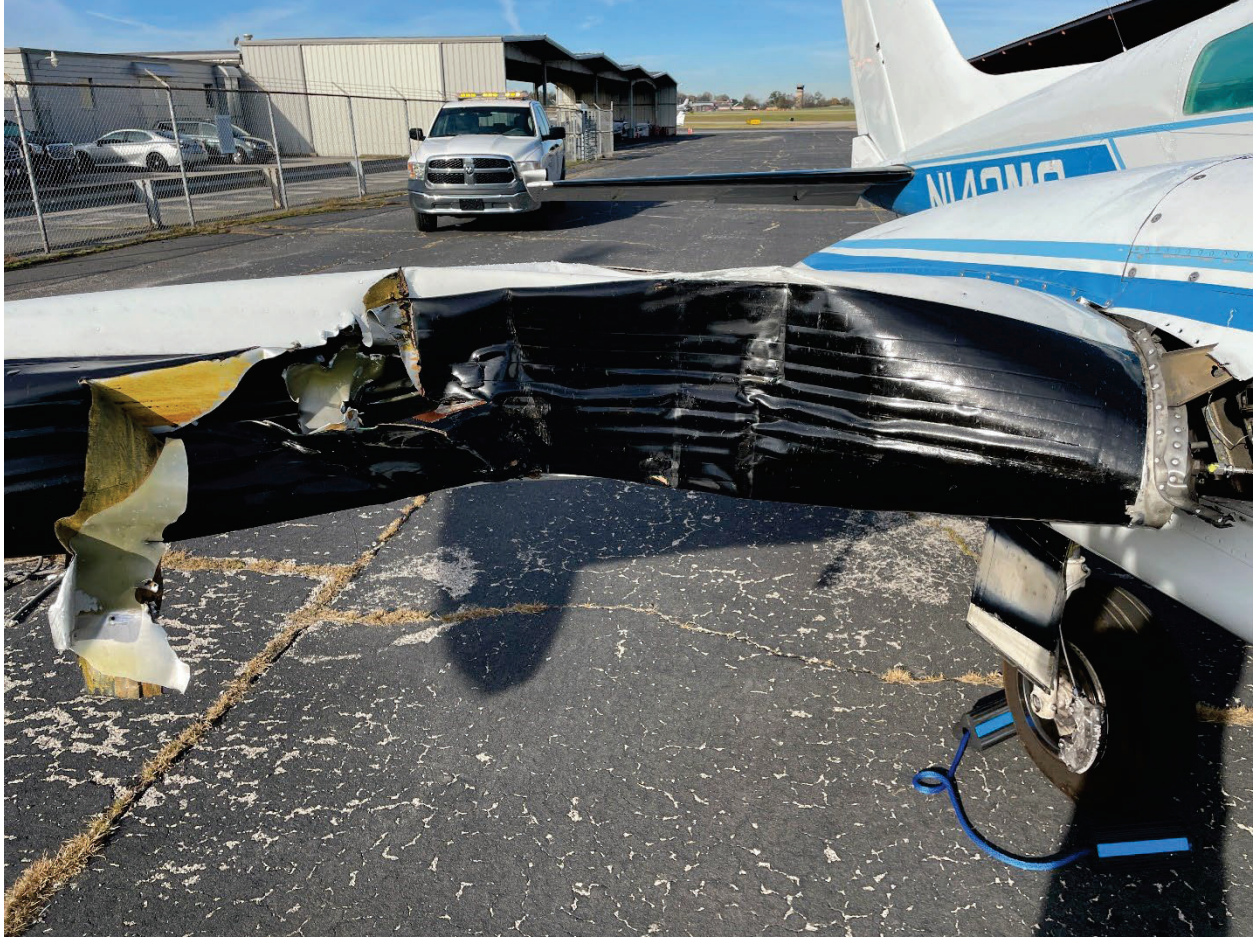
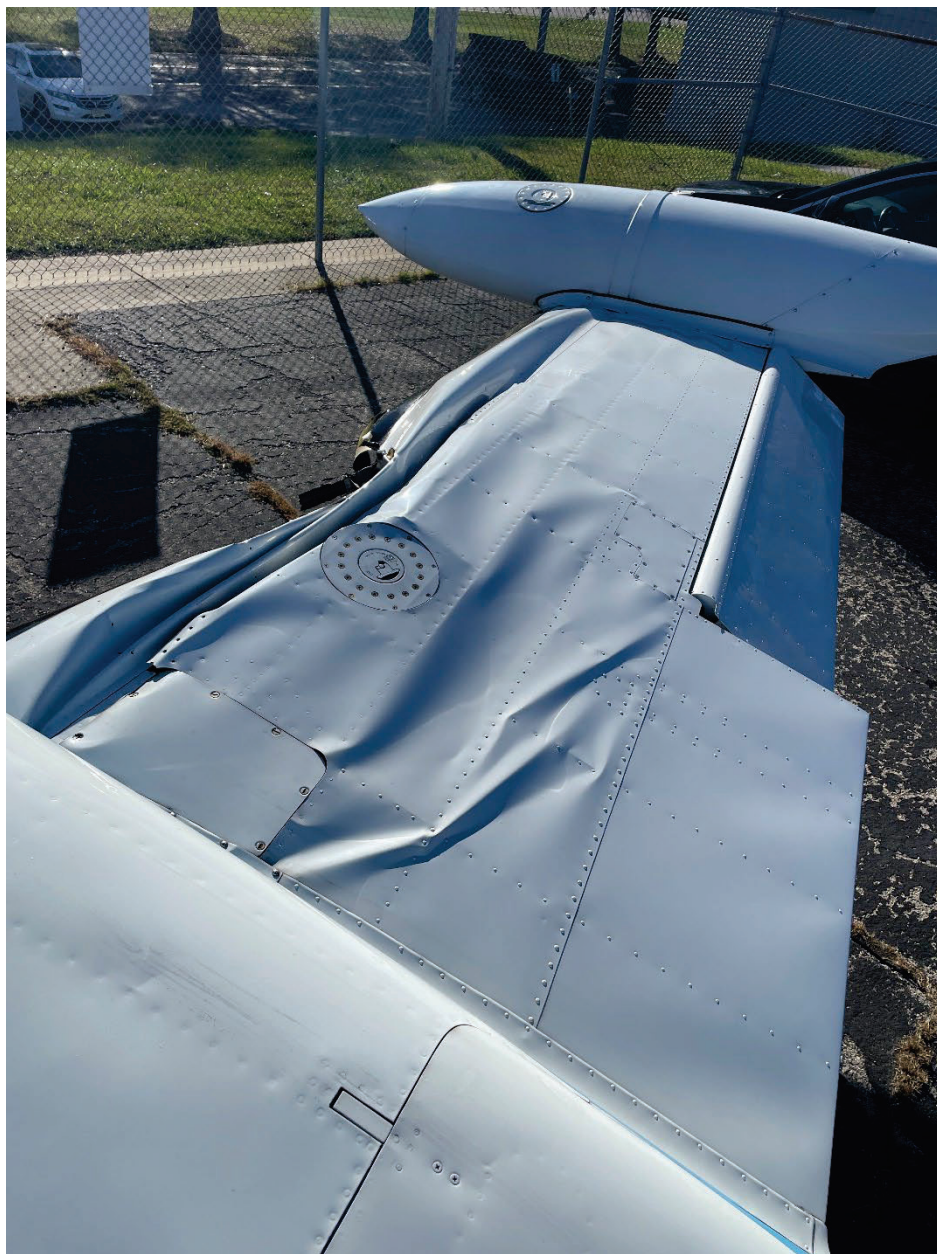
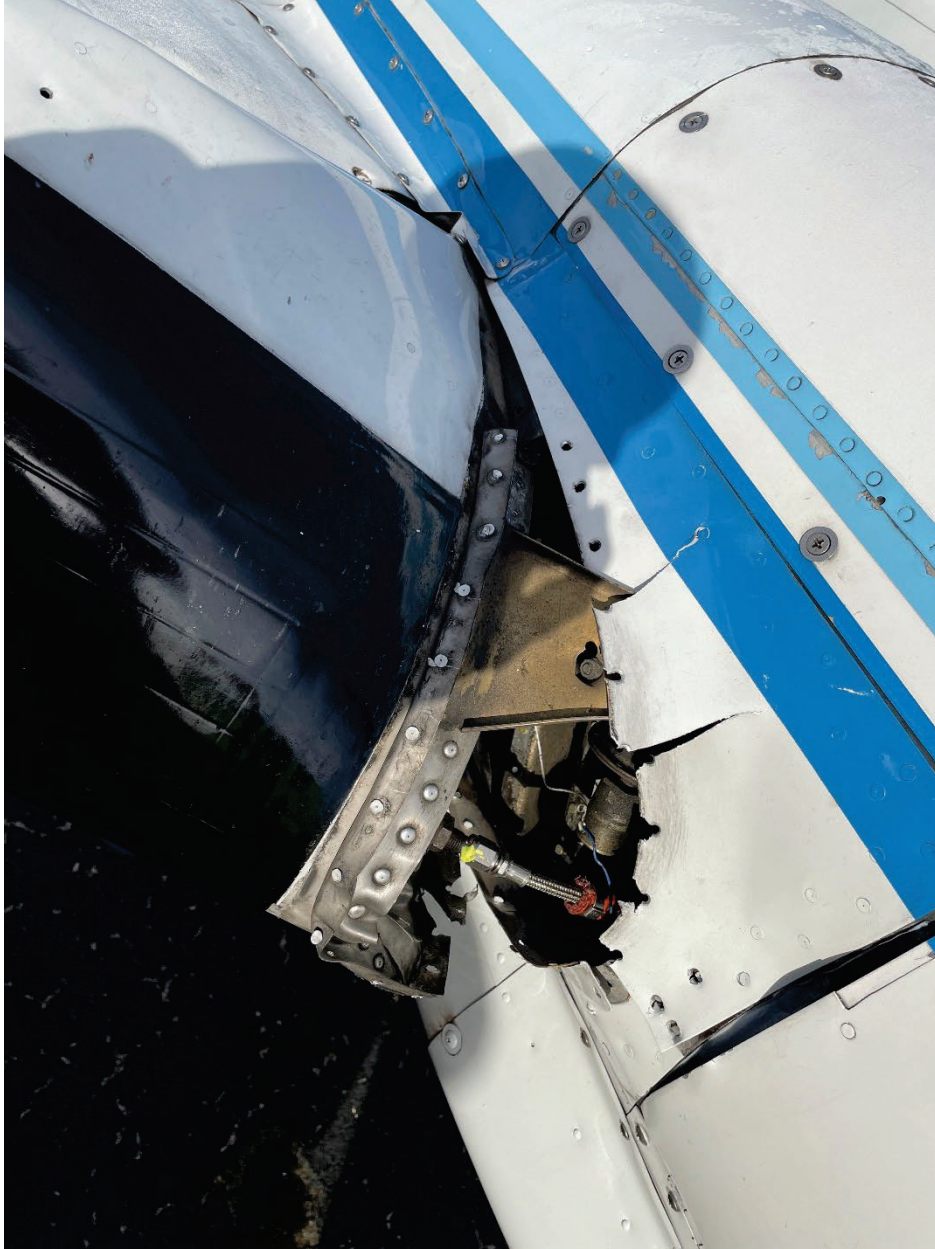
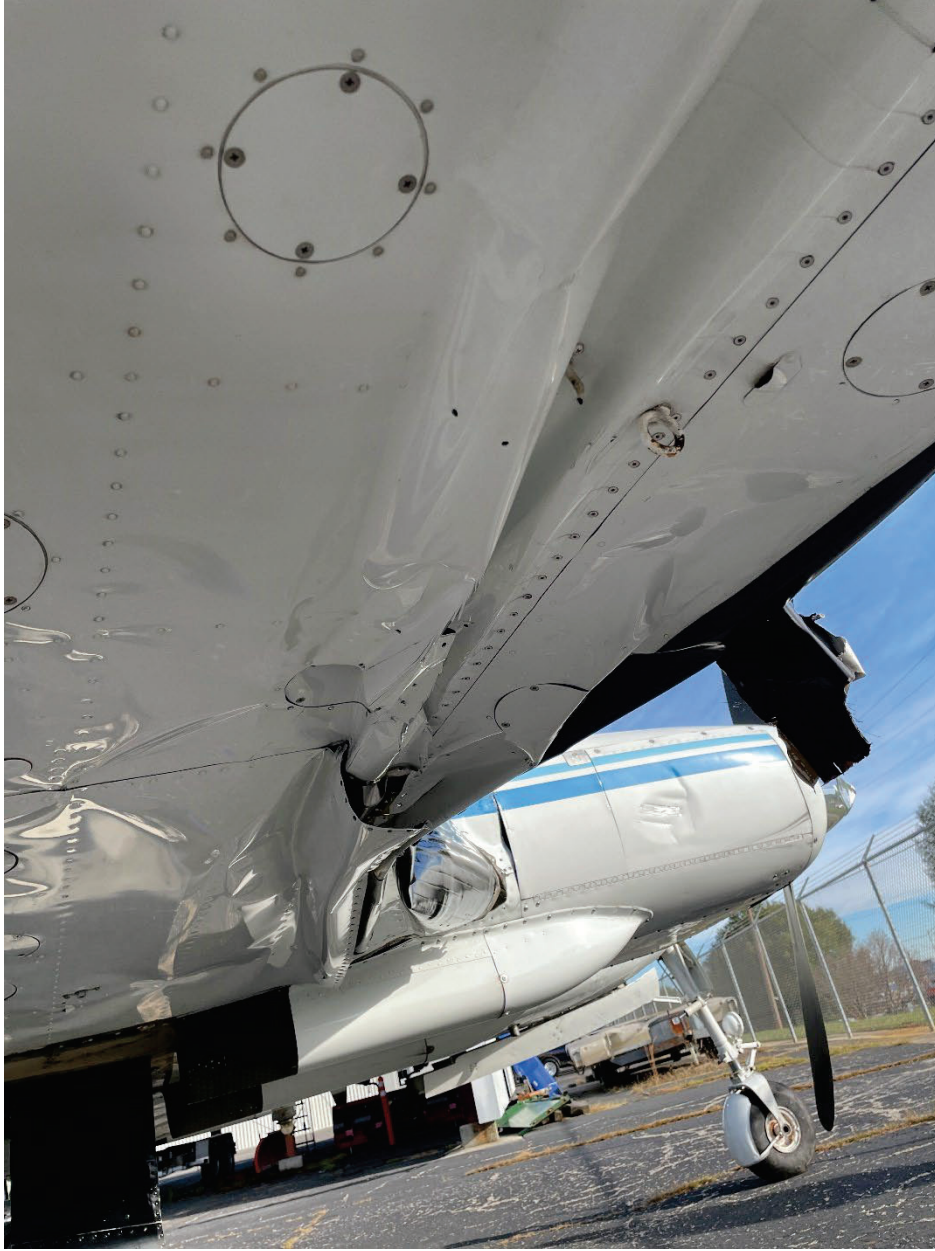
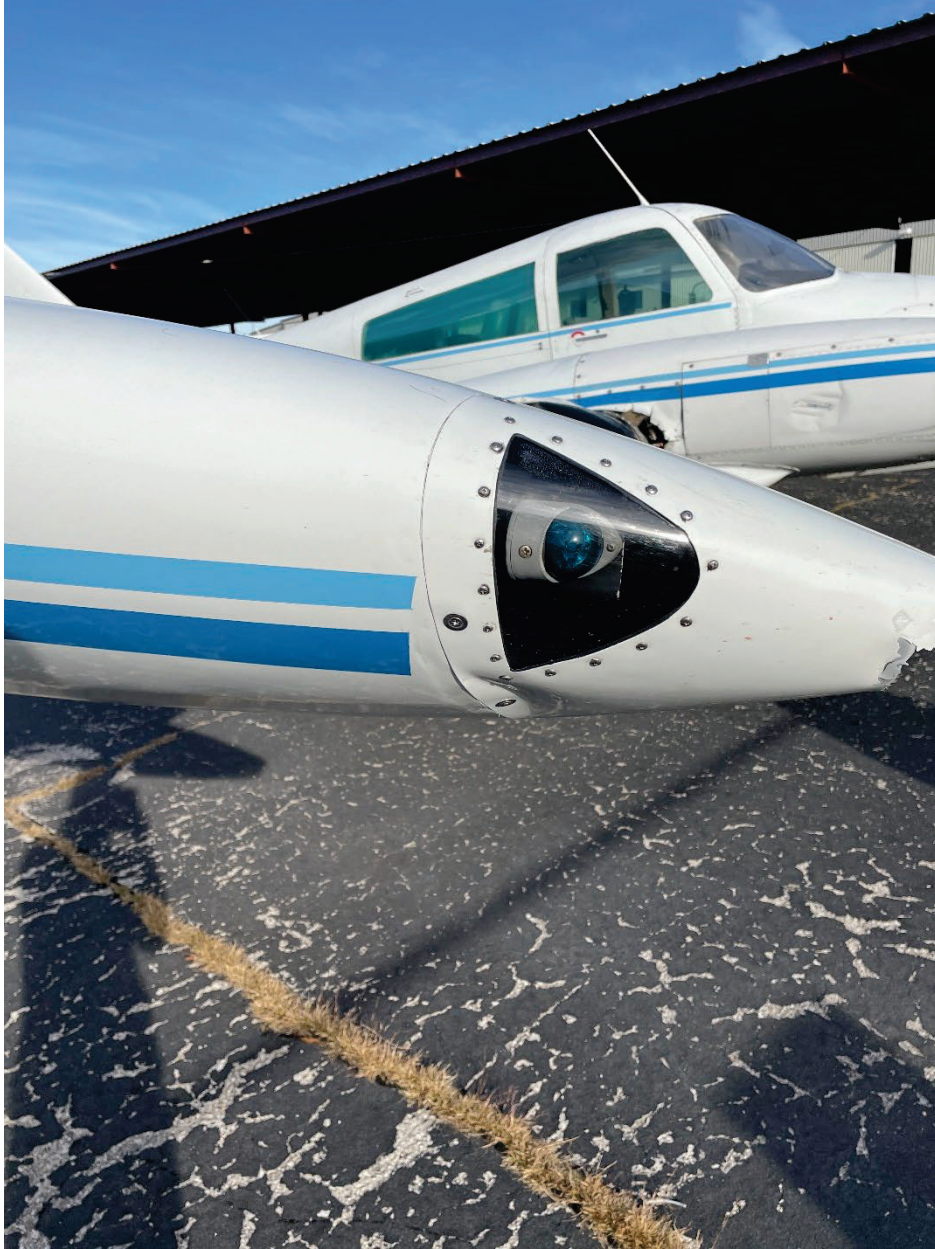
*Wings.* The left wing had no noted damage. The right wing contained significant damage to the leading edge on the center portion of the wing, directly beside the right engine nacelle. The damage to the leading edge measured approximately 164 inches in length. Significant fragmentation of the wing skin was evident. Impact damage to the right wing's leading edge is consistent with the aircraft striking the wind sensor at a high taxi speed. Significant wing separation at the attachment point to the right engine was evident. The right wing's leading edge wing spar was significantly bent, and cable damage was visually apparent. Wing skin buckling aft of the impact damage and wing/nacelle attachment point was present. The lower portion of the right wing showed fuselage buckling behind the point of impact. The right-wing tip tank showed impact damage forward of the position near the strobe light assembly.

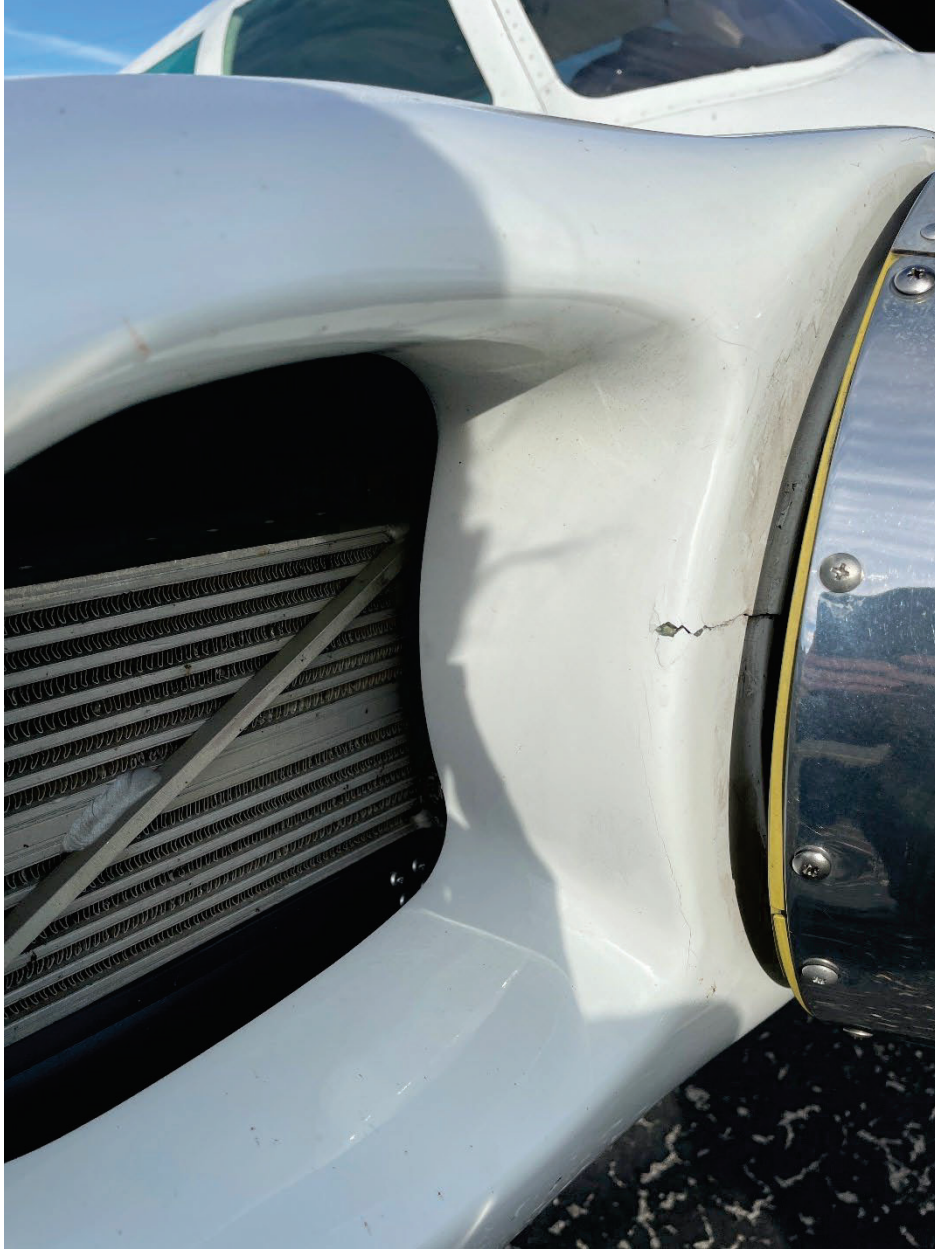
*Right engine.* Right engine nacelle skin damage was present at the attachment point of the leading-edge point of attachment between the right wing and right engine nacelle. Scrapping damage was evident on the right side of the nacelle, indicating a point of impact on the wind sensor. The right engine nose cone showed impact damage and denting. The propeller blades of the right engine showed minor scrapping damage along the tips. The propeller blades were positioned vertically. The propeller blades were not curled, indicating little to no power at the time of impact on the wind sensor. The nacelle skin behind the nose cone showed a crack on the right side.

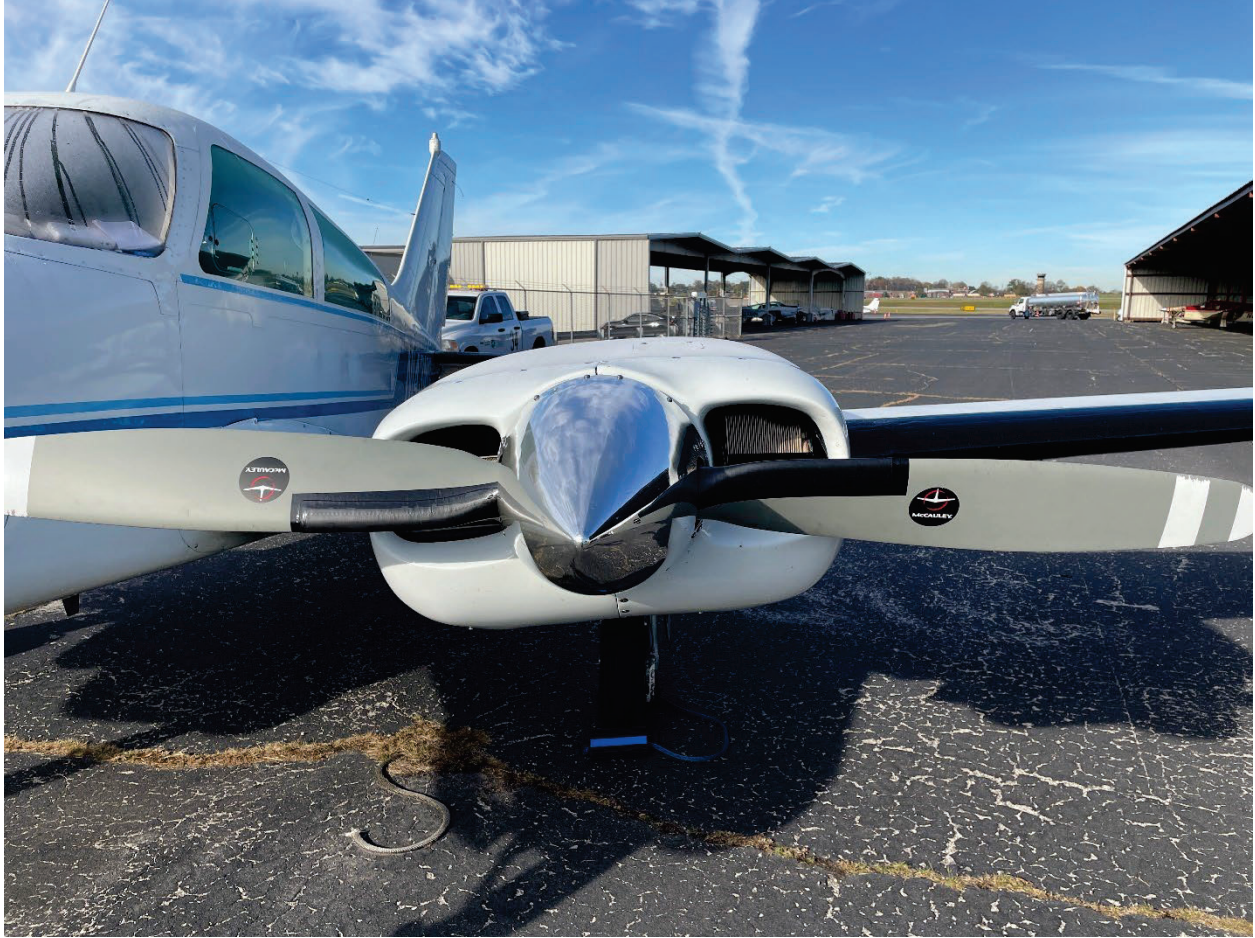
*Left Engine.* The left engine had no noted visible damage by Inspector Gordon. The left engine's propeller was positioned horizontally. Upon further evaluation from the aircraft mechanic with oversight from Inspector Ian Mullins, a stripped bearing was located at the throttle body of the left engine. This part failure results in the throttle plate fail safe to the full open throttle position. See Inspector Mullins report below.

The left engine cowlings were then removed to inspect the throttle body/linkages of the engine. Linkages all appeared to work normally while being manipulated, but it was noted that the throttle shaft was not moving while controls were manipulated. The throttle arm was then removed to inspect the splined bushing. It was noted that the splined bushing was stripped, which resulted in no resistance to the throttle shaft, allowing full power upon start.

Depending on when the bushing was stripped/failed, it is possible that the failed component could have contributed to the aircraft's tendency to want to move in the right direction as stated by the pilot.

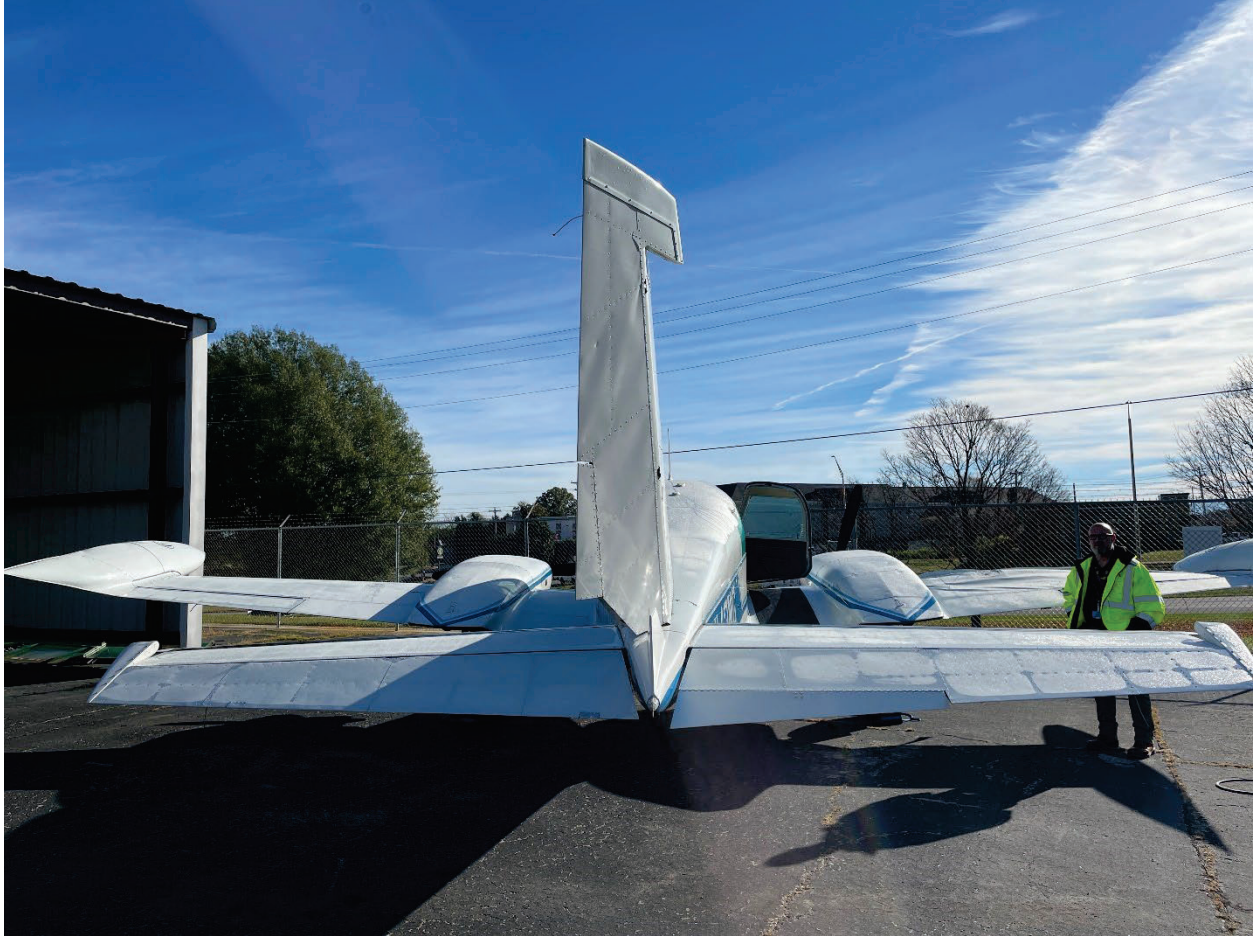
*Flight controls.* The left aileron was undamaged. The elevator was undamaged. The rudder appeared undamaged but did present minor signs of hangar rash on the right-hand side. The rudder trim tab was set in the neutral position. The elevator trim is set slightly nose low. The right aileron appeared visually undamaged. Both the left and right flaps were in the retracted position. Inspector Gordon established flight control continuity for the ailerons, rudder, and elevator from both the left and right seats. Observation from TYS operations personnel noted that the rudder deflected further left than it did when deflected to the right. The difference in travel in inches is 11.5 of travel for left rudder input versus 8 inches of travel for right rudder deflection.

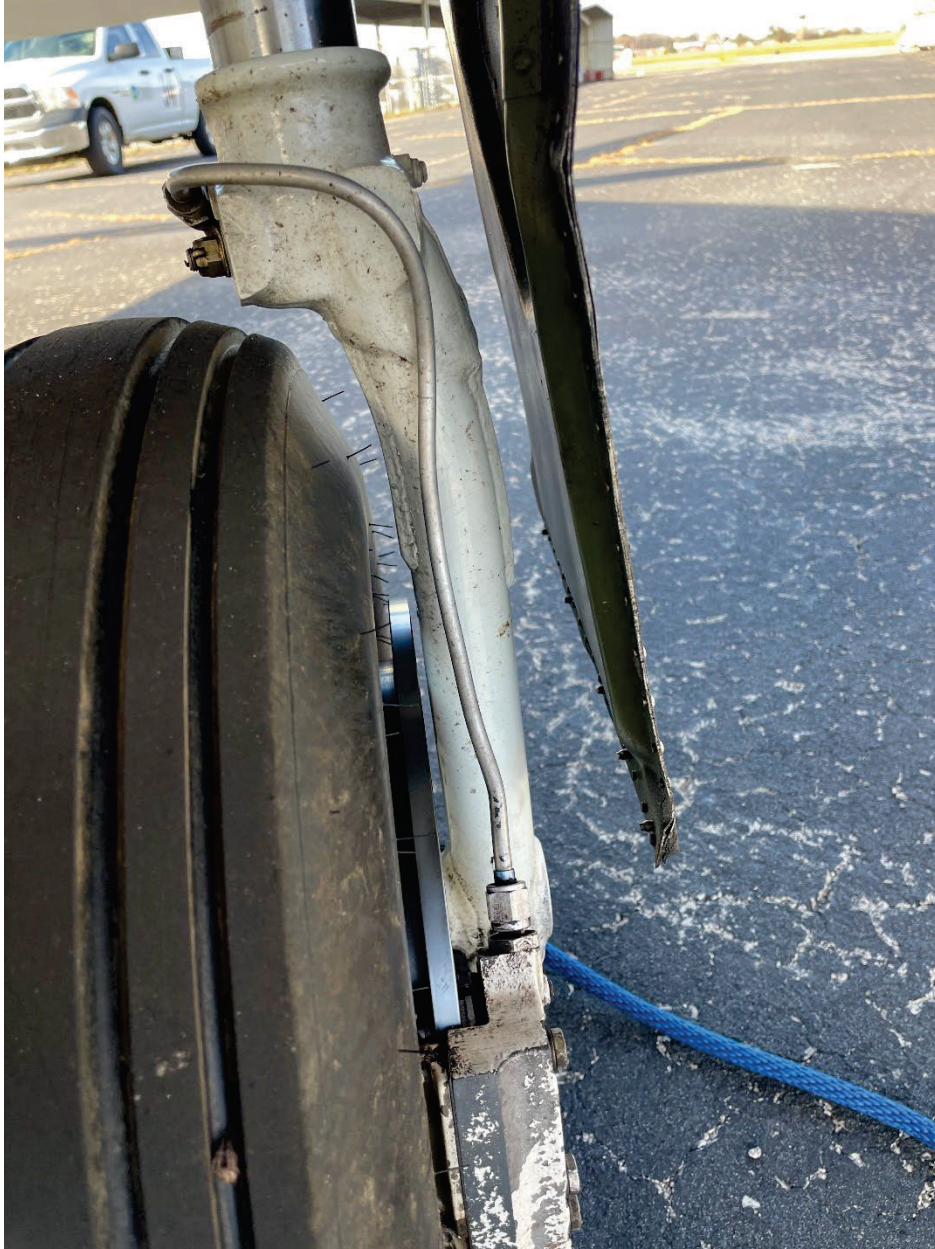
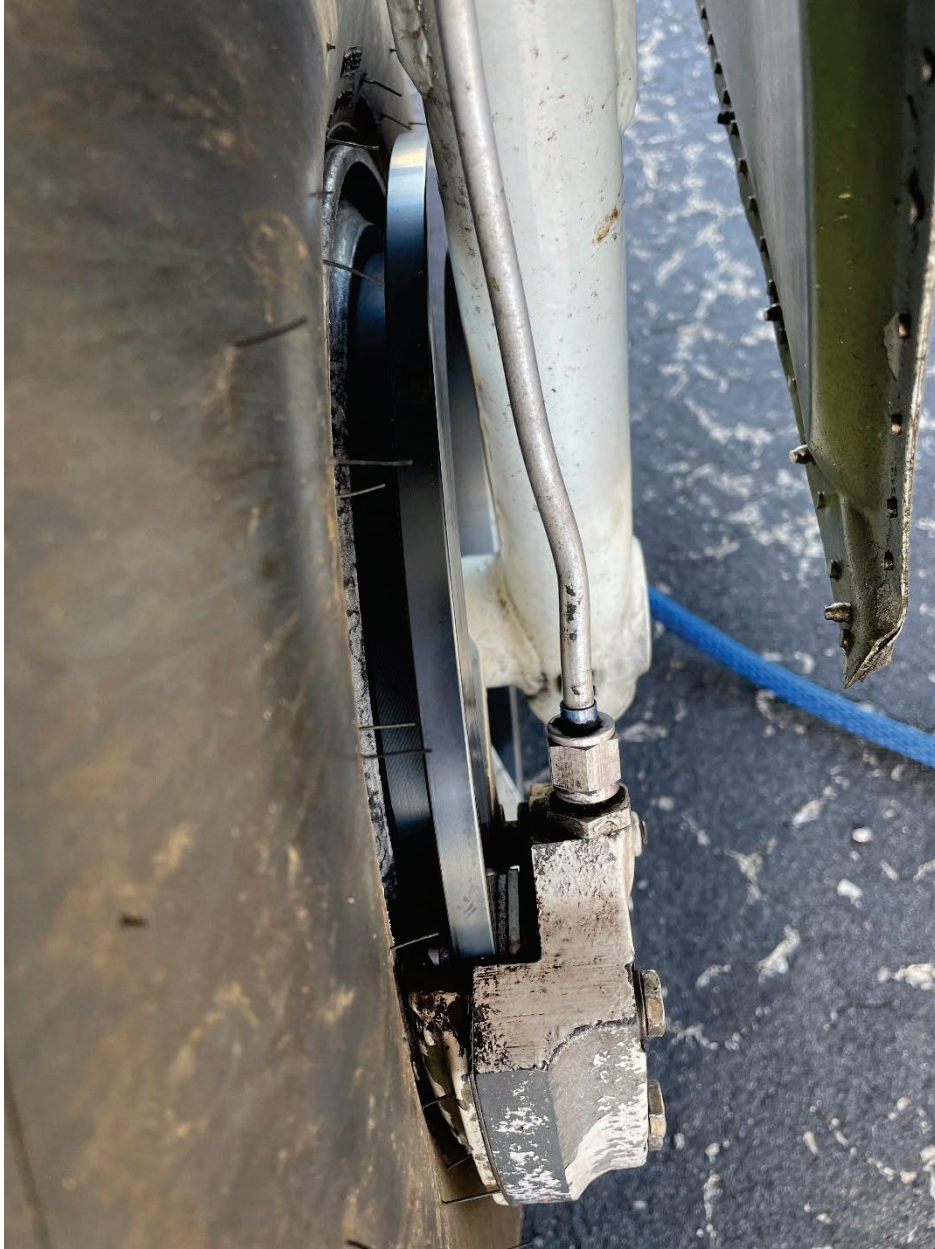
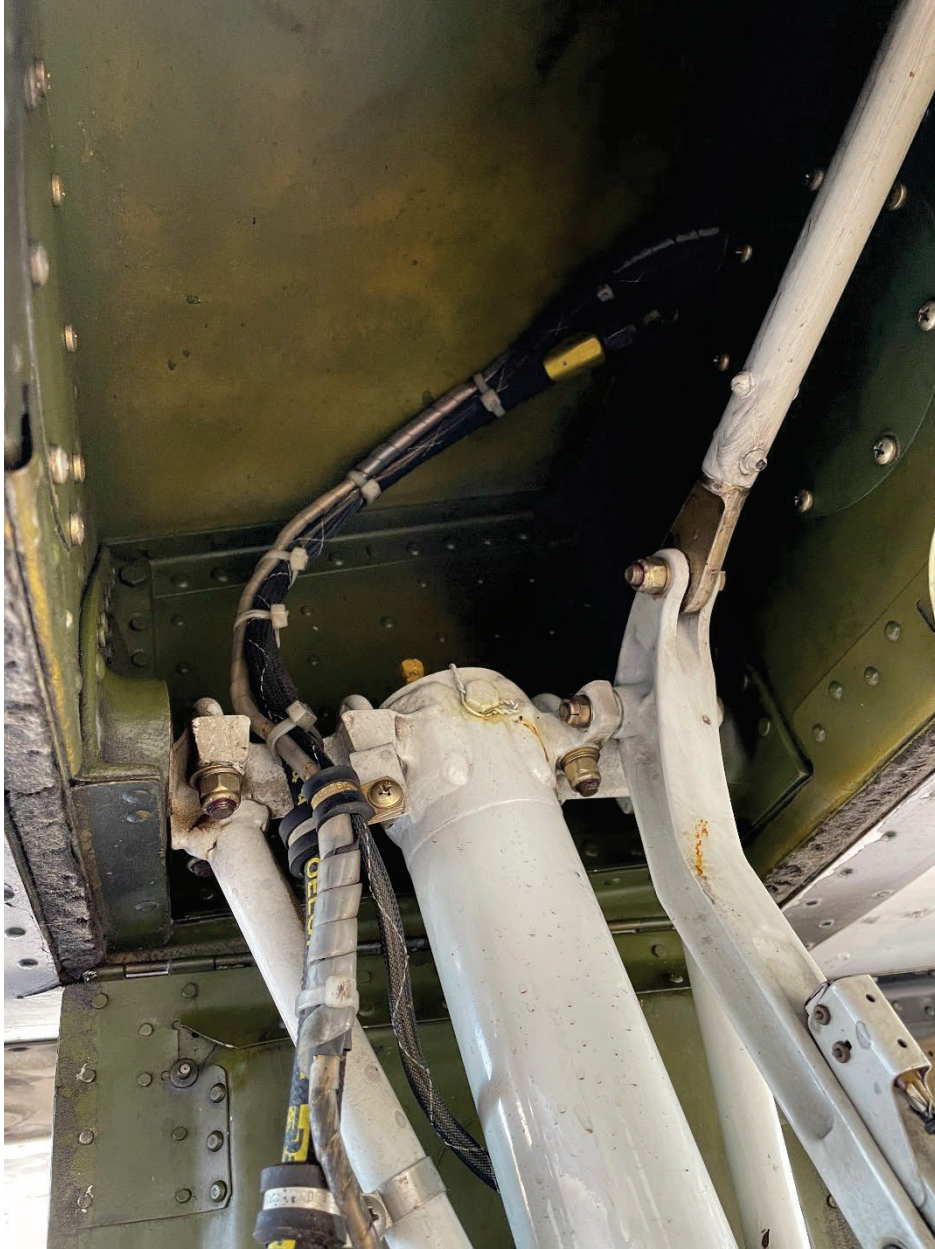
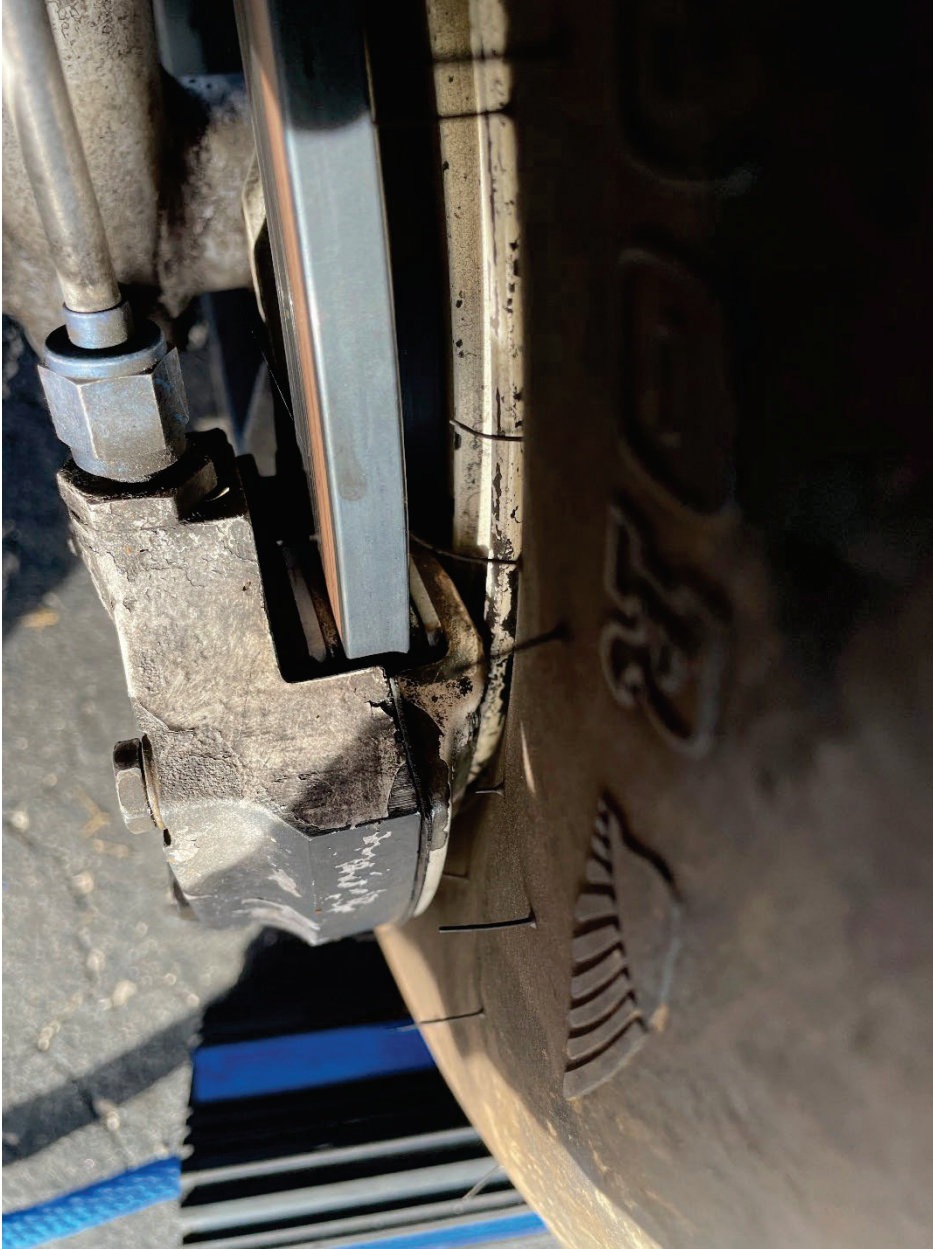
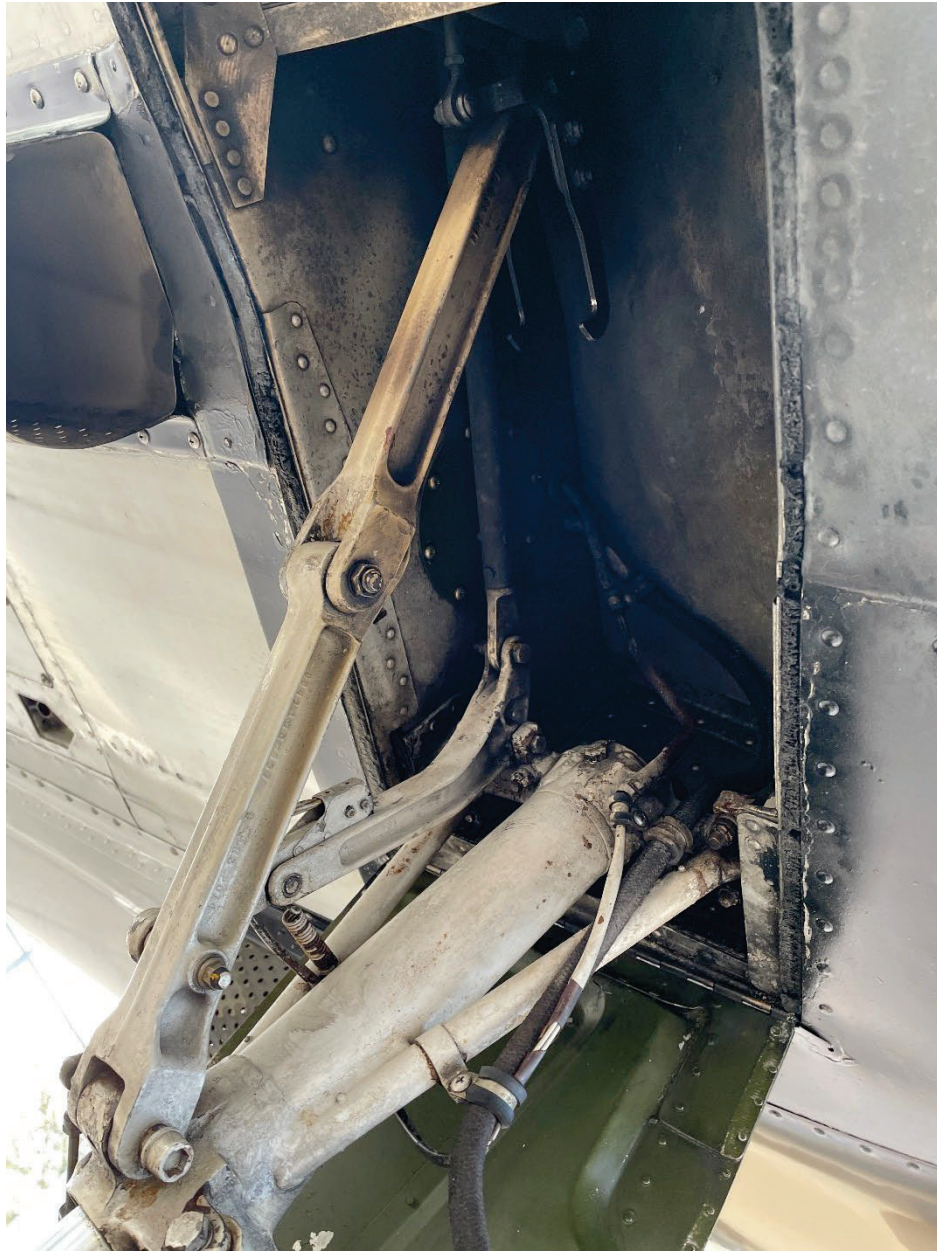
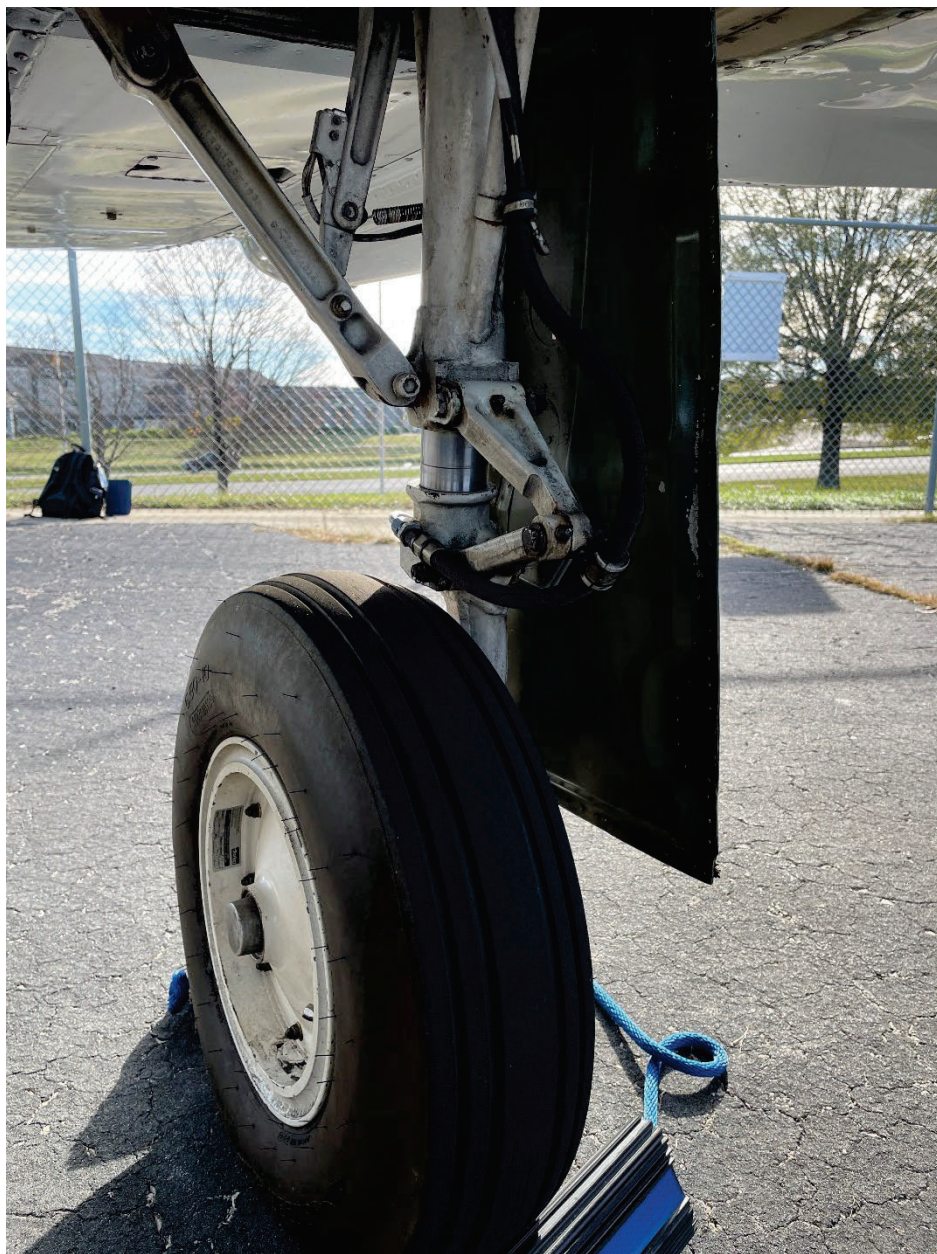
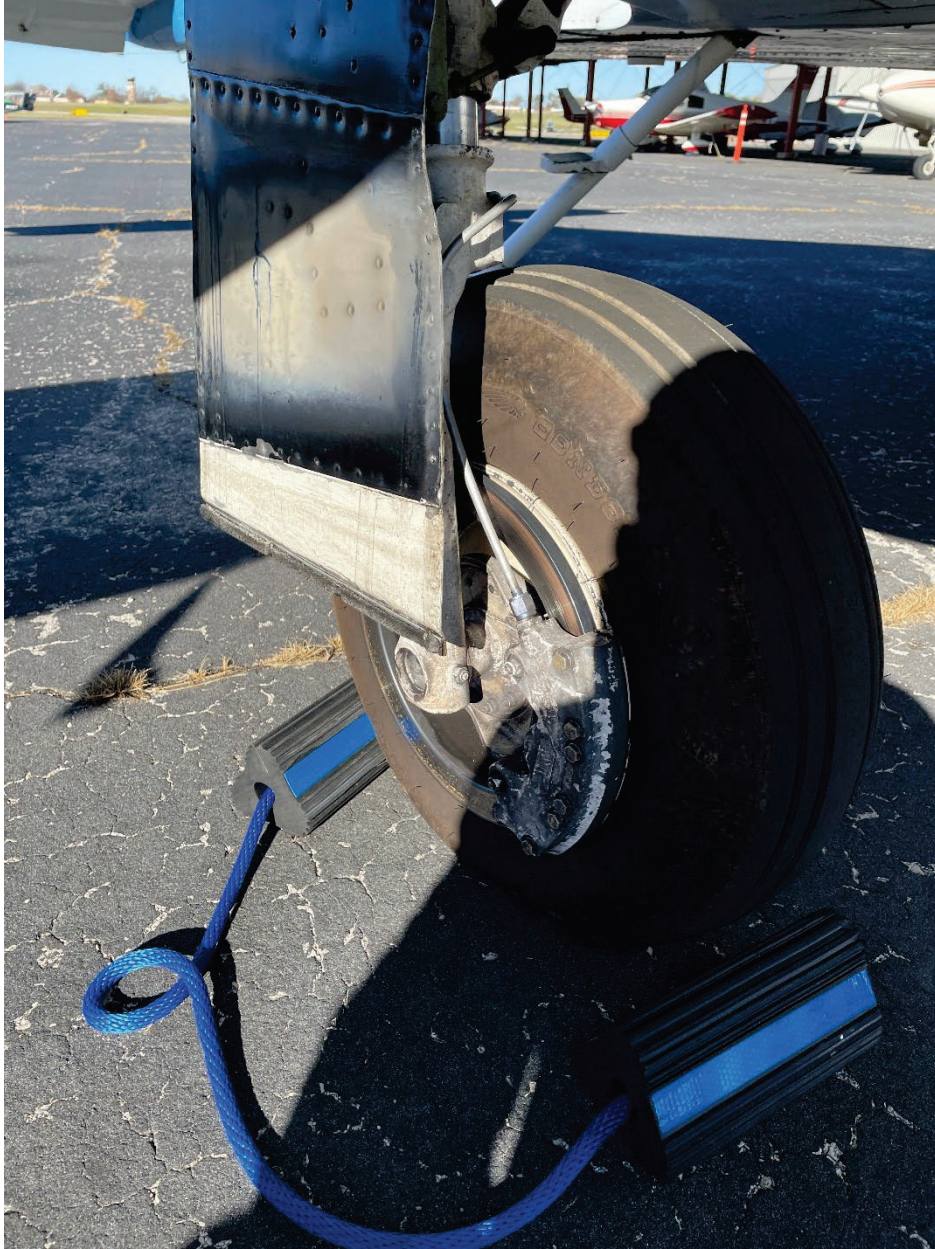
*Landing Gear and brakes.* The landing gear system showed no visible damage. All three main landing gears appeared to be in suitable condition with no visible hydraulic fluid, appropriate tire pressure, appropriate strut compression, and no additional concerns. The brakes showed no visible damage, no leaking hydraulic fluid, no torn or distressed brake lines, or significant wear on the brake pads. A full operational check of the brakes was completed by the owner's mechanic with oversight from Inspector Ian Mullins. No issues or concerns were noted during the check, and the brakes were fully operational with full power applied on the left engine.
