# Inspector Statement

## Accident of N143MG, October 9<sup>th</sup>, 2024, KTYS

Phoebe E. Gordon, Aviation Safety Inspector, Operations

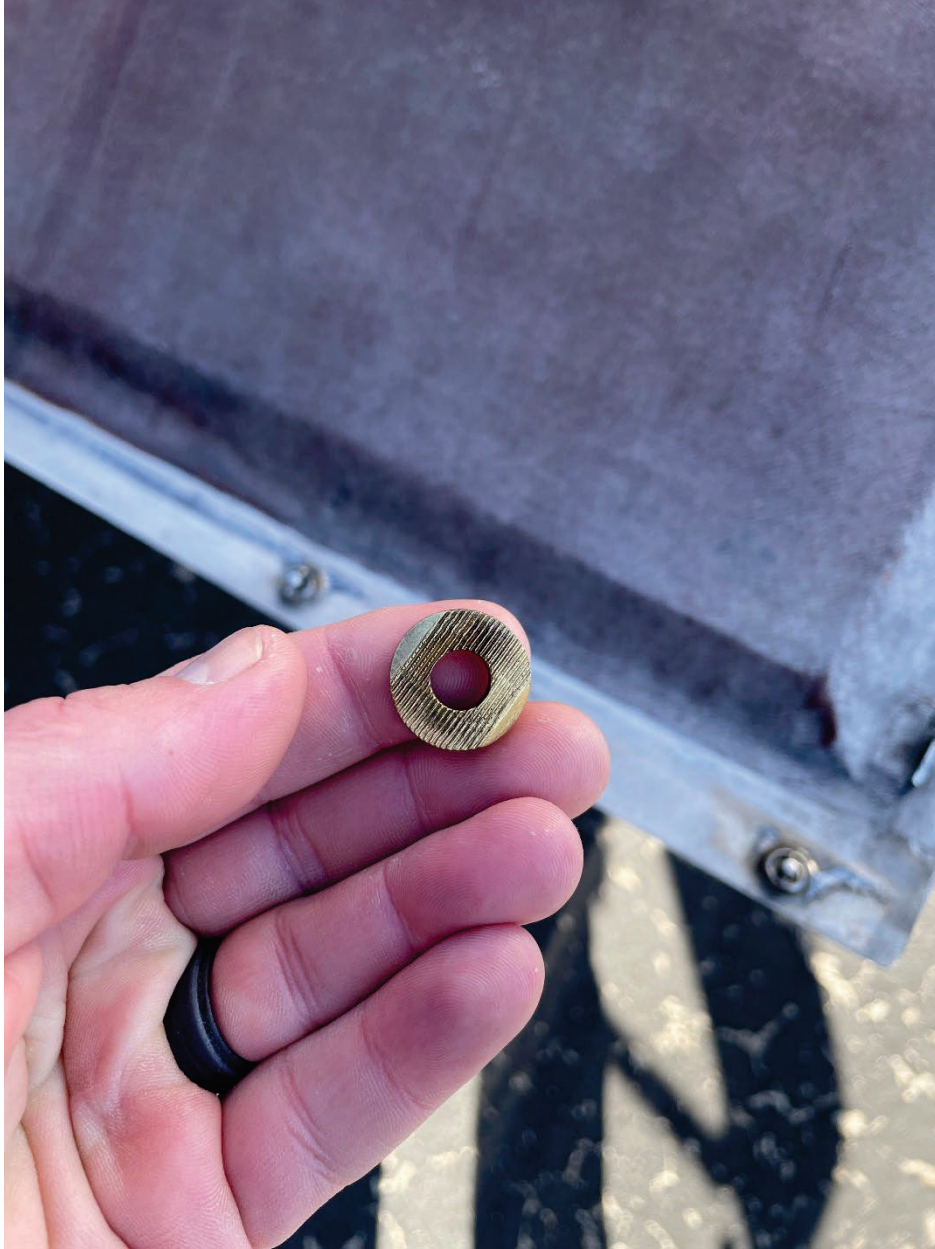
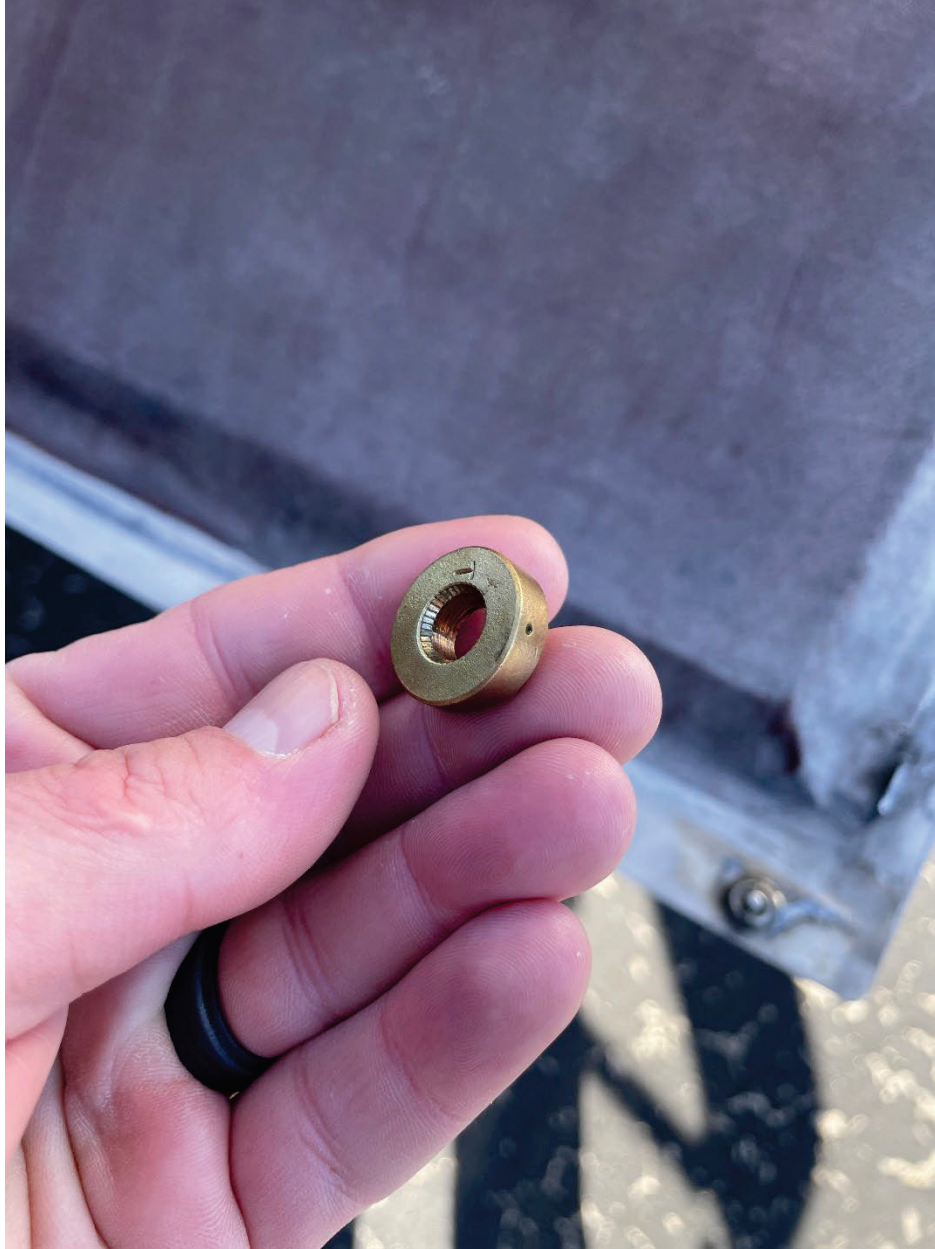
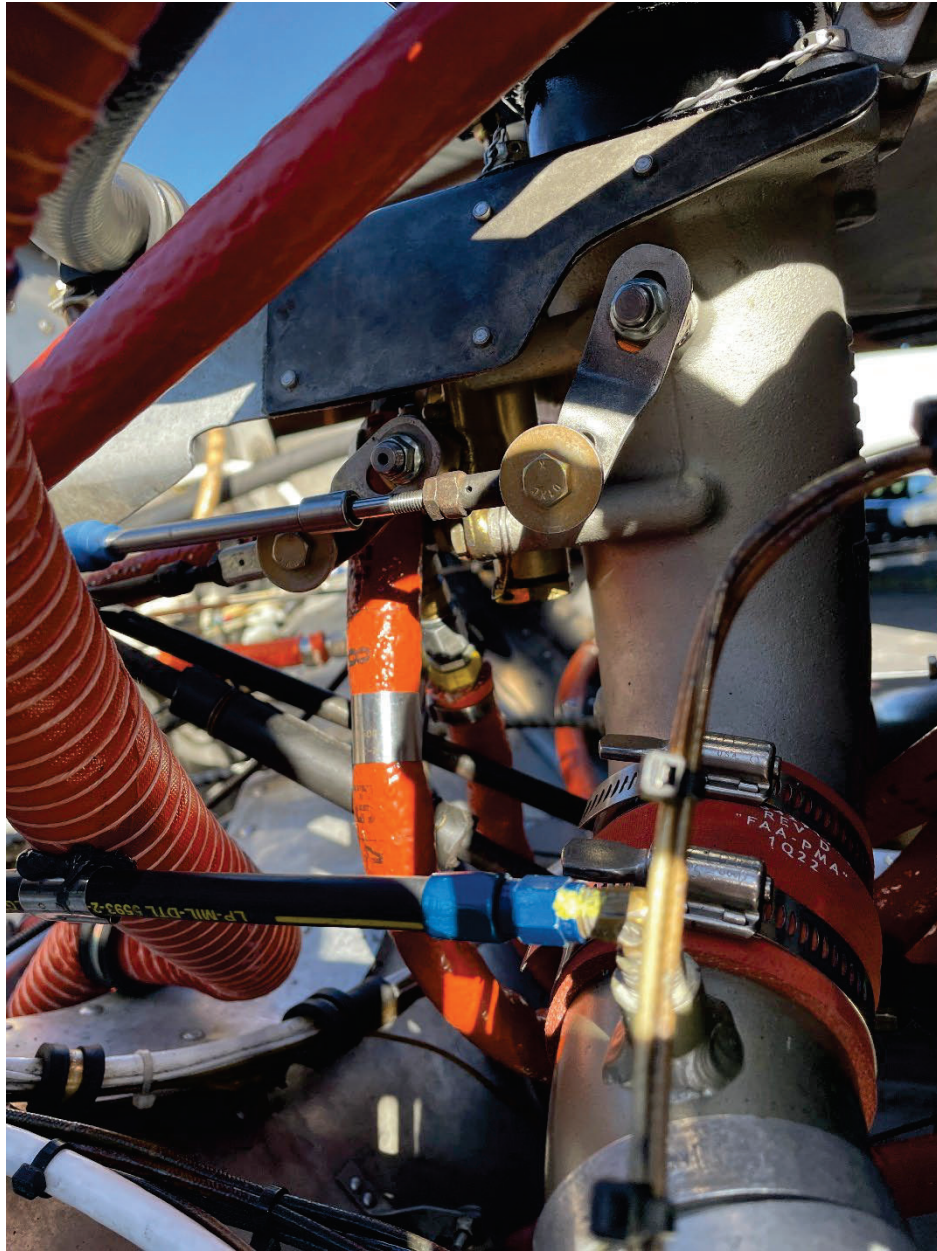
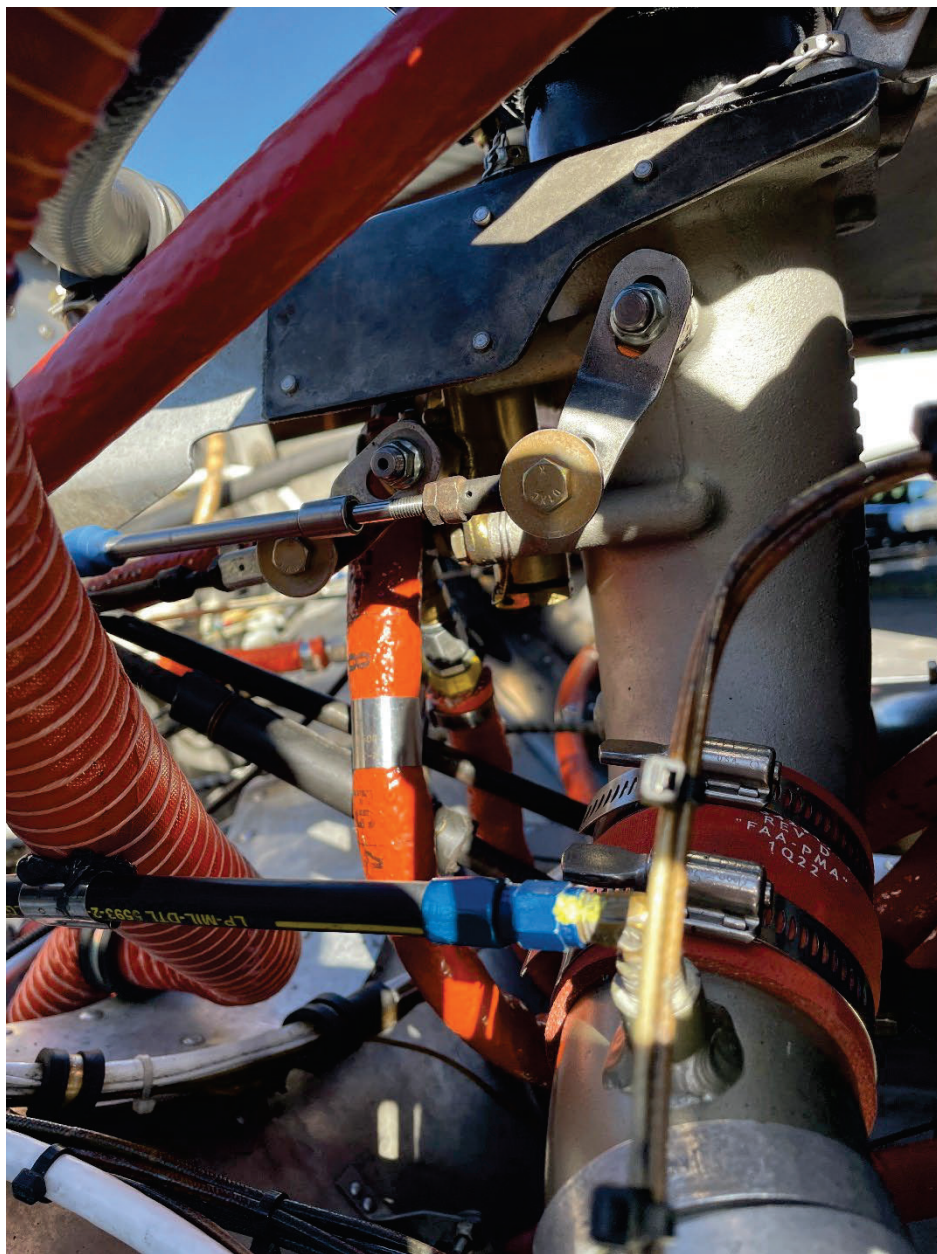
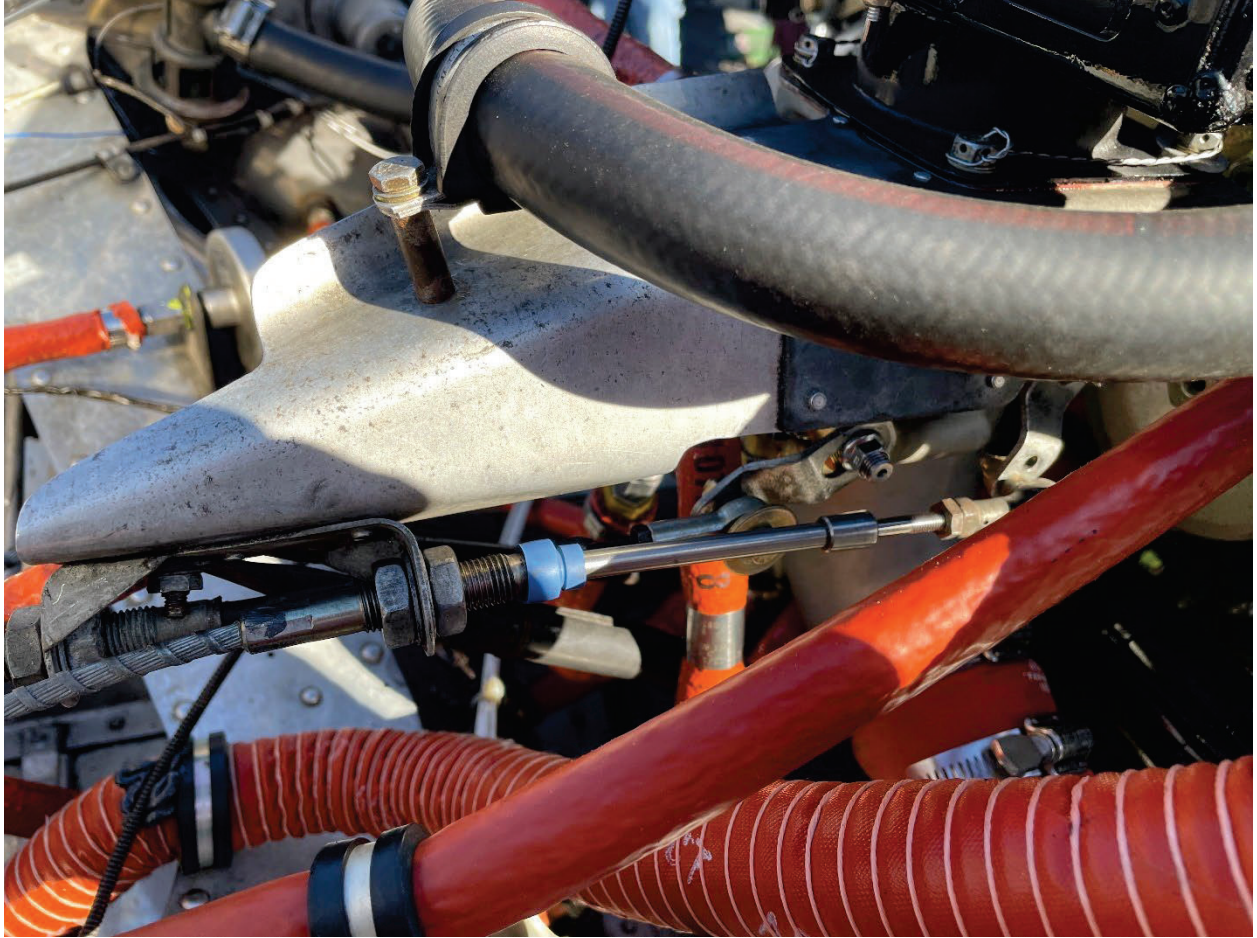
The left engine cowlings were then removed to inspect the throttle body/linkages of the engine. Linkages all appeared to work normally while being manipulated, but it was noted that the throttle shaft was not moving while controls were manipulated. The throttle arm was then removed to inspect the splined bushing. It was noted that the splined bushing was stripped, which resulted in no resistance to the throttle shaft, allowing full power upon start.

Depending on when the bushing was stripped/failed, it is possible that the failed component could have contributed to the aircraft's tendency to want to move in the right direction as stated by the pilot.
