# National Transportation Safety Board

ERA25LA053

## ENGINE RUN REPORT

Location: Doylestown, PA  
Date: November 18, 2024  
Time: 12:21 EST  
17:21 EST  
Airplane: Beechcraft A36 Bonanza, N8152R

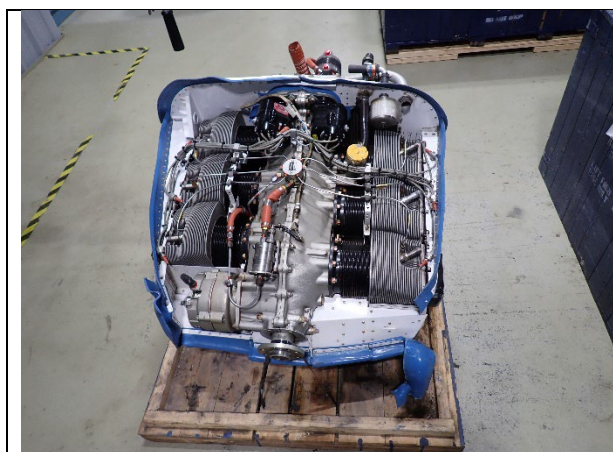
Photograph 1: Top of engine overview

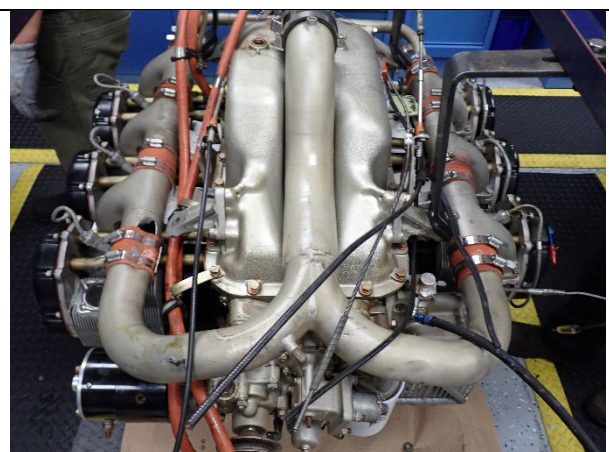
The engine was shipped to Continental Aerospace Technologies in an engine shipping crate. The crate appeared to be undamaged from shipping. The engine was removed from the crate and visually examined for damage. All four engine mounts were broken, the left side exhaust risers were slightly bent, the No. 1 intake tube had a hole near the Y-tube attach

coupling, and the intake Y-tube had a large dent in the tube at the attach coupling end. The engine mounts were replaced with serviceable engine mounts, the damaged intake tube was replaced with a serviceable tube, the exhaust risers were replaced with straight pipes, and the dent in the intake Y-tube was manually reshaped to prevent any intake leaks during the engine run. The magneto to engine timing was checked, and the left magneto was found to be 25° before top dead center (BTDC), and the right magneto was found to be 26° BTDC. The magneto timing specifications for the IO-550-B engine was 22° BTDC. A cold compression check was conducted with the following results:

Photograph 2: Bottom of engine overview (impact damage to intake tube visible)

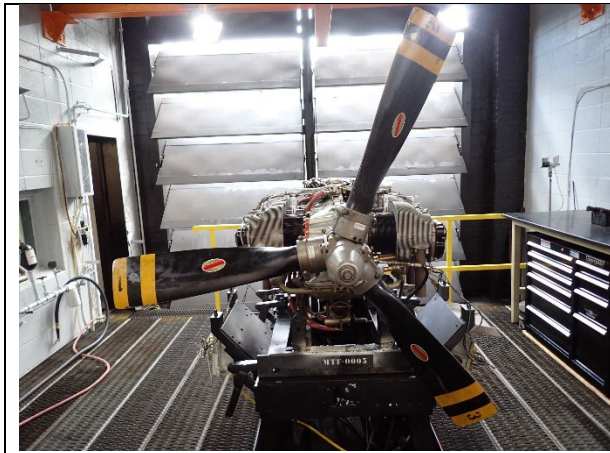
Photograph 3: Engine on test stand

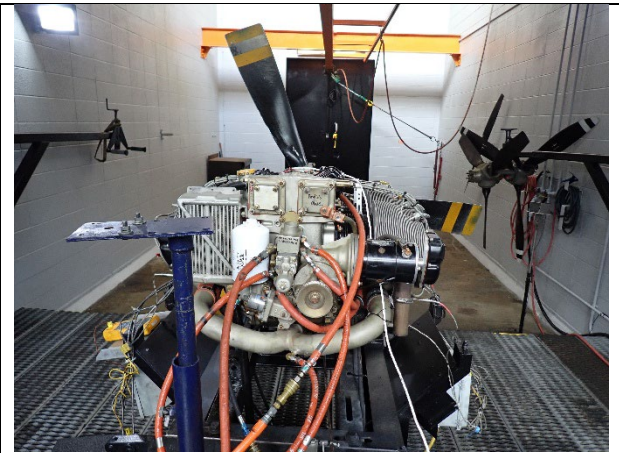
Photograph 4: Engine on test stand

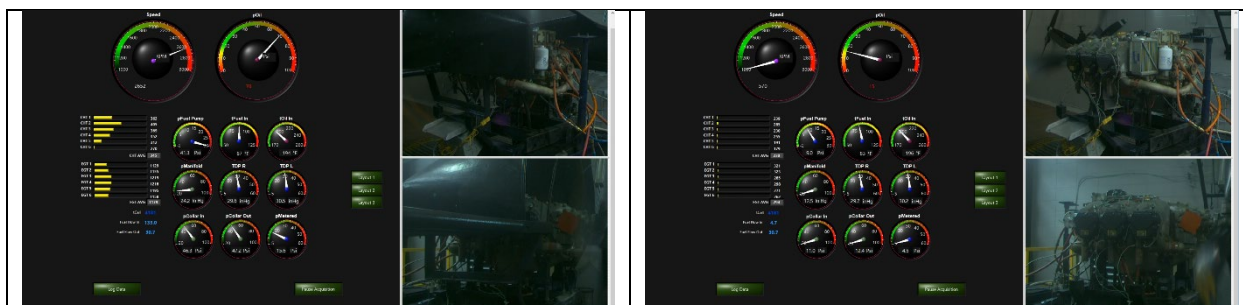
Photograph 5: Screenshot of engine test run video while engine is at full throttle (Source: CAT)

Photograph 6: Screenshot of engine test run video while engine is at idle (Source: CAT)

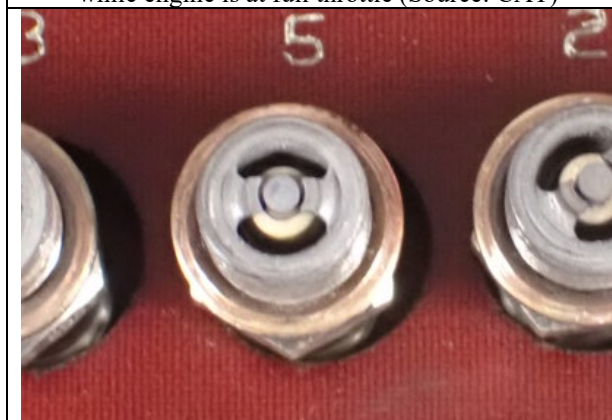
Photograph 7: No. 5 top spark plug on initial examination (Source: CAT)

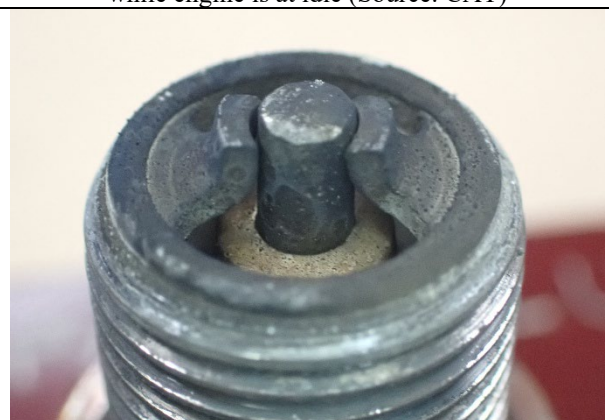
RPM. When the magneto was switched to the right magneto, the RPM dropped by 220 RPM, and the No. 5 cylinder EGT level dropped to levels consistent with combustion no longer occurring in the cylinder. The magneto switch was put back into the both position and the No. 5 cylinder EGT levels indicated normal combustion within the cylinder. The engine run continued, and the RPM was increased to 2450 and allowed to stabilize for five minutes. The throttle was then advanced to full throttle, and the engine RPM increased to approximately 2620 RPM, and the engine continued to run smoothly without any stumbling or hesitation. The engine RPM was decreased to idle, and the engine was allowed to cool prior to shutting down the engine. After the engine was shut down, the engine was troubleshooted to determine the cause of the high RPM drop during the right magneto check. The No. 5 top spark plug was found to have the outer and center electrodes contacting each other, resulting in a short that would have prevented a spark from forming between the gap. The spark plug electrode gap was compared with the photographs taken of the spark plug prior to the engine run. The photographs show a clear gap between the electrodes during the examination. This is consistent with the spark plug being damaged during engine preparation for the engine run. A new spark plug was installed into the No. 5 cylinder top position and another engine run was performed. At 2,100 RPM, another magneto check was performed; the engine RPM only dropped approximately 50 RPM, and the No. 5 cylinder EGTs were normal. Another full power check was performed, and the engine RPM increased to 2700 RPM and without any stumbling or hesitation. While at full power, it was observed that the unmetered fuel pressure was higher than specifications; however, it did not prevent the engine from operating normally at full throttle. The engine was then brought back to idle RPM and multiple throttle bursts from idle to full power were performed. The engine accelerated normally during each throttle burst and would reach 2,700 RPM during each throttle burst.

Photograph 8: No. 5 top spark plug found after initial engine run with no gap (Source: CAT)
