# National Transportation Safety Board

ERA25LA053

## WRECKAGE AND ENGINE EXAM REPORT

Location: Doylestown PA.  
Date: November 18, 2024  
Time: 12:21 EST  
17:21 UTC  
Airplane: Beechcraft A36 Bonanza

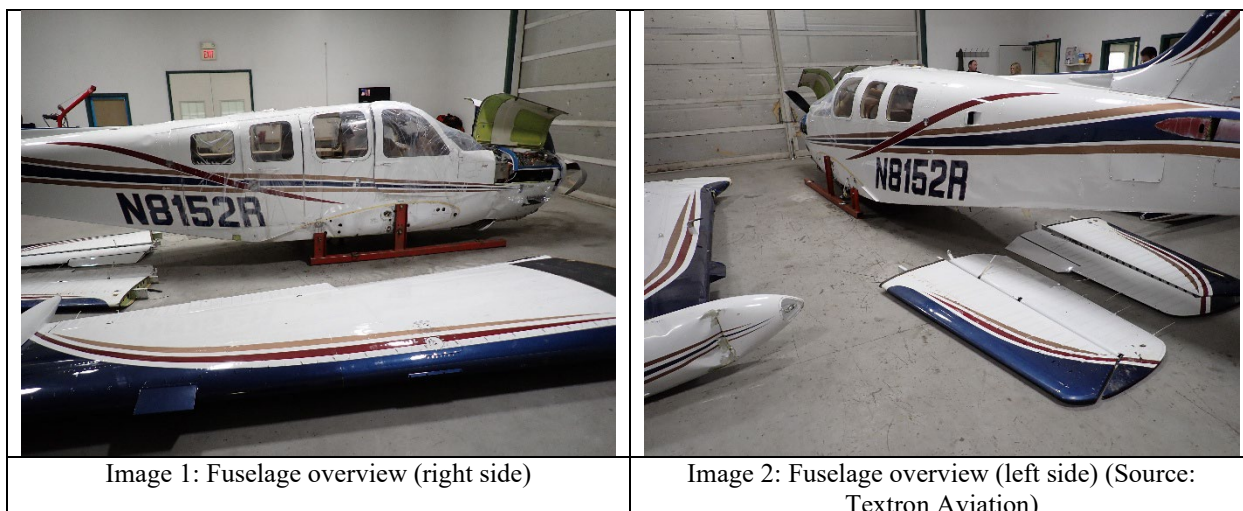
Examination of the fuselage revealed that the front windshield had shattered. The pilot's windshield post was damaged from impact. The upper fuselage was damaged in multiple places, and the forward door frame was impact-damaged, which prevented the pilot's door from fully closing. There was substantial damage to the lower fuselage.

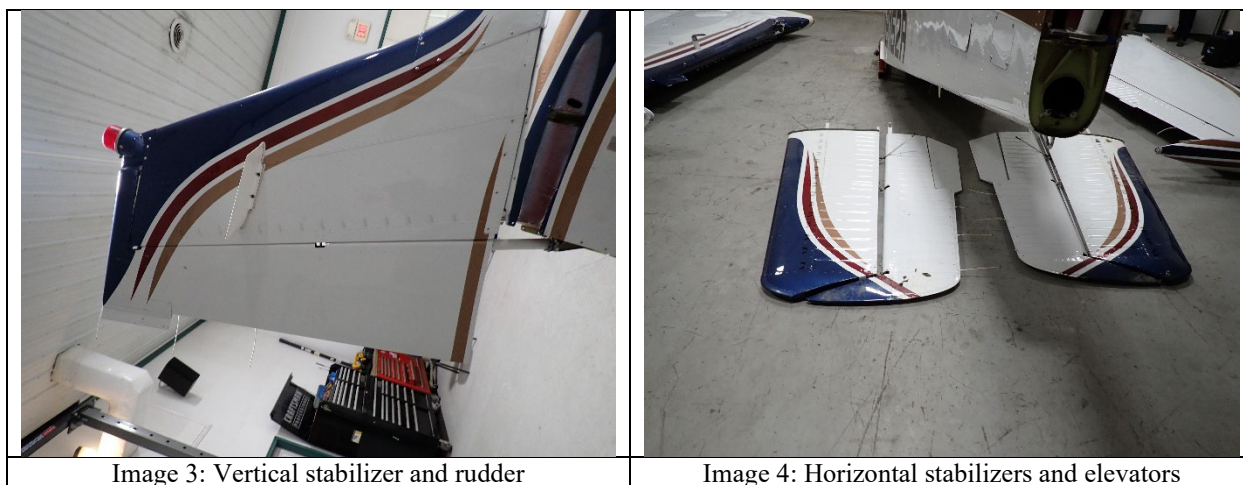
The horizontal stabilizers were removed by the recovery personnel prior to the examination. Both elevators were still attached to the horizontal stabilizers. No damage or abnormalities were found in any section of the empennage.

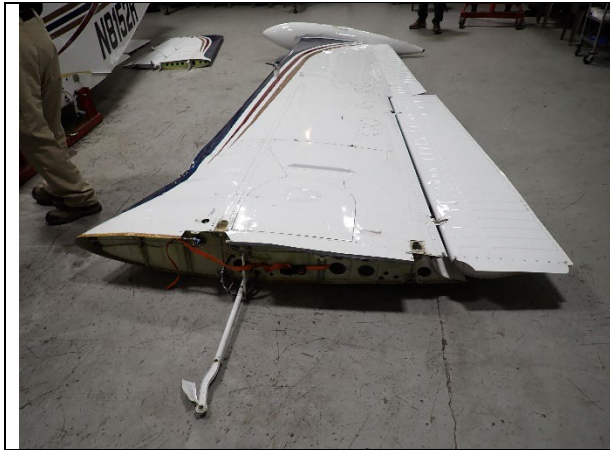
Image 5: Left wing overview (wing inverted)

The wings were removed from the fuselage by the recovery personnel prior to the examination. The left wing sustained impact damage to the leading edge at the root and 10 inches outboard of the root. The left wing tip tank was damaged at the nav light and along the bottom. The right wing sustained minor damage to the lower skin. The stall warning vane operated normally.

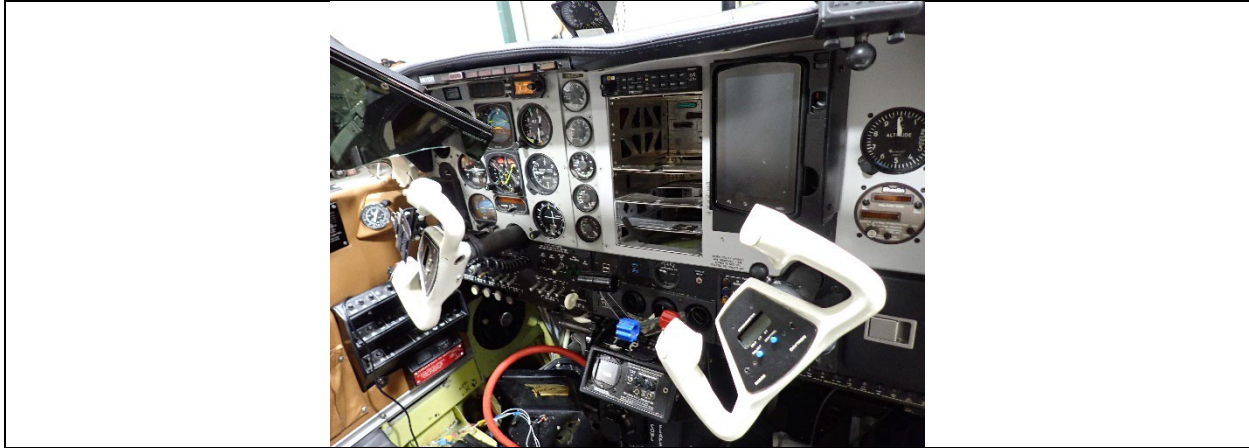
Image 7: Instrument panel overview

The seats and interior floor panels were removed by the recovery personnel. The instrument glare shield was broken into multiple pieces. A Shadin Ful/Airdata Computer (P/N: 912802, S/N: 087), a JPI EDM-900 (P/N 790000-A-1862, S/N: 03051), and a Garmin Aero 796 (S/N: 2CY014482) were removed and shipped to the NTSB Recorders Laboratory in Washington, D.C. for data download.

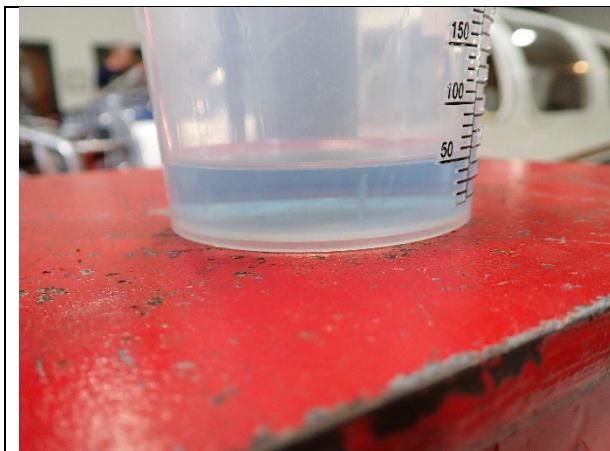
Image 8: Recovered fuel

Both main wing bladder type fuel cells were intact and undamaged. The right and left wing tip tanks had scraping damage along the lower length of the pod. The left tip tank was breached along the outboard side of the pod. All the fuel caps were intact with pliable seals. Both wing tank vents were free from obstruction. Both wing tank finger screens were clean. The fuel selector valve was found in the "OFF" position. The fuel selector handle assembly exhibited positive detents and passed air from the tank outlets to the firewall bulkhead fitting as selected. Fuel was found in the strainer assembly. The residual fuel was free of contaminants and water and had the color and odor consistent with 100LL Avgas. The airframe electrically power fuel pump switch was found in the "OFF" position.

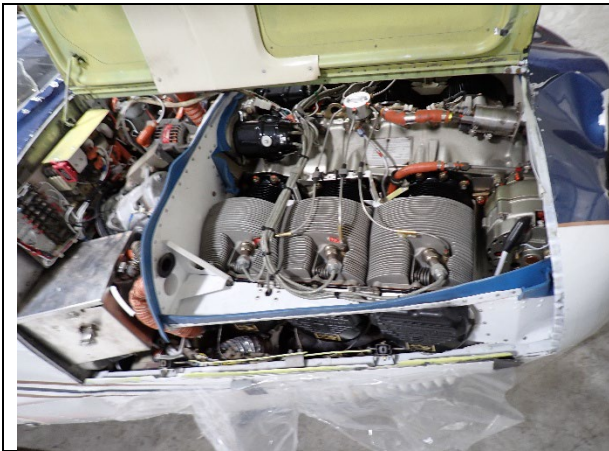
Image 10: Engine overview (right side)

The top spark plugs were removed. The electrodes displayed normal operating and wear signatures. The cylinders were inspected using a lighted borescope; the cylinder walls, piston

faces, and valve heads displayed normal operating and combustion signatures. Continuity was established between the crankshaft, camshaft, connecting rods, and associated components by rotating the crankshaft 720°. All six cylinders displayed thumb pressure and suction during crankshaft rotation. The magneto impulse couplings operated normally during crankshaft rotation. The engine throttle and fuel metering inlet screen contained light debris but no blockage that would prevent normal fuel flow. No evidence of leakage was found in the fuel system between the firewall and the engine injectors. The fuel injectors were GAMI injectors, and all were found to match the placarded locations. All 4 engine mounts were impact damaged and broken. As a result, the engine was removed and crated for shipment to Continental Aerospace Technologies for further testing.

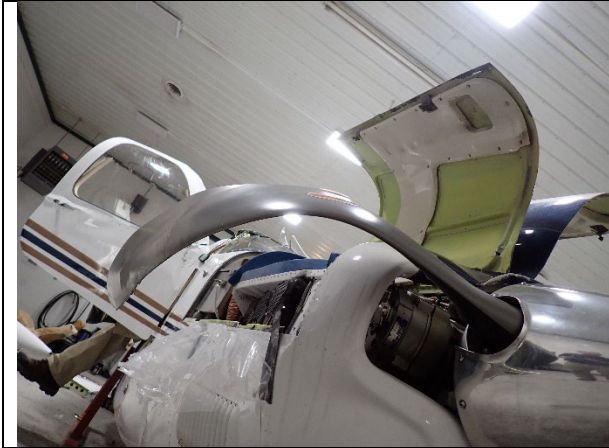
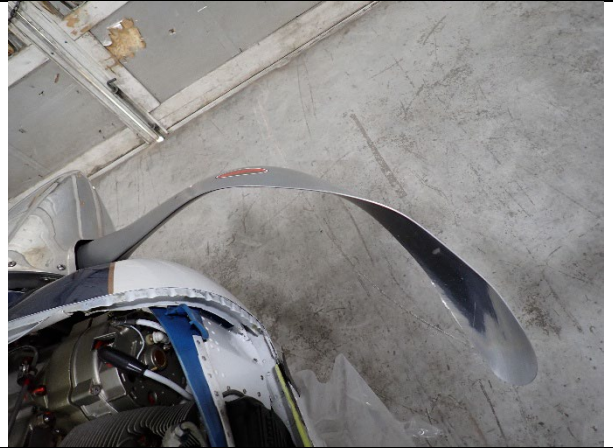
The propeller remained attached to the engine and displayed impact damage. The propeller blades were marked “A”, “B”, and “C” for identification purposes. The propeller blade marked “A” displayed aft bending and twisting deformation, polishing of the cambered end, and the face side. The propeller blade marked “B” displayed aft bending and twisting deformation, polishing of the cambered end, and the face side. A portion of the blade tip was missing. The propeller blade marked “C” displayed aft bending with minor tip curling.

Image 18: Propeller blade "A"

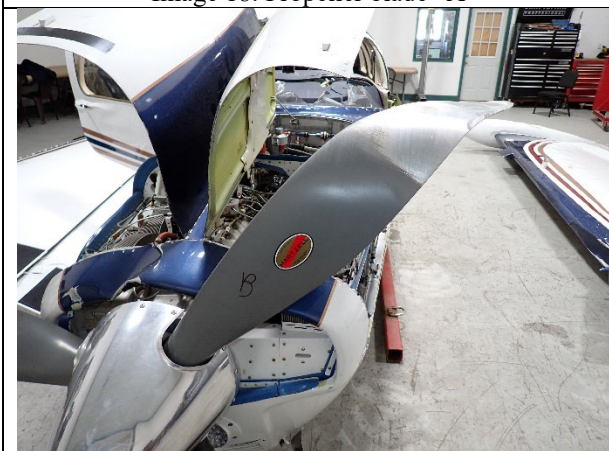
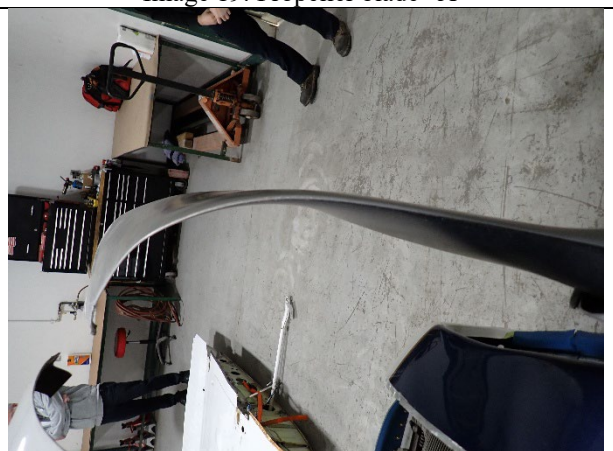
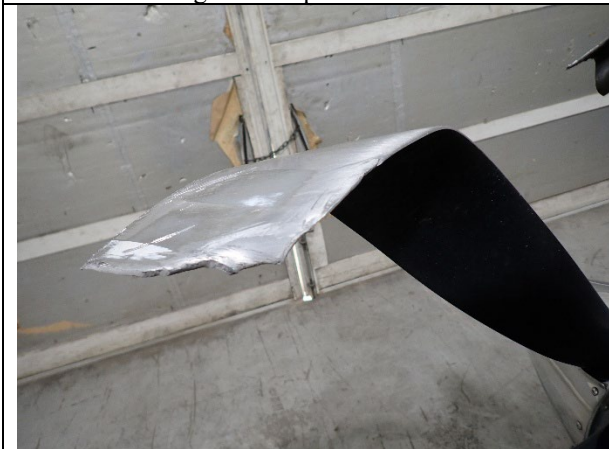
Image 20: Propeller blade "B"

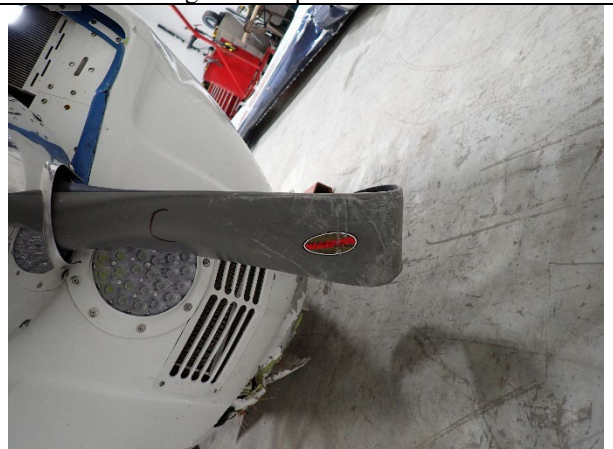
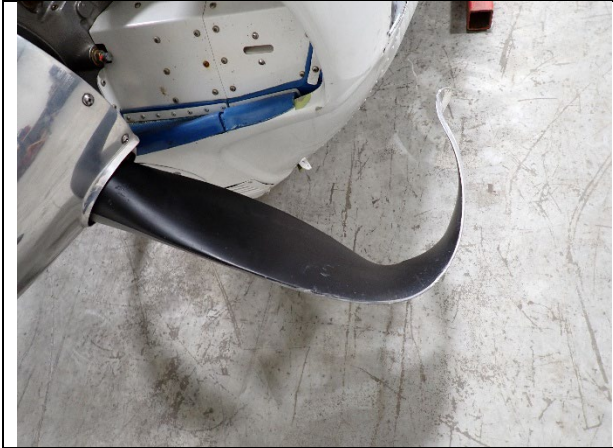
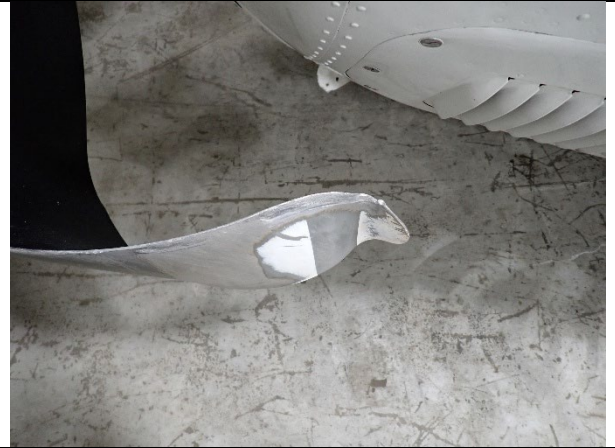
Image 23: Propeller blade "C"
