ERA25LA055

## INVESTIGATIVE PHOTOS

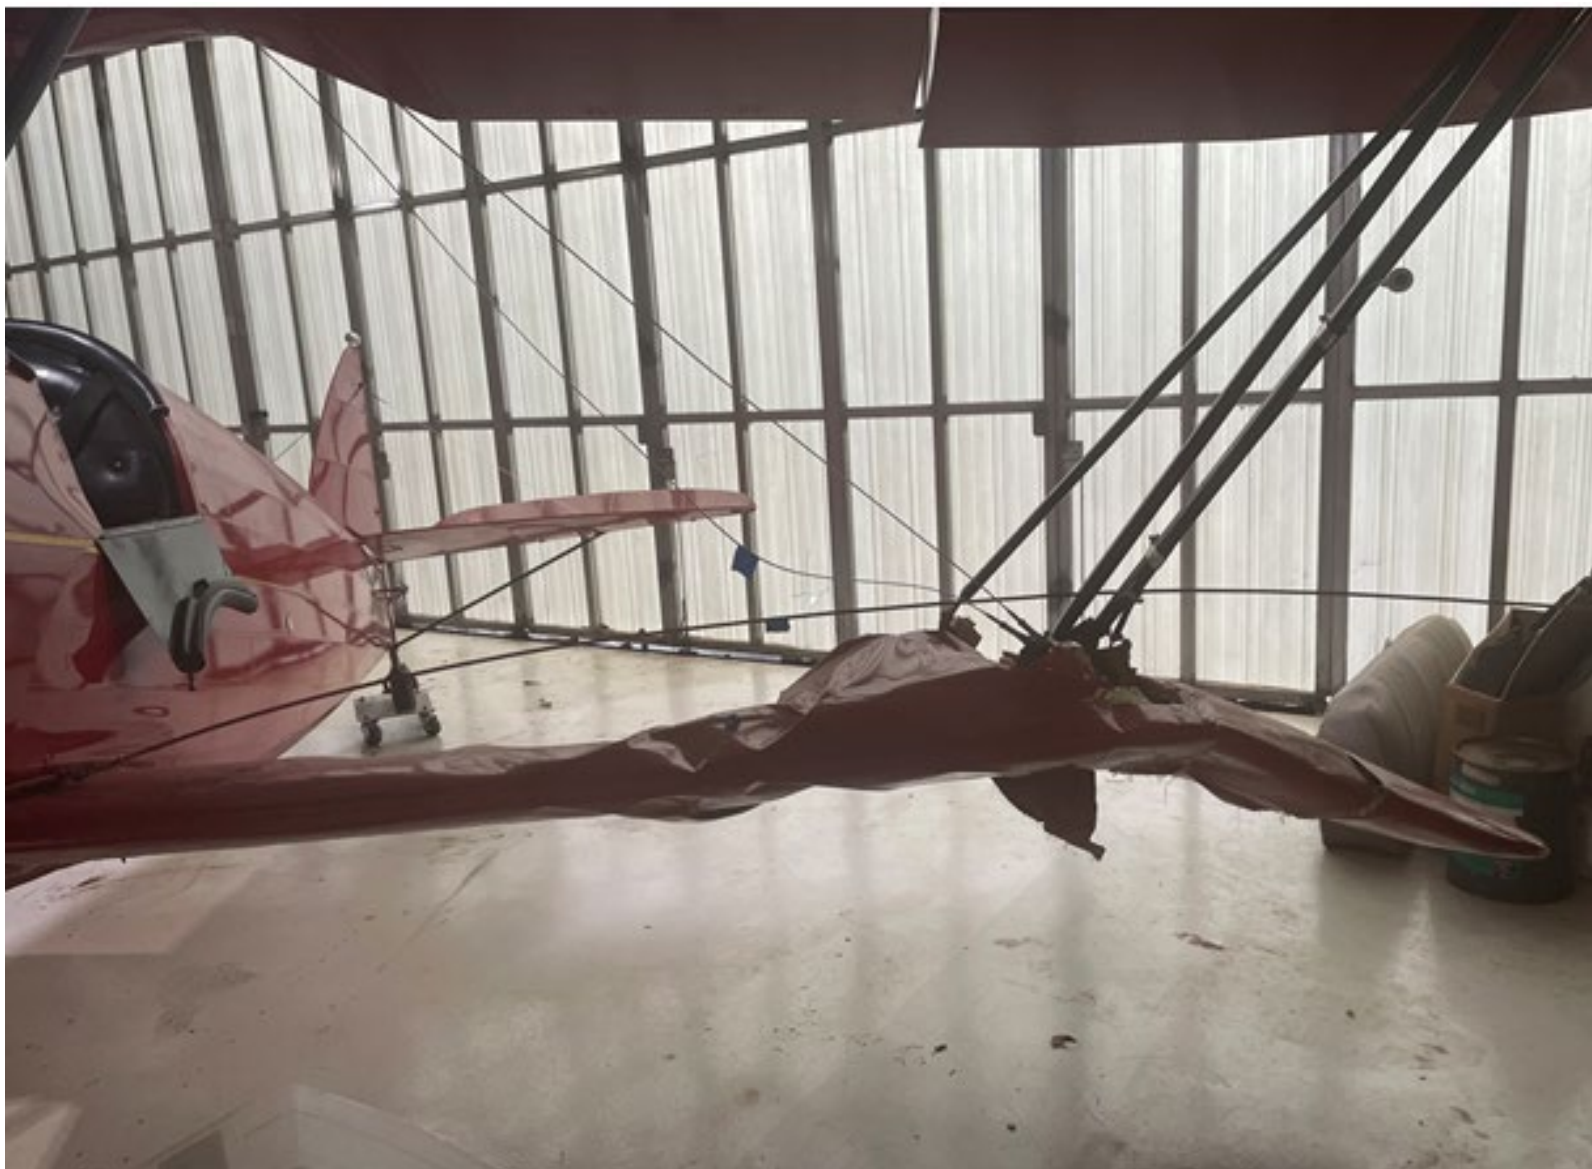
**Photograph 1 - Left lower wing damage (Courtesy of FAA)**

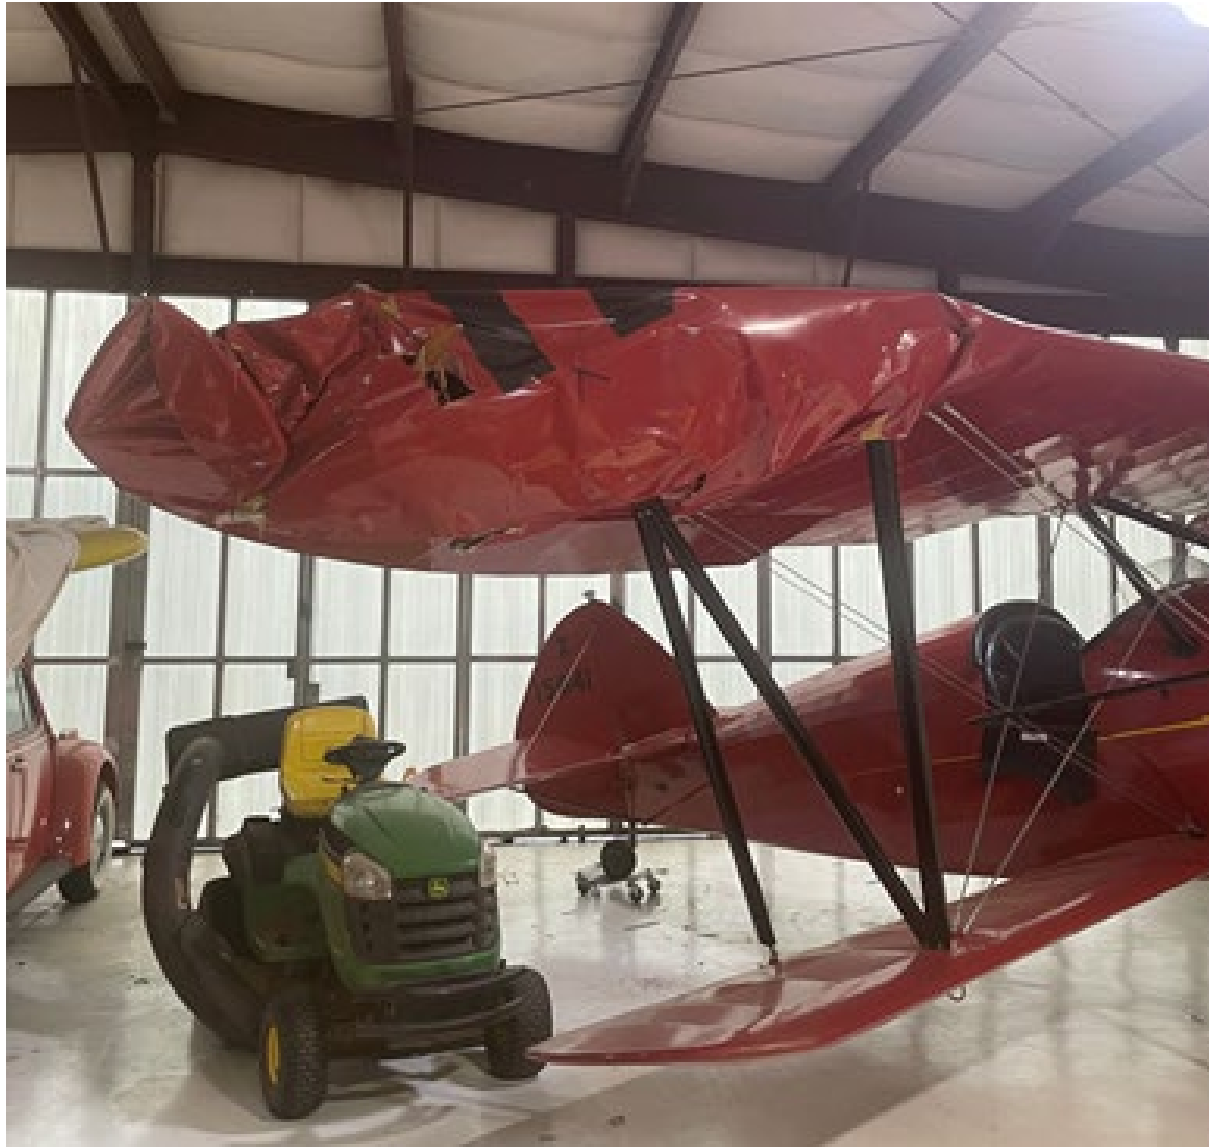
**Photograph 2 - Right upper wing damage (Courtesy of FAA)**
