# N651CA

SN: 039

During taxi, N651CA was struck by a tug pulling another aircraft. The tug impacted the tail of the aircraft damaging the elevator, horizontal stabilizer, elevator stop block, stop block attaching structure, and cables. This presentation will attempt to detail this damage.

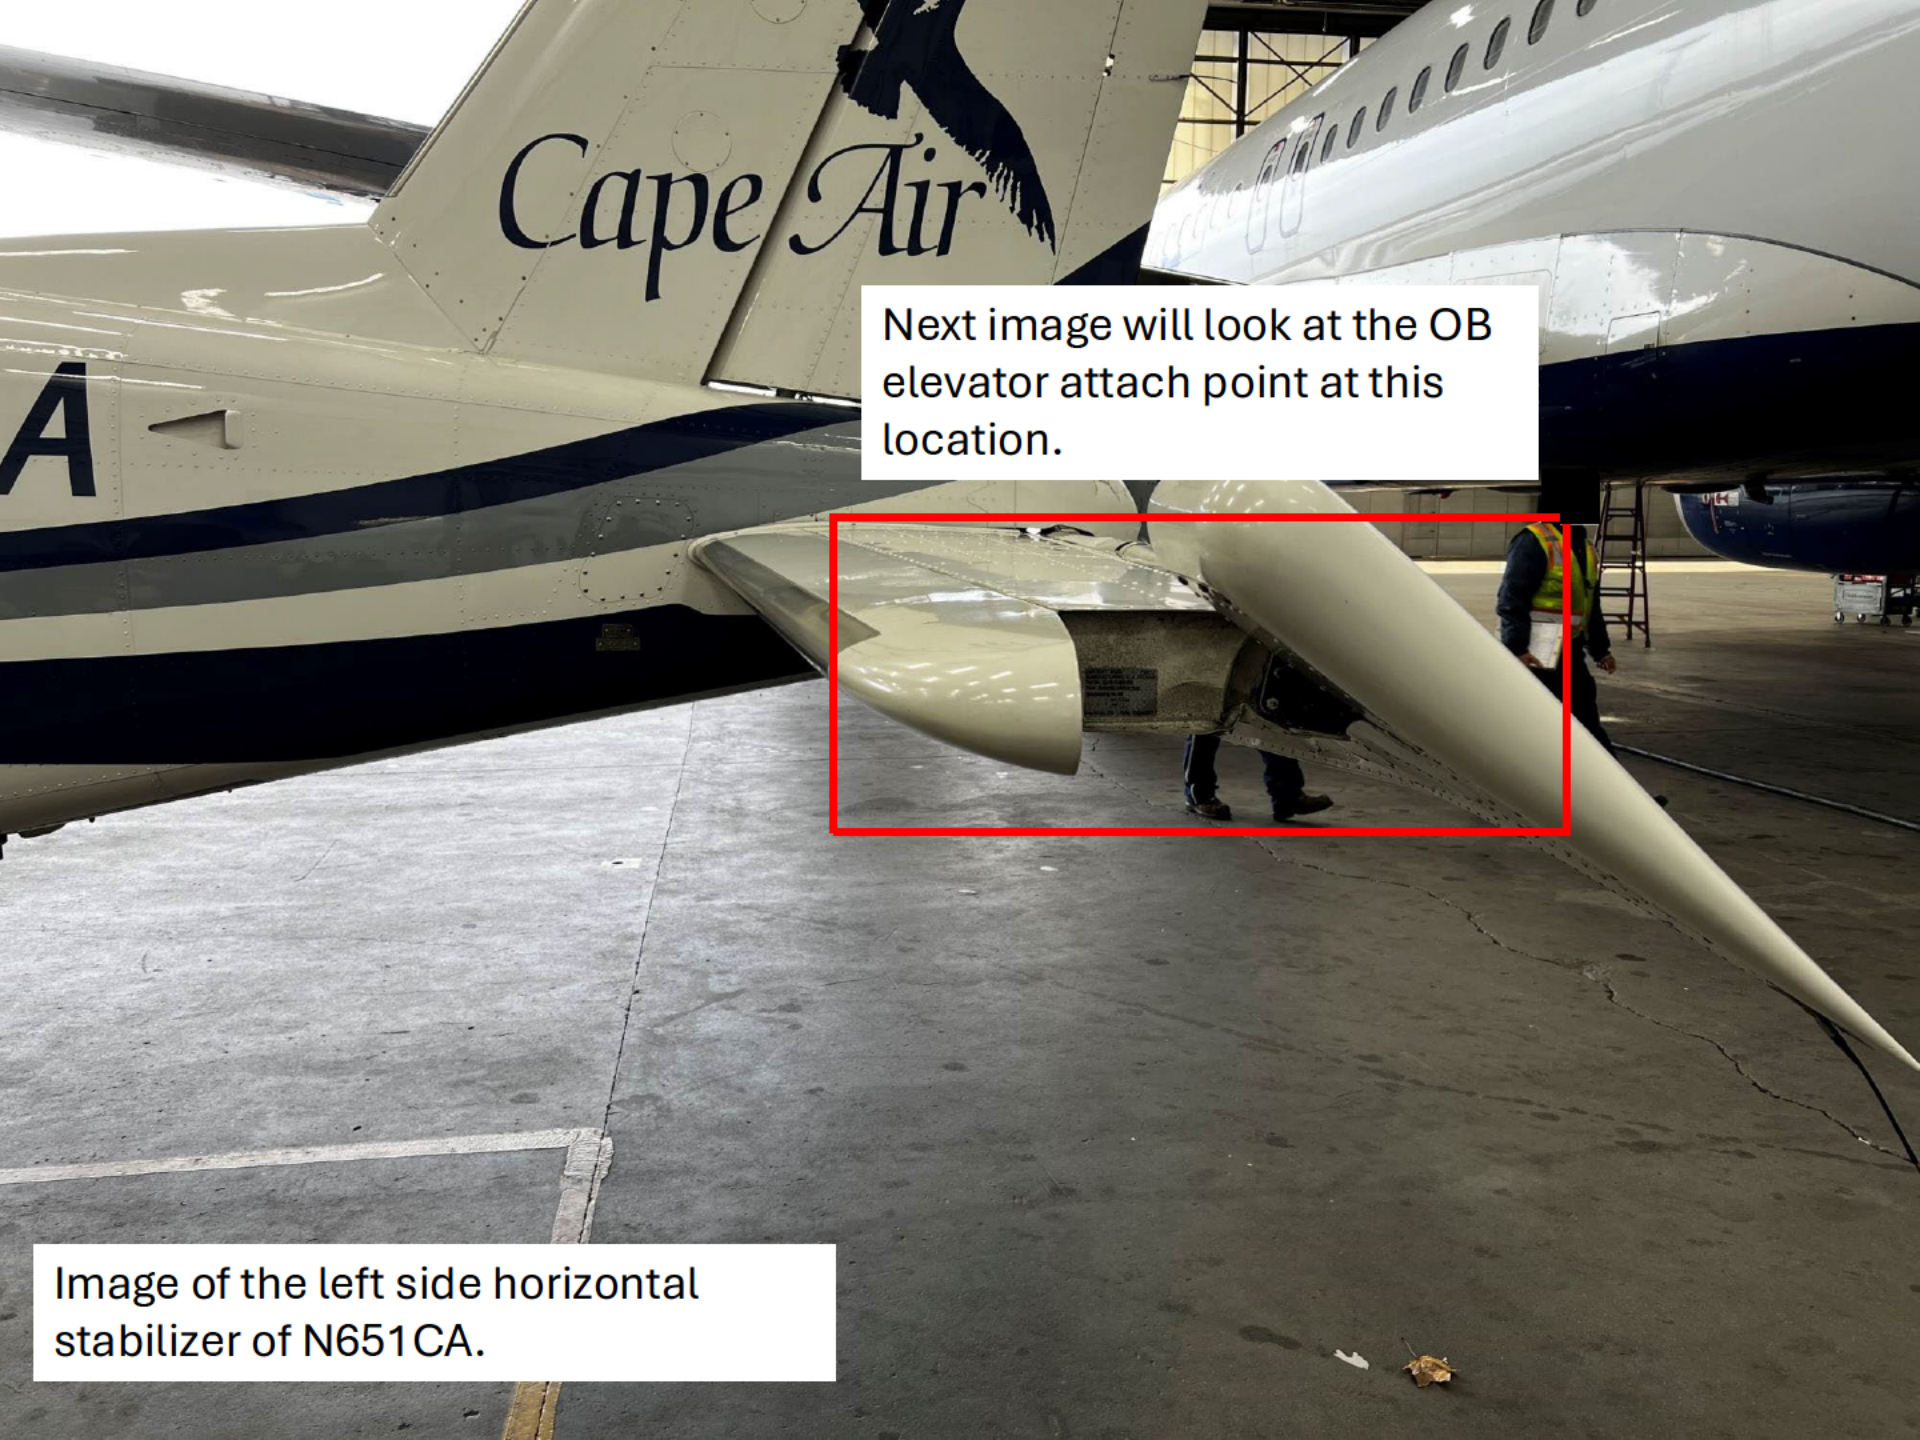
Image of the left side horizontal stabilizer of N651CA.

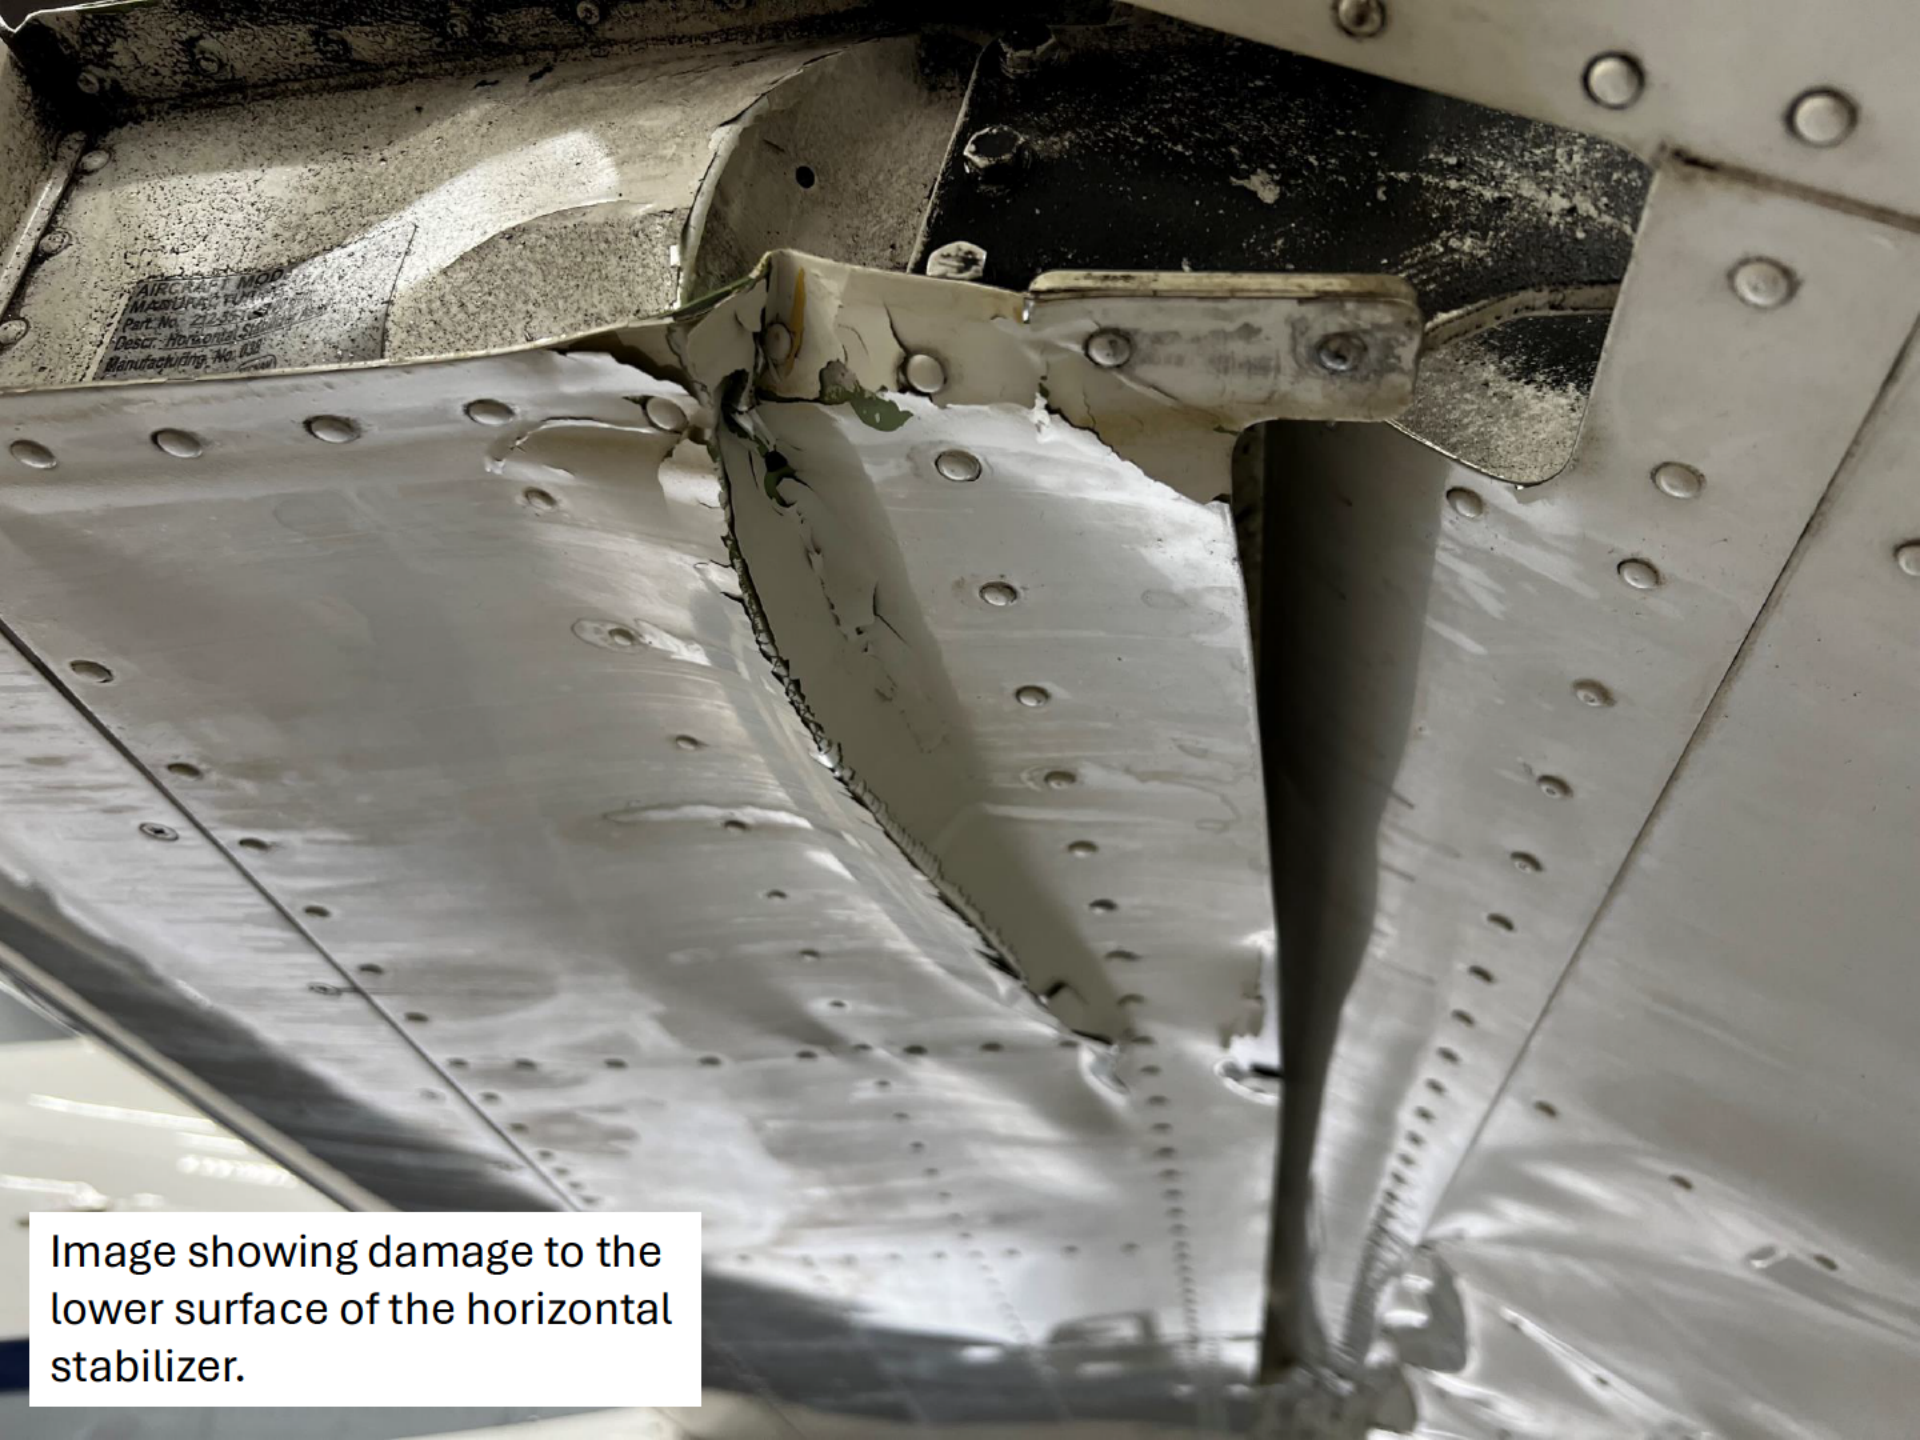
Image showing damaged  
elevator attach point.

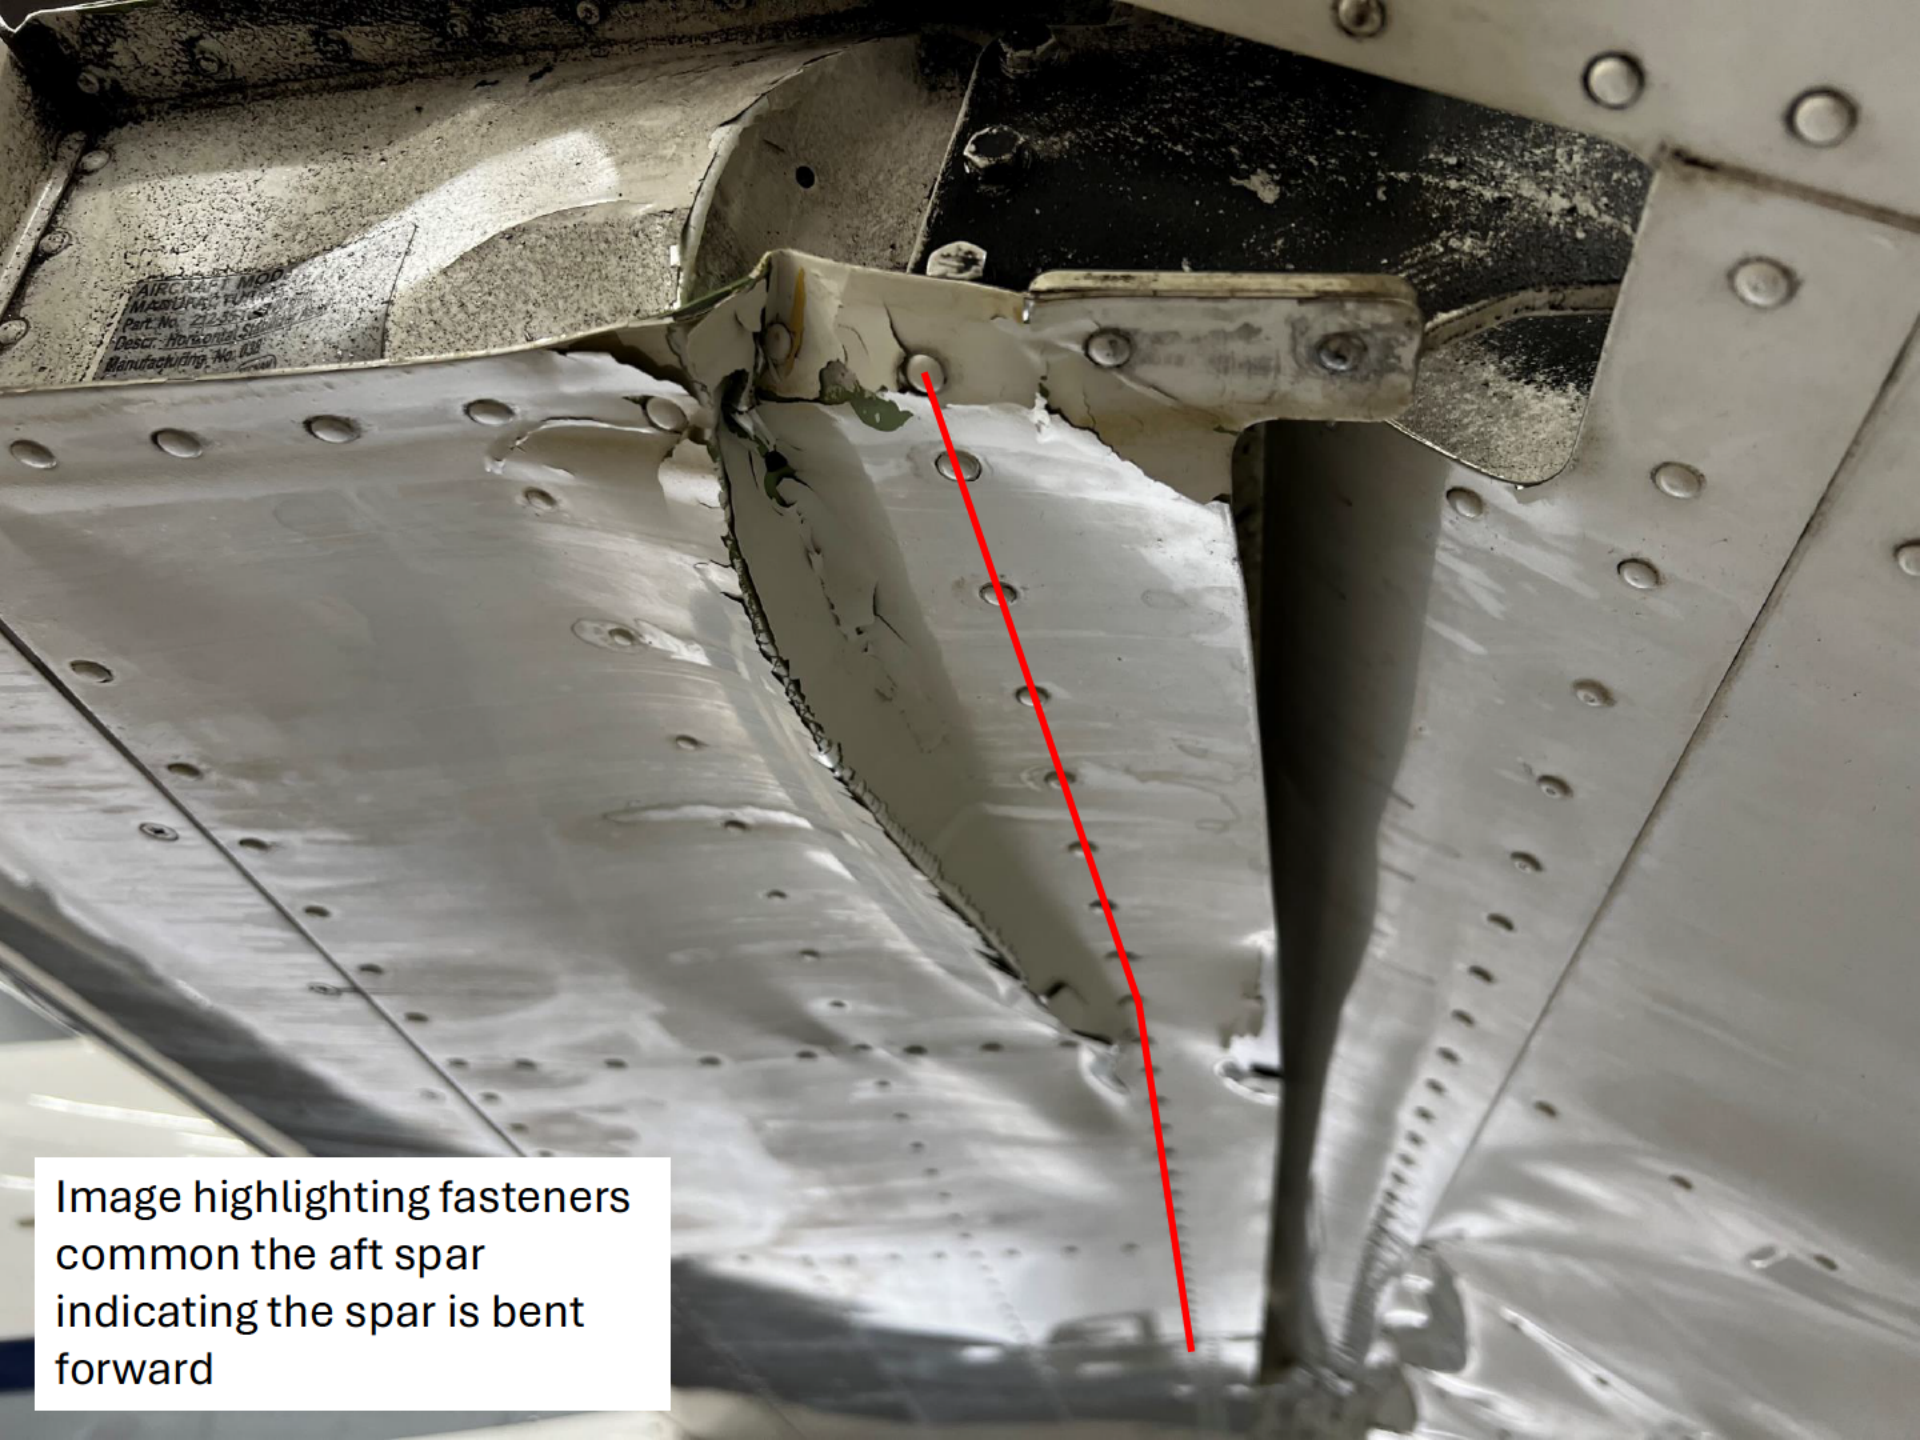
Image showing damage to the lower surface of the horizontal stabilizer.

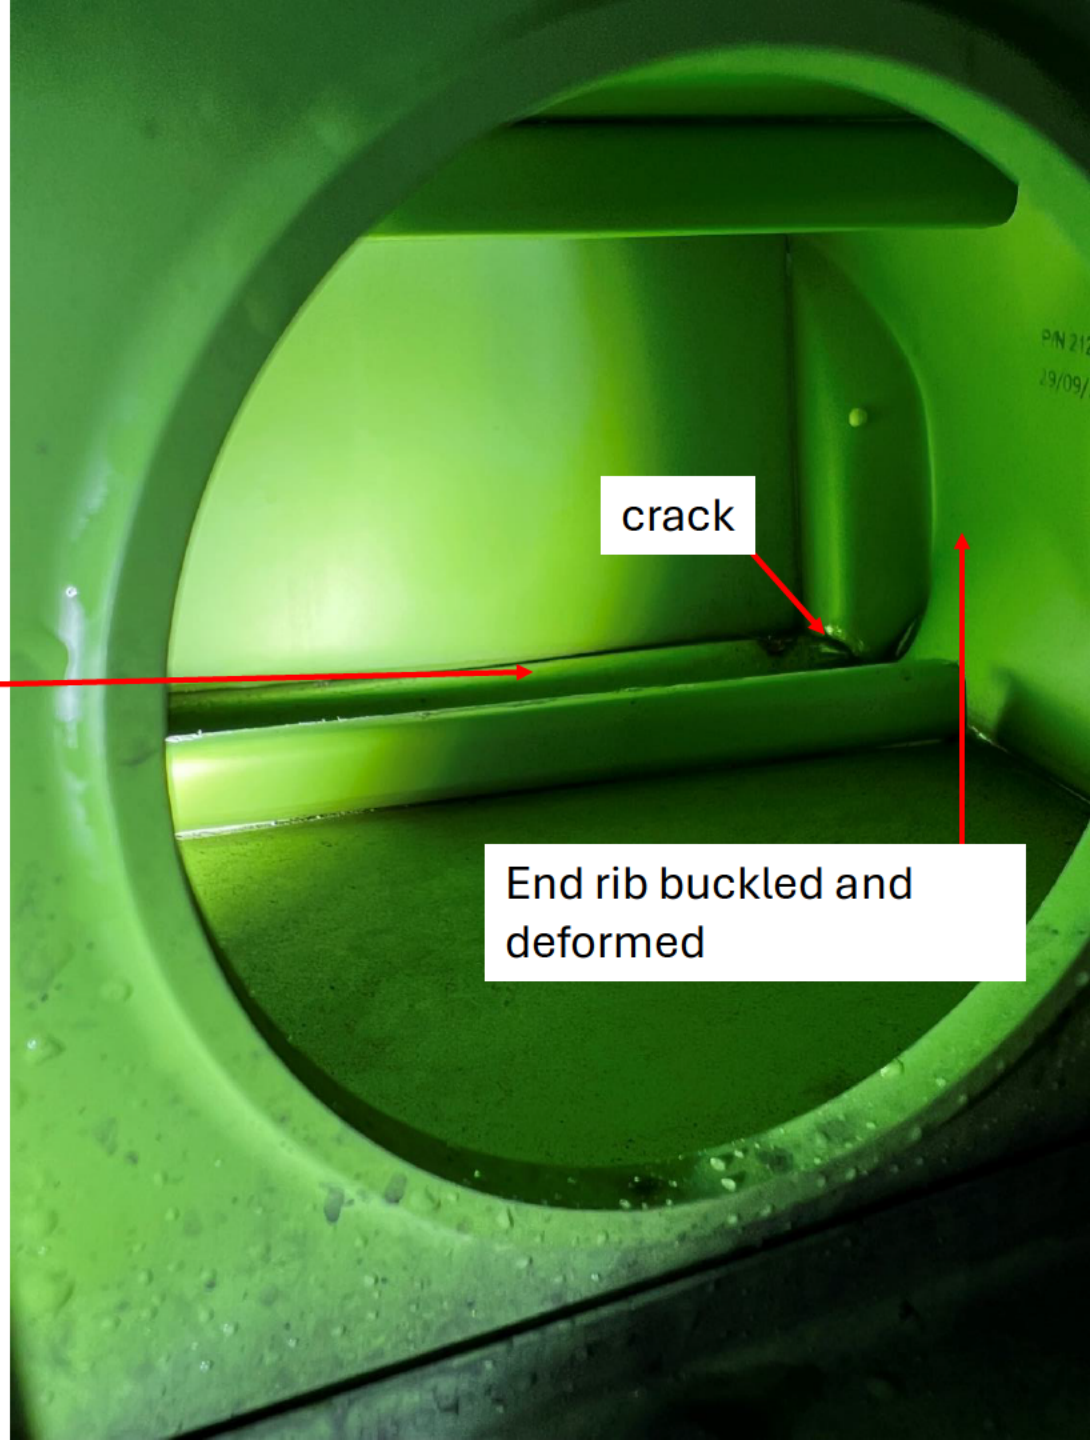
Image taken looking through lightening hole referenced in previous slide. The aft spar can be seen here cracked and buckled.

Buckling

crack

End rib buckled and deformed

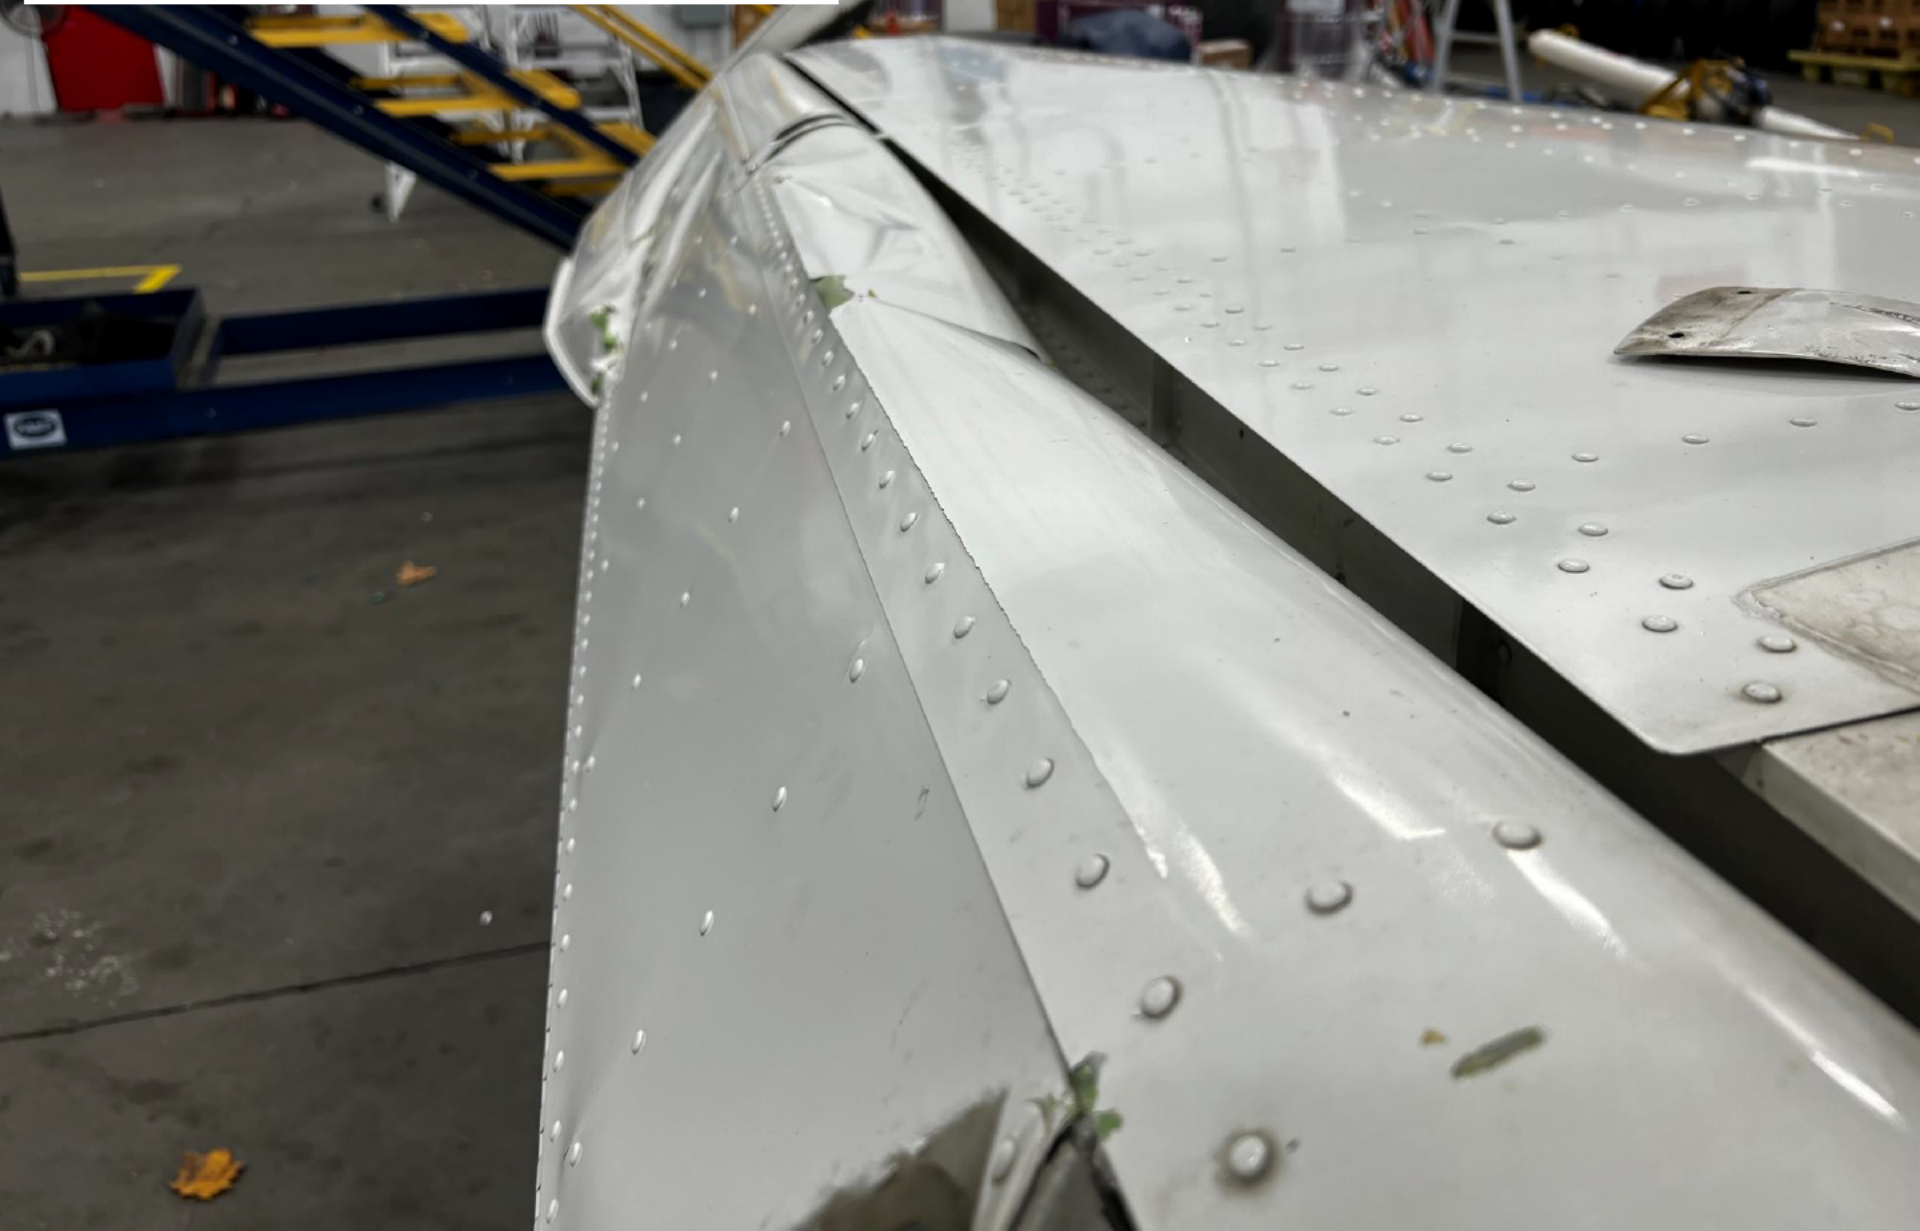
Image showing the leading edge of the left side of the elevator as shown from above.

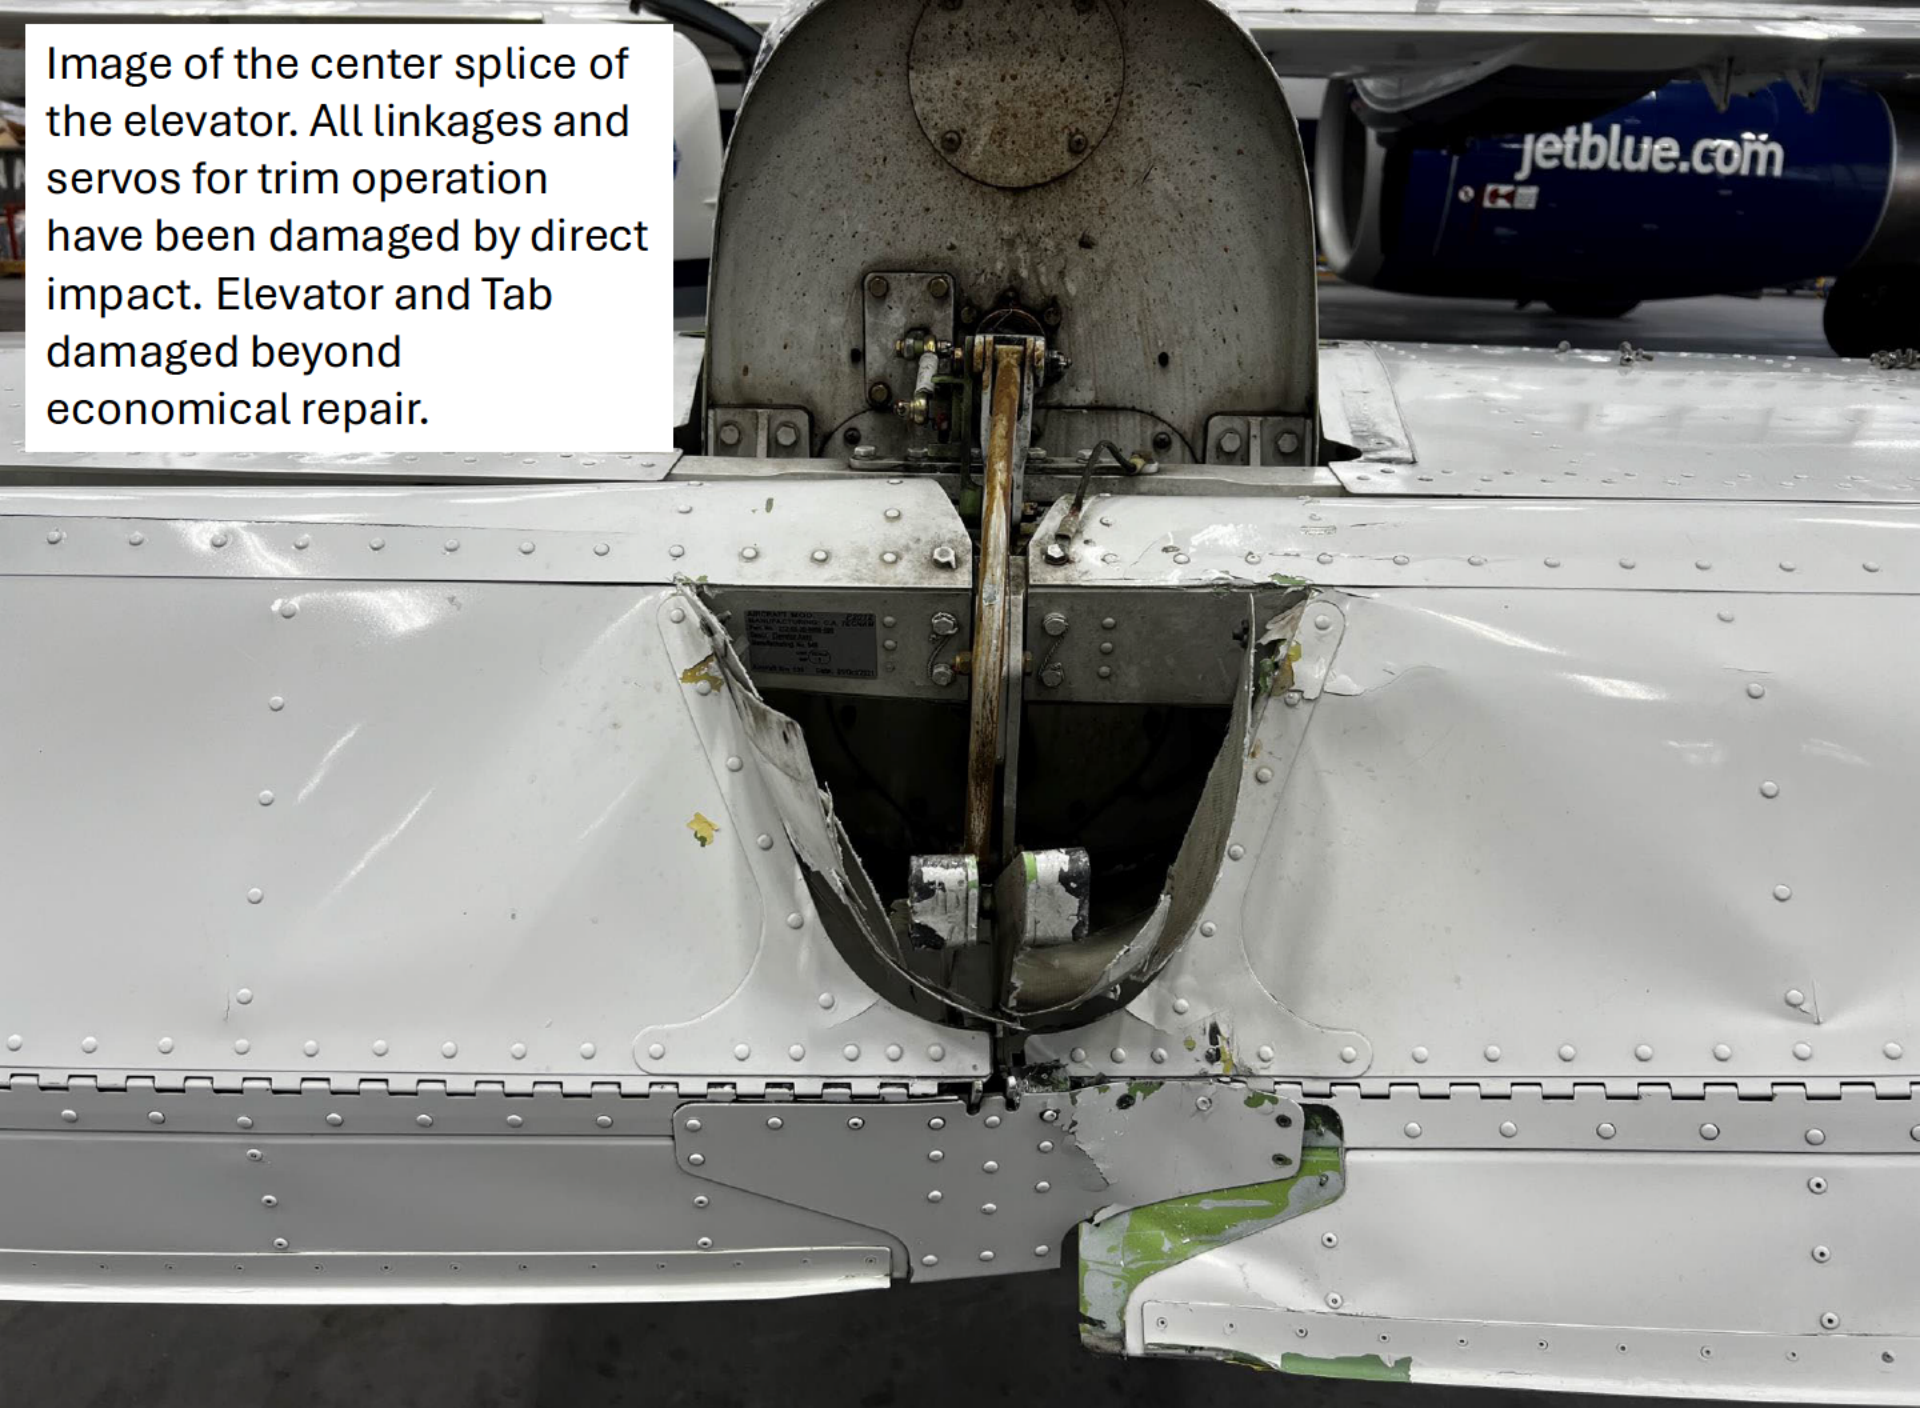
Image of the center splice of the elevator. All linkages and servos for trim operation have been damaged by direct impact. Elevator and Tab damaged beyond economical repair.

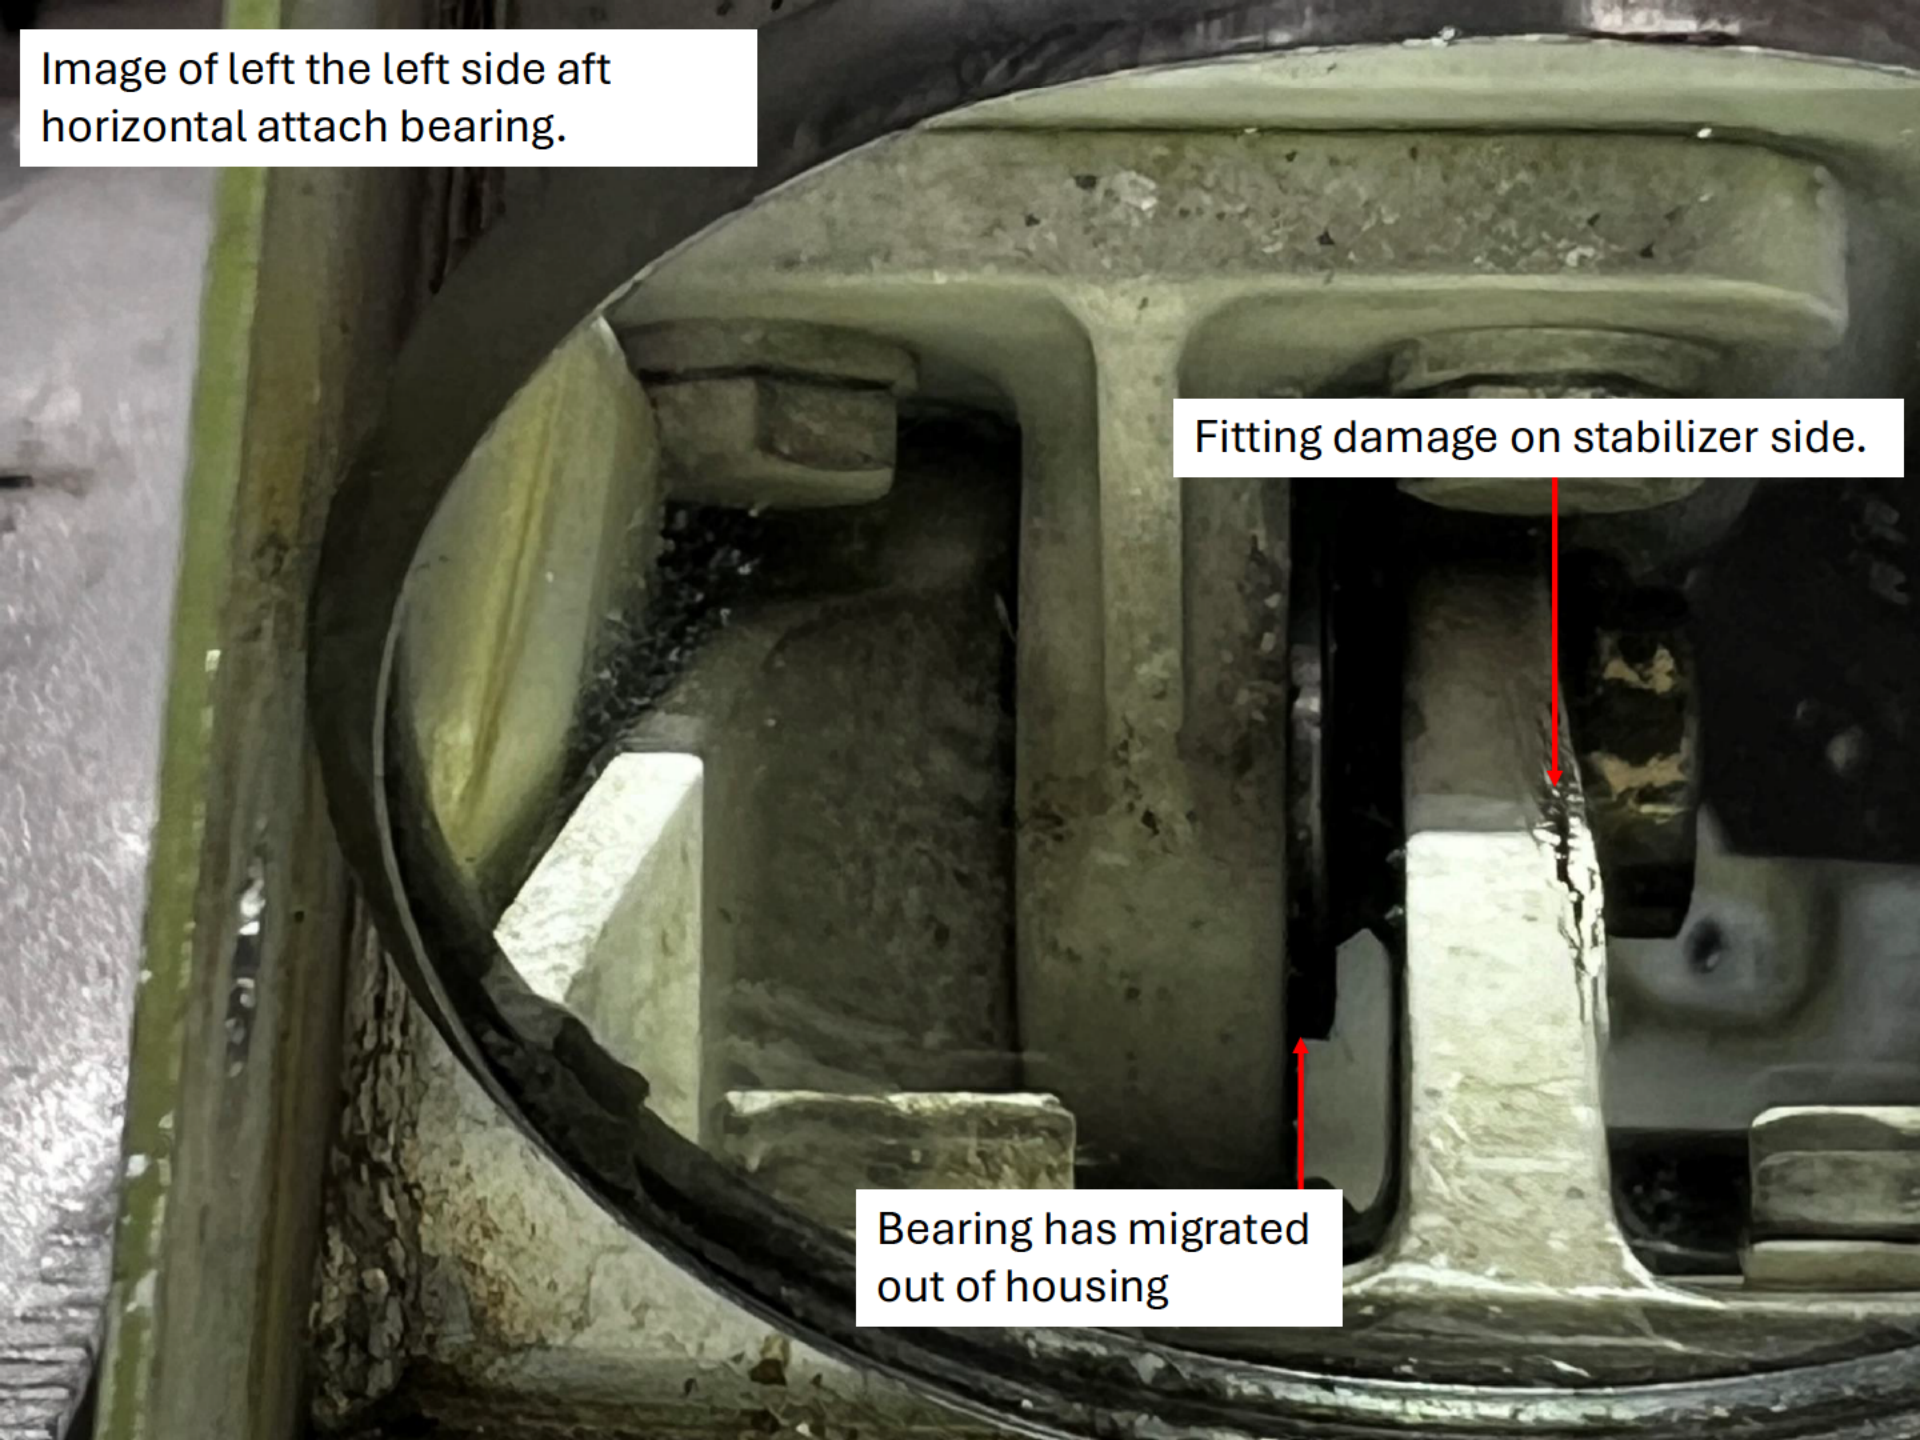
Image of left the left side aft  
horizontal attach bearing.

Fitting damage on stabilizer side.

Bearing has migrated  
out of housing

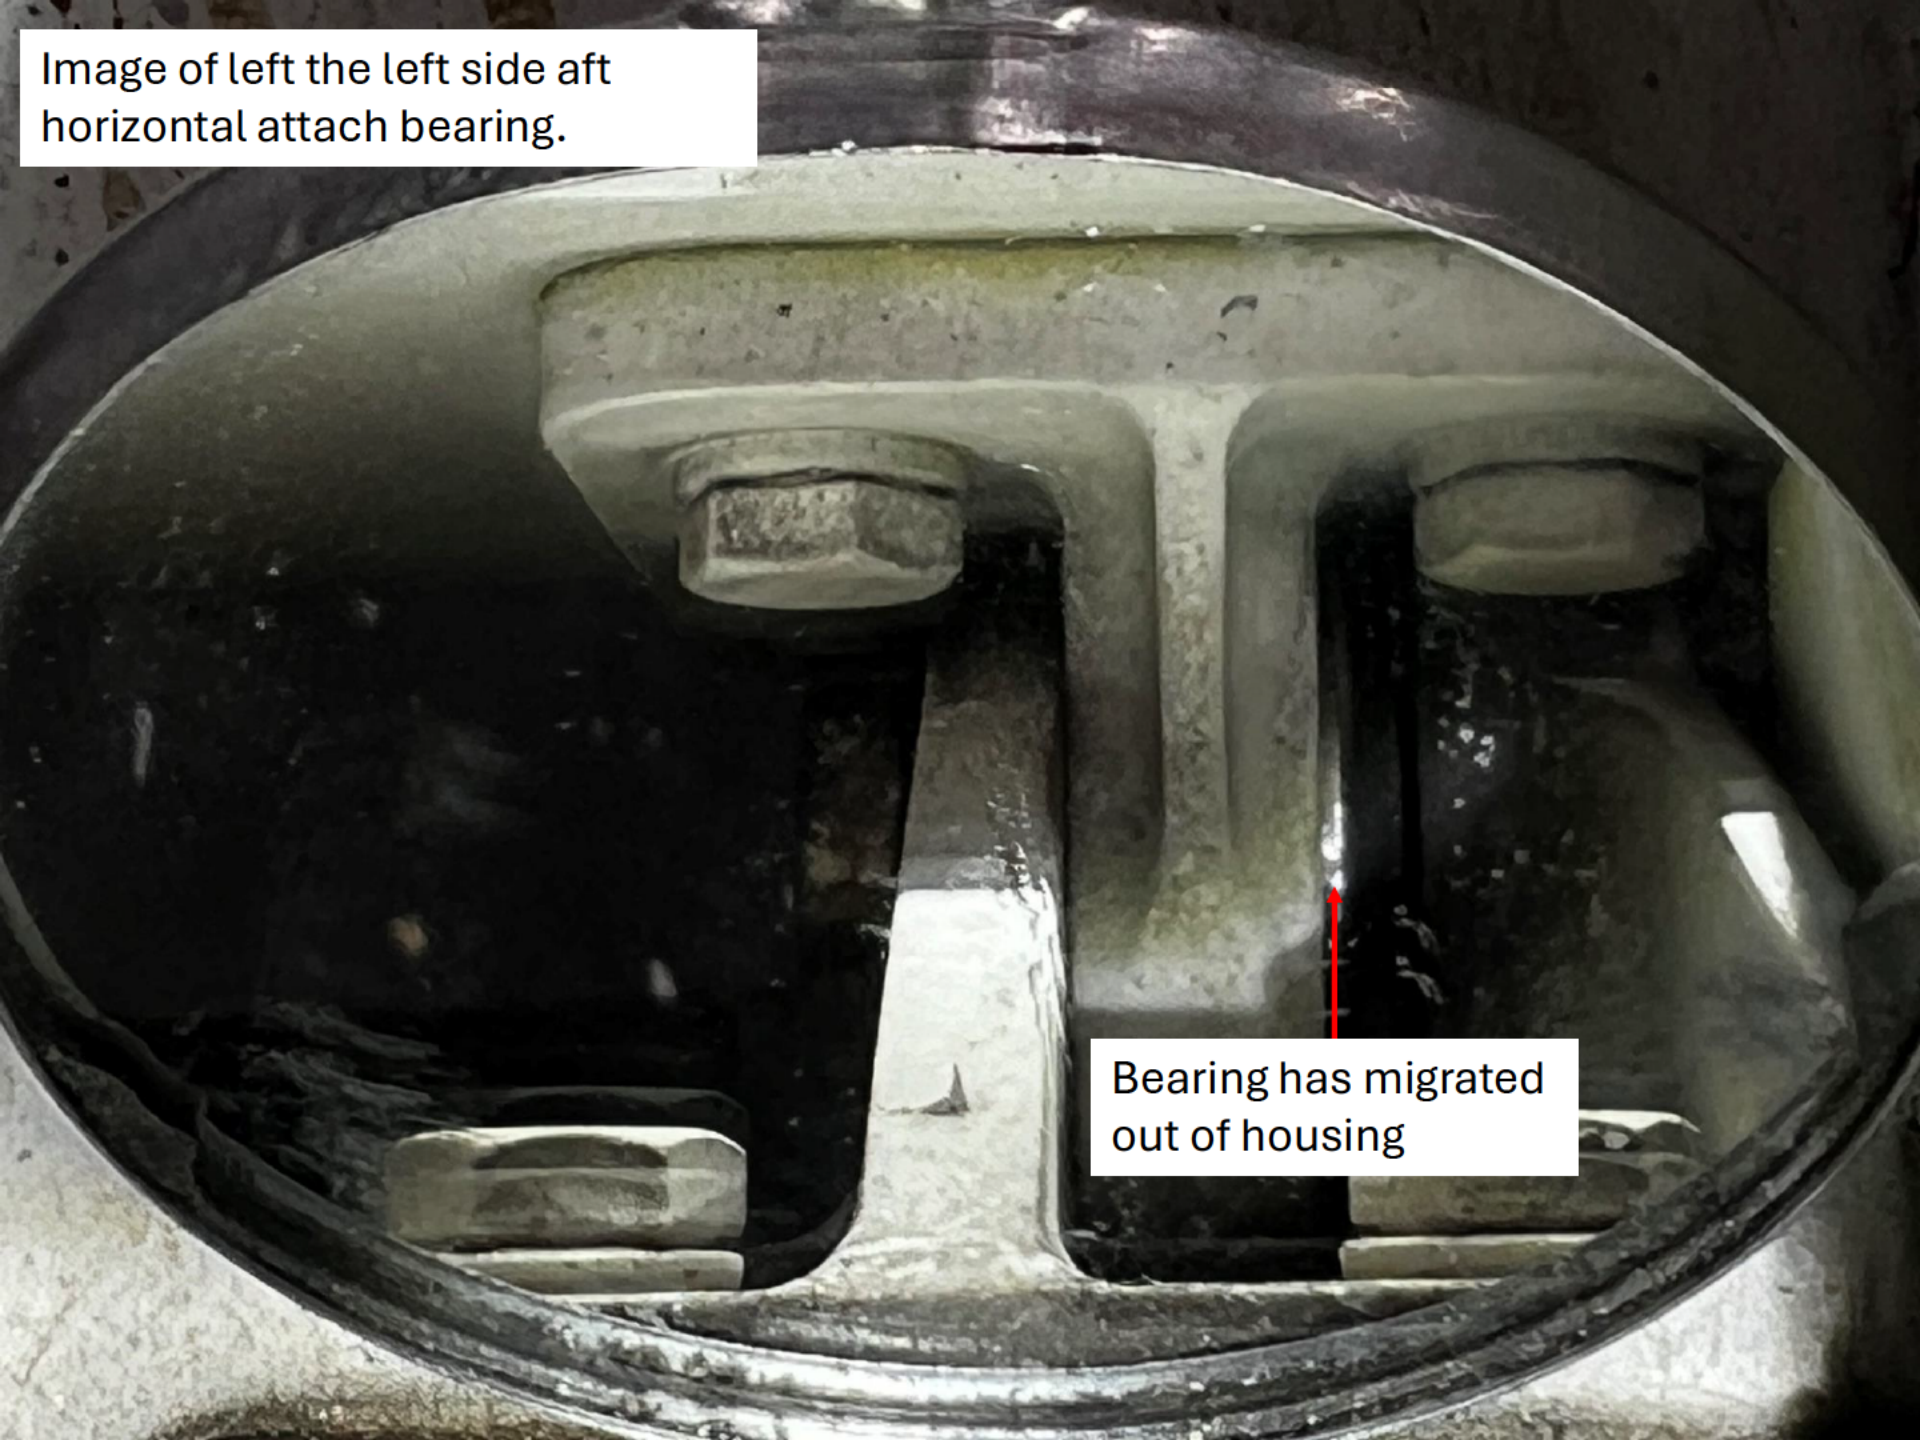
Image of left the left side aft  
horizontal attach bearing.

Bearing has migrated  
out of housing

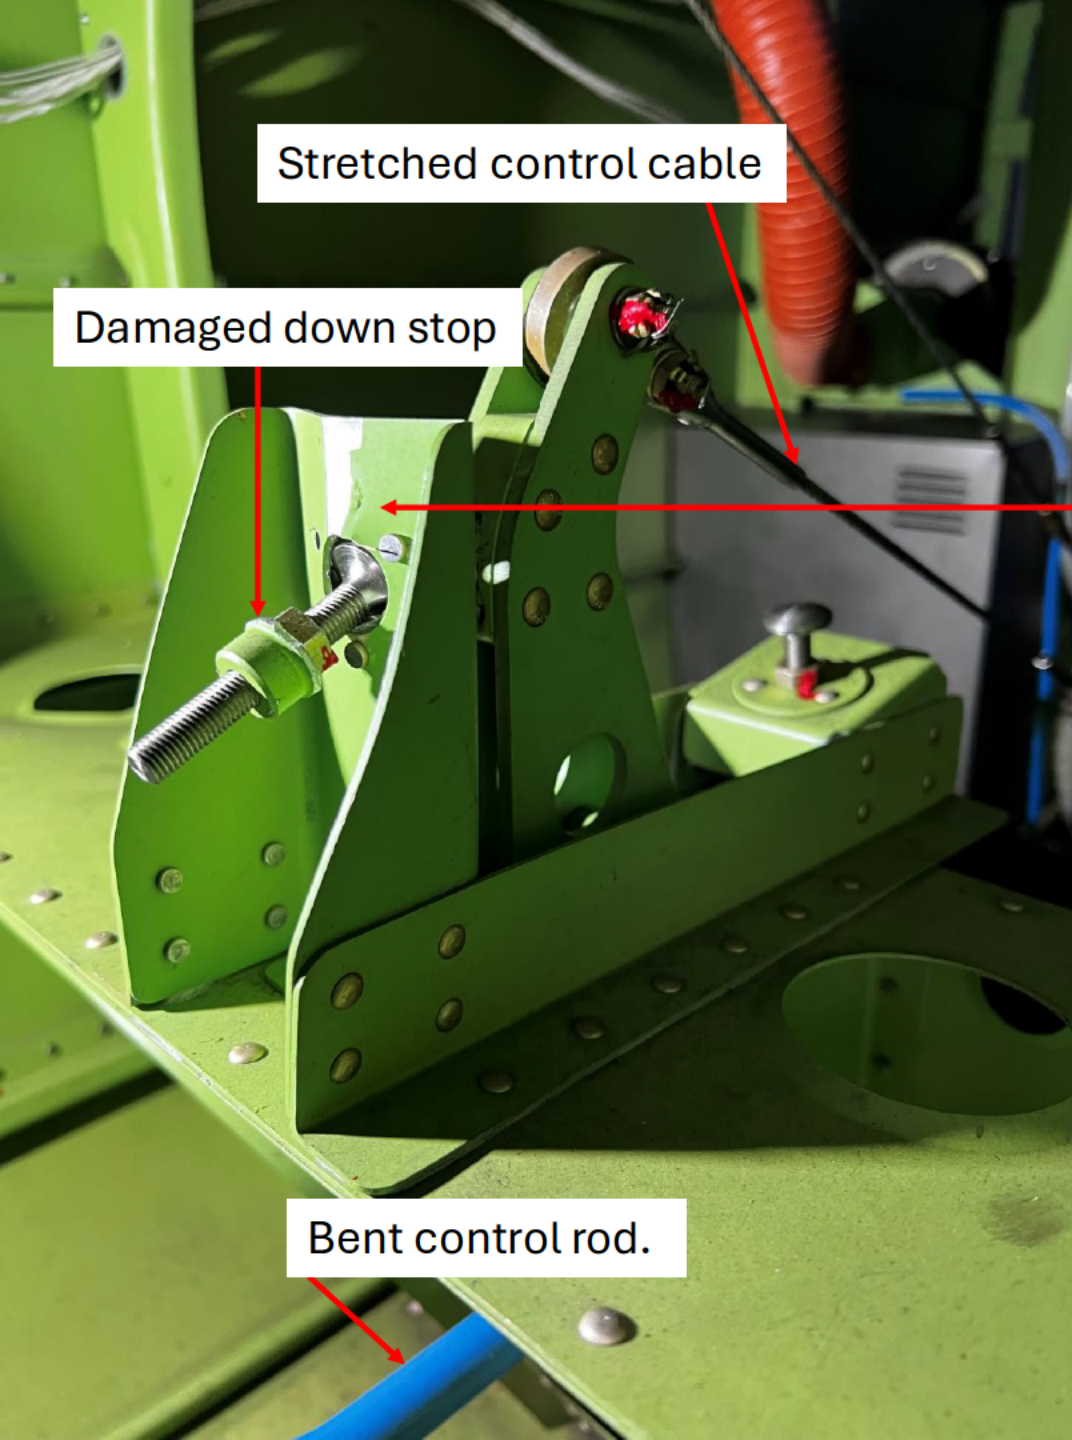
Image showing the elevator's down stop pushed through its bushing. The lower control rod is also bent, and the elevator cables have been stretched due to over extension.

Damaged structure

Bent control rod.
