# N651CA

SN: 039

During taxi, N651CA was struck by a tug pulling another aircraft. The tug impacted the tail of the aircraft damaging the elevator, horizontal stabilizer, elevator stop block, stop block attaching structure, and cables. This presentation will attempt to detail this damage.

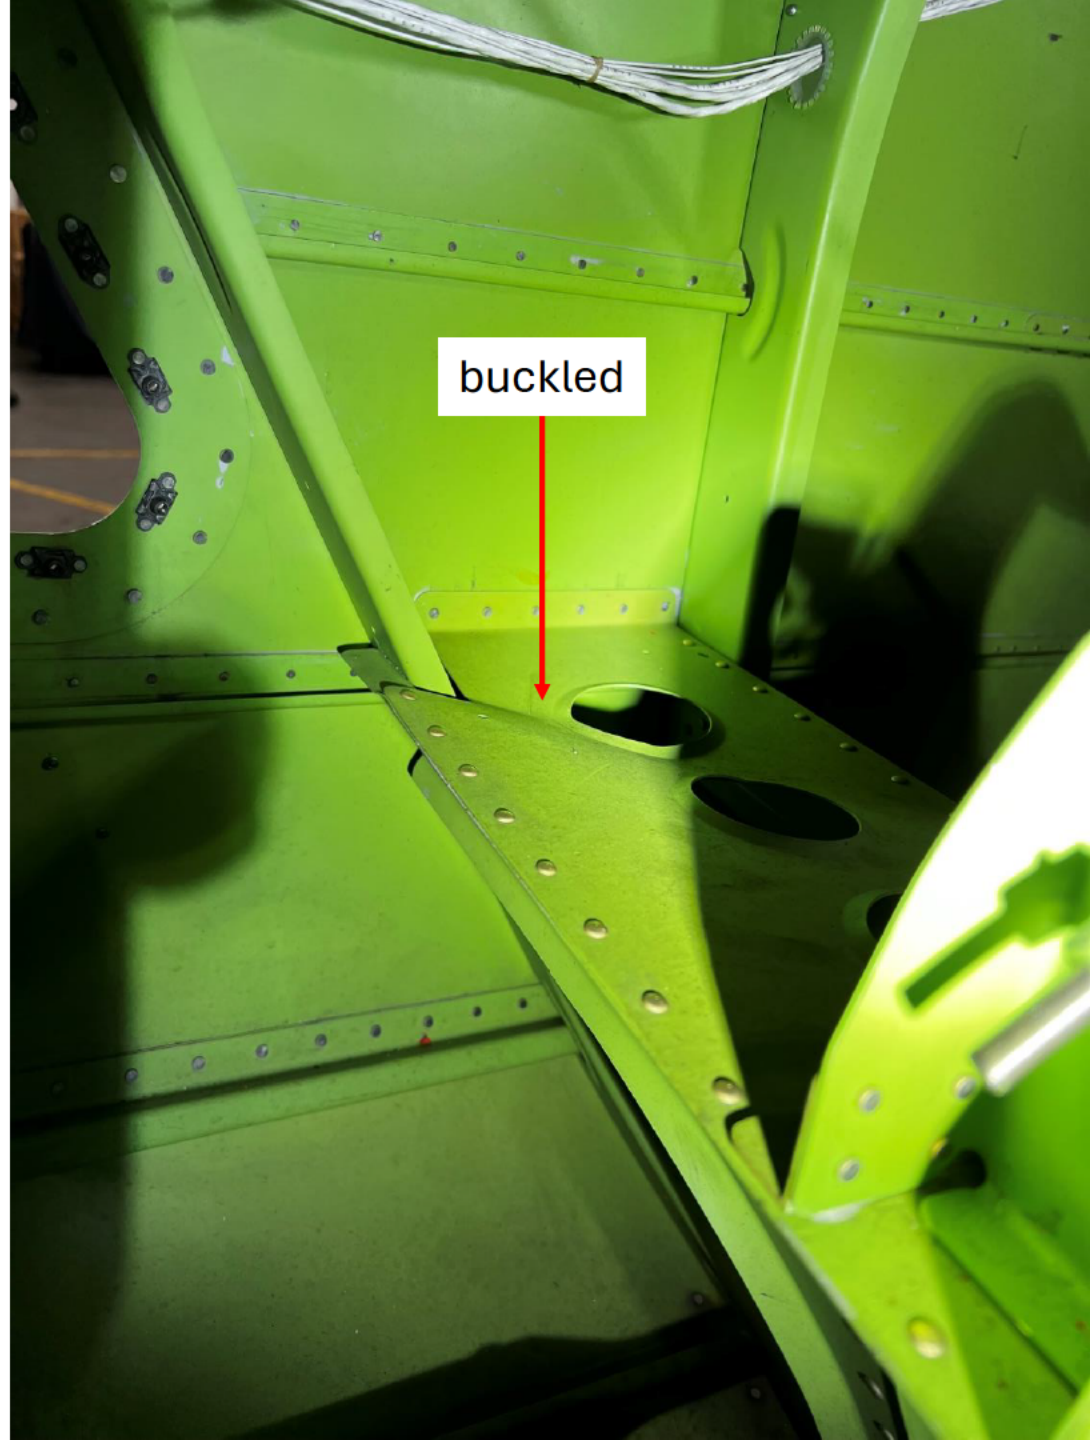
Image of the left side of the frame that the elevator stop is attached to showing the frame is buckled.
