# National Transportation Safety Board

ERA25LA064

## **EXAMINATION SUMMARY**

Location: Centralhatchee, Georgia  
Date: November 20, 2024  
Time: 1330 EST  
1830 UTC  
Airplane: AMS FLIGHT D O O, Carat A, N17GF

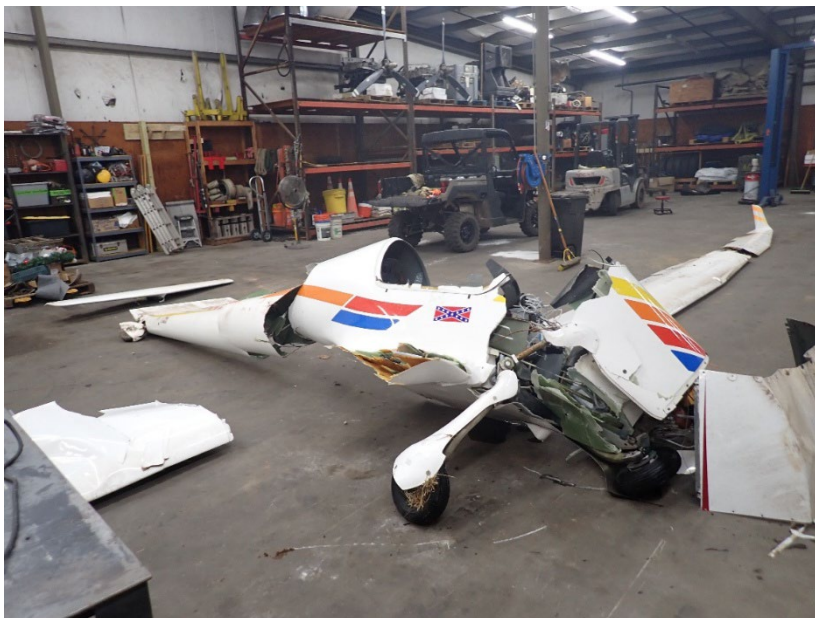
The airplane came to rest inverted in a grassy area at the Sunset Strip Airport (7GE5), Centralhatchee, Georgia.

*Photograph 1: Airplane overview.*

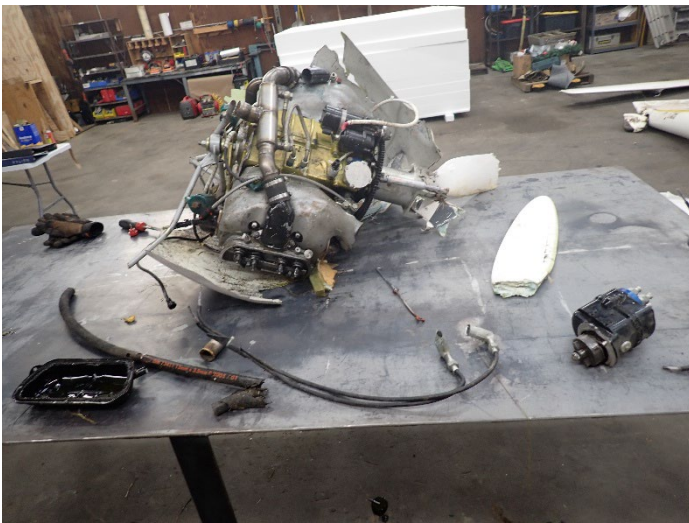
The engine was a Sauer GMBH, S18001 ES10. The engine was separated from the fuselage and its mount was fragmented. The right valve cover was impact separated from the engine. The engine oil sump contained about two quarts of oil and the oil screen was clear of debris. The carburetor was separated from the intake manifold and its control cables remained attached. No fuel was observed in the float bowl, and no anomalies were noted to its interior components. There were no preaccident anomalies noted to the exhaust system. The electronic ignition was fragmented, and the magneto was impact separated from the engine. The magneto produced spark from all four ignition towers during hand rotation of its attached drive coupler. The sparkplug electrodes from cylinders No. 1, 2, & 3 exhibited normal wear and coloration when compared to the Champion Check-A-Plug chart. The top sparkplug electrode of the No. 4 cylinder exhibit impact damage and the bottom sparkplug was seized and fractured during removal attempts.

*Photograph 2: Engine prior to full examination.*

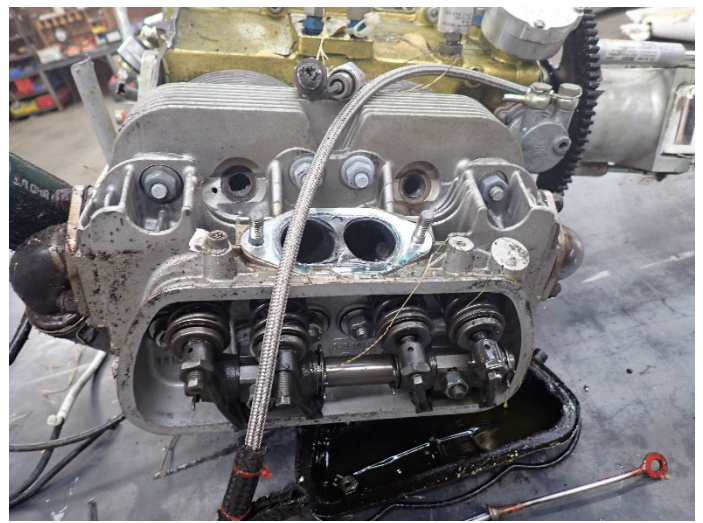
Examination of the engine revealed that the No. 4 cylinder intake valve separated from its keepers and was ingested into the cylinder. The rocker arm adjustment screw's jamb nut was not attached. Abrasion was noted to both No. 4 cylinder rocker arms, consistent with the rocker arms contacting the rotocaps during engine operation.

valve cover and exhibited abrasion at its rotocap contact area: The other keeper was not located. The intake rocker arm's adjustment screw was backed off, and the jamb nut was separated and located in the valve cover. The jamb nut of the No. 4 cylinder exhaust rocker was secured, and its adjustment screw was backed off, inconsistent with the adjustments observed on the remaining three cylinders. The exhaust valve and keepers remained intact. Abrasion was noted to the No. 4 cylinder intake and exhaust rocker arms at their adjustment area, consistent with the rocker arms contacting the rotocaps during engine operation. Removal of the No. 2 & 4 cylinder head revealed impact damage to the interior of the No. 4 cylinder bore, piston and head. Following the removal of the cylinder head, crankshaft rotation and geartrain continuity was established.

*Photograph 3: No. 4 cylinder rocker arms.*

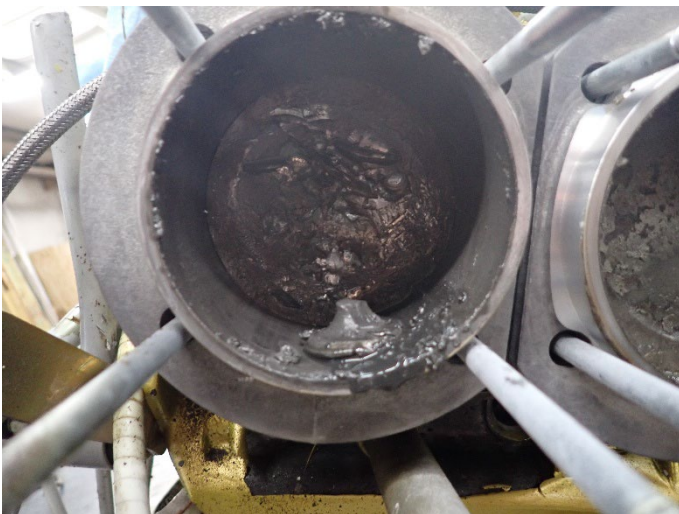
*Photograph 4: No. 4 cylinder impact damage.*

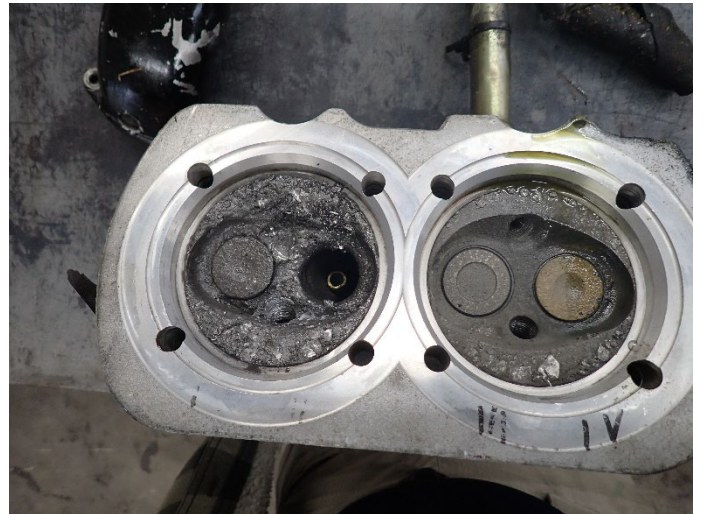
*Photograph 5: No. 4 cylinder head impact damage.*

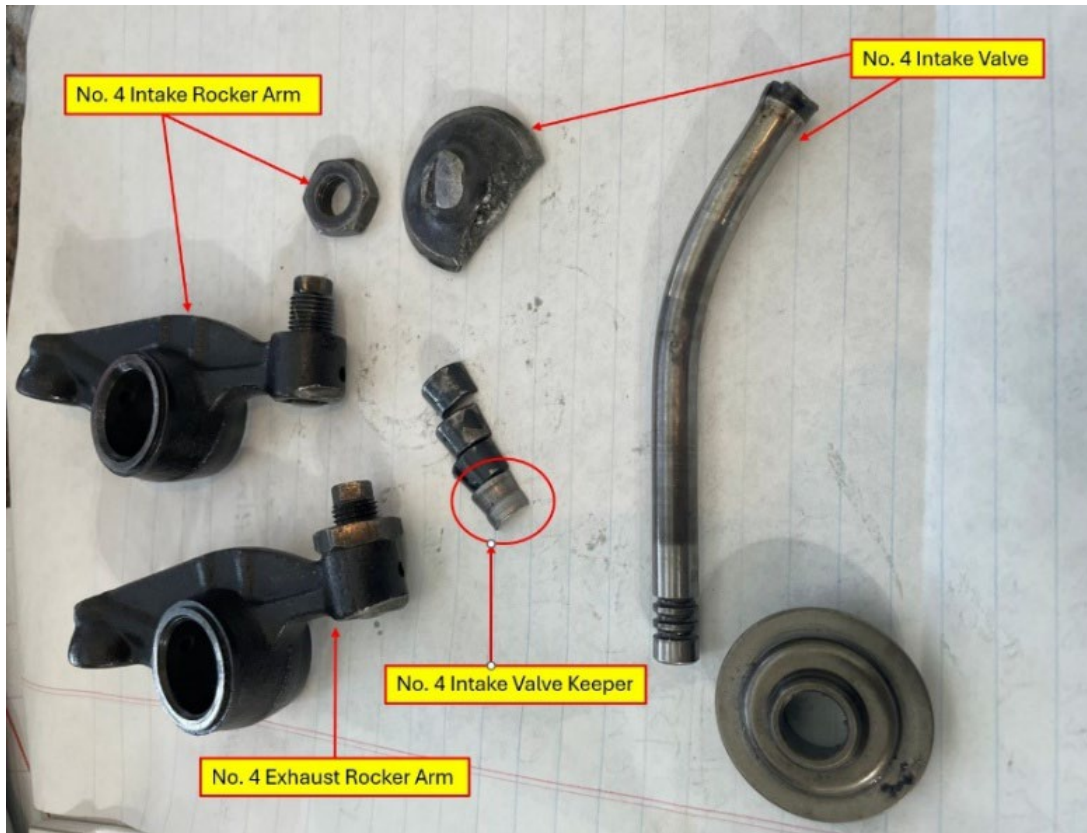
The engine's crankshaft could not be rotated. Further examination revealed the No. 4 cylinder intake valve was fractured in three sections. The valve's head was found within the combustion chamber, and the stem was deformed and observed in the intake manifold. One of two valve keepers (safety wedges) was observed in the

Photograph 6: Annotated photograph of the No. 4 cylinder rocker arms and intake valve.

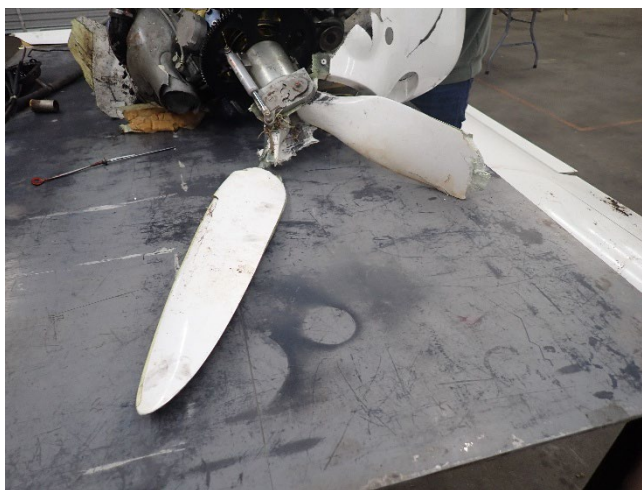
The composite two-bladed forward-folding fixed pitched propeller remained attached to the engine. One propeller blade was separated at the hub, and the other blade was separated about 12 inches from the hub. The actuators remained attached and about 2-inches of the actuator pistons were exposed. Impact damage was noted to the pinion wheels and precluded articulation of the propeller blades.

Photograph 7: propeller.
