**TECHNICAL NOTE NO. 26**

Valve adjustment and control of the rocker arm geometry of engines with and without hydraulic valve clearance compensation (hydraulic tappet).

**TECHNICAL NOTE NO. 25**

Control of the rocker arm geometry and the contact surfaces between the valve stem and the valve adjustment screw.

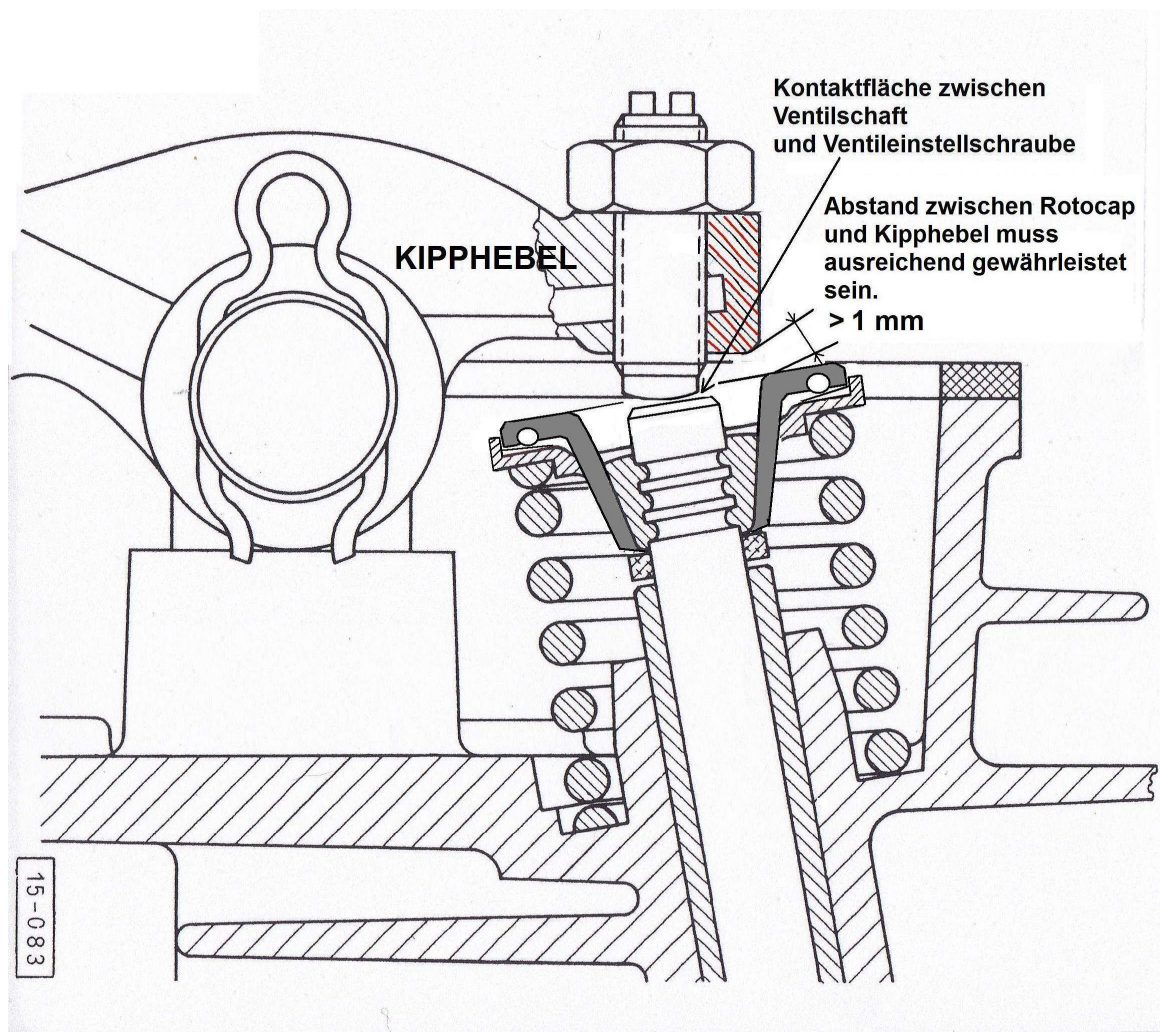
When the valve is pressed, the rocker arm can then touch the Rotocap. This can cause the valve wedges to loosen and, in extreme cases, jump out of their seat. The valve is then no longer held and sucked into the cylinder, which inevitably results in capital engine damage.

1.5 When the valve is fully depressed, the specifications in accordance with TM 25 must be checked. There must be at least 1mm of clearance between rocker arm and Rotocap (see Picture).  
If this minimum clearance does not occur, contact should be made with the company Sauer Flugmotorenbau to remedy the problem, where further instructions can be requested.  
Other valves are adjusted in the same way.

2.1. For motors with mechanical tappets, a valve clearance of 0.2 - 0.25 mm is required. This valve clearance must be checked and, if necessary, adjusted.  
To do this, the motor must be rotated by hand and the rocker arm geometry must be checked. With the valve half pressed, the valve adjustment screw should be perpendicular to the valve stem. When the valve is fully depressed, there must be at least 1 mm of clearance between the Rotocap and the rocker arm. (See TM25).  
At no time must a rocker arm touch the Rotocap.

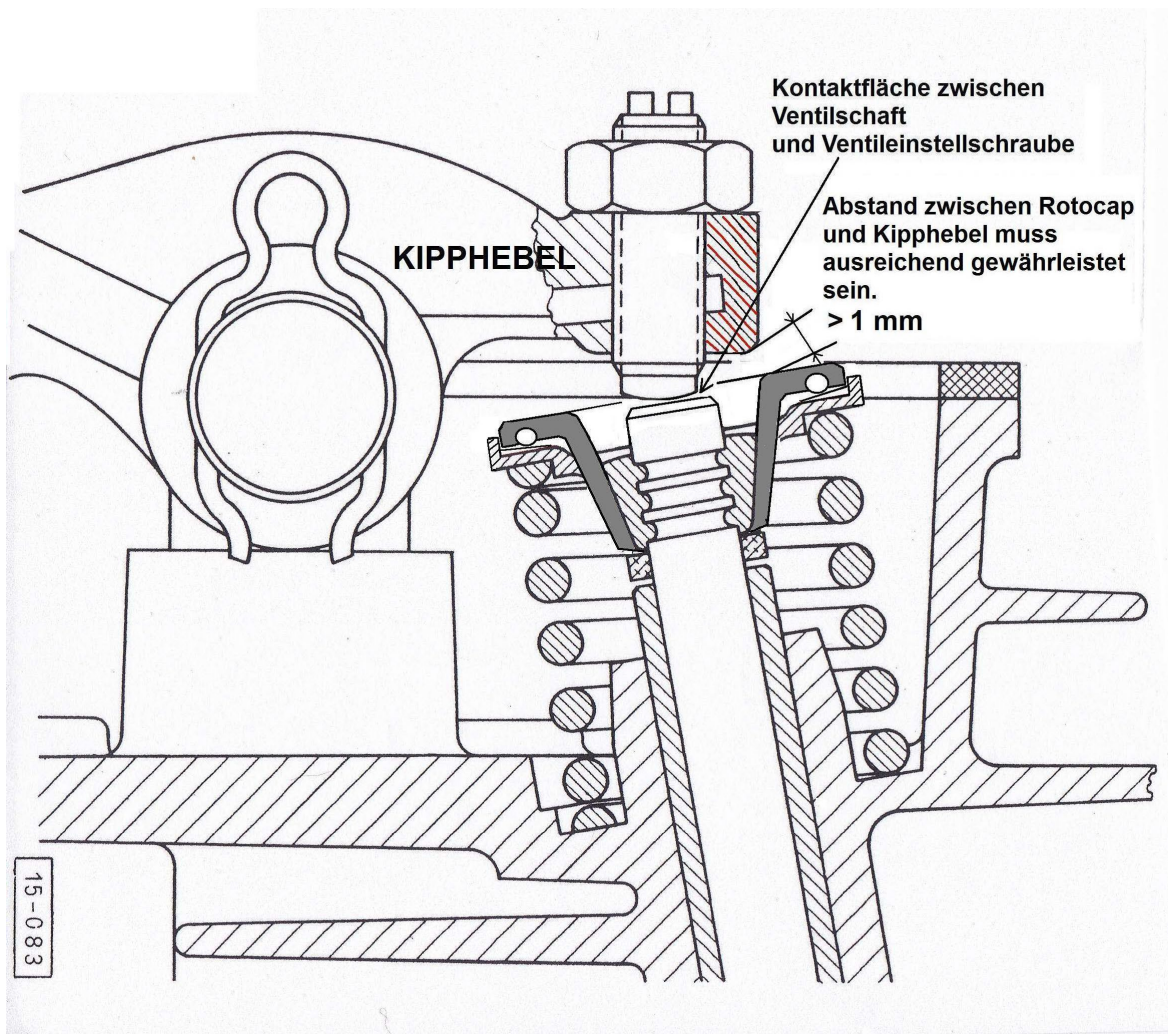
Over time, this increases the penetration depth of the rocker arm into the valve train to such an extent that, in extreme cases, a rocker arm begins to act on a Rotocap. As wear progresses, this can lead to the loss of the safety wedges of a valve and thus to major engine damage. For this reason, the distance between the rocker arm and the Rotocap must be visually inspected at regular intervals.

With the valve half-pressed, the valve adjustment screw should be perpendicular to the valve stem.

When the valve is fully depressed, there must be at least 1 mm of clearance between the Rotocap and the rocker arm.

If there is less than 1mm of clearance between the rotocap and the valve stem and or the contact surfaces between the valve adjustment screw and the valve stem have run in in such a way that there is a suspicion of insufficient lubrication, the company Sauer Flugmotorenbau GmbH must be informed.

The corresponding information on the repair will be provided by the company Sauer Flugmotorenbau GmbH.
