**Date:** December 6, 2024  
**Subject:** ERA25LA067, Record of Conversation/Interview  
**Contact:** Michael T. Howard

Mr. Michael T. Howard contacted the National Transportation Safety Board Response Operation Center (NTSB ROC) on December 5, 2024, to report an aviation accident that occurred on November 7, 2024, involving N6444W, a Cessna P210N, that occurred at KCNI.

N6444W Landing Incident

A Cessna P210N single engine piston airplane was substantially damaged due to a hard bounce landing that resulted in a runway excursion, impact with airport signage, loss of nose gear, and subsequent engine stoppage due to propeller strike.

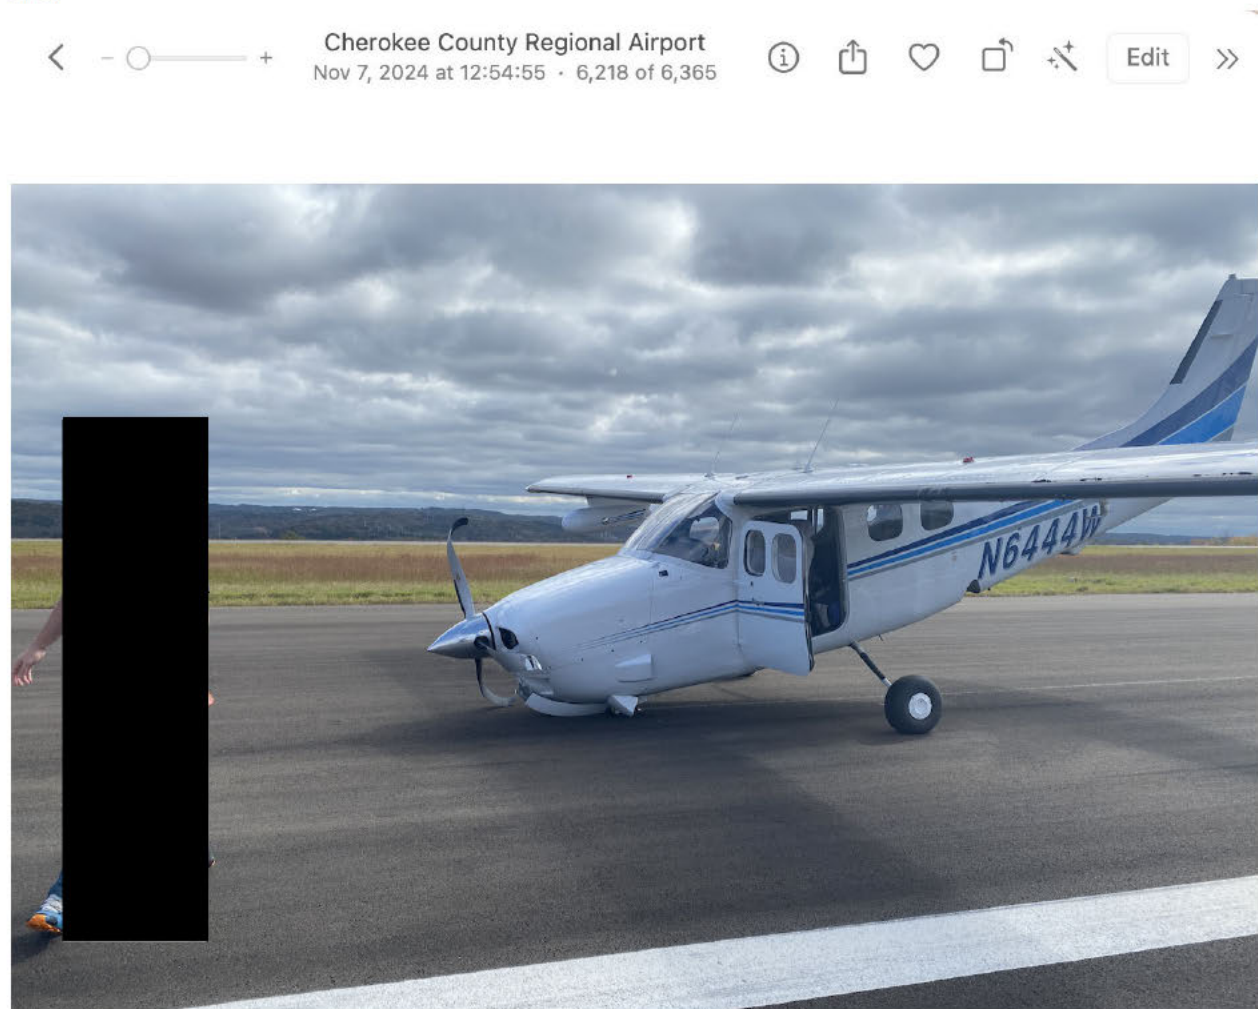
This photo, taken by the pilot after exiting the airplane, is timestamped 7 Nov 2024 12:54:55 EDT

The airplane was at rest, right of center of the runway, nose down with prop bent.

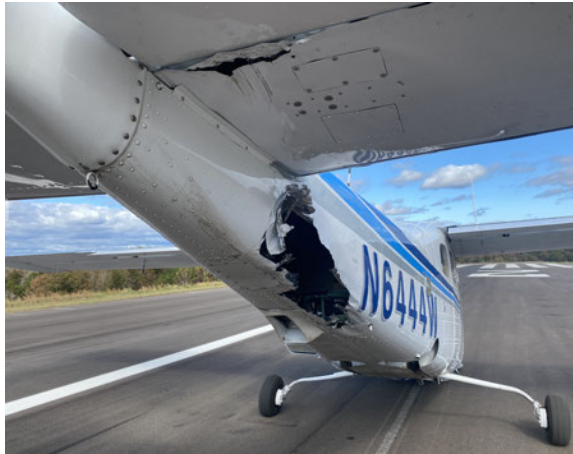
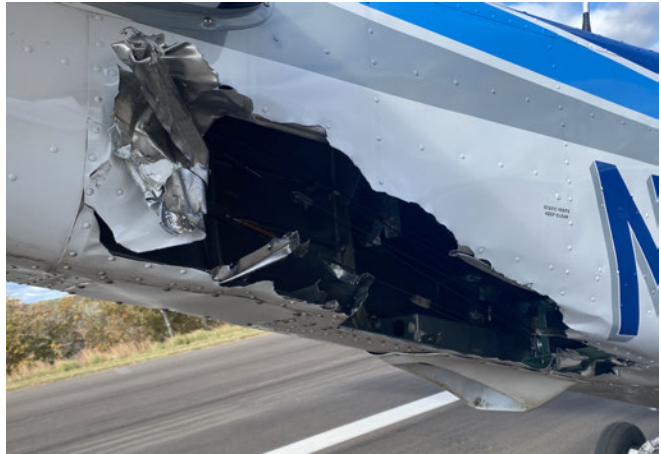
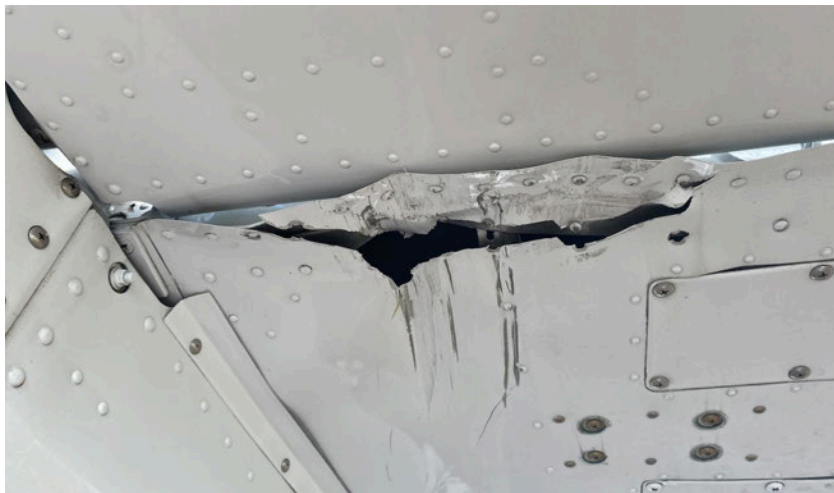
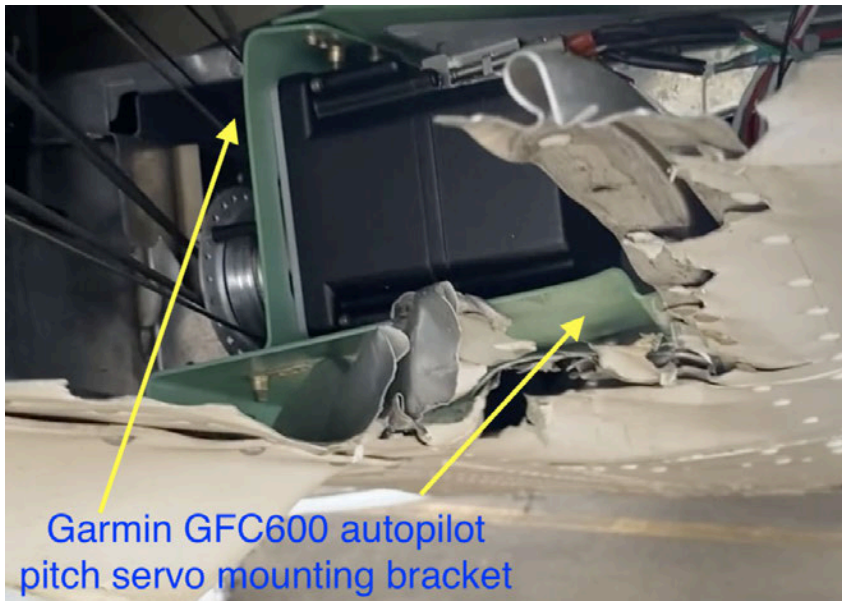
Inspection showed a significant rupture along the lower starboard/right tail cone and some impact on the underside of the starboard/right horizontal stabilizer. The autopilot pitch servo mounting bracket is slightly bent.

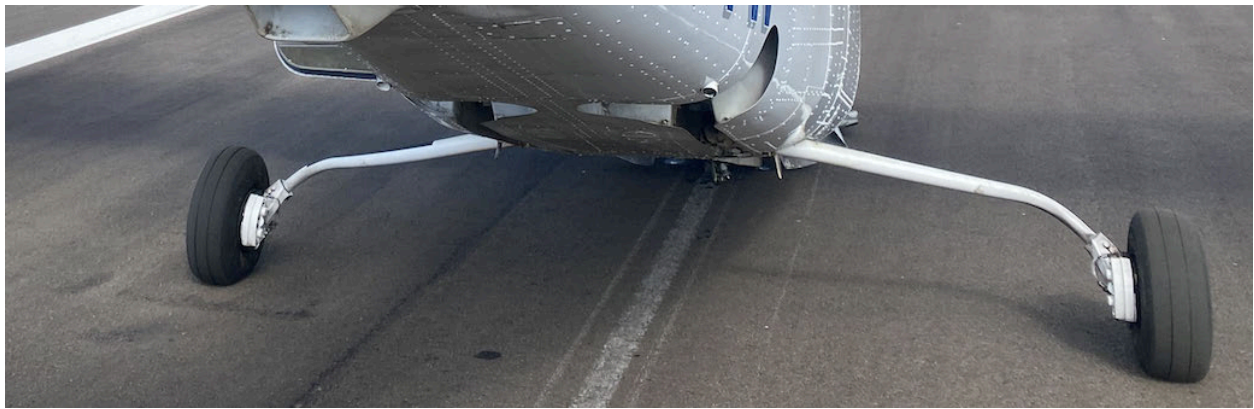
Visual inspection of the main landing gear seems to show that the port/left main gear leg was bent slightly, presumably due to the initial impact. The left tire/tube had a slow air leak.

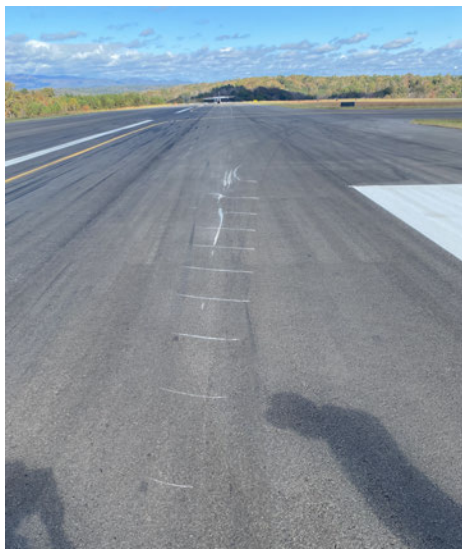
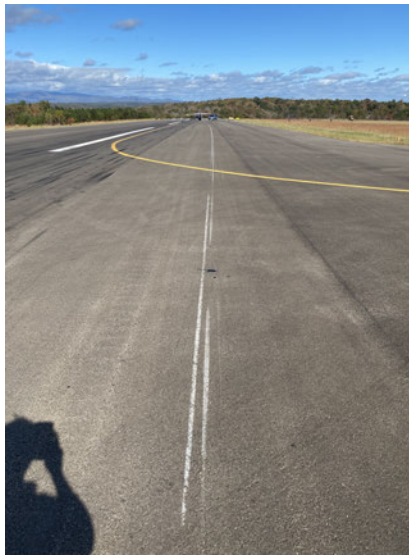
The runway showed strakes where the propeller had impacted the runway.

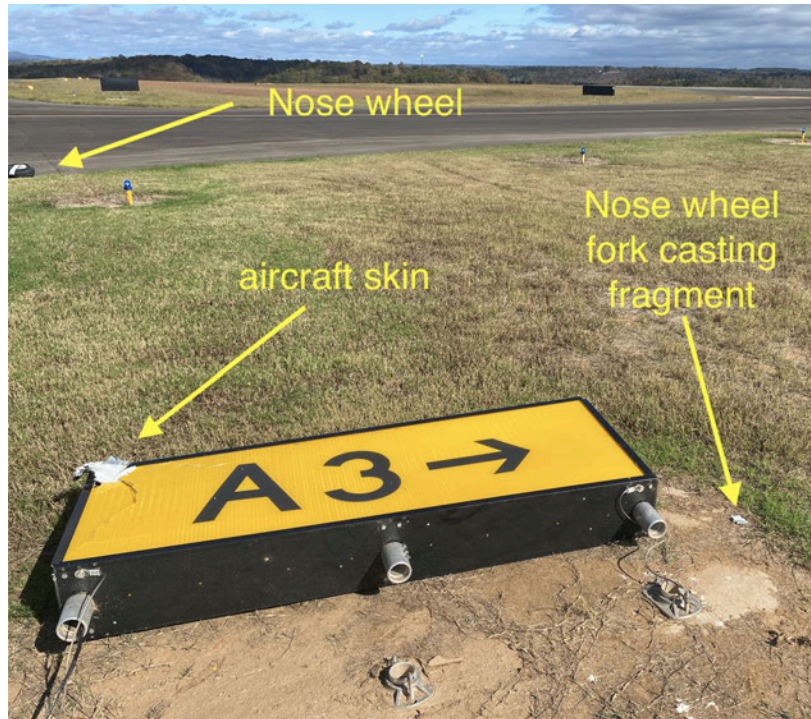
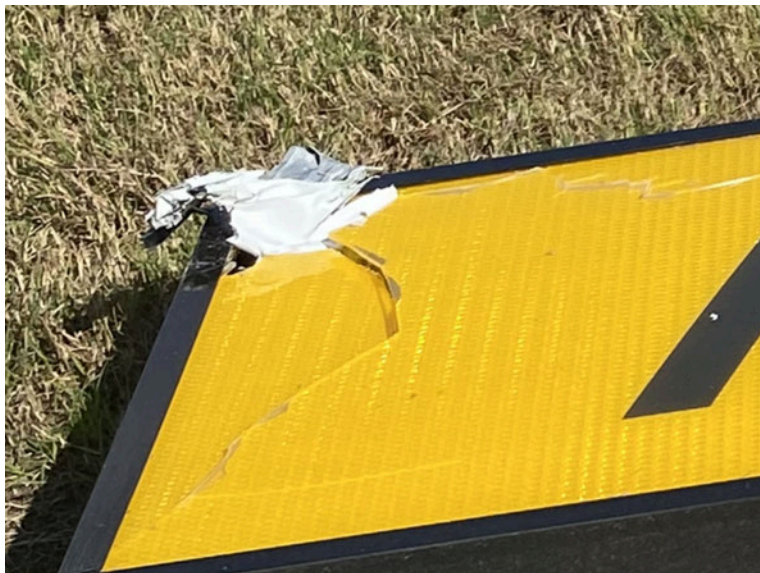
Further back was a taxiway sign, laying on its back, with the breakaway fuses broken/sheared. Painted sheet aluminum clearly shows that the tail cone had impacted the corner of the taxiway sign.

A piece of the nosewheel fork casting was found beside the impacted sign. The nosewheel itself was on the edge of the taxiway beyond the sign. The rubber on the tire sidewall showed cuts.

The pilot believes that the nose tire impacted the corner of the taxiway sign, as evidenced by cuts on the tire, resulting in the broken fork casting and the nose wheel departing the airplane. Subsequently, the tailcone contacted the sign corner, rupturing the tail cone and knocking the sign over.

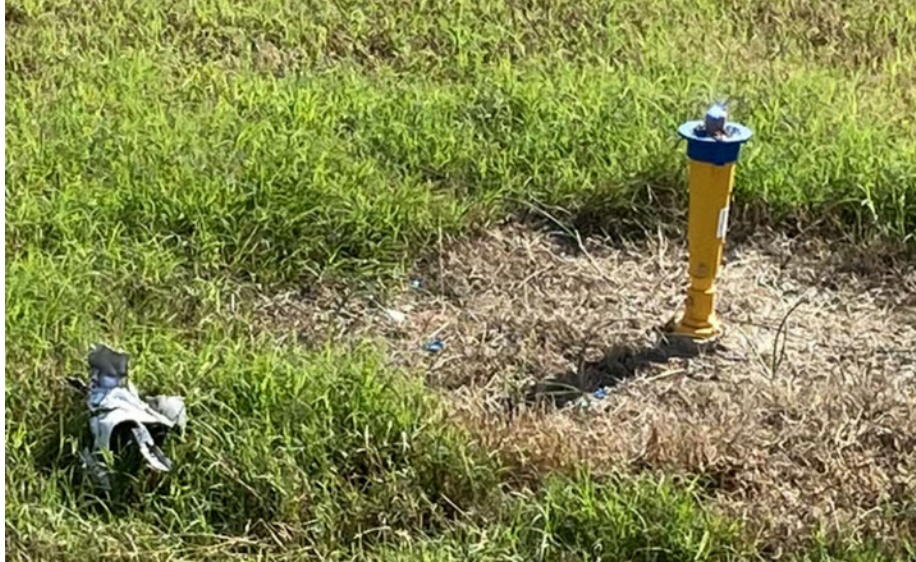
The lens of one runway light was also damaged. It is likely that this runway light was impacted by the piece of adjacent debris rather than the airplane itself.

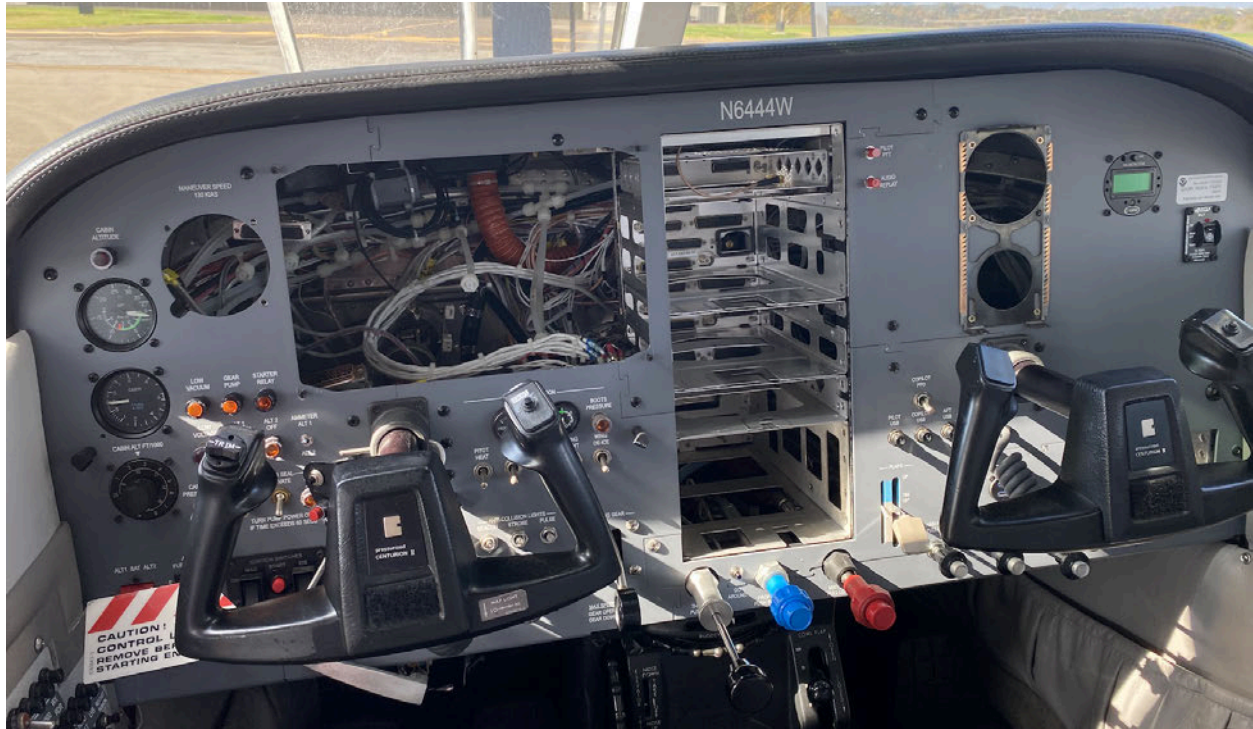
Because the left wing was low, fuel had been cross-feeding and leaking through the left wing fuel vent. While the pilot was removing the avionics the FBO staff drained 47 gallons of fuel from the left wing.
