ERA25LA068

## INVESTIGATION PHOTOGRAPHS

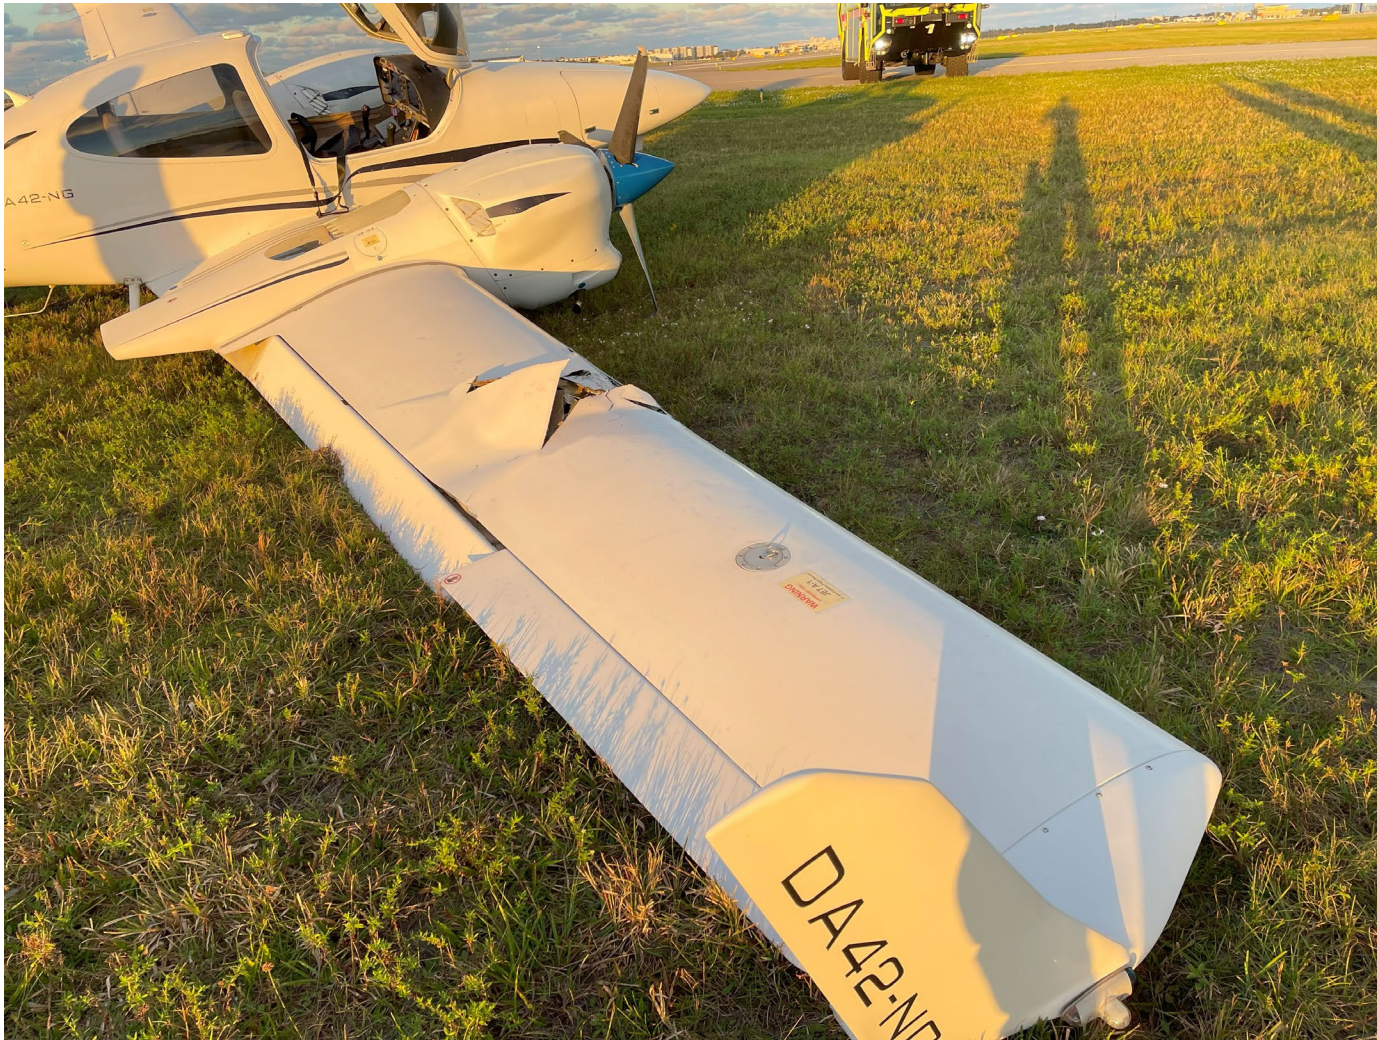
**Photograph 1 - Accident Damage Right Wing (Courtesy of PEA)**

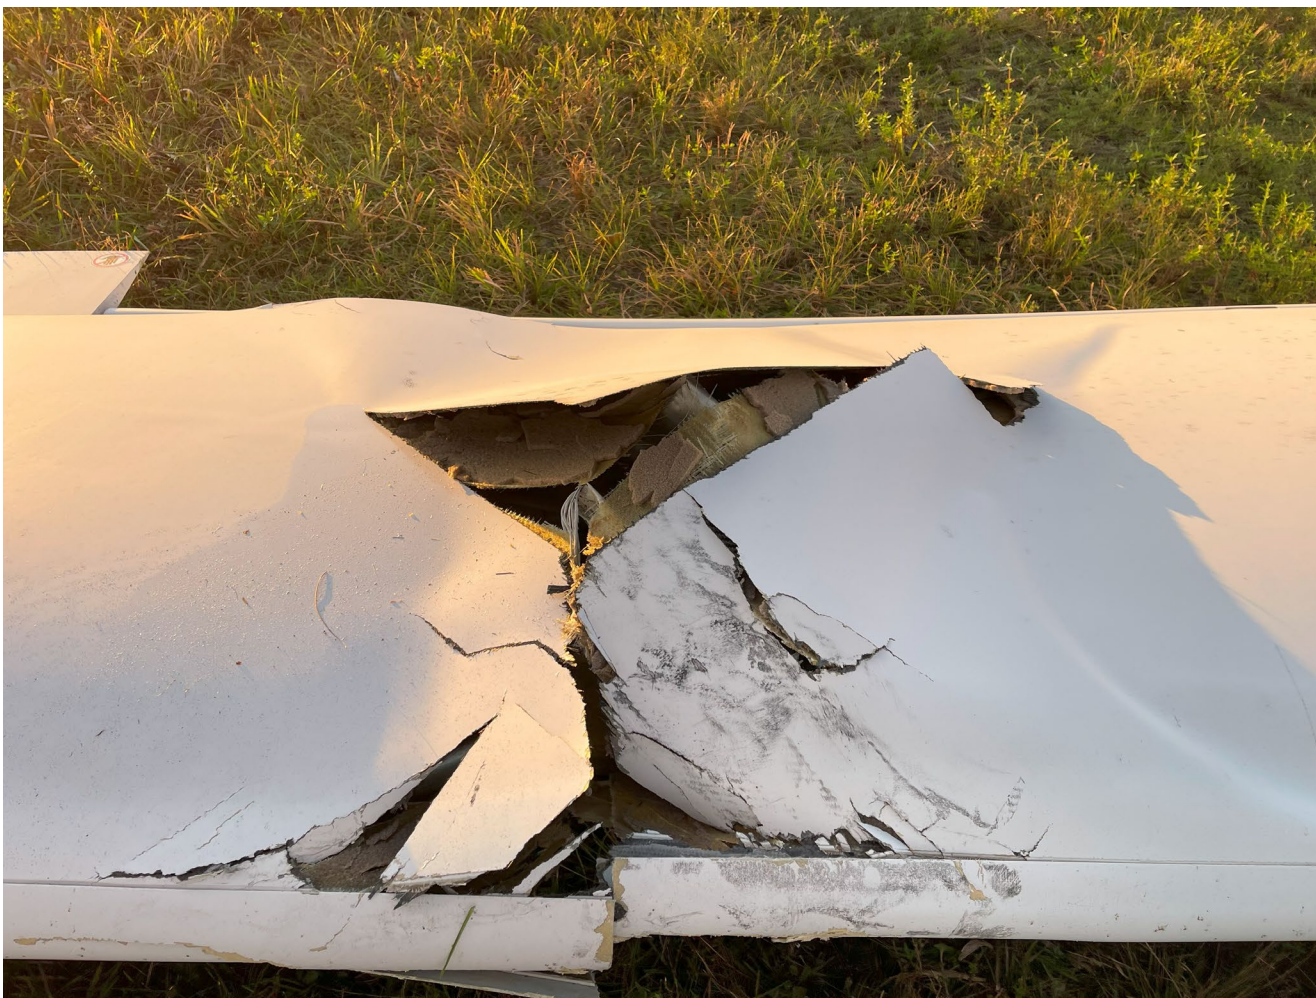
**Photograph 2 - Accident Damage Upper Forward Right Wing (Courtesy of PEA)**

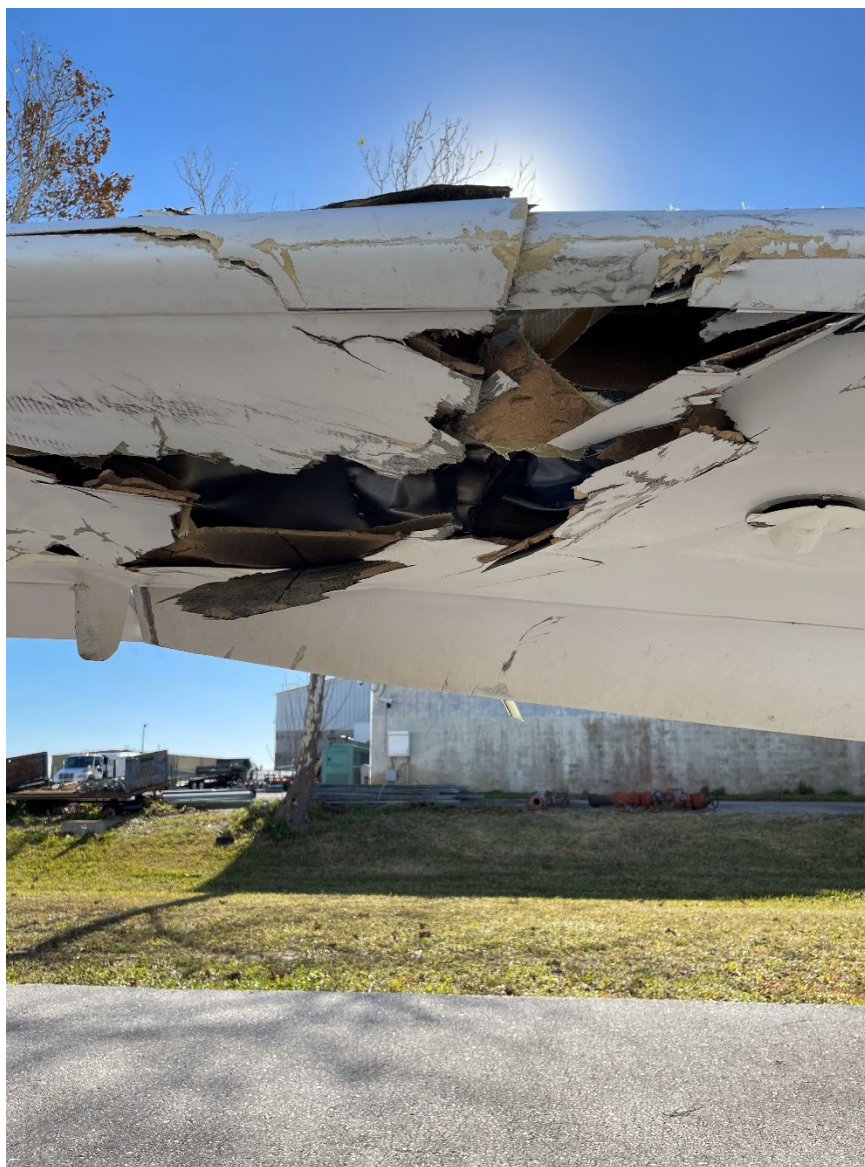
**Photograph 3 - Accident Damage, Lower Forward Right Wing (Courtesy of PEA)**

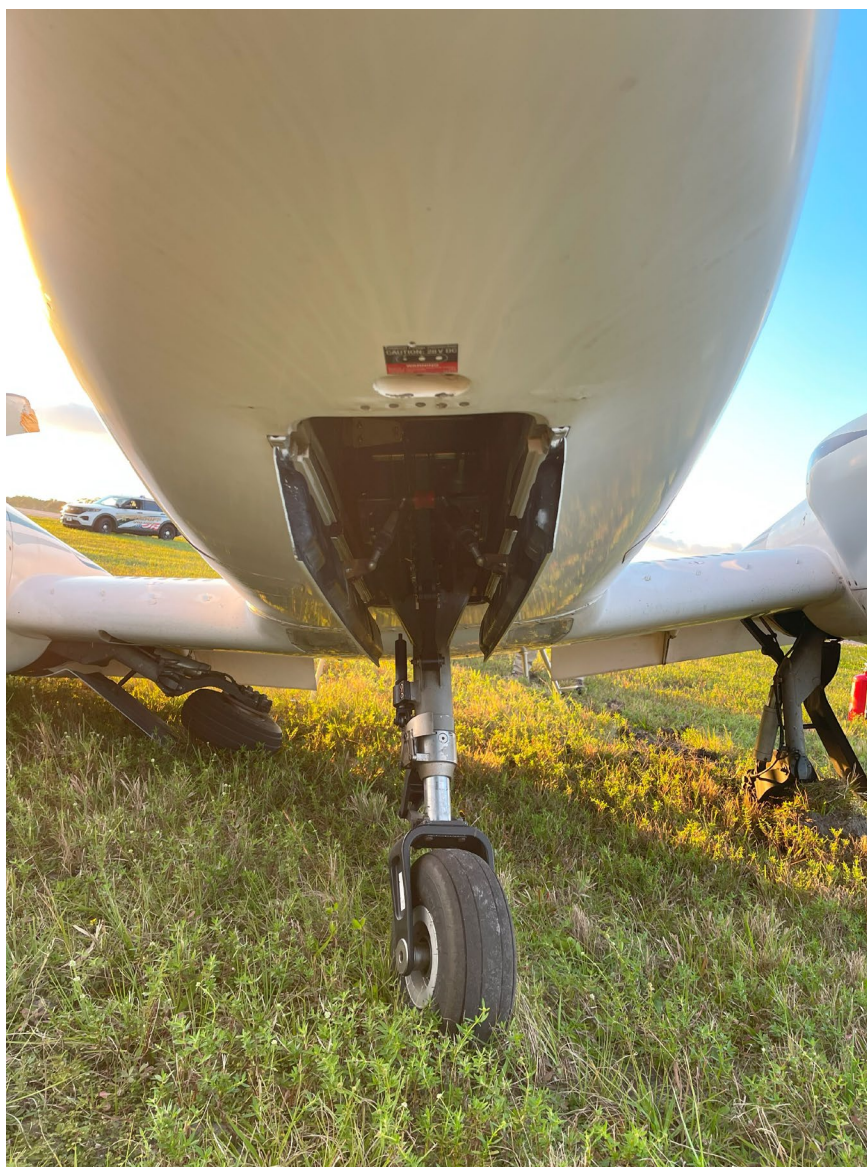
**Photograph 4 - Postaccident Undercarriage (Courtesy of PEA)**

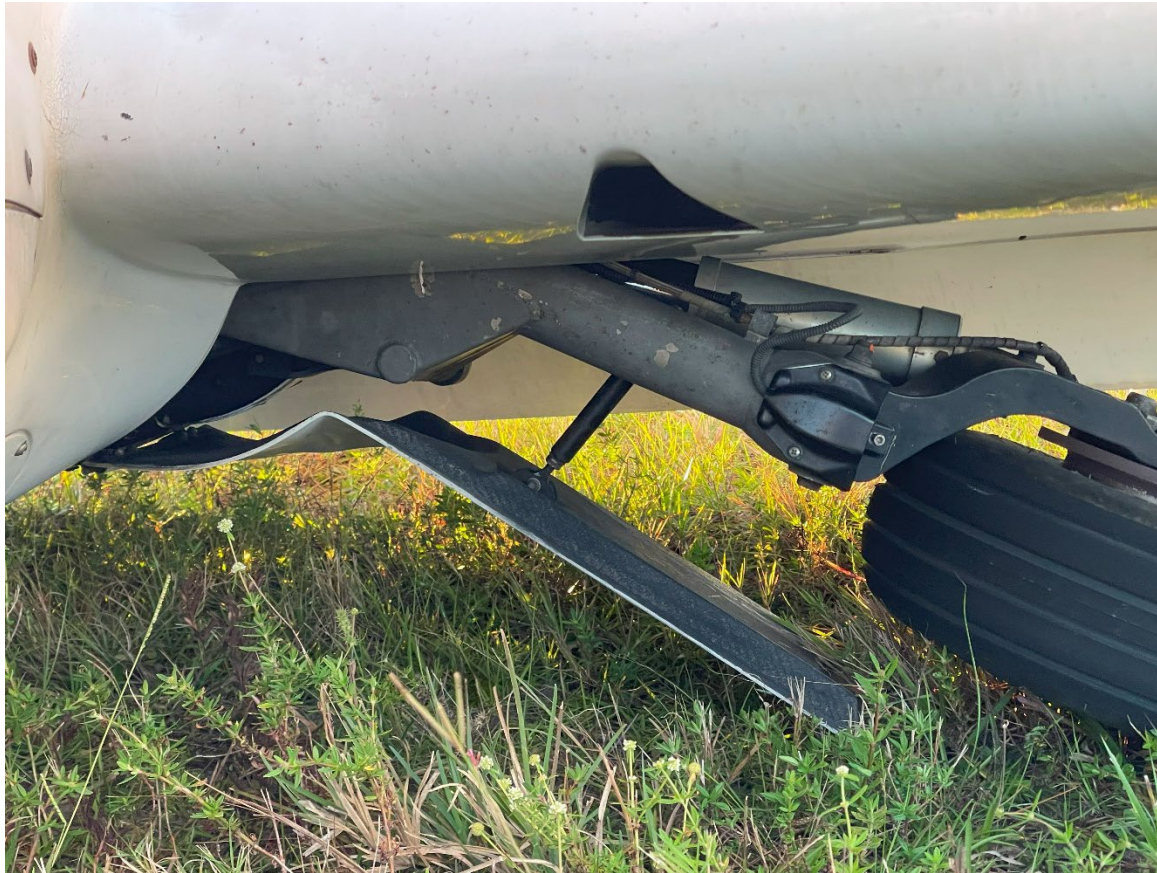
**Photograph 5 - Collapsed Right Main Gear Leg (Courtesy of PEA)**
