ERA25LA074

## INVESTIGATION PHOTOGRAPHS

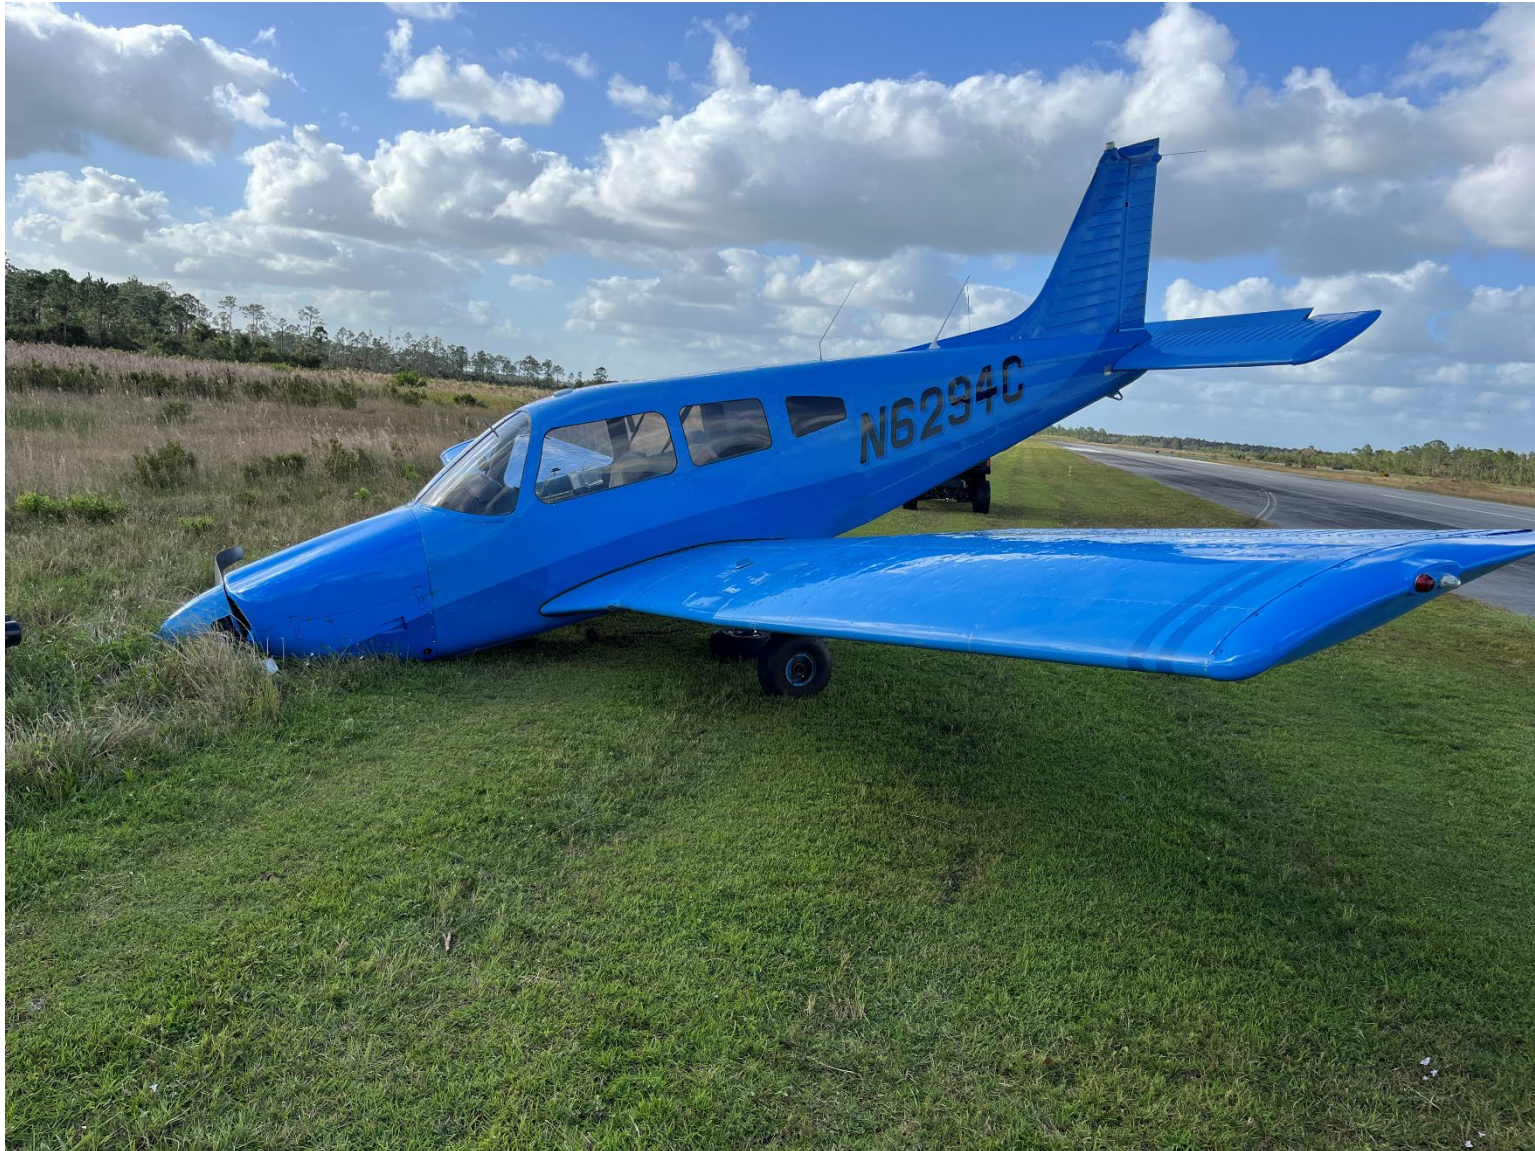
**Photograph 1 - Airplane overview (Source: FAA)**

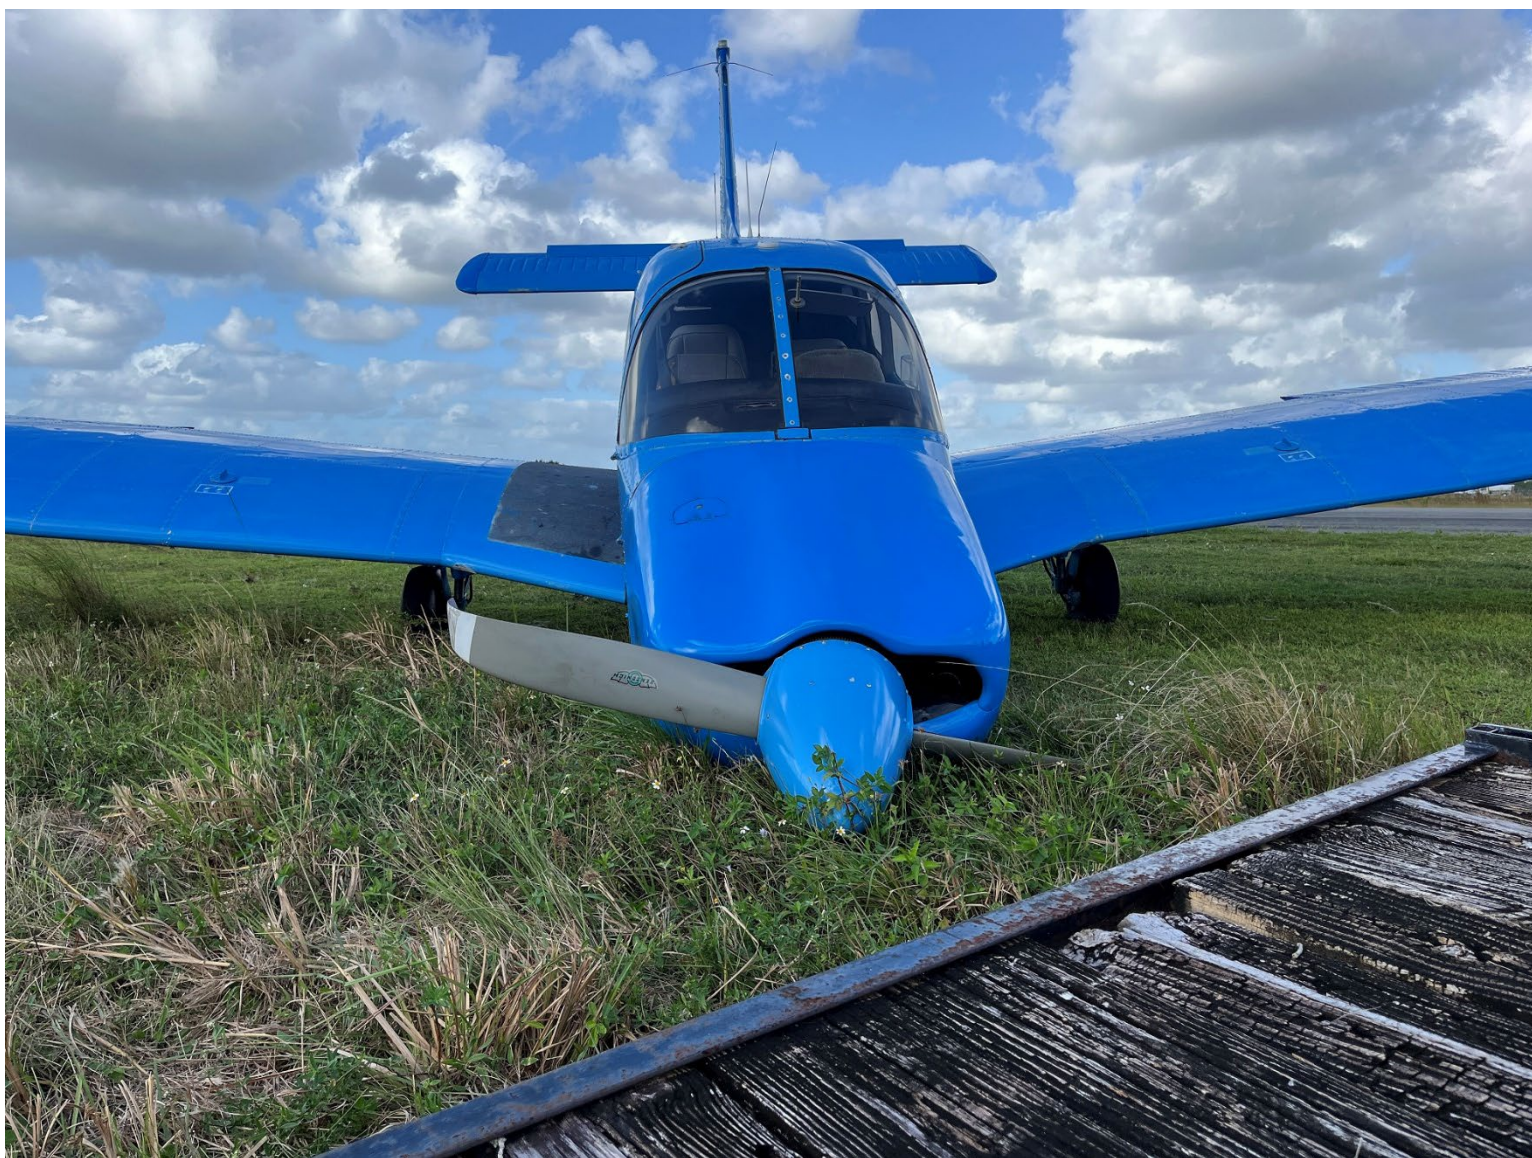
**Photograph 2 - Airplane overview (Source: FAA)**

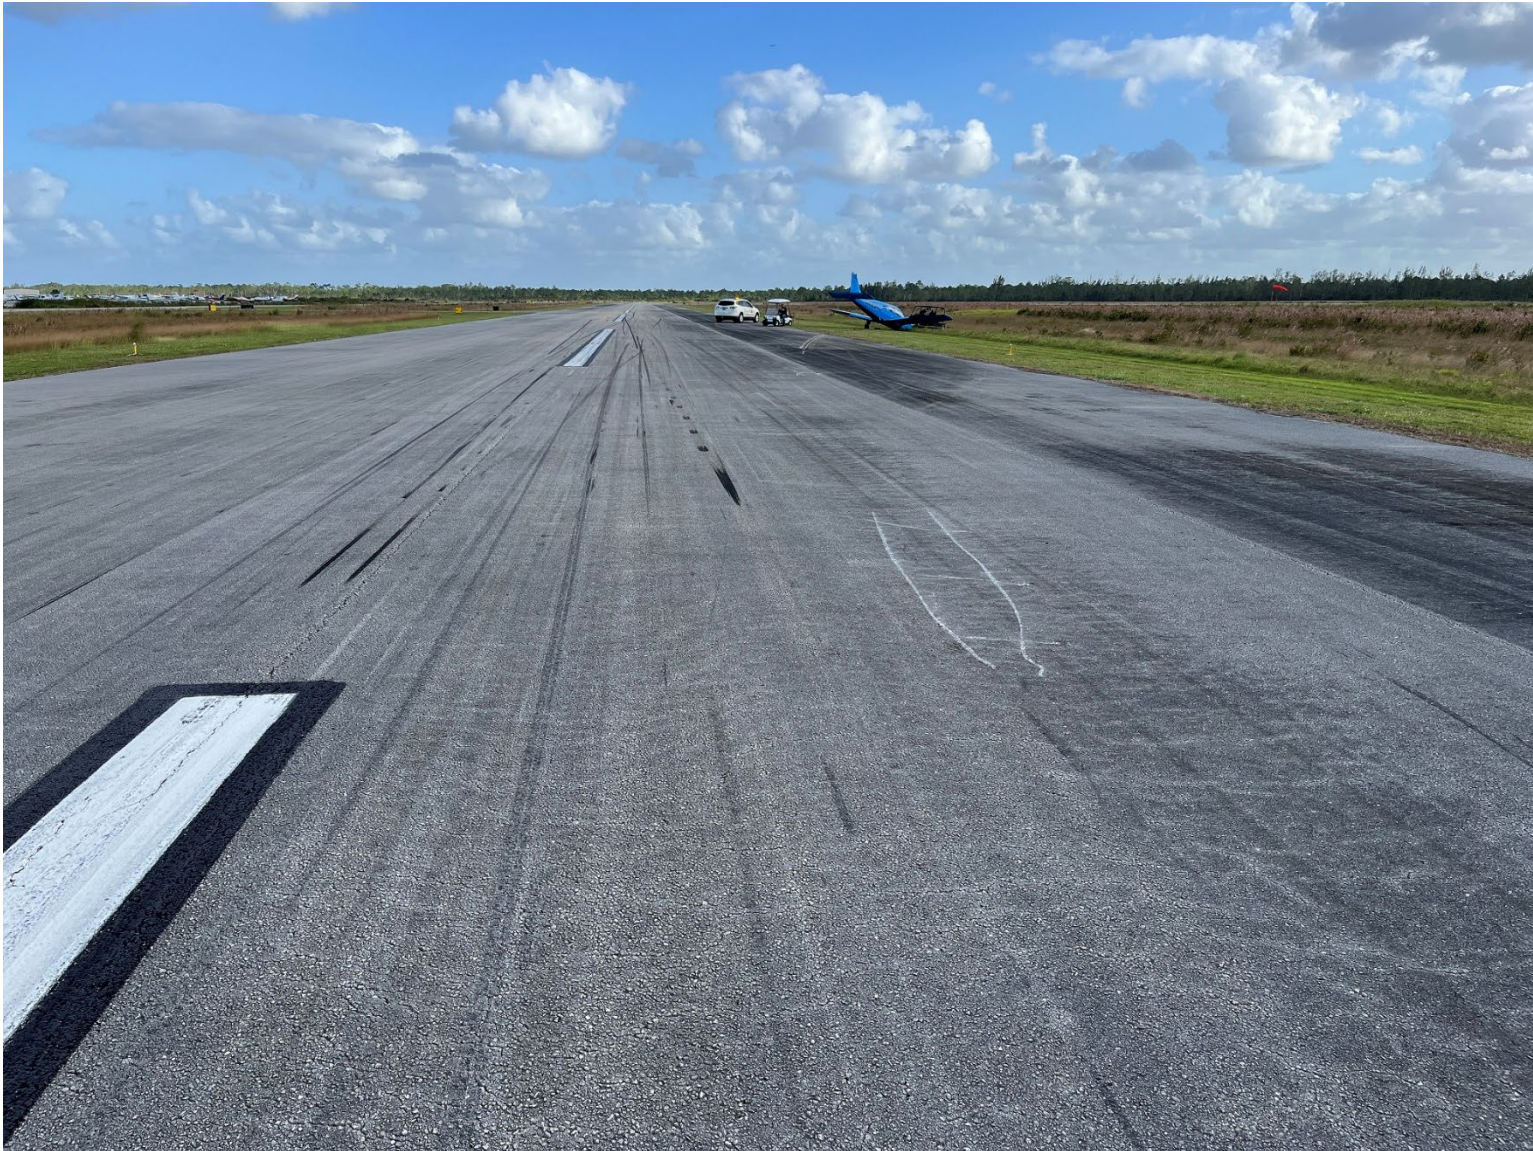
**Photograph 3 - Runway damage and airplane at accident site (Source: FAA)**

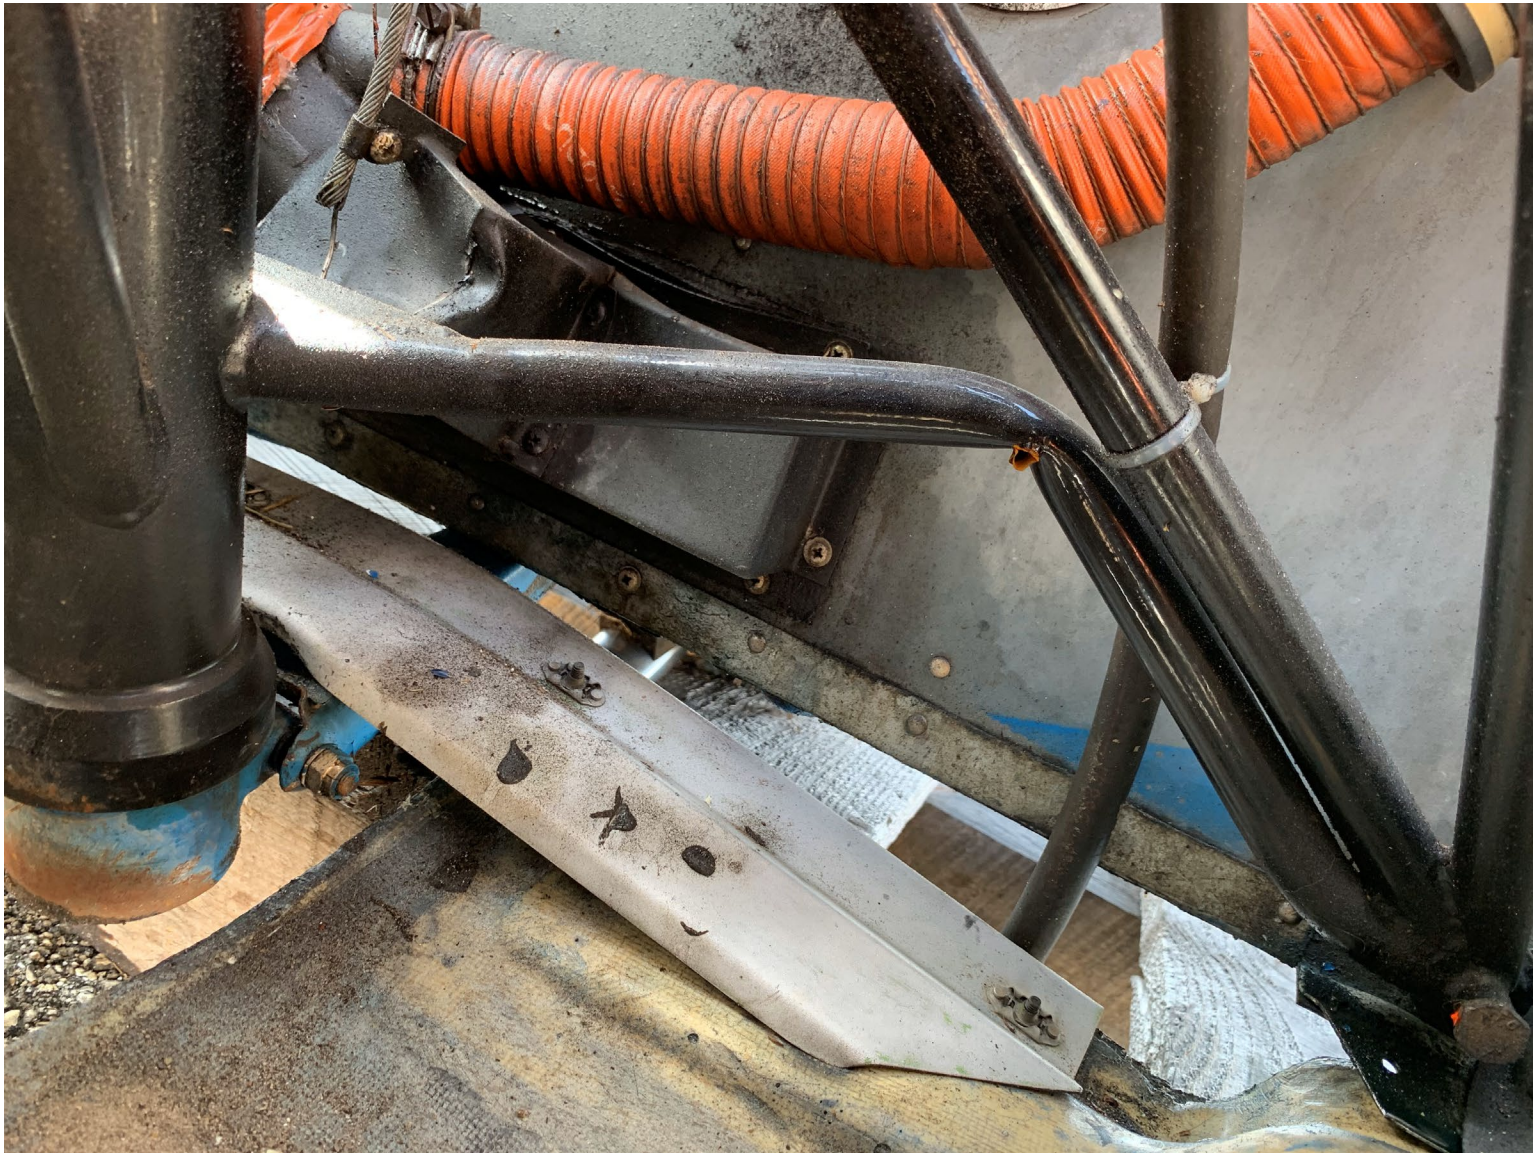
**Photograph 4 - Damage to tubular engine mount (Source: SkyBlue Aviation)**

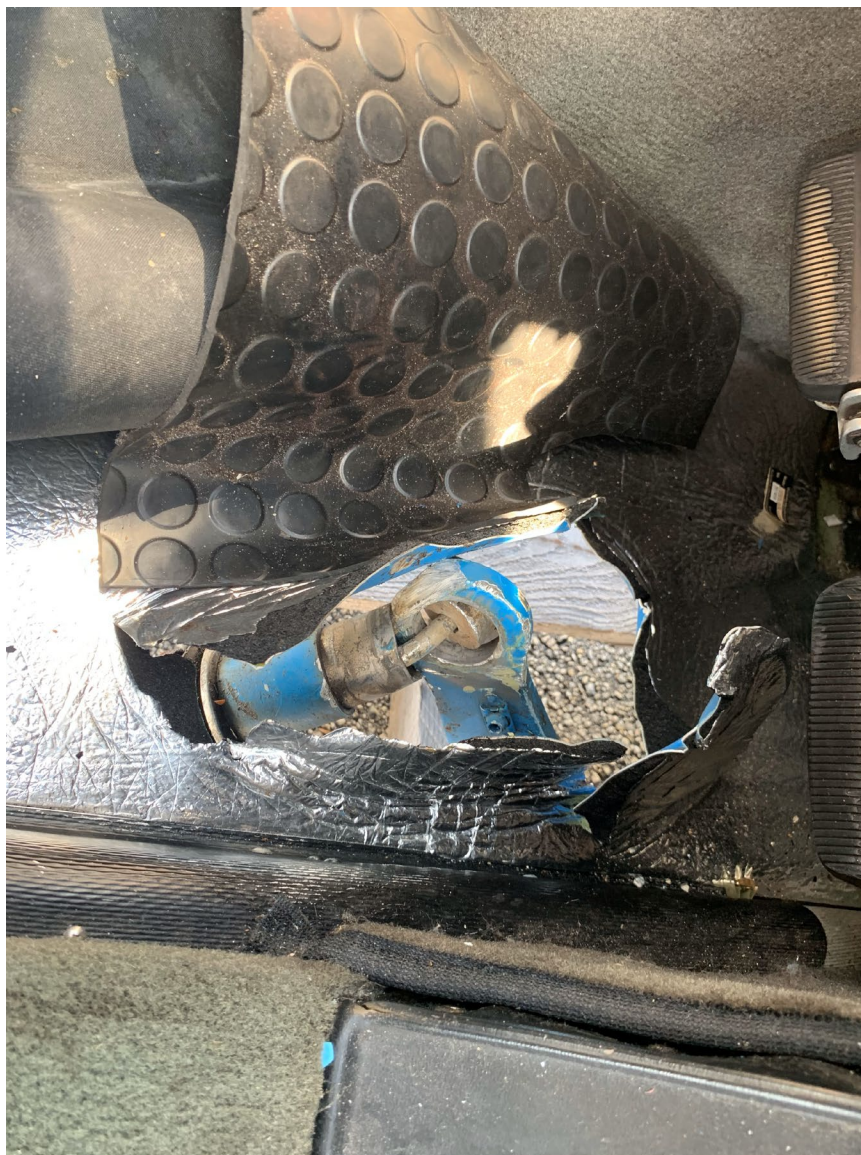
**Photograph 5 - Damage to cabin floor (Source: SkyBlue Aviation)**
