# National Transportation Safety Board

ERA25LA079

## **AIRFRAME EXAMINATION**

Location: Big Cypress, FL  
Date: December 18, 2024  
Time: 1630 EST  
2130 UTC  
Airplane: N8516V; Air Tractor AT-504

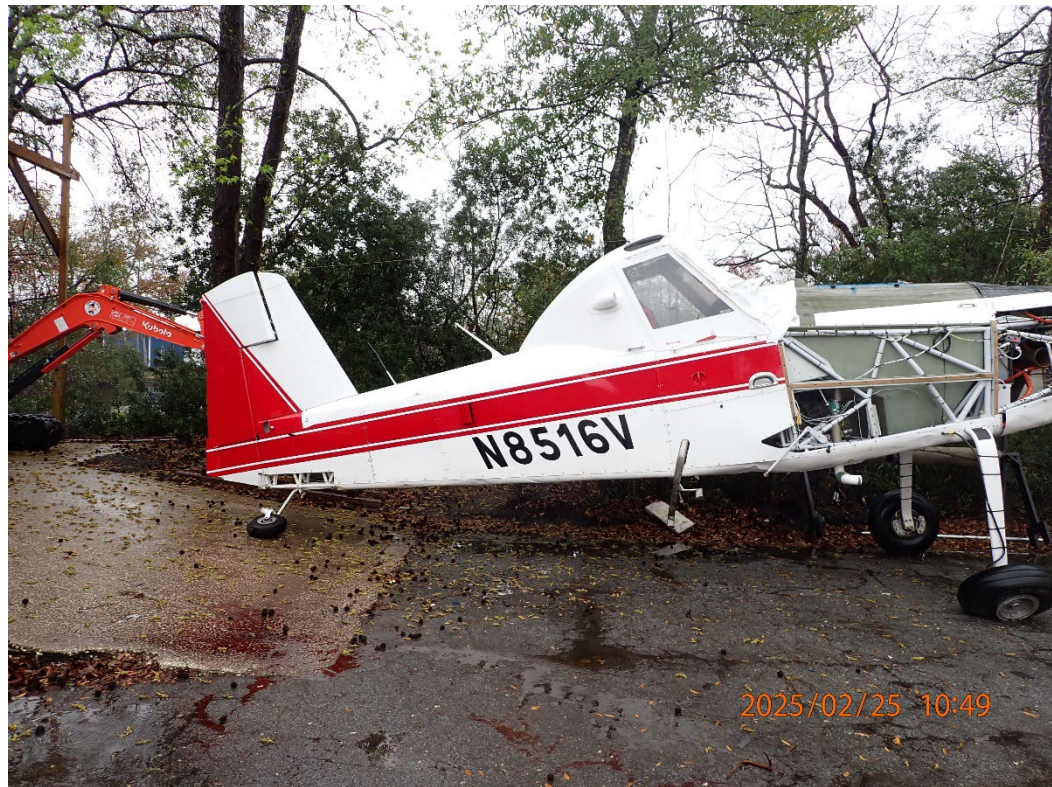
The fuselage was found with slight upward bending on the motor mount and upward bending of the frame members around the right landing gear spring attach. The fuselage skin panels were removed, and a large amount of baggage was observed zip tied to the tubular metal fuselage structure aft of the baggage compartment and under the cockpit area. Multiple zip ties were found cut and others were found loose.

**Photo 1: View of the airplane fuselage.**

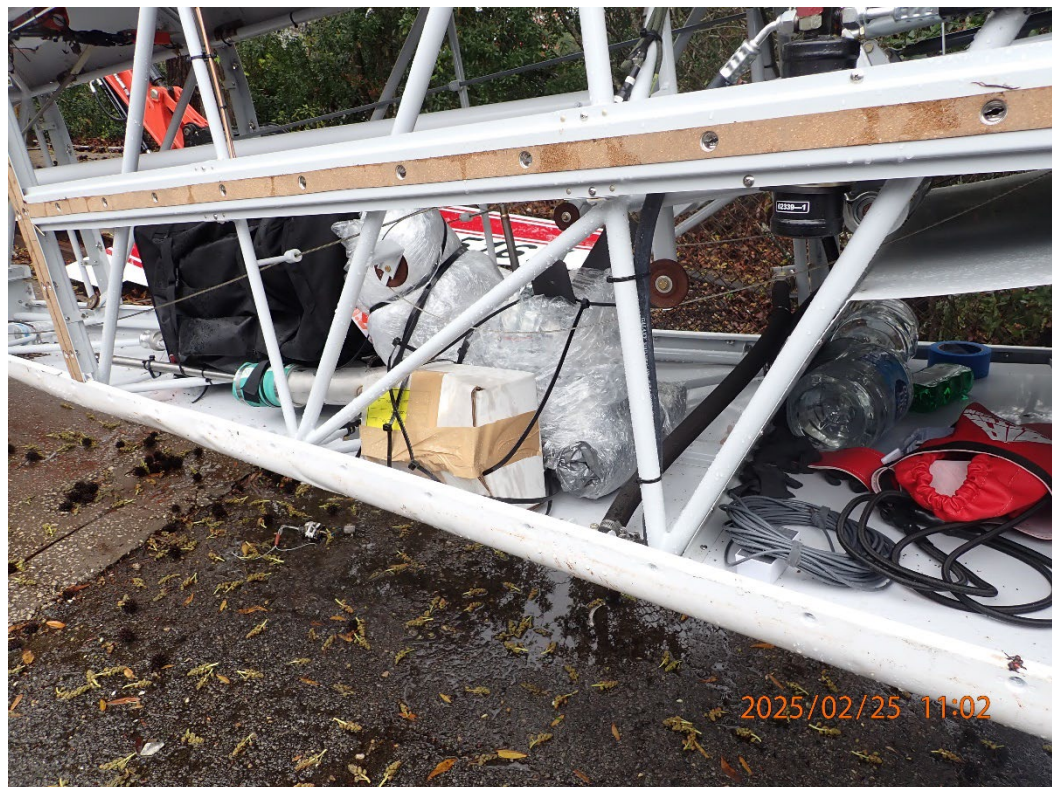
**Photo 2: View of baggage zip-tied to the tubular fuselage frame.**

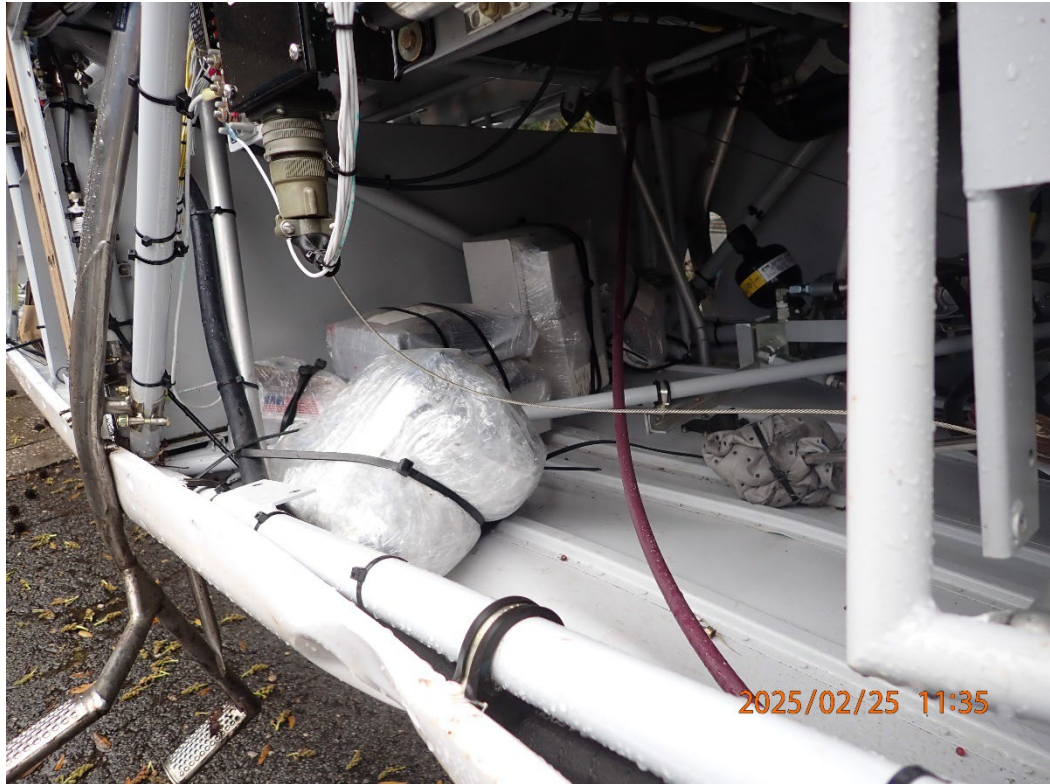
**Photo 3: View of baggage under the cockpit zip tied to the tubular fuselage frame.**

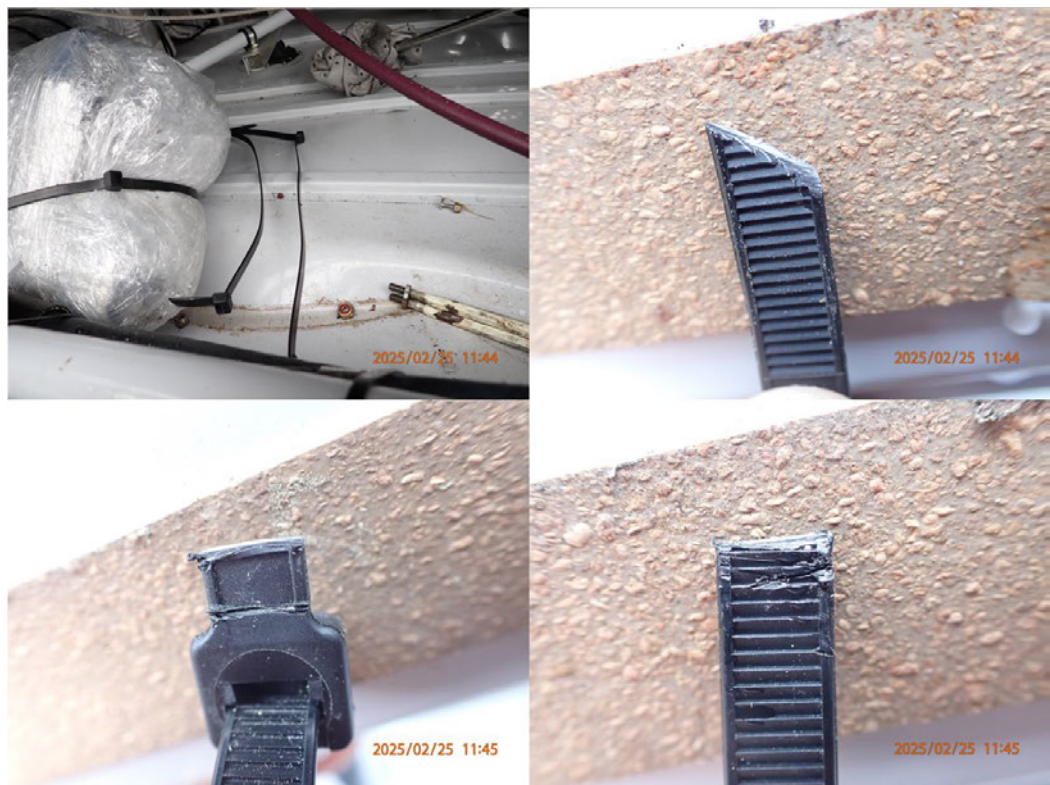
**Photo 4: View of cut zip ties from under the cockpit area.**

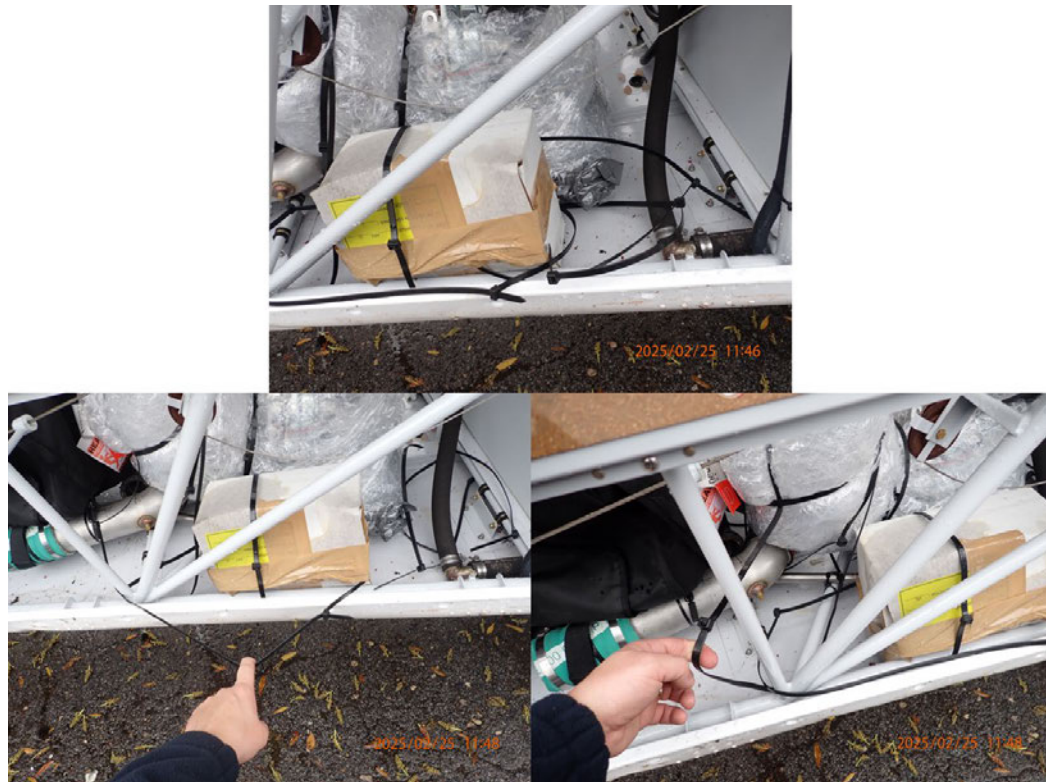
**Photo 5: View of cut and loose zip ties in the aft fuselage area.**

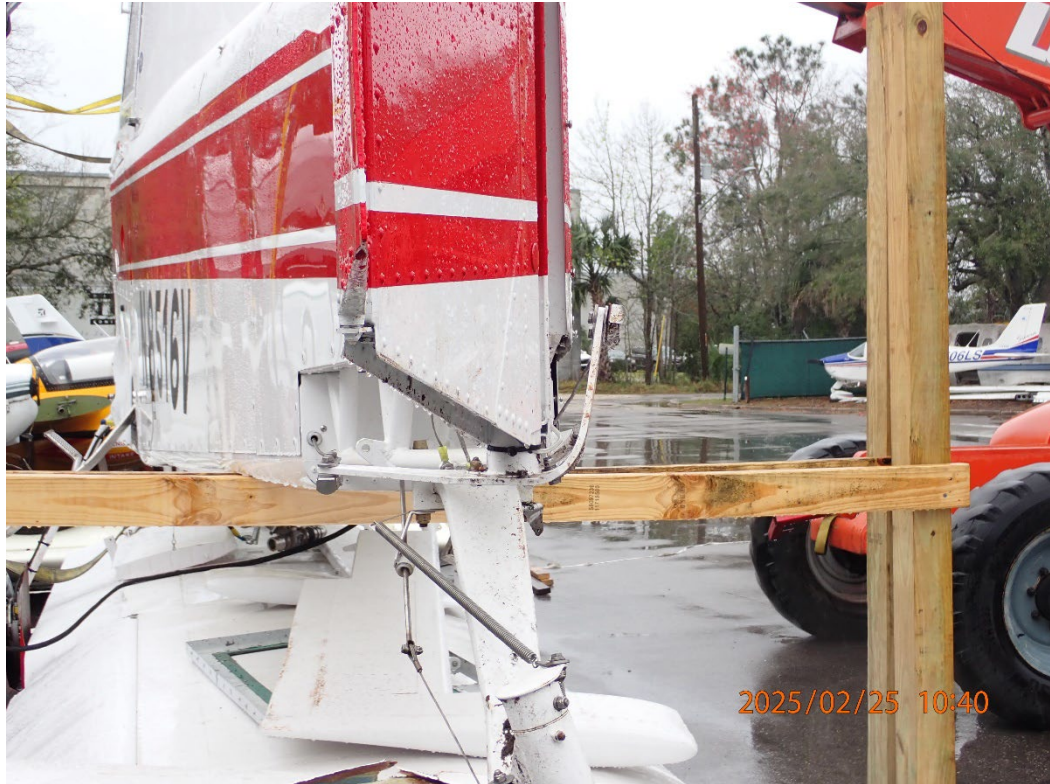
The vertical stabilizer remained attached to the empennage and the rudder remained attached to the vertical stabilizer. The right rudder control horn was found impact bent upwards. The right rudder limit stop was found impact bent upwards. Initially during the review, the rudder was able to move left to the limit but not to the right. The left and right rudder cables were found to be continuous from the rudder control horn to the rudder pedals. The rudder cables were traced and found to be continuous from the rudder control horn to the rudder interconnect system. The left seat and right seat rudder push rods were traced and found to be continuous to the rudder interconnect system. All members and fasteners in the rudder interconnect system were found to be in their correct perspective locations. The right rudder control horn was bent downwards towards a normal position and the rudder was able to move from stop to stop using the rudder pedals in the cockpit.

**Photo 8: View of the rudder horn as first observed.**

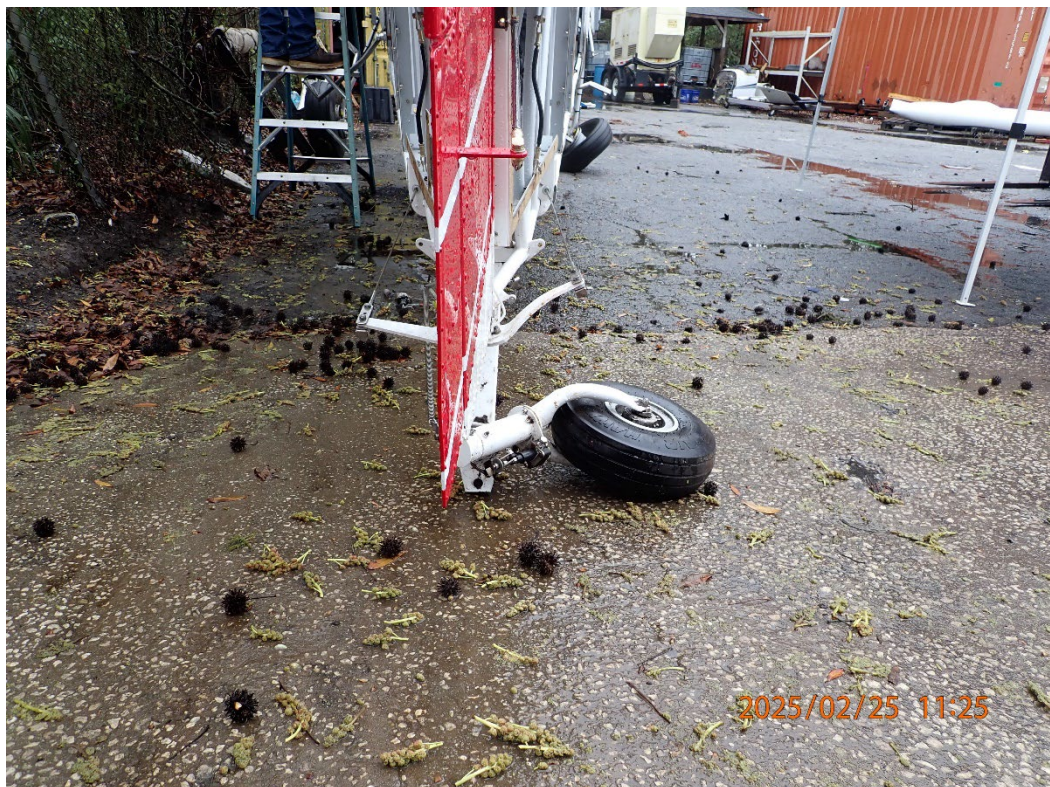
**Photo 9: View of the rudder horn when bent down towards a normal position.**

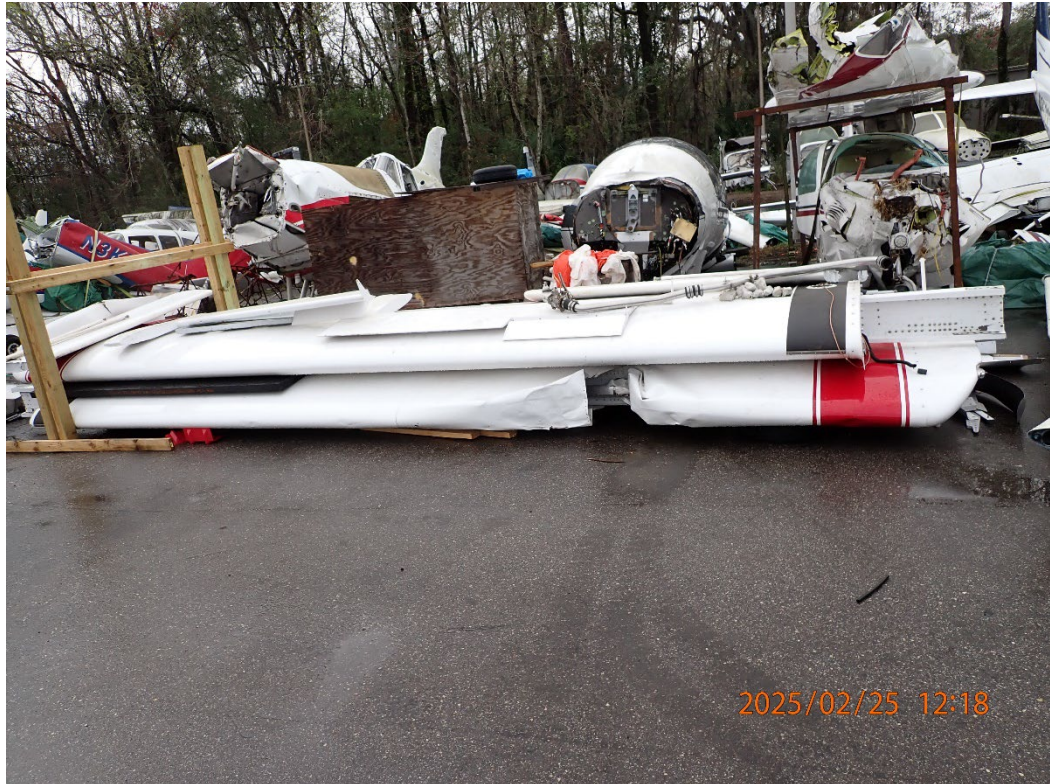
The right wing tip was found with upwards crush damage. The right wing flap was separated from the wing and was found next to the wing. The right aileron and right aileron trim tab were found attached to the wing. The right aileron controls were continuous from the control stick to the fuselage mounted bellcrank. The fastener that connects the fuselage mounted bellcrank to the main wing push rod was removed for transportation. The right wing main wing pushrod was found to be continuous to the aileron though movement of the inboard end of the pushrod.

The left wing was found intact with the flap and aileron attached. The left wing aileron boost tab was not located during the wreckage review. The left wing aileron boost tab rod was found with a separation near the bearing that is fastened to the aileron mounting arm. The left wing aileron outboard rib and boost tab bracket was bent outboard away from the aileron boost tab cove. The left aileron controls were continuous from the control stick to the fuselage mounted bellcrank. The fastener that connects the fuselage mounted bellcrank to the main wing push rod was removed for transportation. The left wing main wing pushrod was found to be continuous to the aileron though movement of the inboard end of the pushrod.

**Photo 14: View of the wings.**

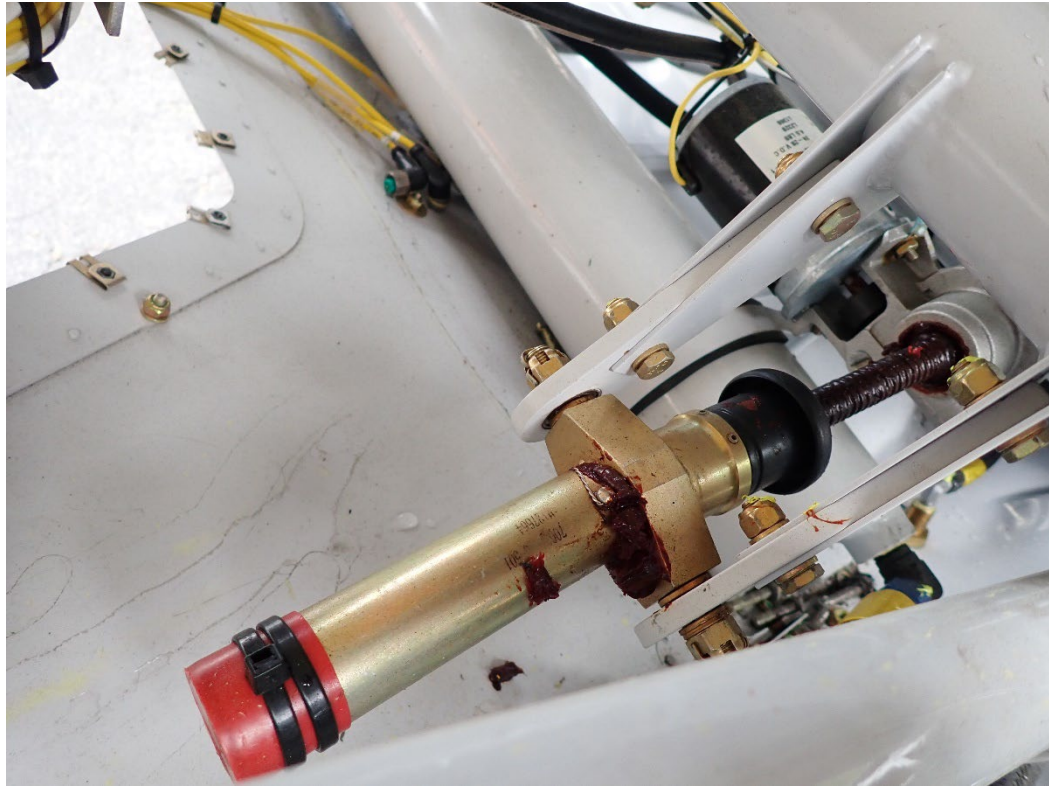
The left and right flap control system was continuous from the flap actuator to the aft push rod fastener that was removed for transportation. The left and right flap control arms were located on the flaps. The flap actuator was found near the fully extended position.

**Photo 15: View of the flap actuator and jackscrew. (Photo Courtesy of Air Tractor)**

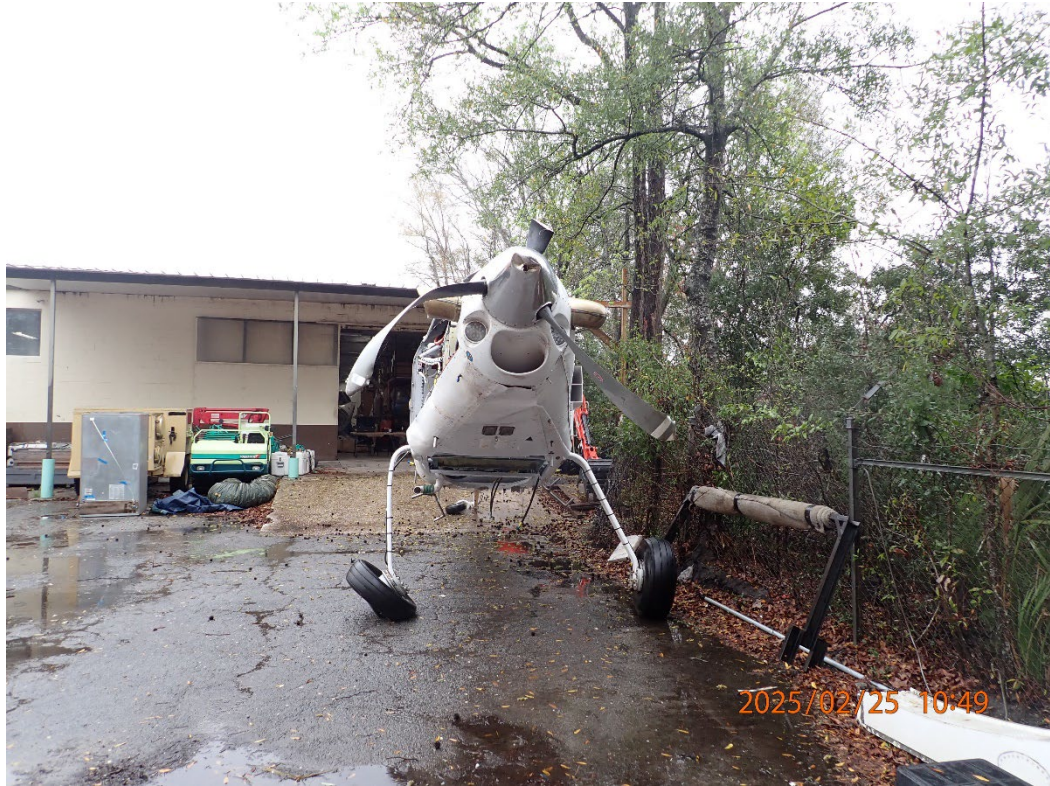
The left main gear was found attached to the fuselage frame. The right main gear was found attached to the airframe with inboard bending. The tail gear spring was found attached to the aft fuselage and the tail wheel and axle assembly was connected to the spring with the lower attach bolt separated.

**Photo 16: View of the main landing gear.**

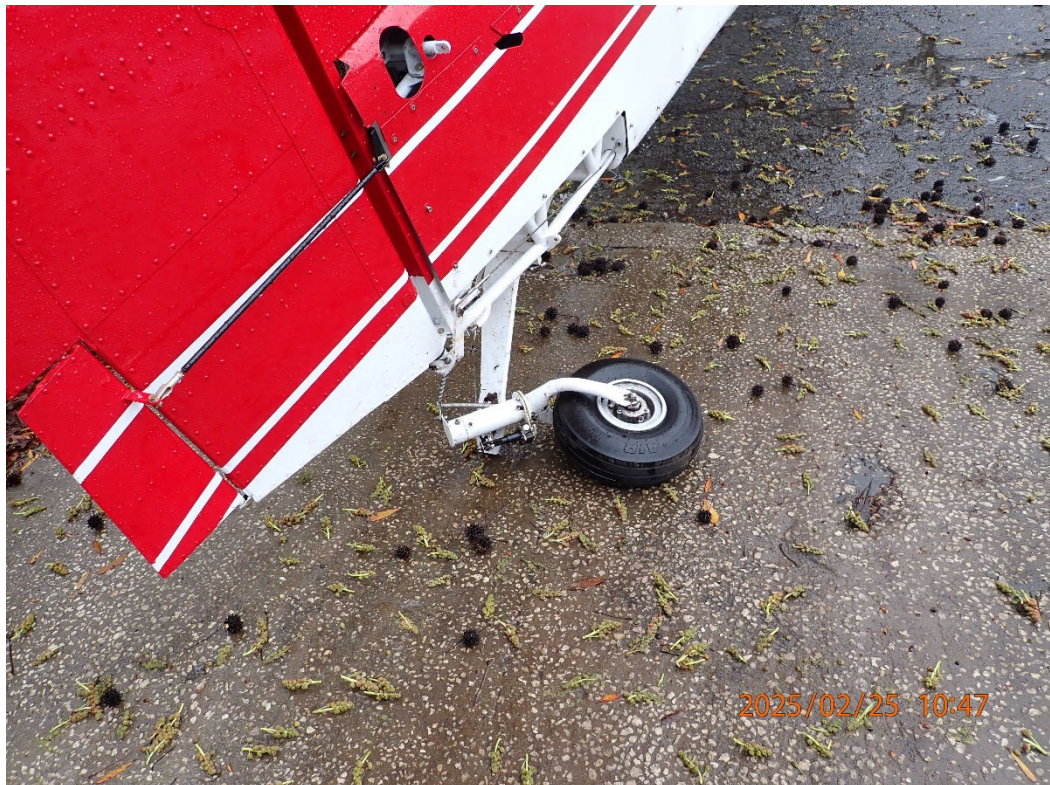
**Photo 17: View of the tailwheel.**

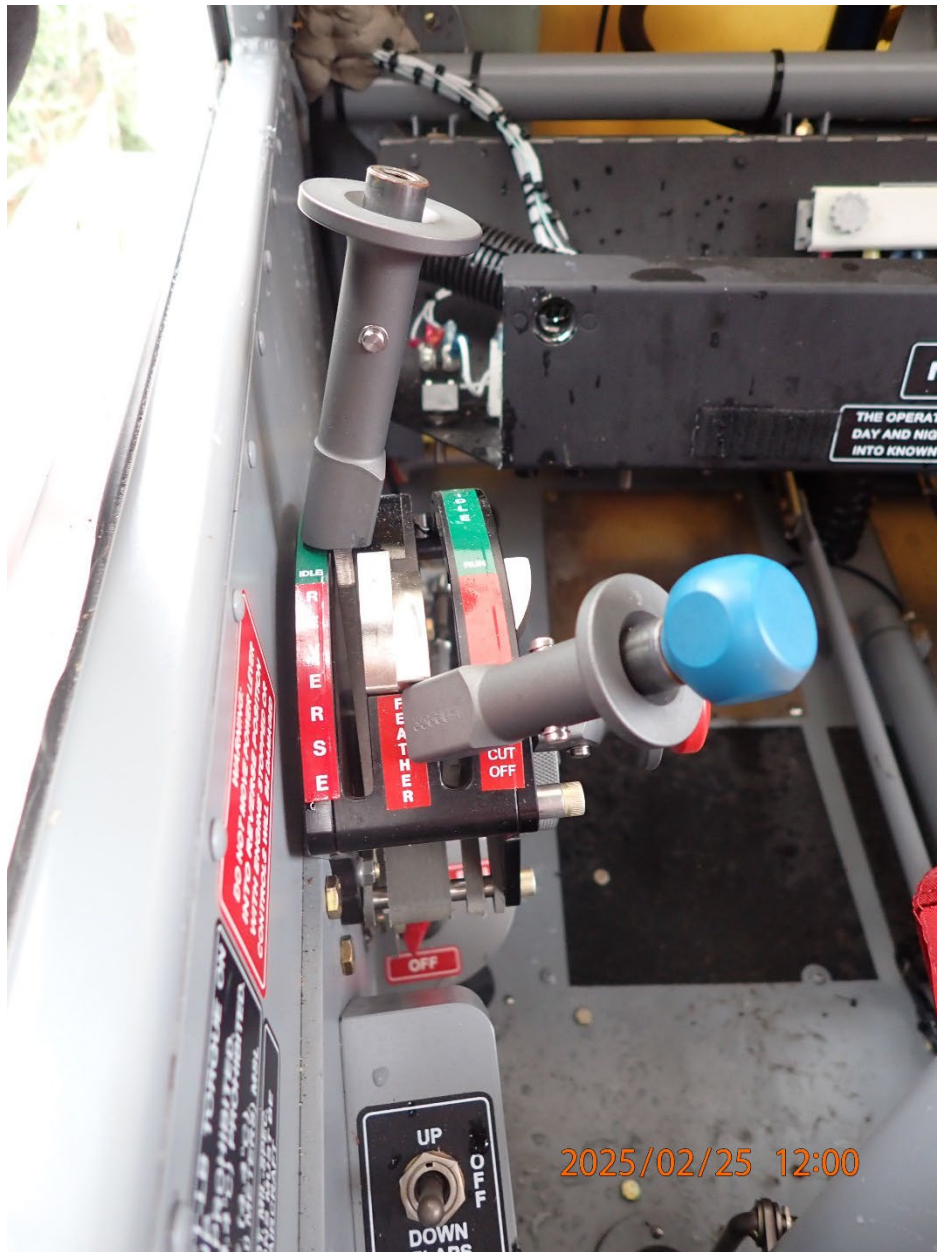
- Fuel condition Lever: Cutoff
- Propeller lever: Feather
- Power control lever: Idle (against the beta stop)
- Rinse Pump: ON
- Nose Lights: OFF
- Spray: OFF
- Wind. Washer: OFF
- Start: OFF
- Ignitor: OFF
- Dome Light: OFF
- Inst. And Flap Lights: OFF
- Strobe and Nav Lights: OFF
- Air Cond.: OFF
- Blower: LOW
- Fuel Boost Pump: OFF

**Photo 18: View of the throttle quadrant.**

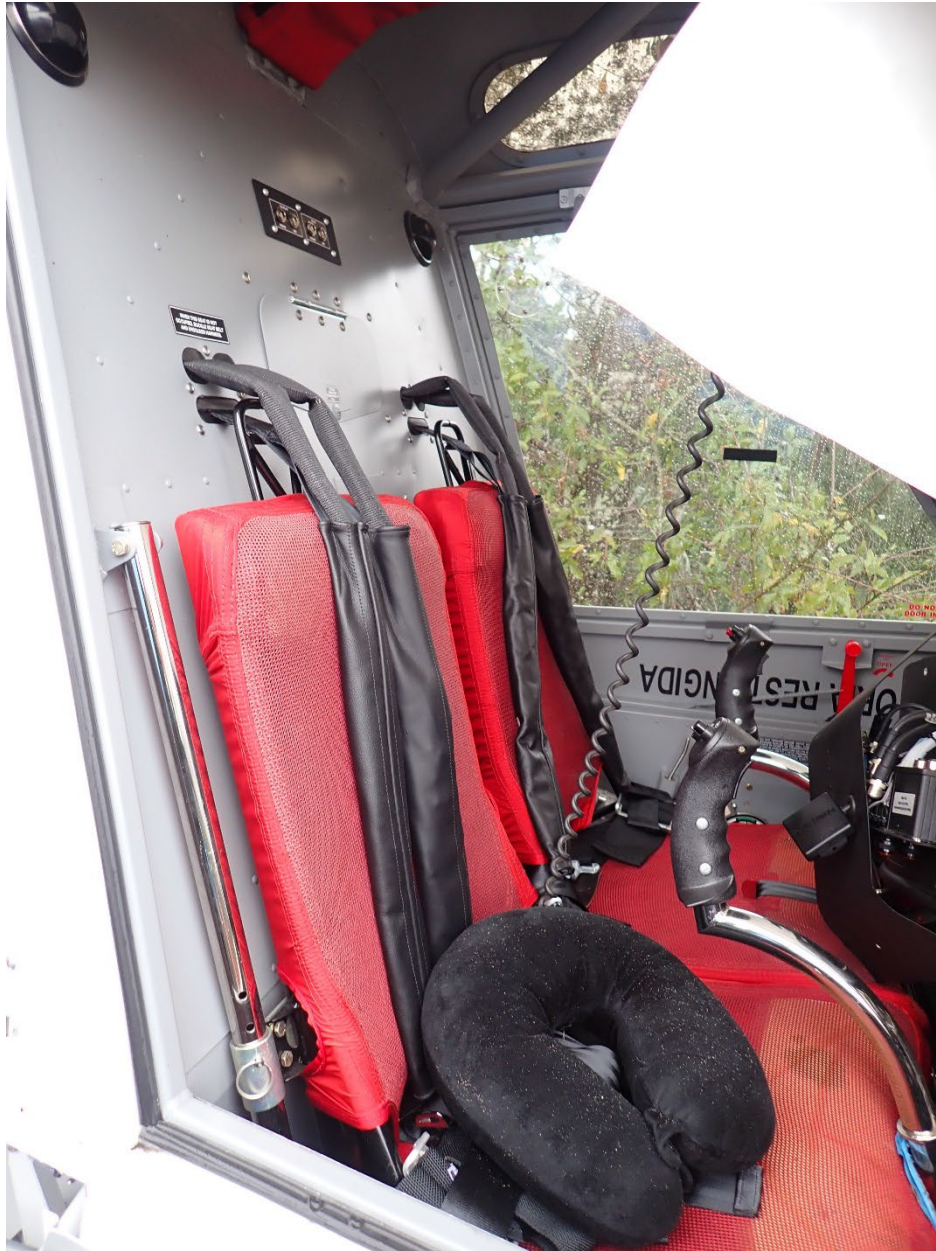
The airplane was equipped with a 5 point harness and airbags. The harness remained attached at all attachment points and the airbags did not deploy. The pilot side harness operated as expected with no anomalies.

**Photo 20: View of the cockpit with harness airbags not deployed.**

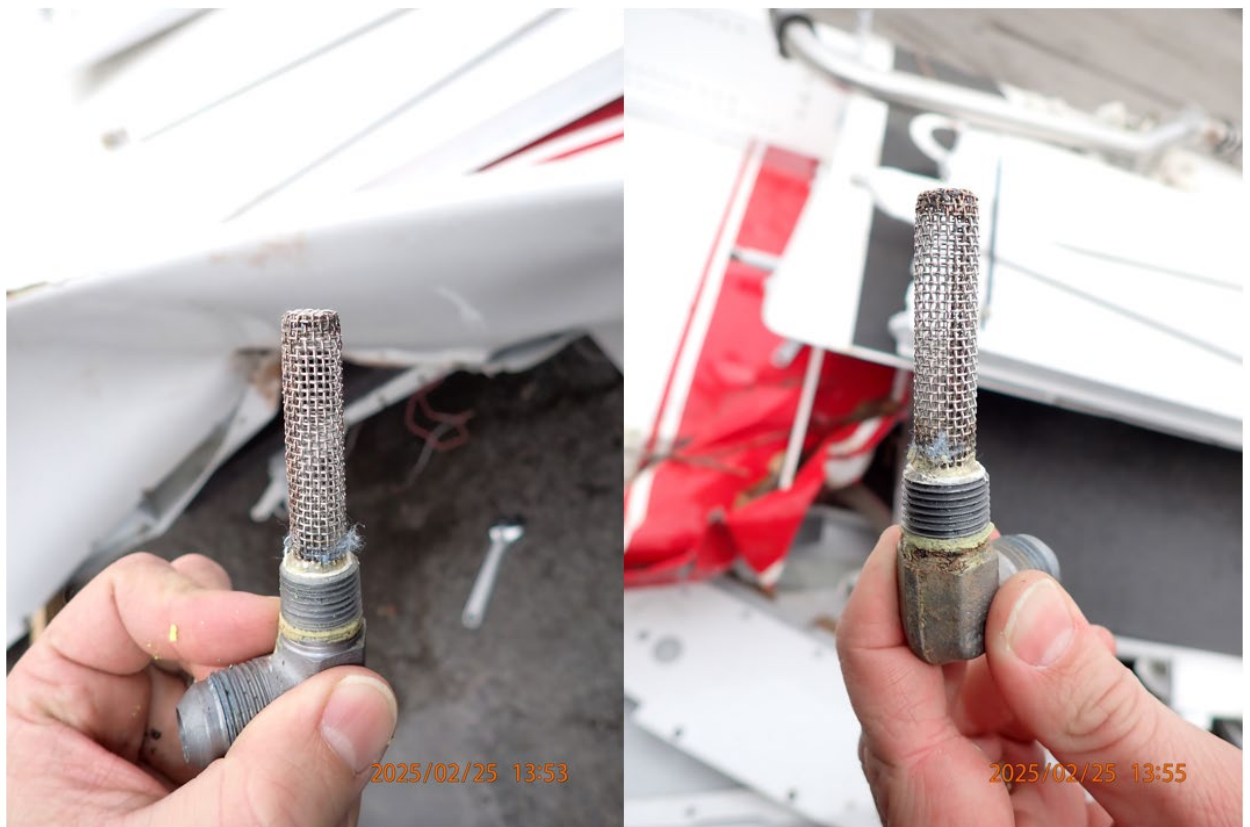
The airplane was equipped with a ferry fuel system which allowed the hopper to carry fuel and be plumbed directly into the fuel selector. The fuel selector in the cockpit was selected to off and operated through it's full range of motion with no anomalies. The finger screens were removed from the integral wing fuel tanks and were free of debris.

**Photo 22: Fuel filter screens from the wing fuel tanks.**

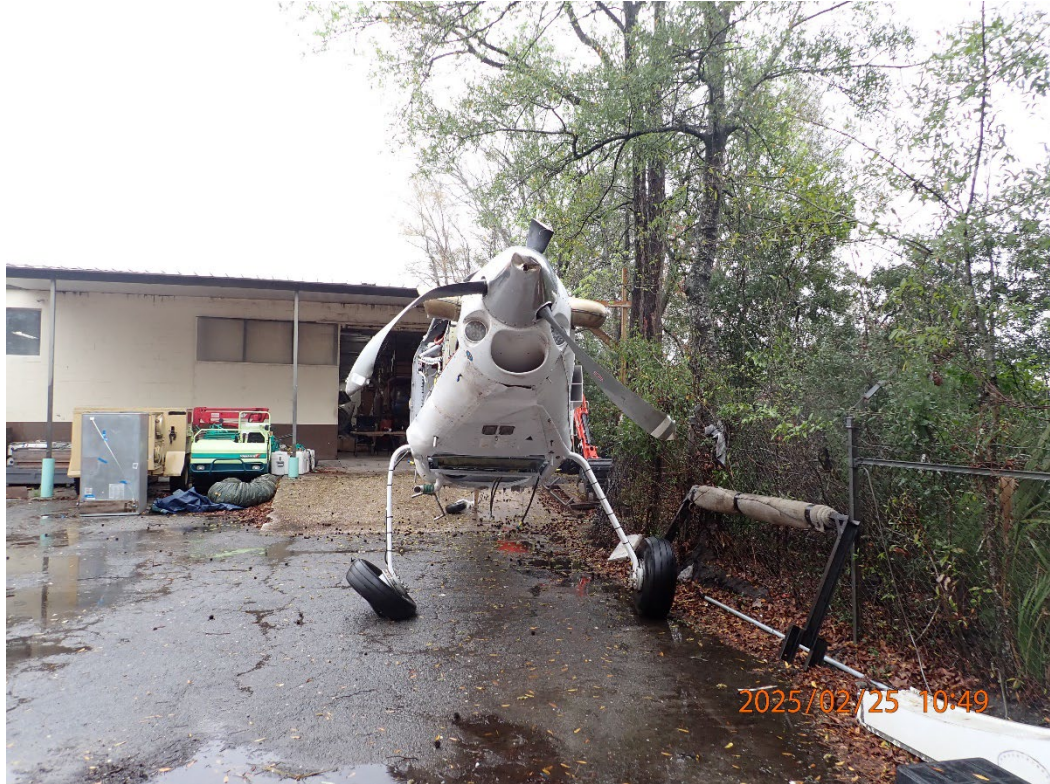
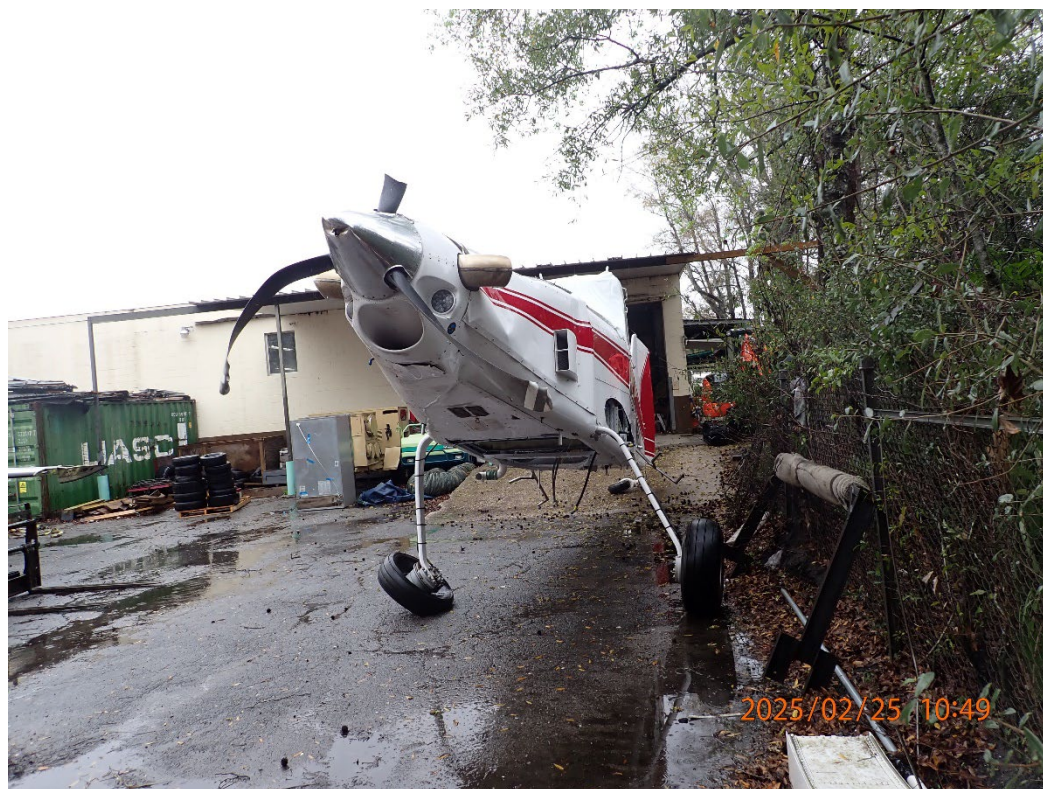
All 3 propeller blades exhibited aft bending, polishing, leading edge gouges, and tip curling.

**Photo 23: View of the propeller.**

**Photo 24: View of the propeller.**

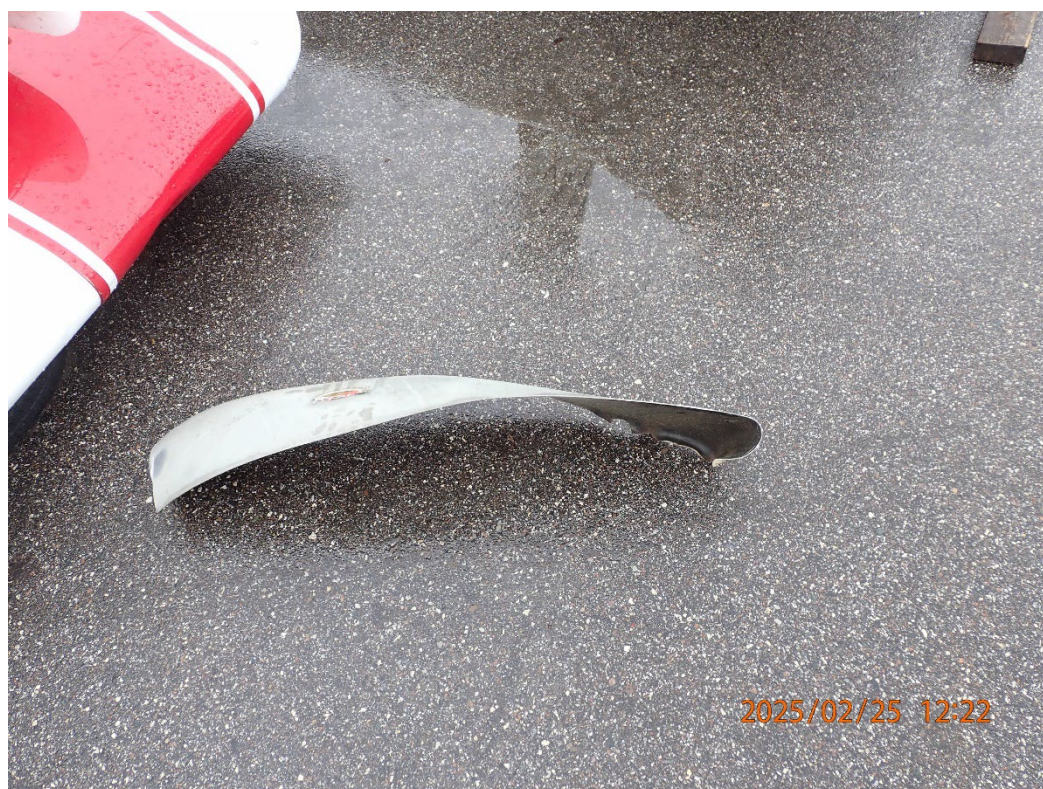
**Photo 25: View of the propeller blade cut by recovery crews.**
