ERA25LA095

## INVESTIGATION PHOTOGRAPHS

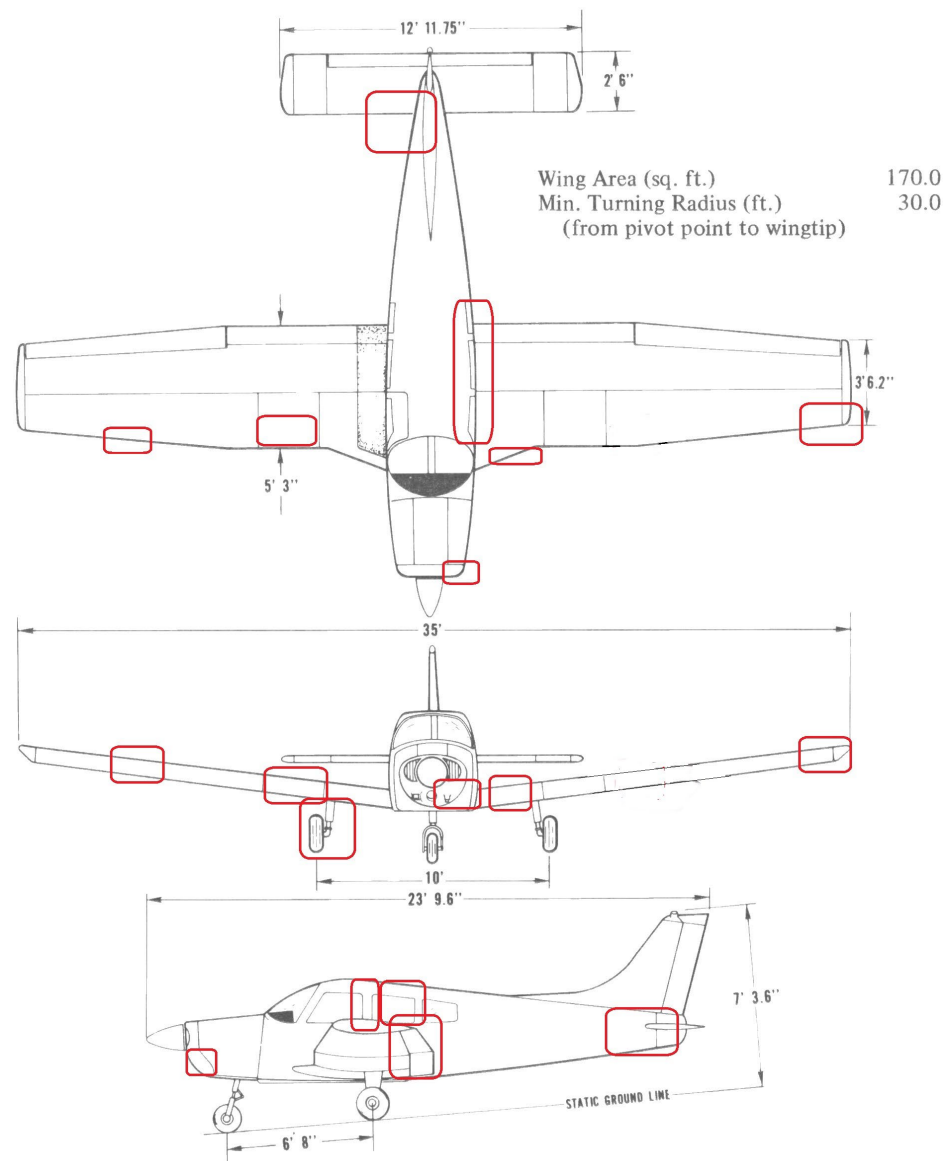
**Photograph 1 - Damage assessment (Courtesy of FAA)**

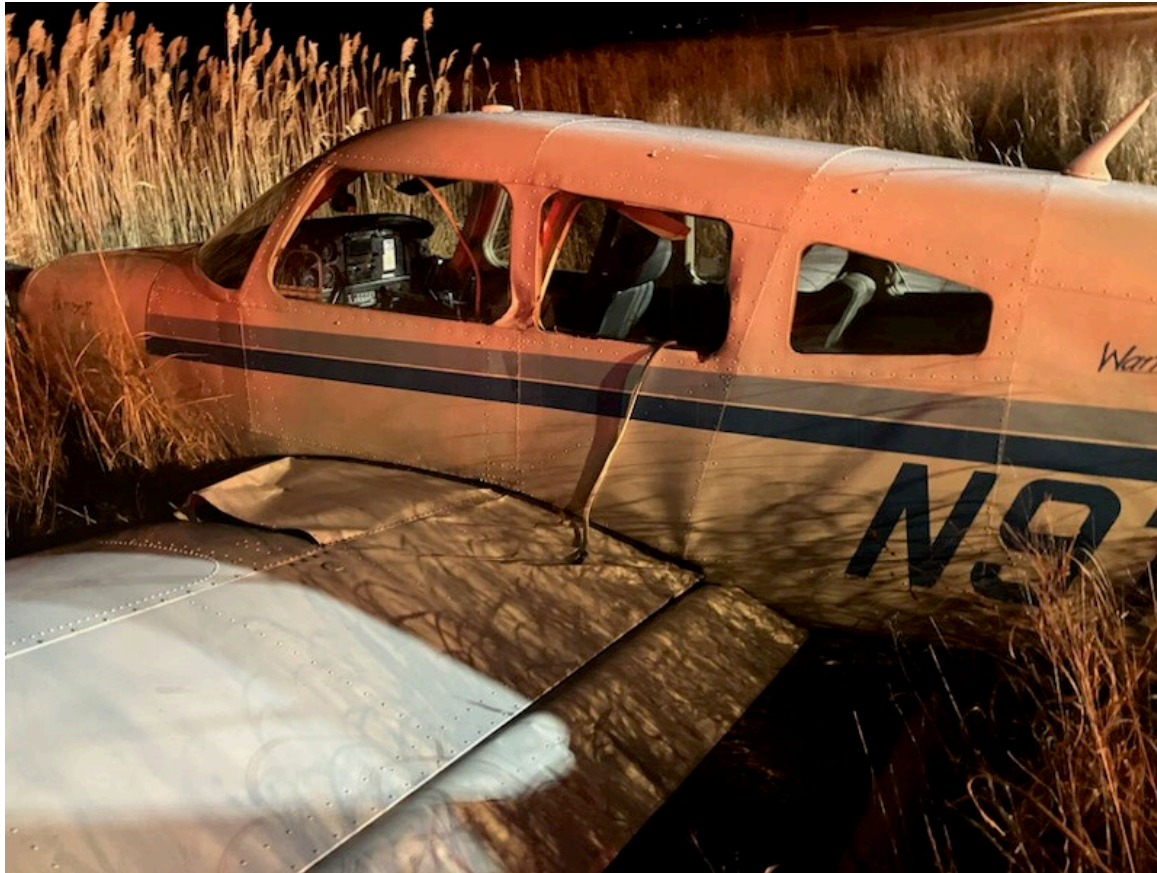
**Photograph 2 - View of left-wing root buckling (Courtesy of FAA)**

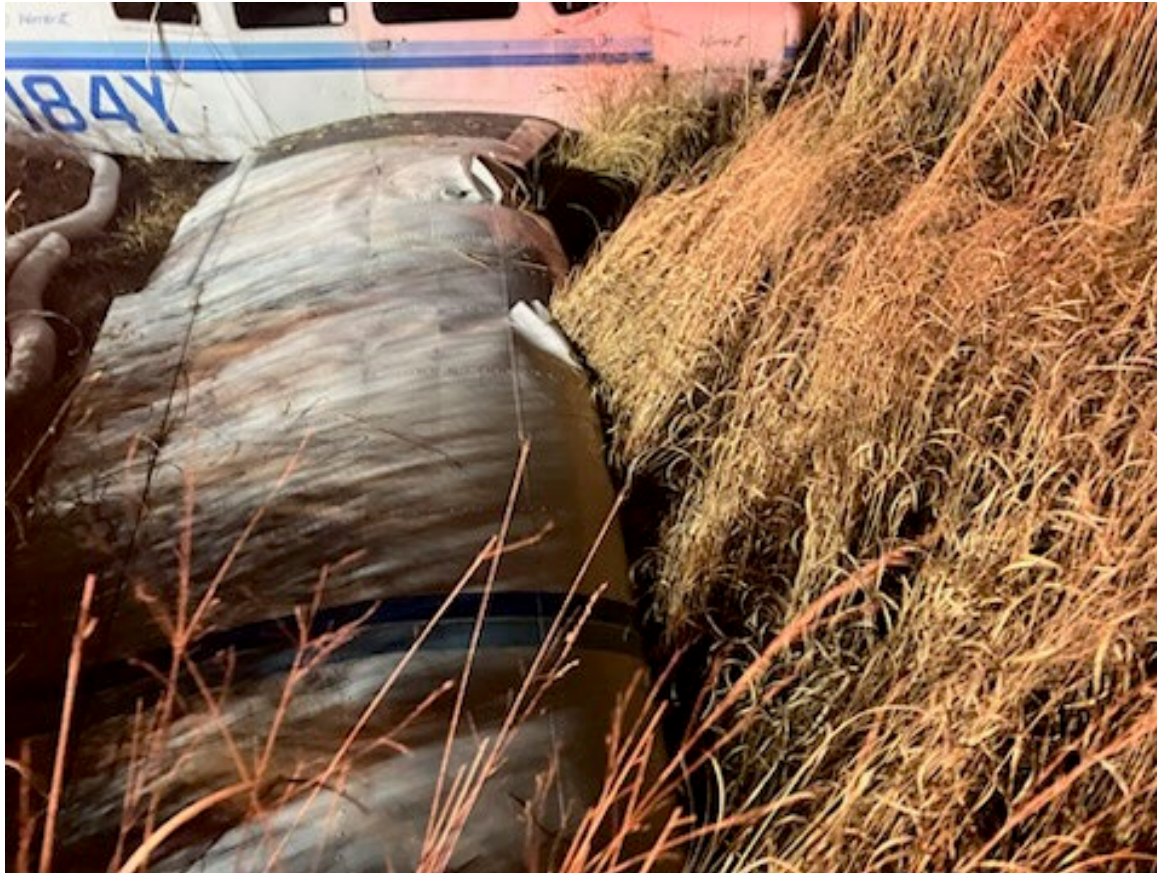
**Photograph 3 - View of right wing buckling (Courtesy of FAA)**

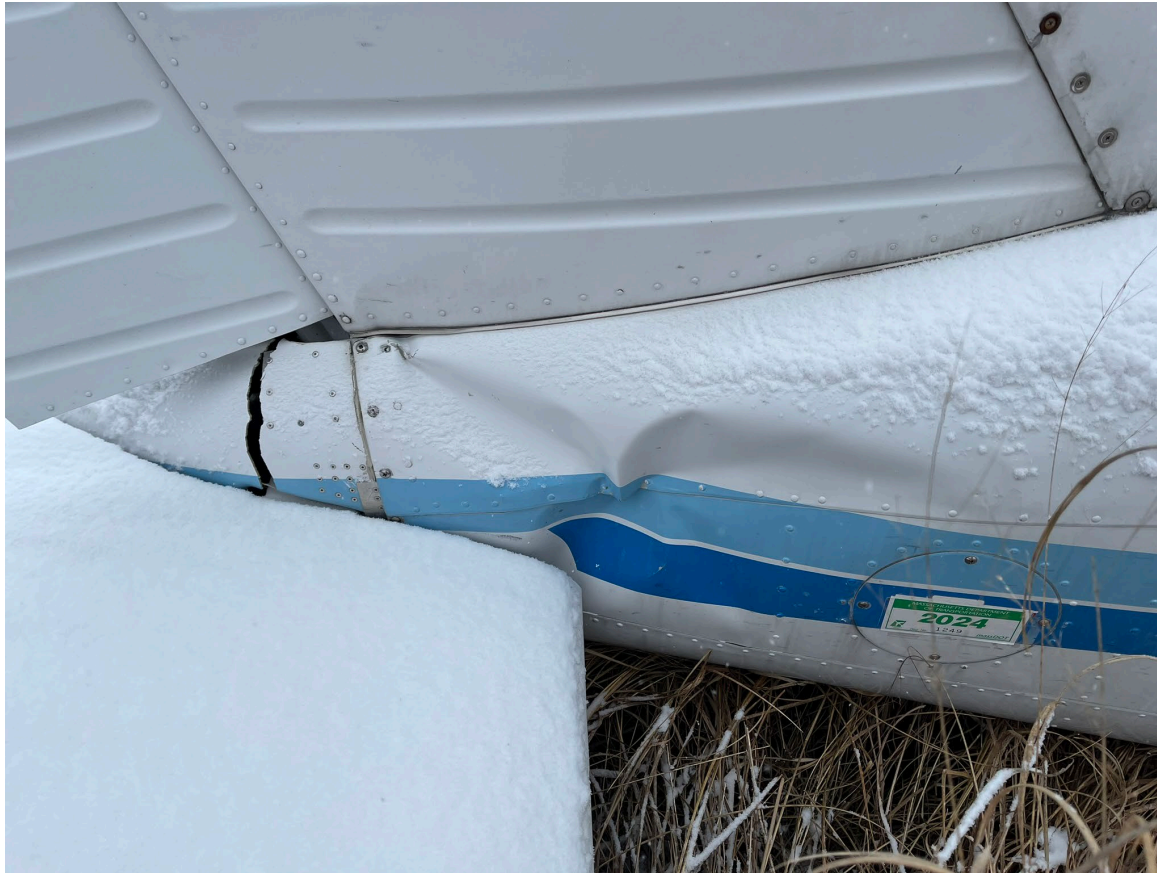
**Photograph 4 - View of the empennage buckling (Courtesy of FAA)**
