ERA25LA096

## INVESTIGATION PHOTOGRAPHS

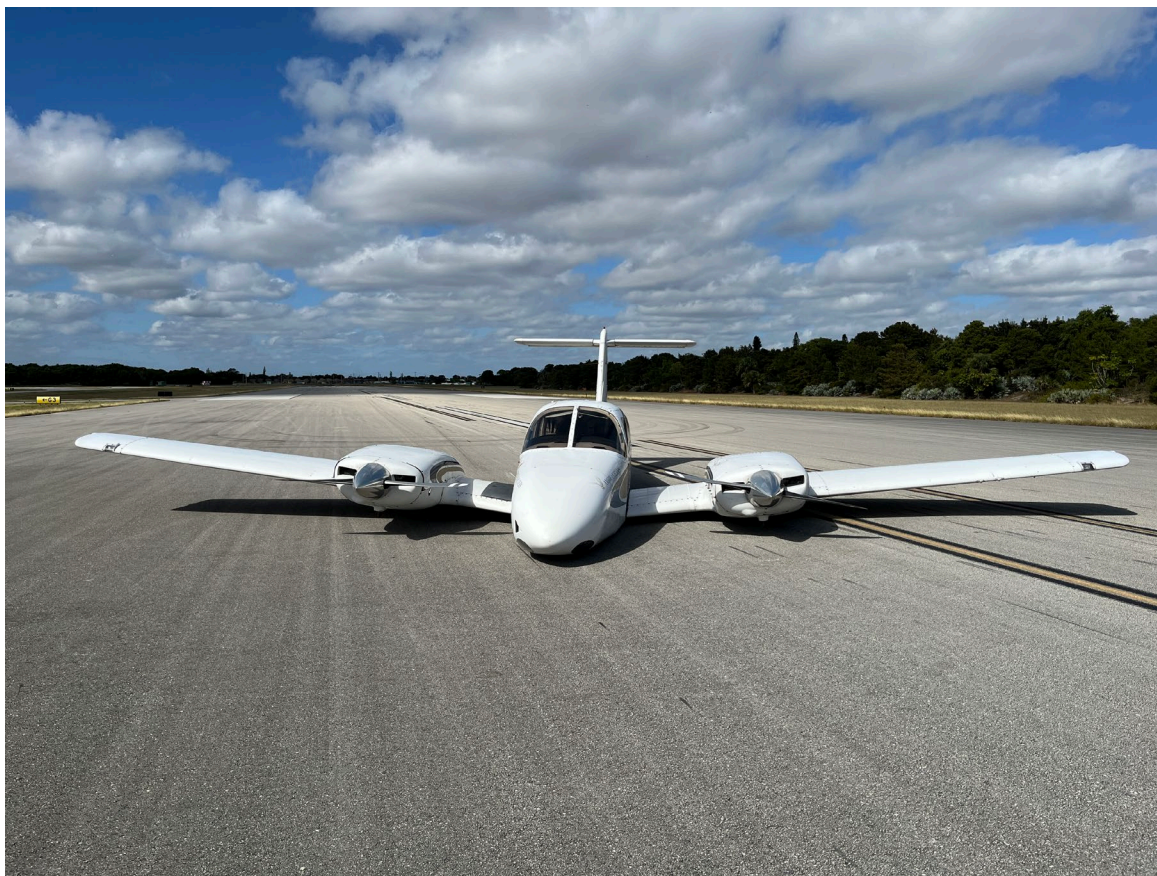
**Photograph 1 - Frontal View Showing Airplane Where Came to Rest on Runway (Courtesy of FAA)**

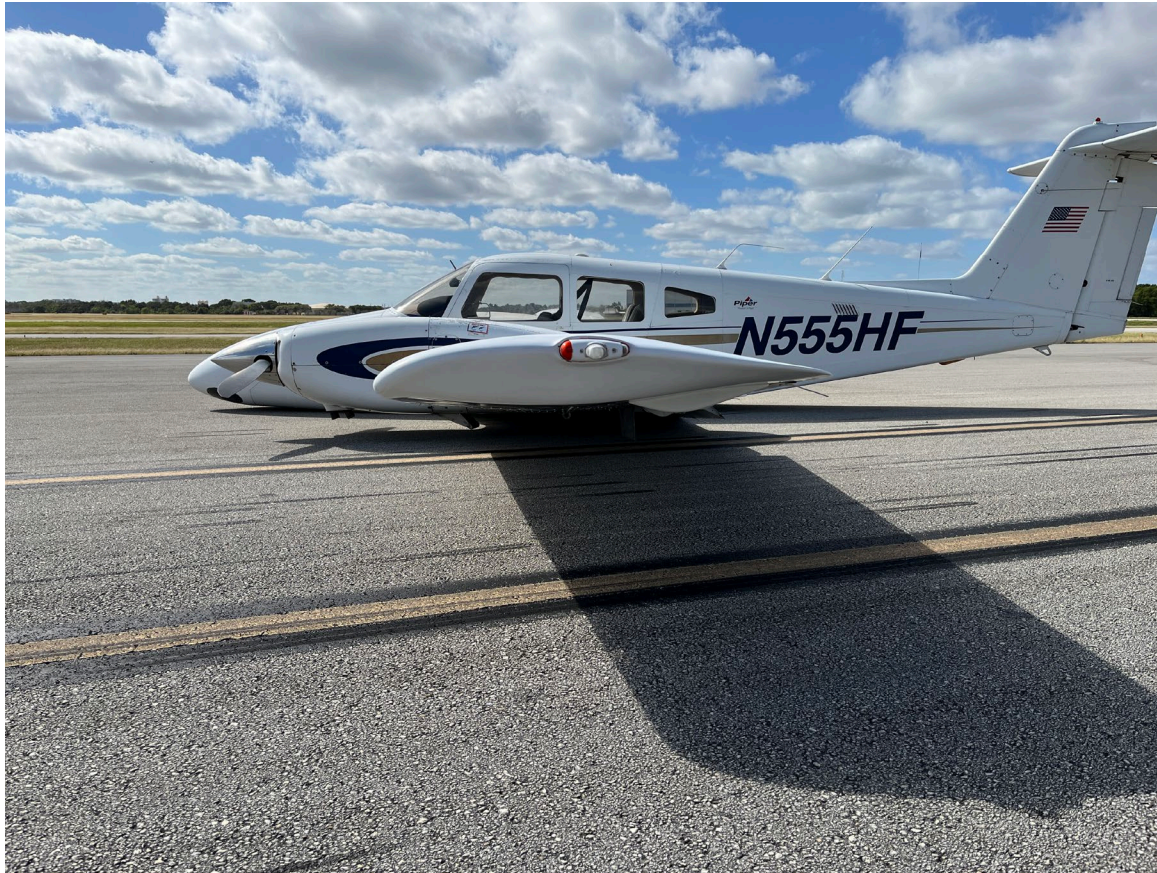
**Photograph 2 - Left Side View Showing Airplane Where Came to Rest on Runway (Courtesy of FAA)**

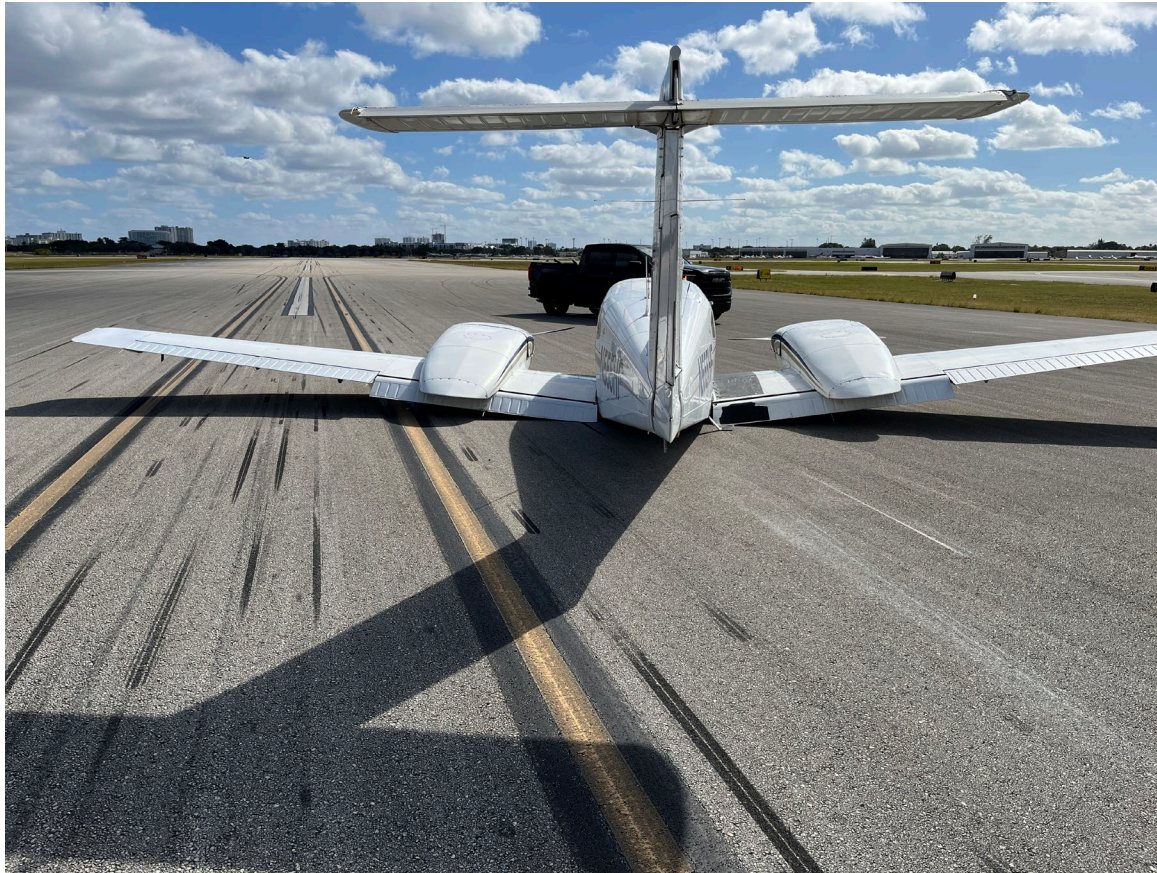
**Photograph 3 - Rear View Showing Airplane Where Came to Rest on Runway (Courtesy of FAA)**

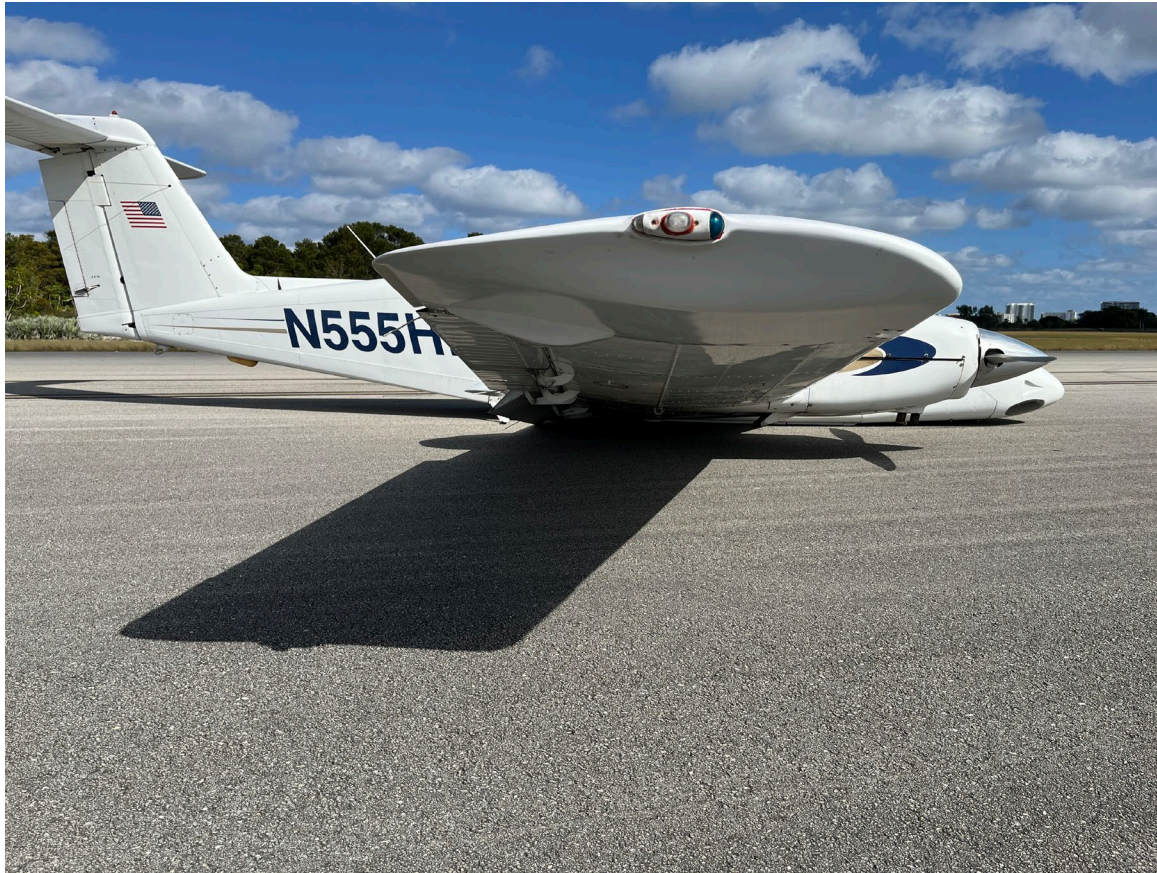
**Photograph 4 - Right Side View Showing Airplane Where Came to Rest on Runway (Courtesy of FAA)**

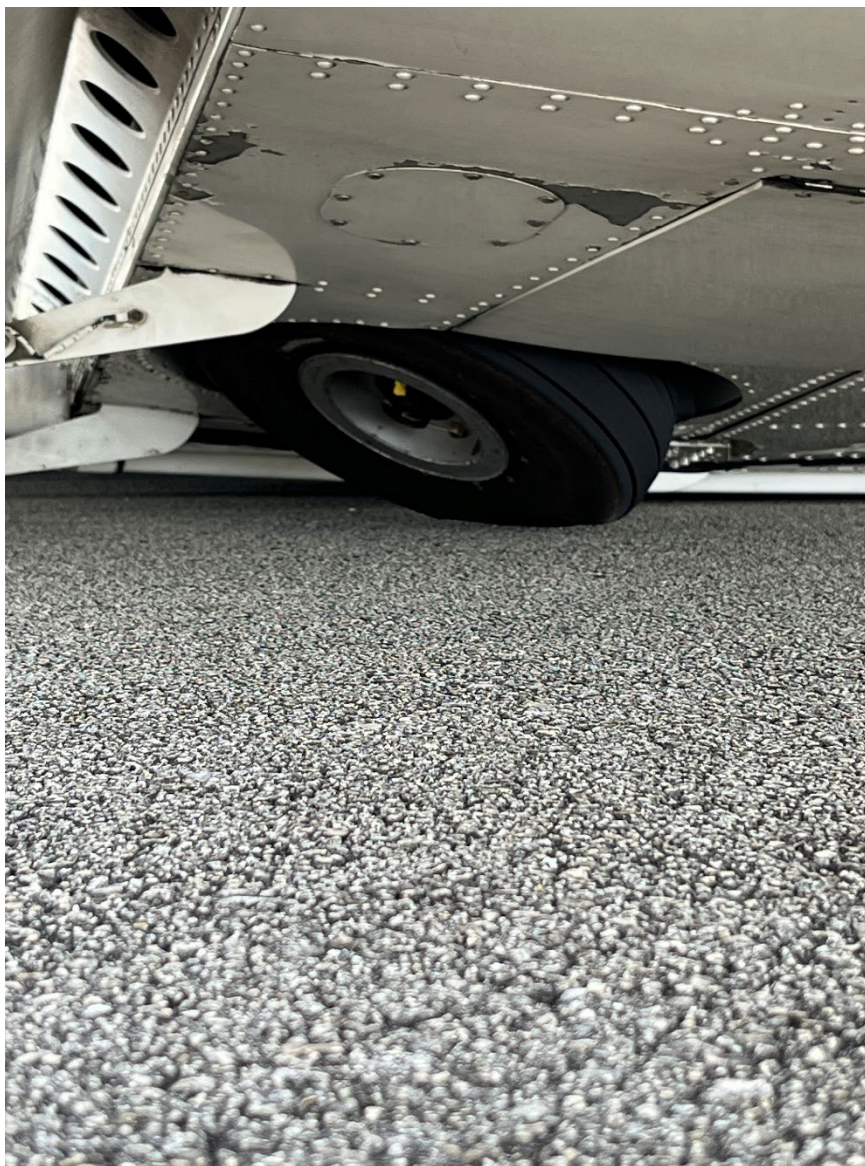
**Photograph 5 - View of Right Main Landing Gear in Wheel Well (Courtesy of FAA)**

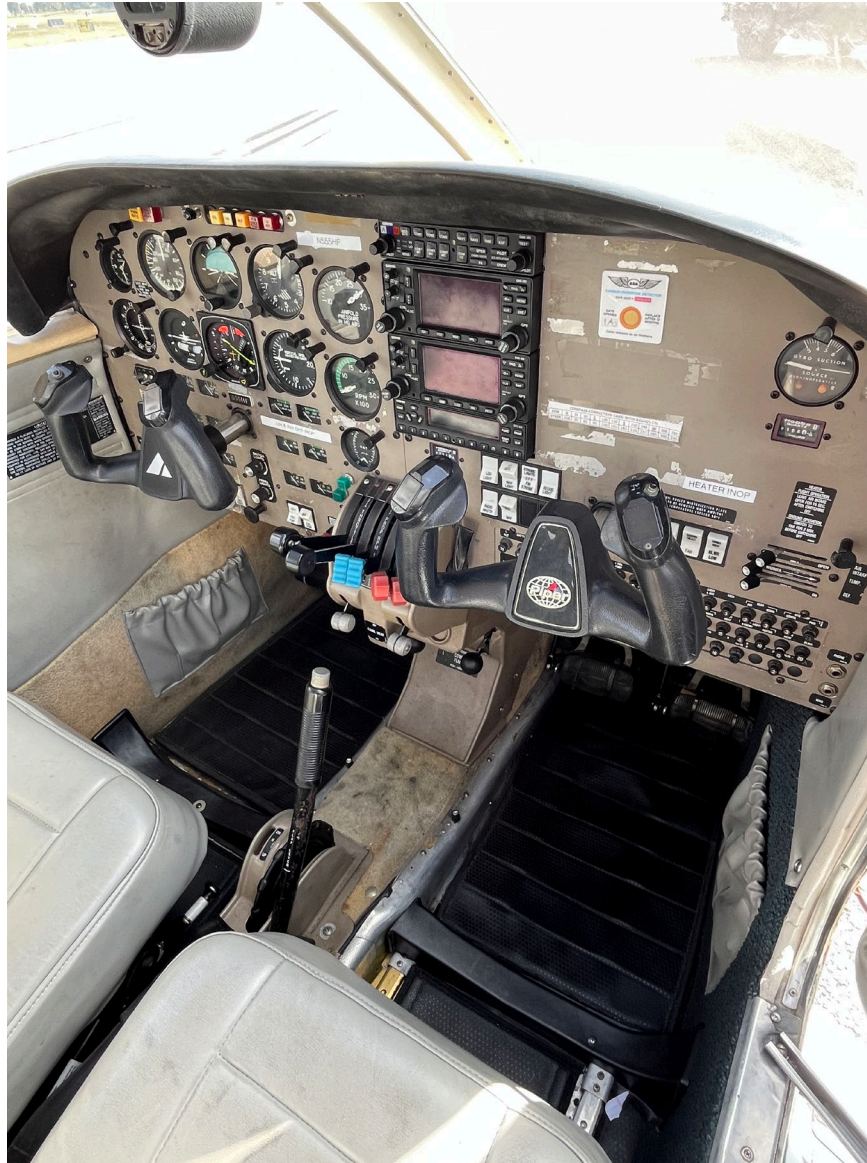
**Photograph 6 - View of the Cockpit (Courtesy of FAA)**

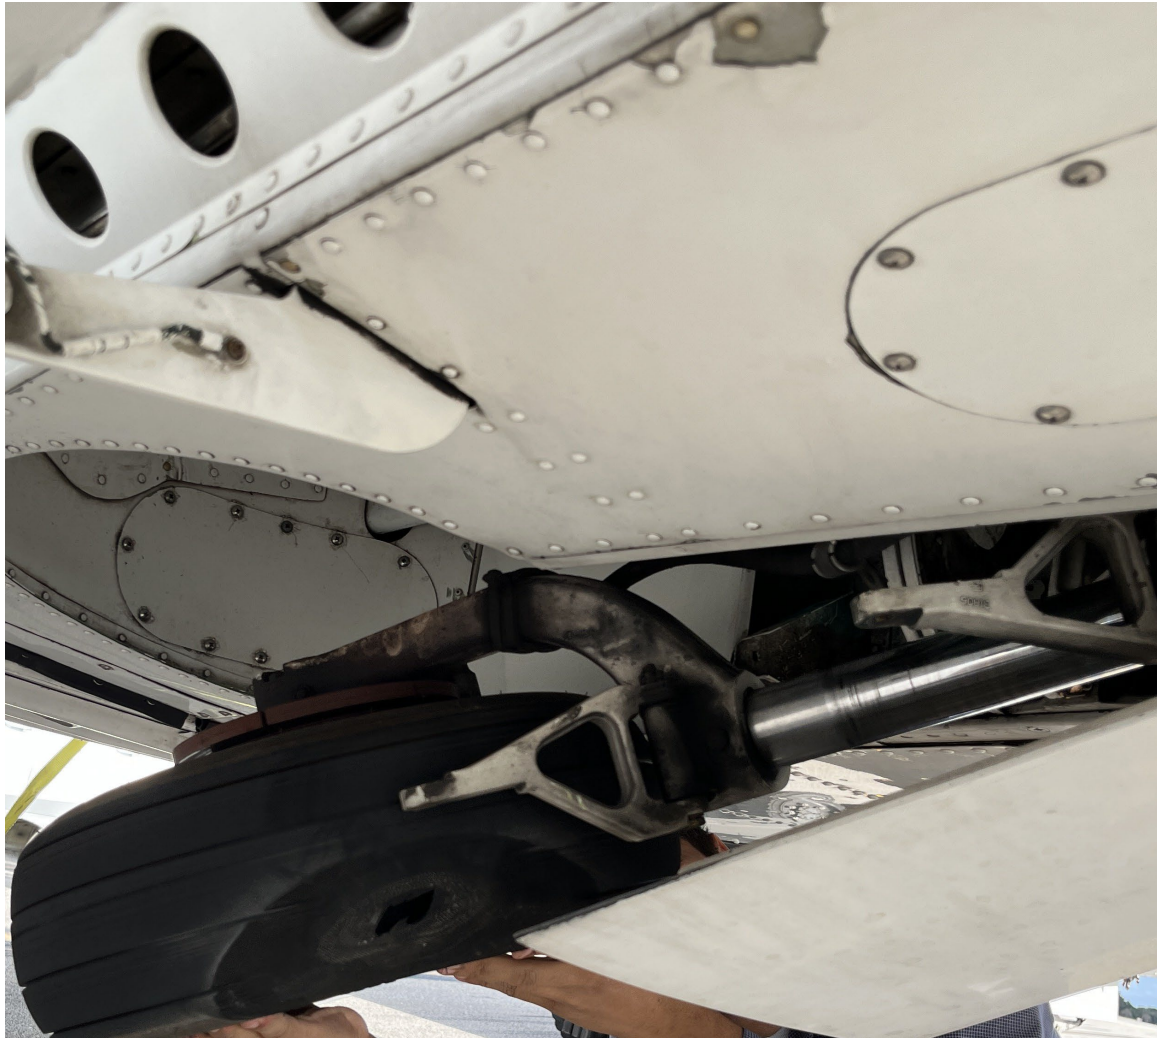
**Photograph 7 - View Showing Separated Upper and Lower Torque Links of Right Main Landing Gear (Courtesy of FAA)**

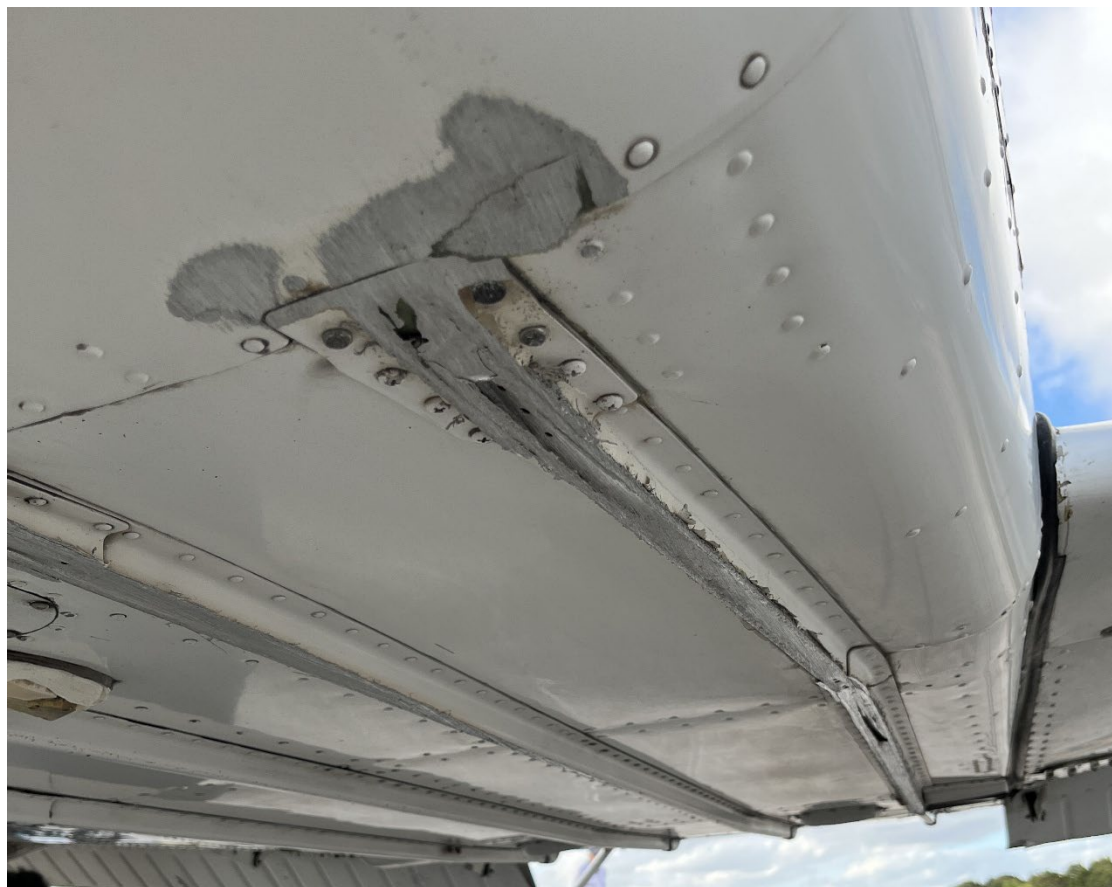
**Photograph 8 - Abrasion Damage to External Longerons on the Bottom of the Fuselage.  
(Courtesy of FAA)**
