ERA25LA100

## INVESTIGATION PHOTOGRAPHS

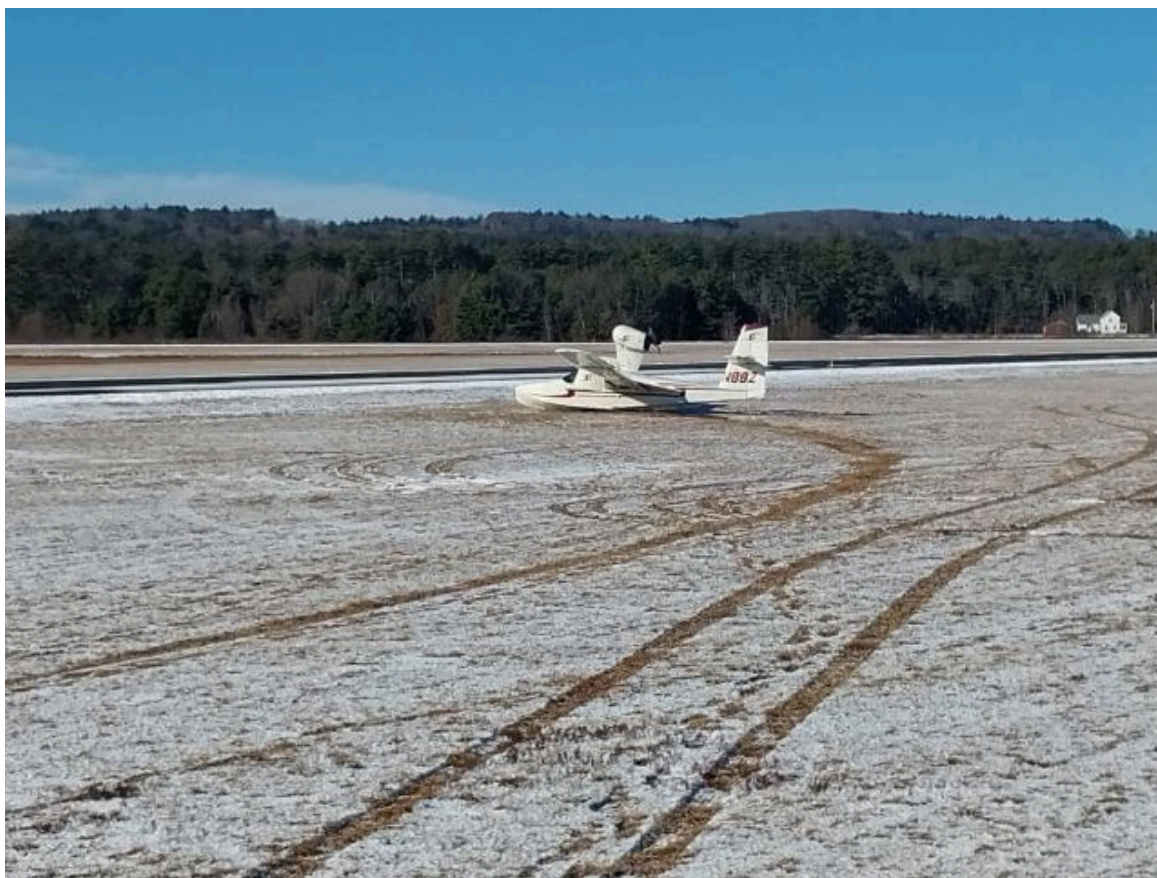
**Photograph 1 - Main Wreckage (Courtesy of FAA)**

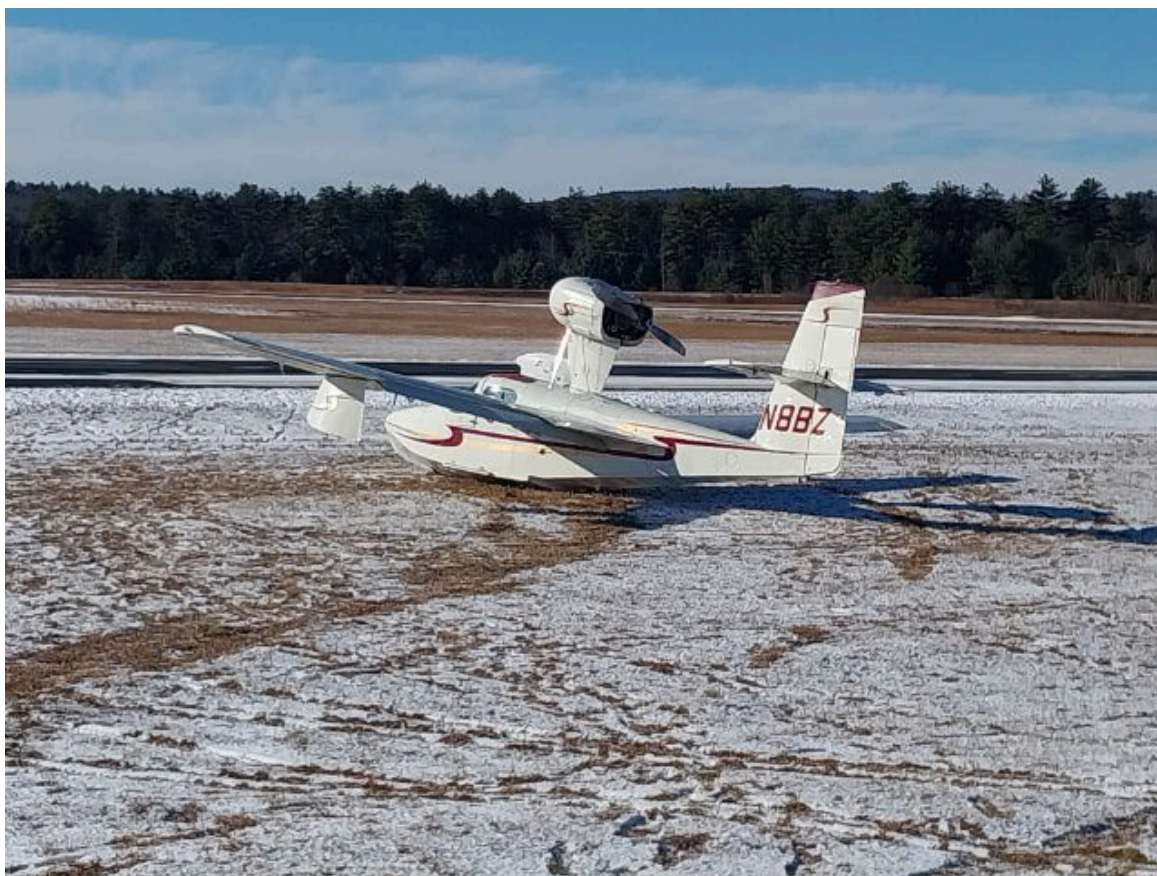
**Photograph 2 - Main Wreckage Zoom View (Courtesy of FAA)**

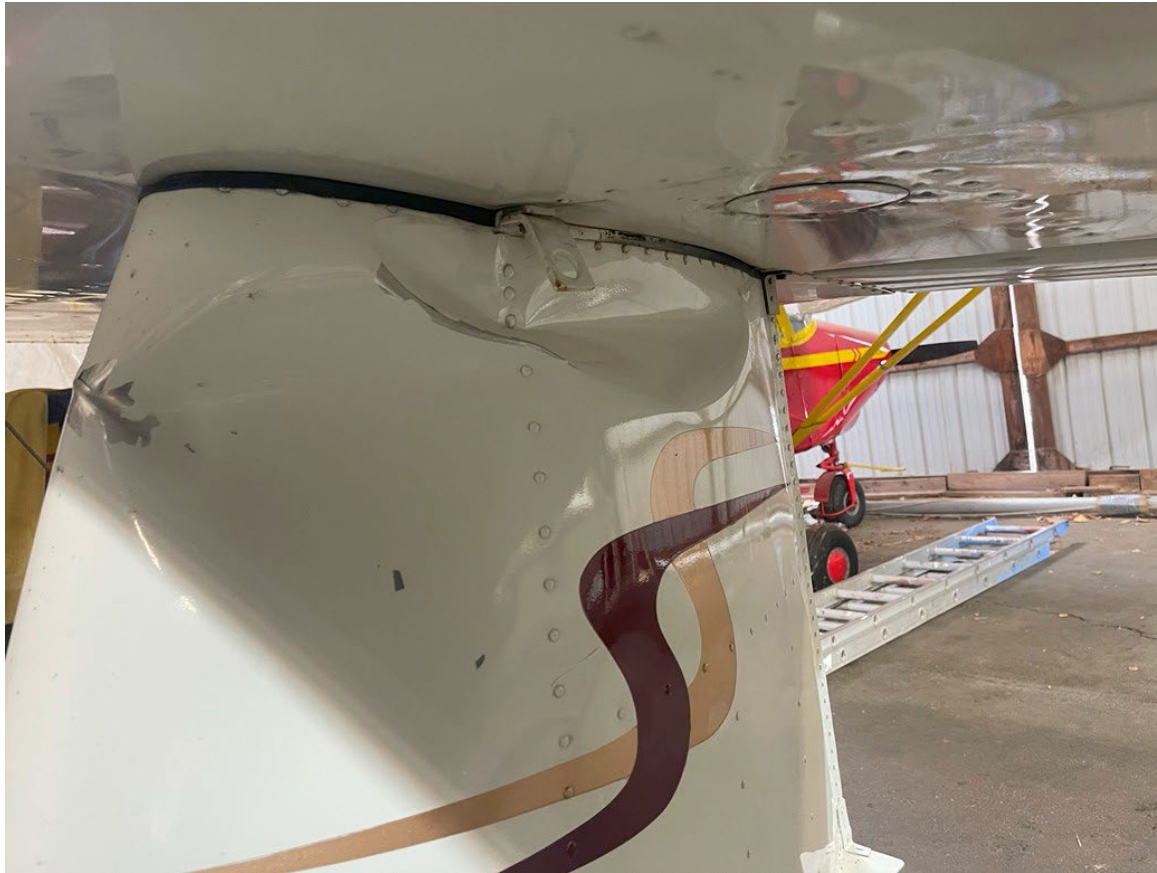
**Photograph 3 - Lower Right Wing Damage (Courtesy of FAA)**

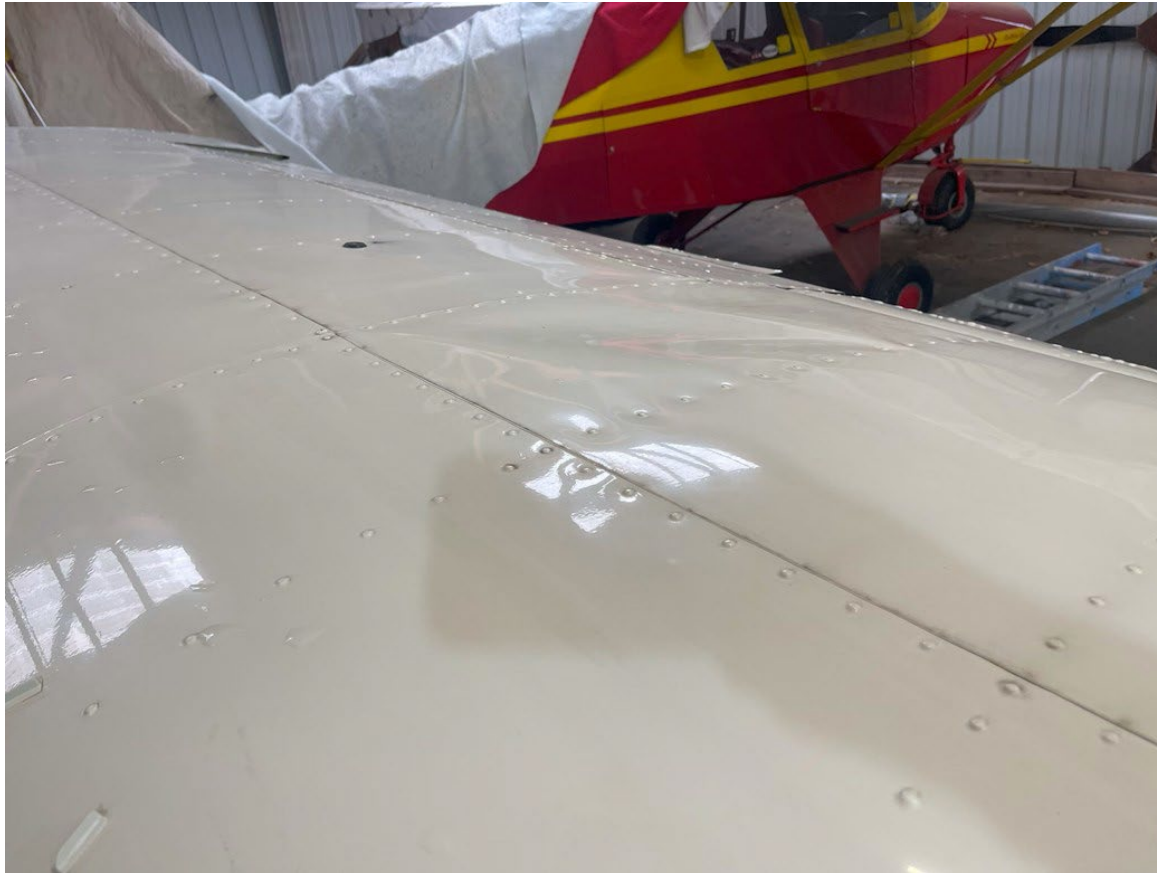
**Photograph 4 - Upper Right Wing Damage (Courtesy of FAA)**
