ERA25LA101

## INVESTIGATION PHOTOGRAPHS

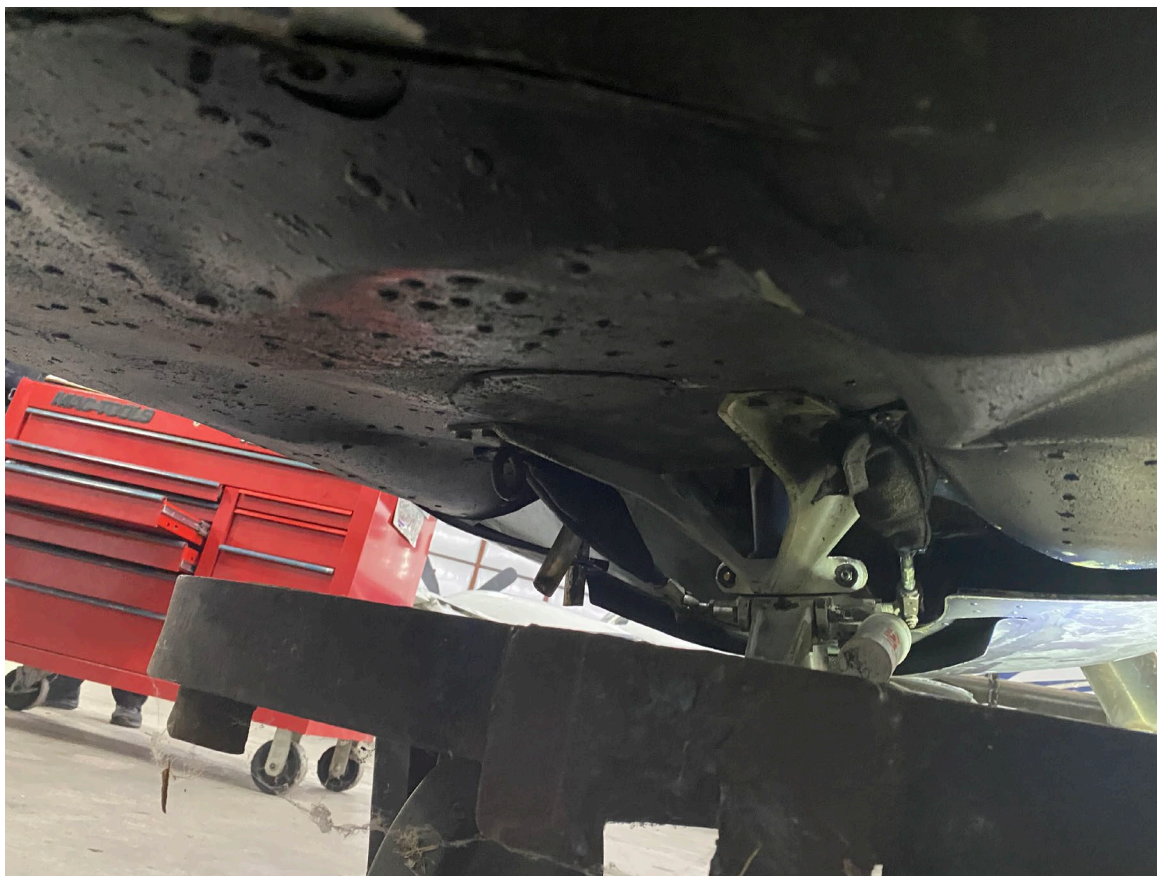
**Photograph 1 - Deformation noted to lower fuselage Structure (Courtesy of FAA)**

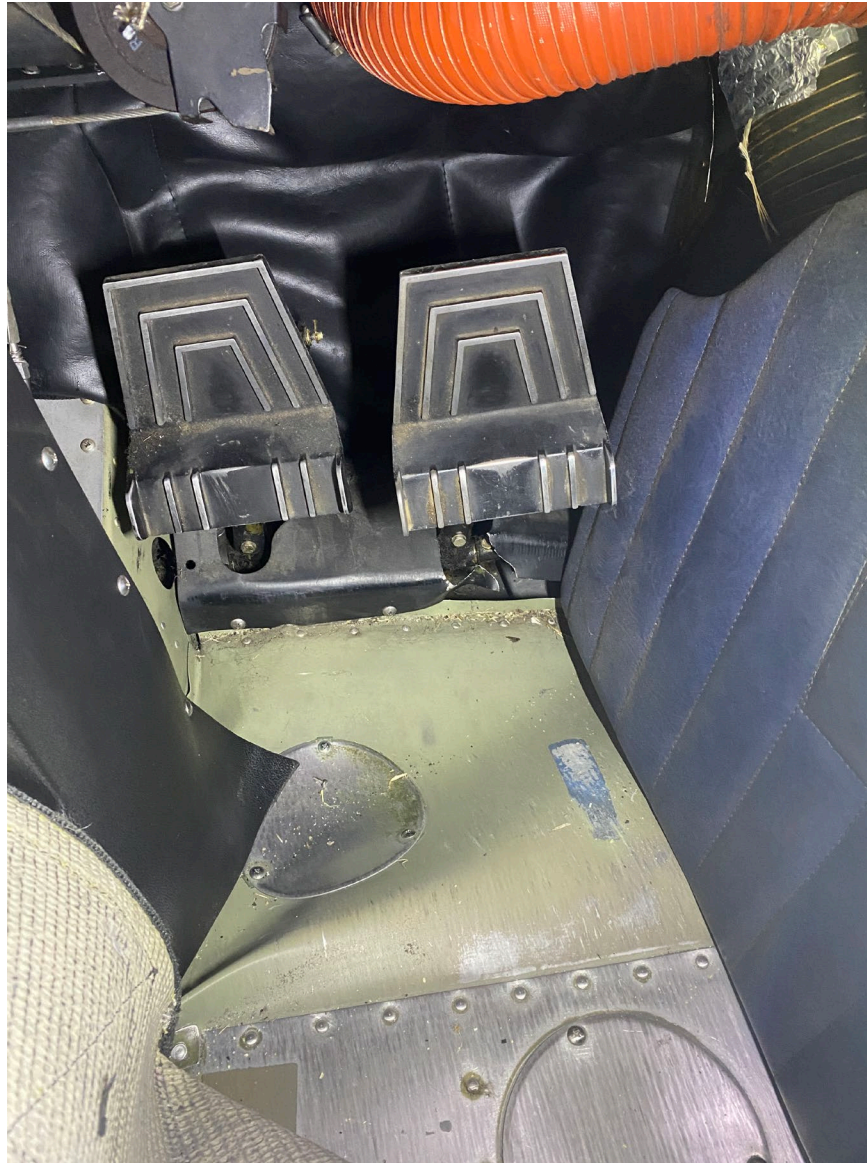
**Photograph 2 - Deformation noted to copilot's floorboard structure (Courtesy of FAA)**
