# Event Report

Aircraft type: Cessna 172 Skyhawk

Aircraft operator: Mid TN Aviation Academy

## Location of Event: KCKV

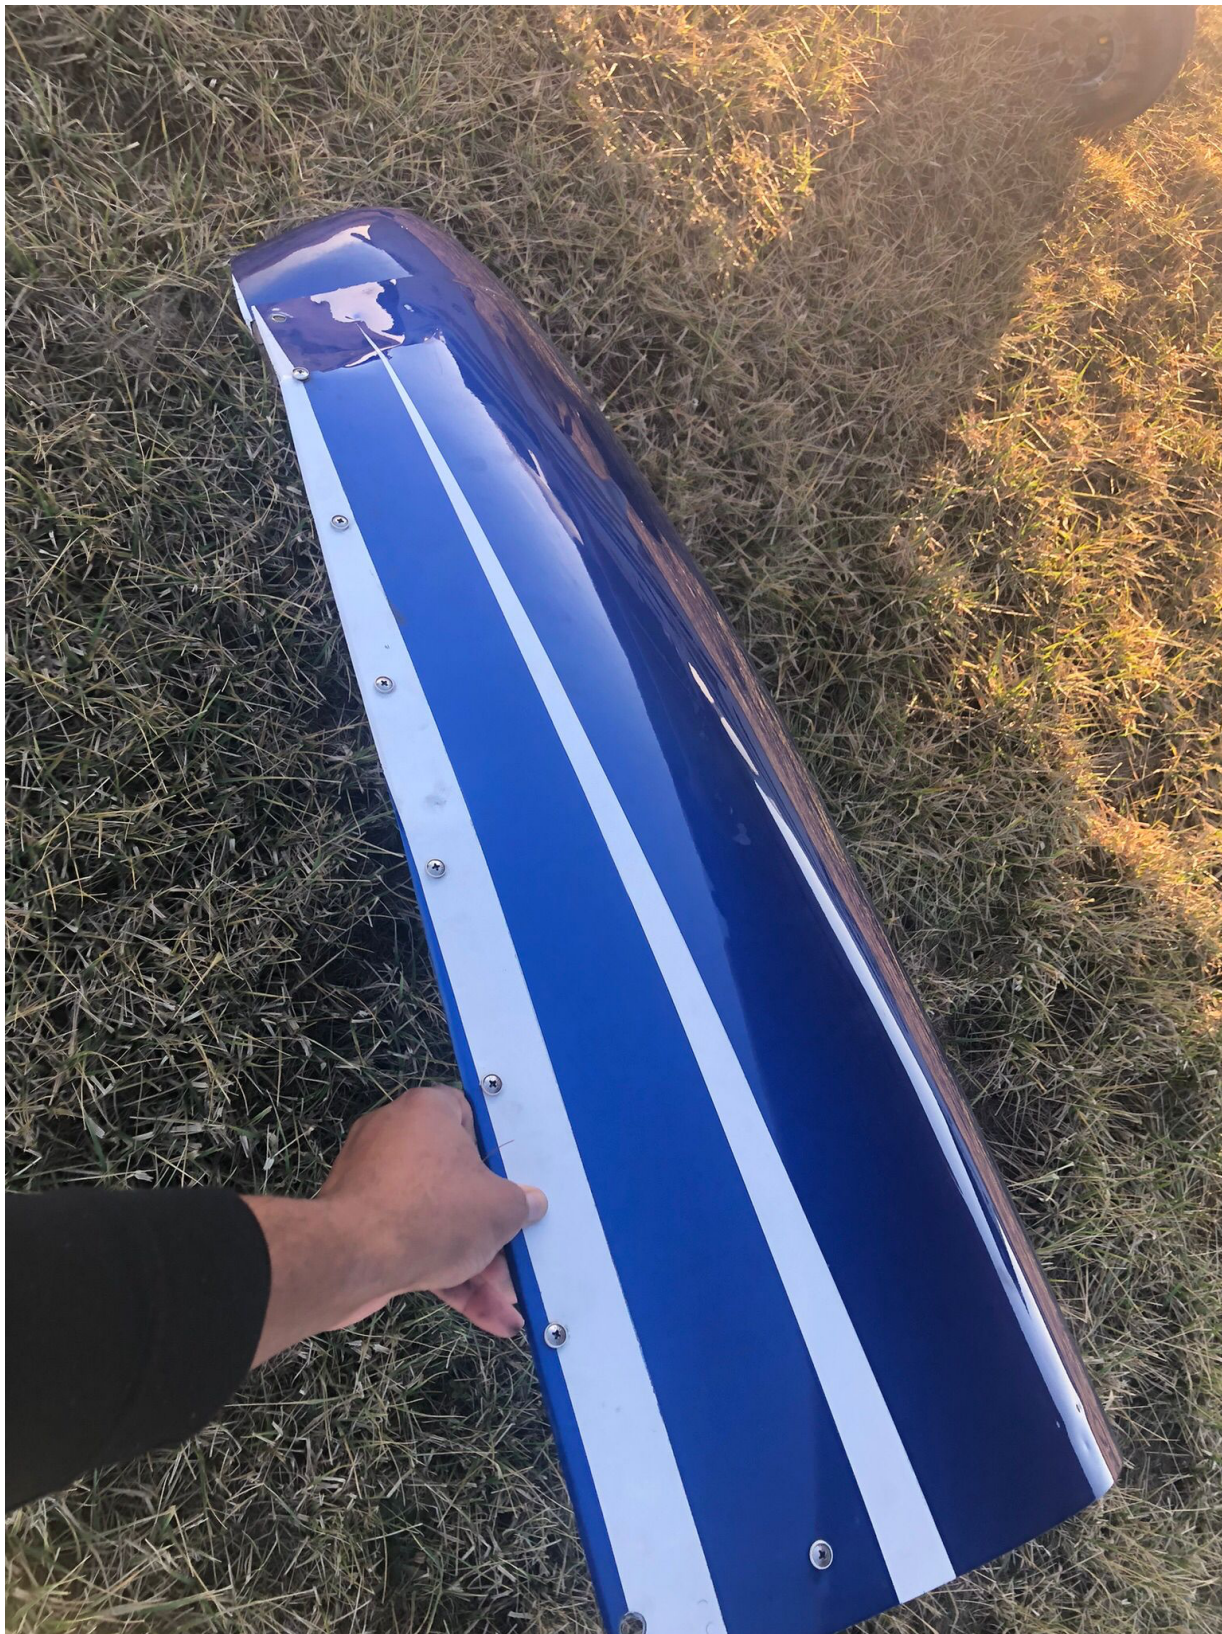
Additionally, my chief suggested that the cowling screws were not in place physically. However, that's incorrect; if the screws had been missing the cowling would have detached much earlier. Moreover,

most of the screws were still in place after landing (please see pictures below, taken shortly after landing).

*Picture 1: Cowling condition after landing – most screws still in place.*

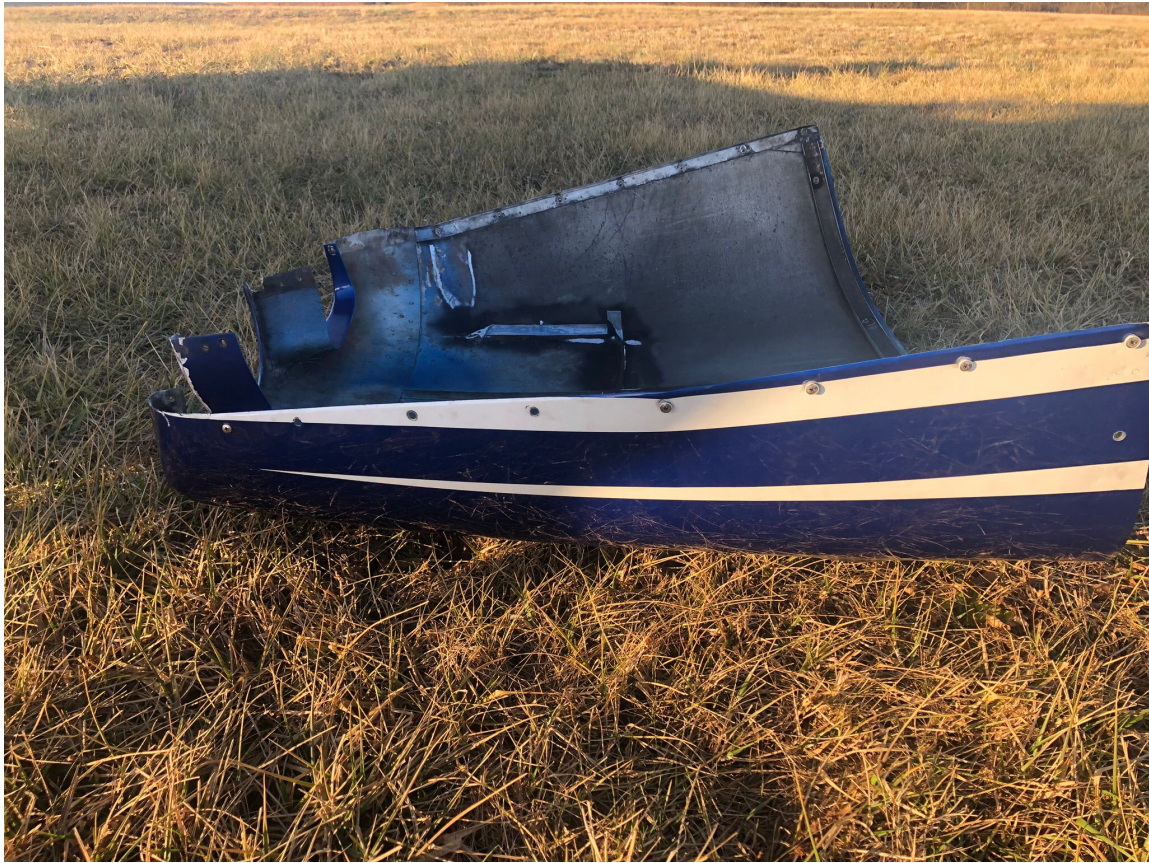
*Picture 2: Cowling condition after landing, some screws missing possibly during detachment.*

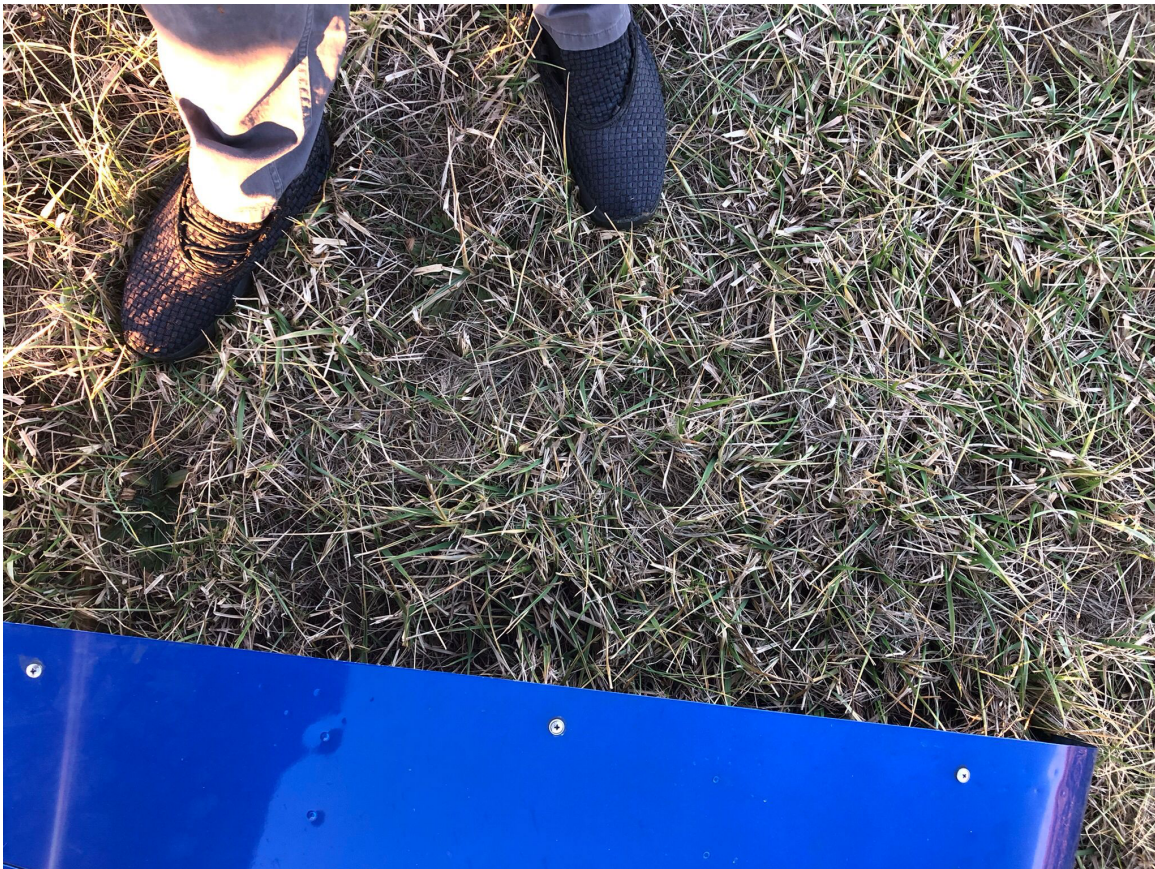
*Picture 3: Cowling condition after landing – all 3 screws on top of cowling present.*
