ERA25LA114

## INVESTIGATION PHOTOGRAPHS

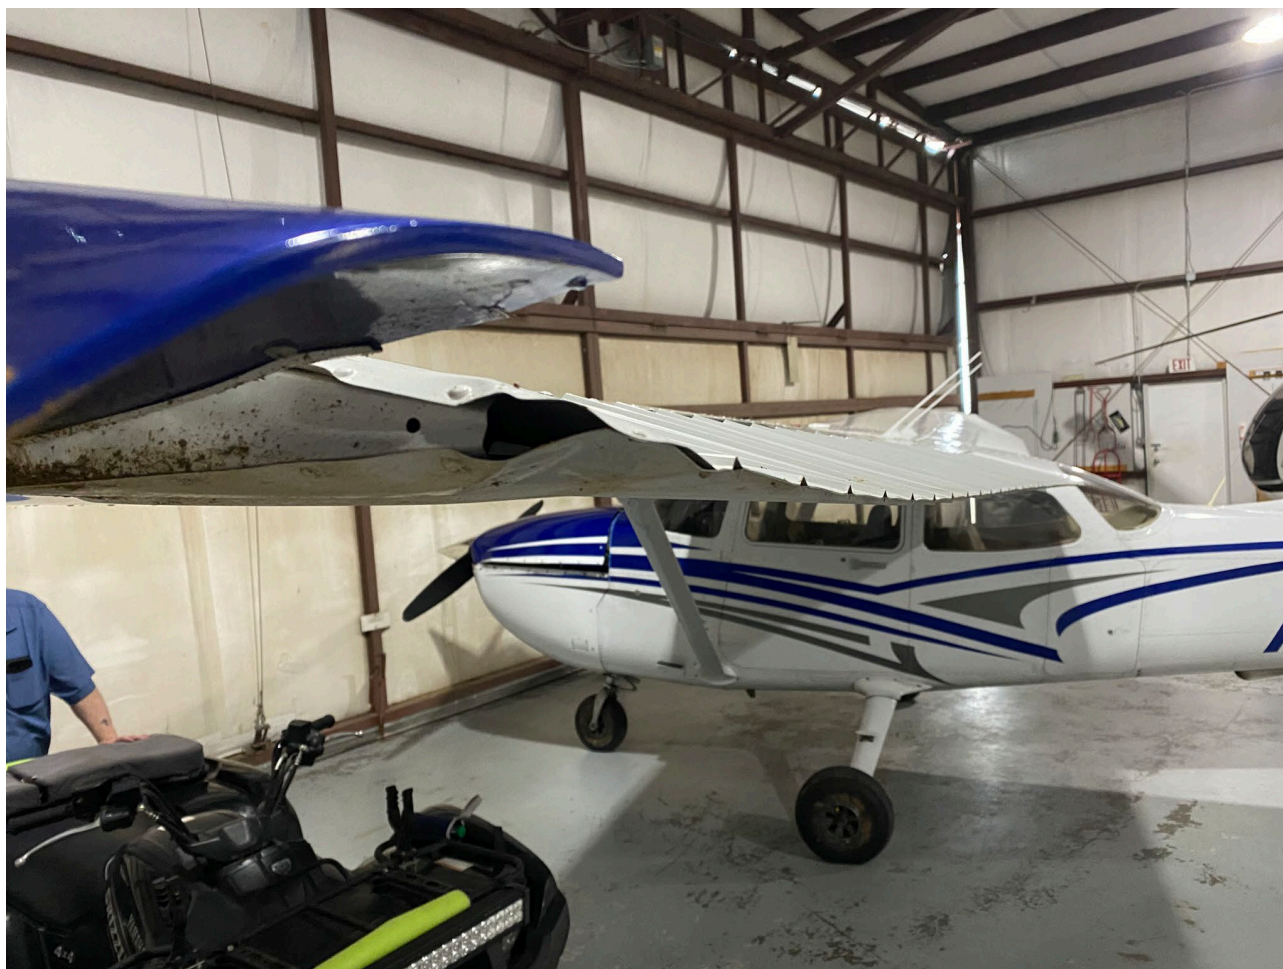
**Photograph 1 - View of damaged left wing. (Courtesy of FAA)**

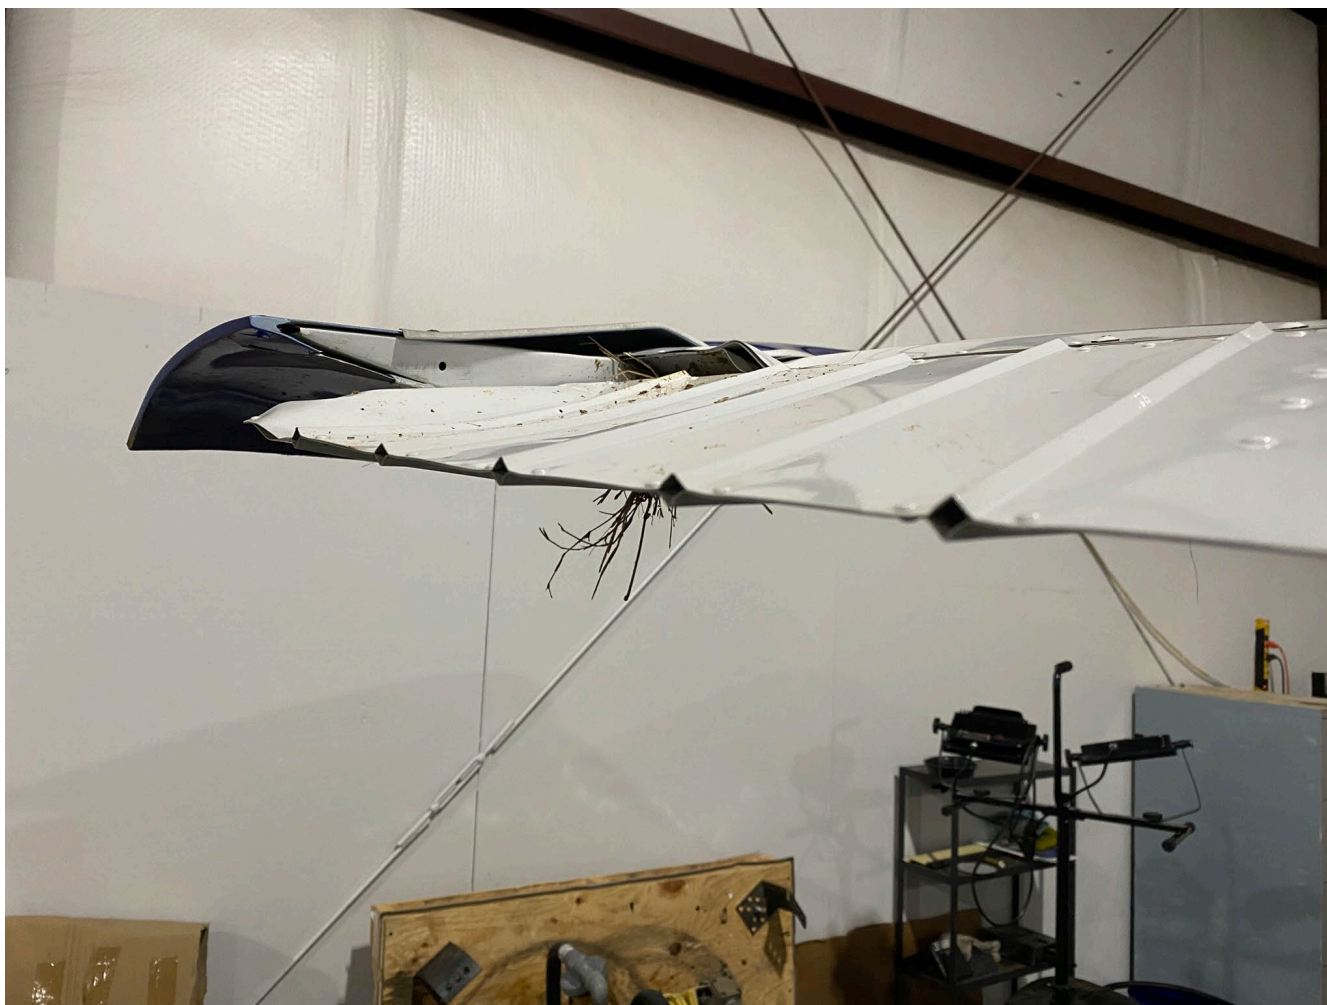
**Photograph 2 - View of damaged left aileron. (Courtesy of FAA)**

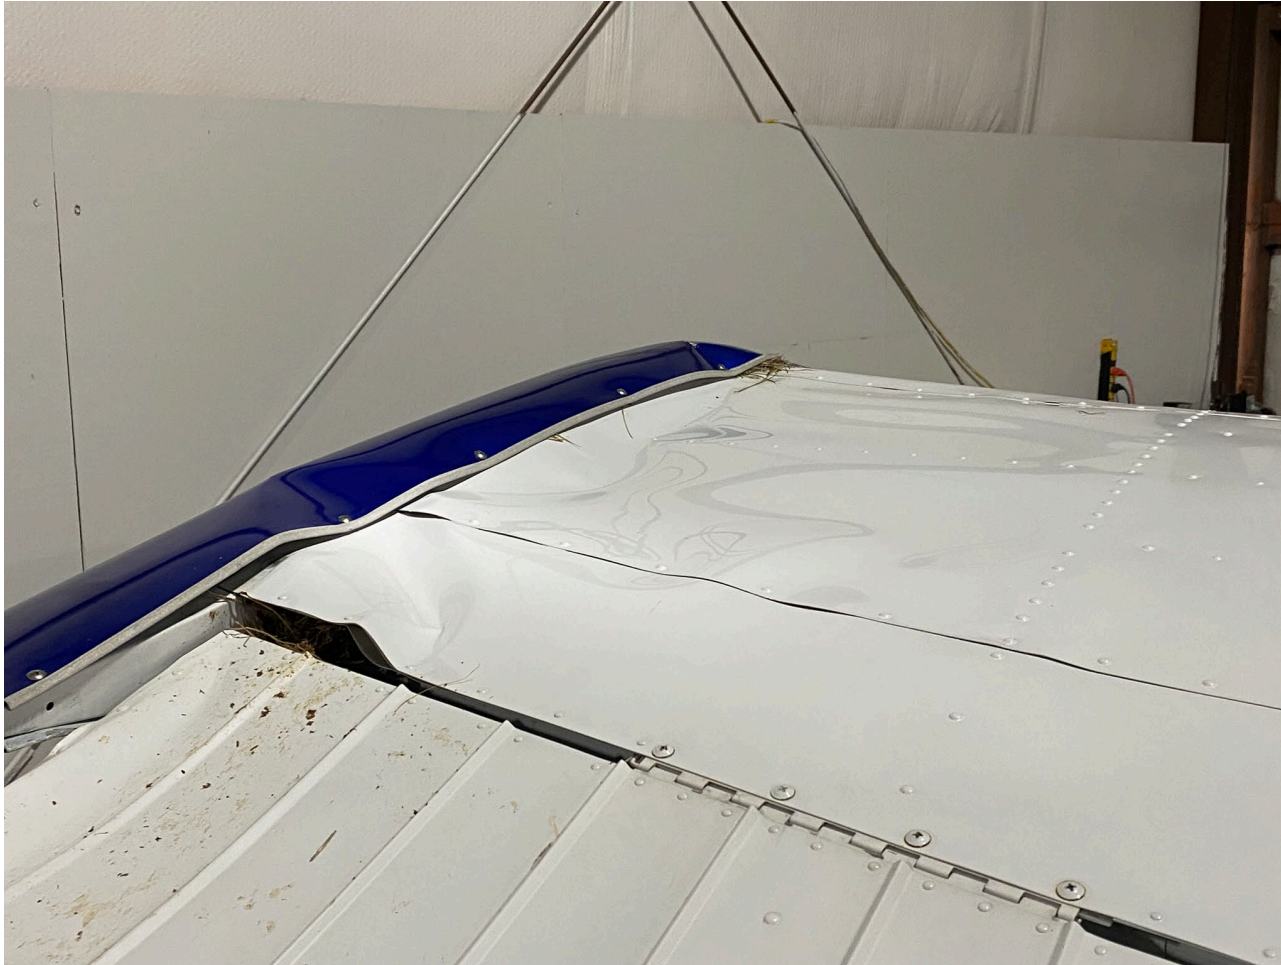
**Photograph 3 - View of top of left wing damage. (Courtesy of FAA)**
