# National Transportation Safety Board

ERA25LA115

## **ENGINE /FUEL SYSTEM/LH AILERON BRACKET EXAMINATION**

Location: Hampton, New Hampshire  
Date: February 11, 2025  
Time: 1110 EST  
1610 UTC  
Airplane: N77989

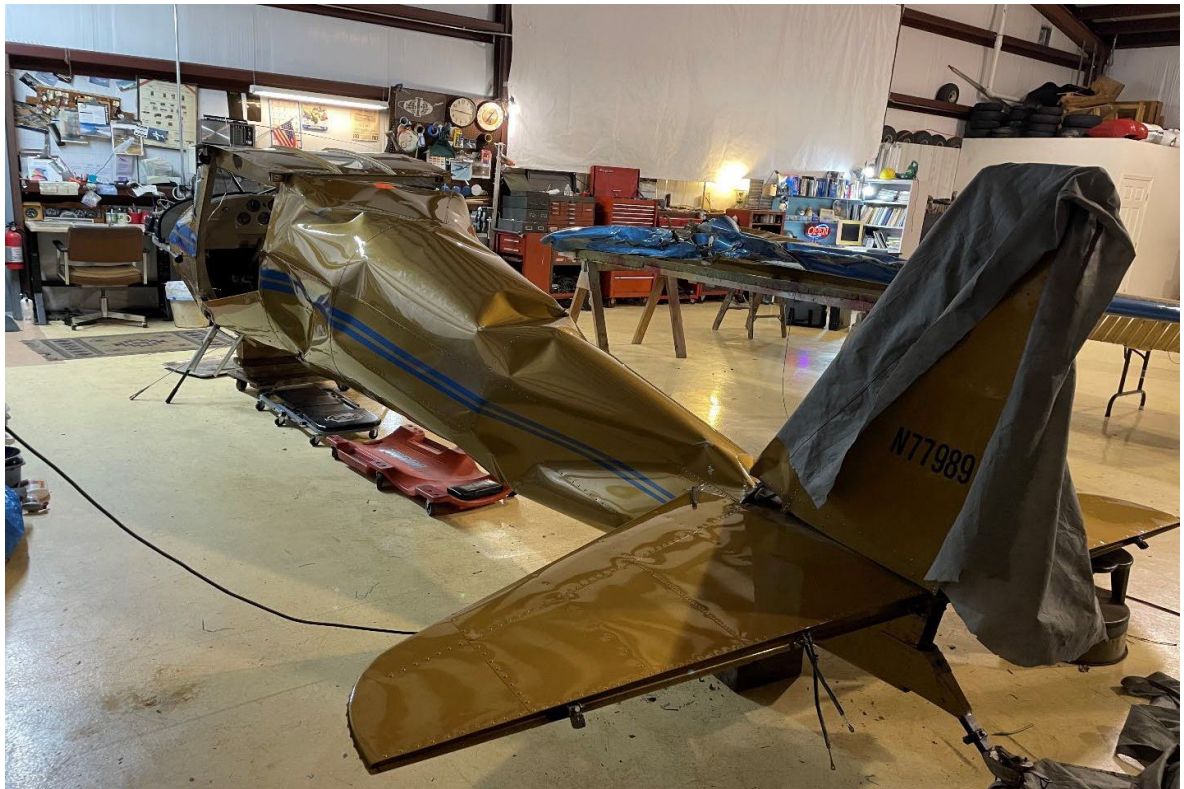
Both wings had been removed from the airplane and were resting upright on saw horses. The main body of the airplane was sitting upright and being supported by blocks. The engine was secure to the firewall and the two bladed metal propeller had been removed. The tail section was partially detached from the empennage and remained connected via control cables. Both elevators had been removed.

Picture 1. Airplane and Wings in Pilot's Hangar.

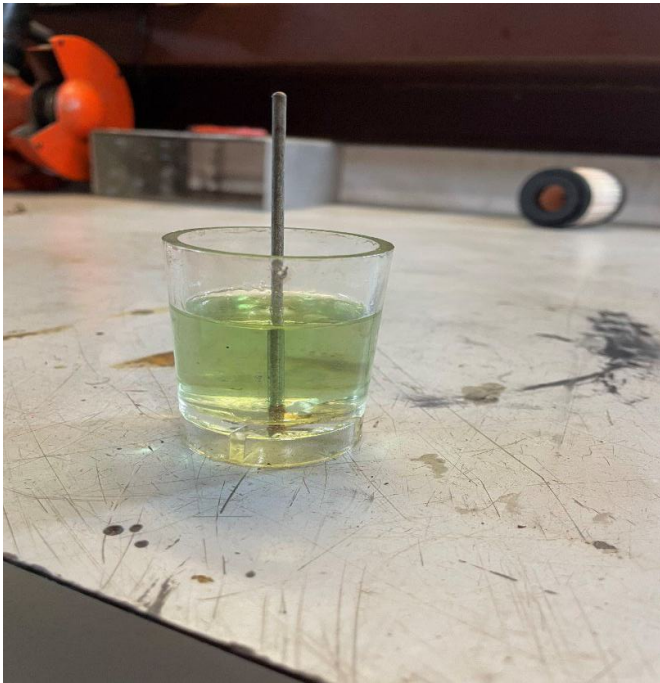
Another sample was taken and appeared light blue, consistent with 100LL aviation gasoline. All samples were absent of water and debris. The fuel filter was removed, and the screen was absent of debris. Shop air was blown into the fuel tank, and fuel/air was observed exiting the fuel filter, indicating the line was clear of debris. No leaks in the fuel system were observed.

Picture 2. Fuel drained from firewall fuel filter.

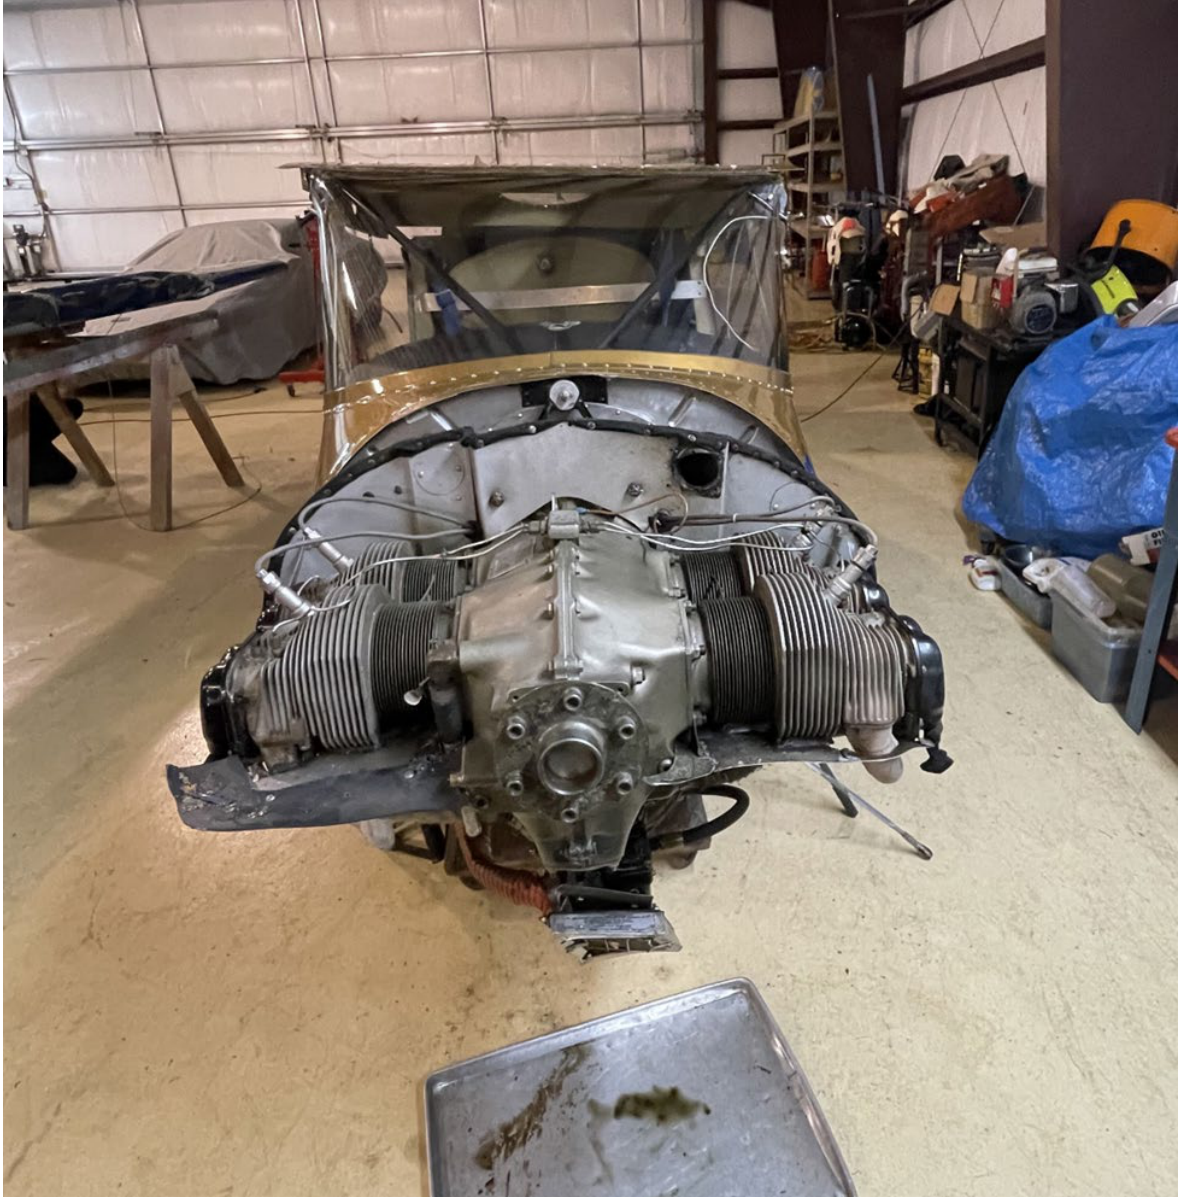
Picture 3. Front View of engine.

The Continental C85-12F (65 hp, 4-cylinder) engine was secure to the firewall and exhibited minor damage. The oil system was breached and little to no oil remained in the engine. Both magnetos were undamaged and secure to the engine.

Examination of the engine revealed no evidence of any preimpact mechanical malfunctions or failures that would have precluded normal operation.
