Ryan Enders  
Aviation Accident Investigator  
Eastern Region

**Date:** February 20, 2025  
**Subject:** ERA25LA118 Student Pilot Interview  
**Contact:** Cristian Abarca

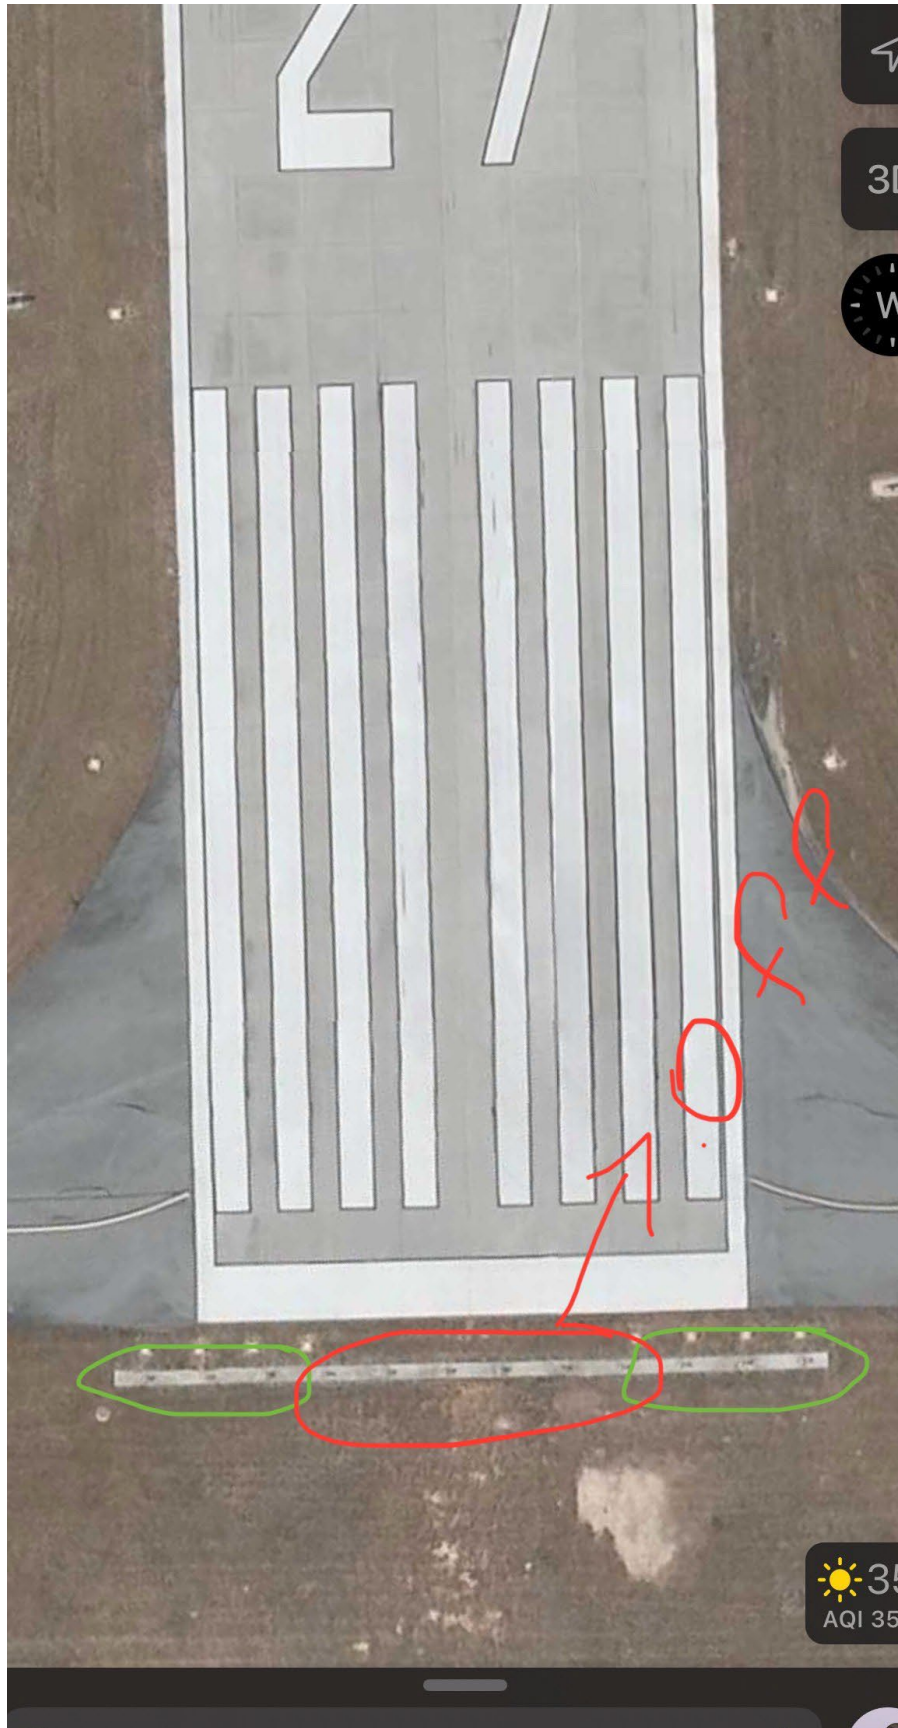
right of the runway. Three lights on each side of the runway were working, but the lights "in the middle" were not working. Since there were no lights in the center, it made it difficult to judge the landing.

Mr. Abarca was asked if the inoperative runway lights were out for the previous landings. He replied that only the three lights on each side, green in color, were working for the entire flight and previous three landings. Mr. Abarca was asked if he and his instructor discussed the runway lights being inoperative. He replied with "no" and that he was unsure if the instructor knew that they were even inoperative.

An email with an aerial photograph of the approach end of runway 27 was sent to Mr. Abarca on February 20, 2025. He replied the same day with a different photograph of the same approach end showing which lights were operating and which lights were not working. The photograph from Mr. Abarca is below.
