ERA25LA122

## INVESTIGATION PHOTOGRAPHS

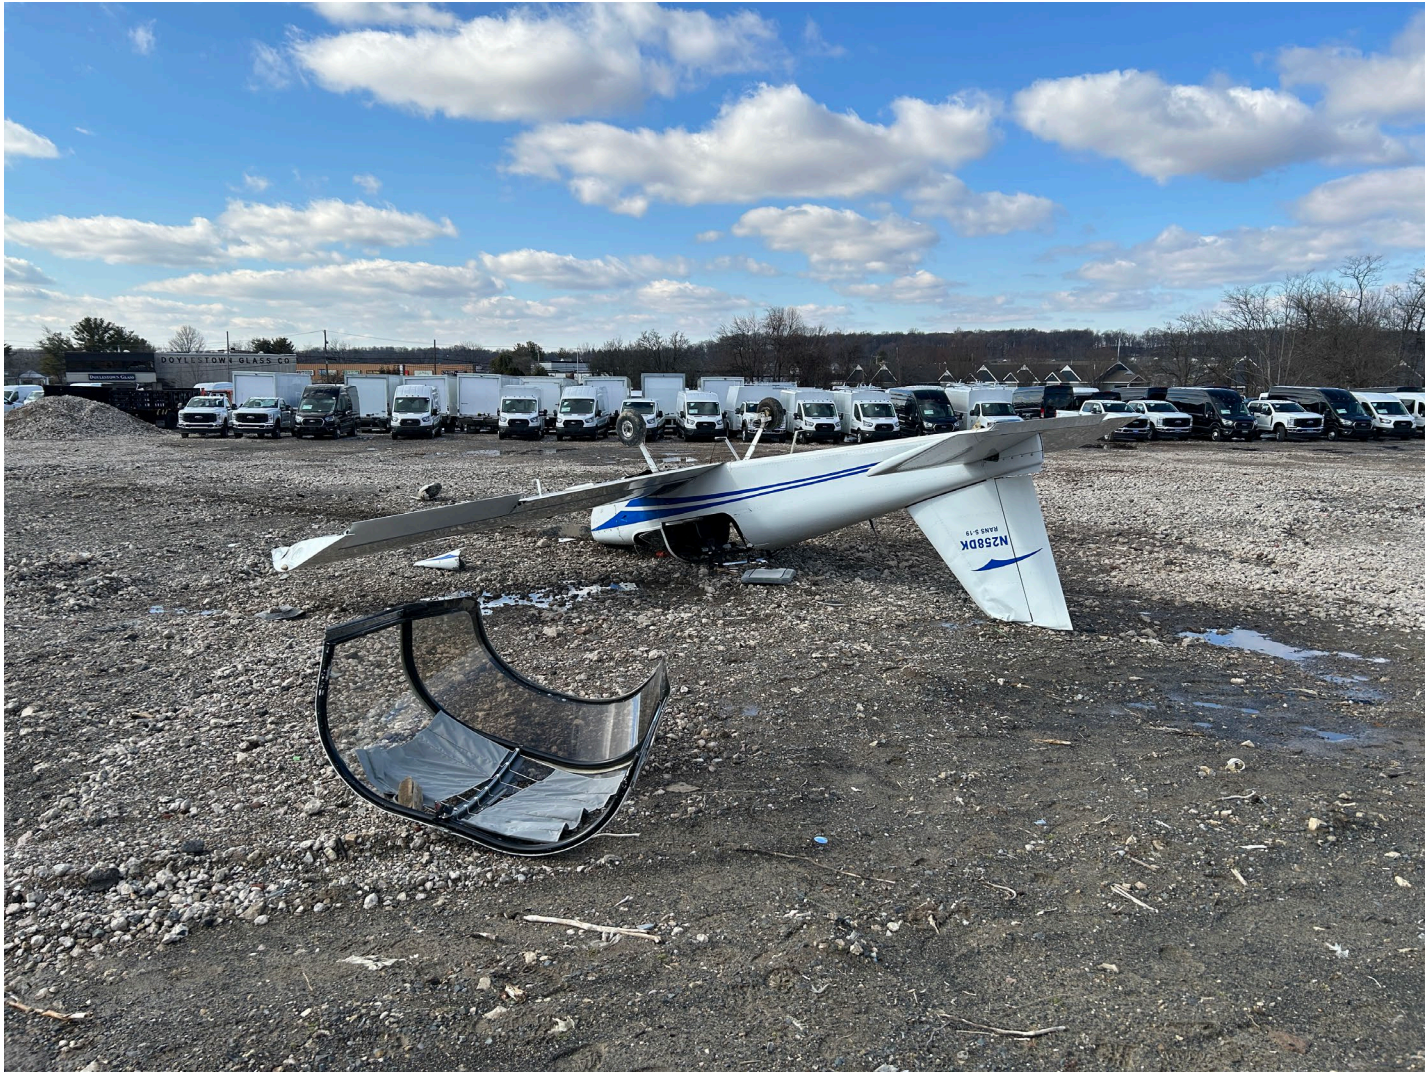
**Photograph 1 - Airplane postaccident (Courtesy of FAA)**

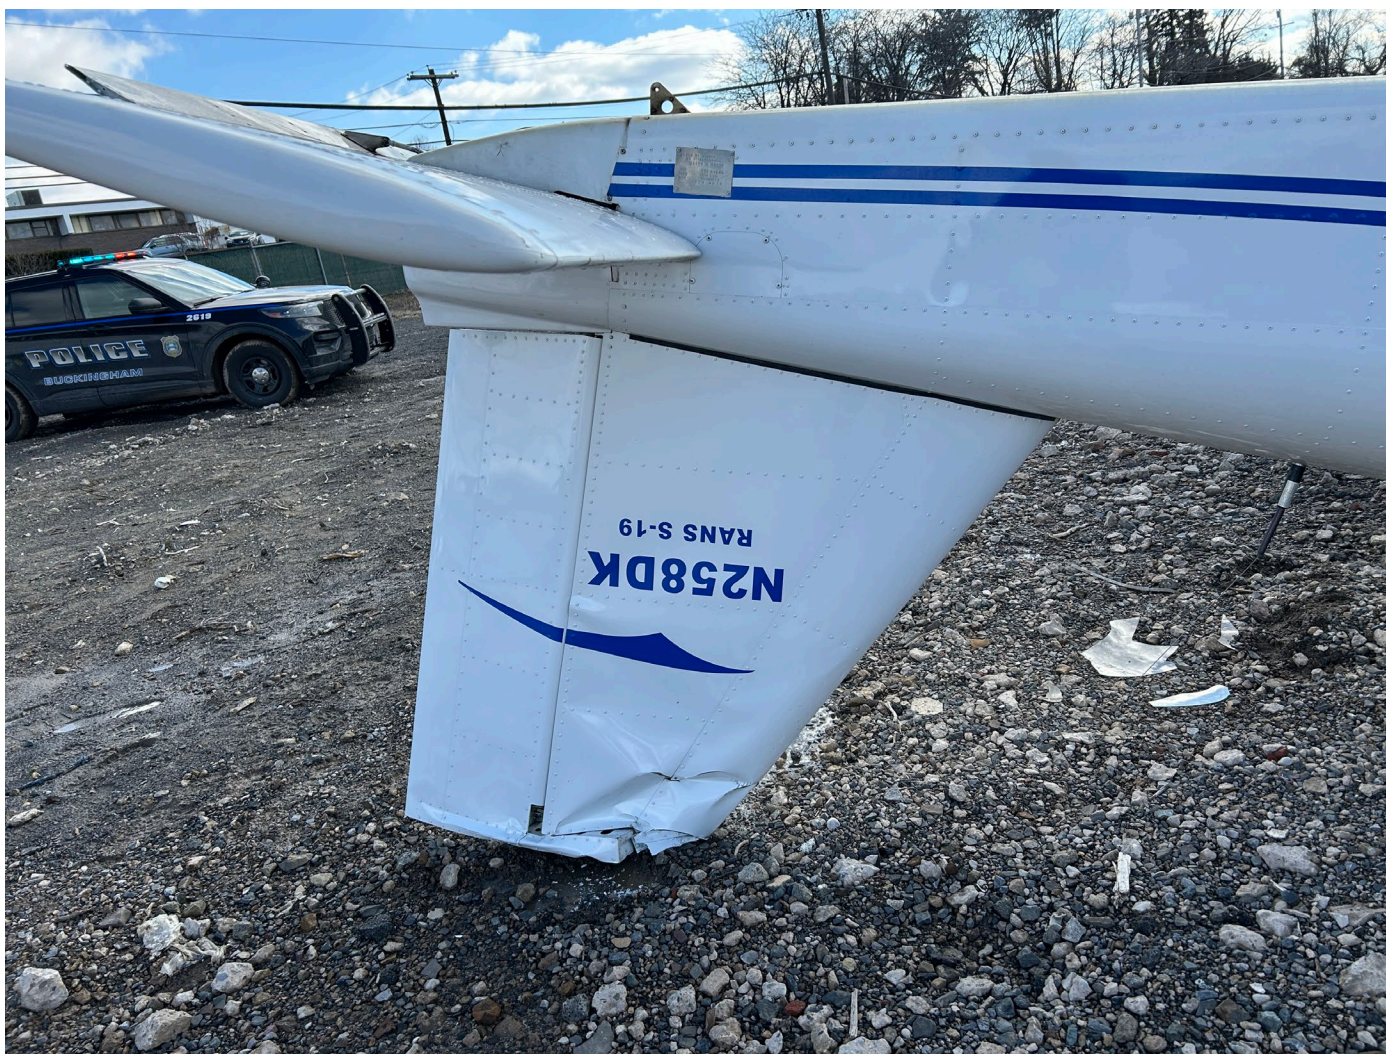
**Photograph 2 - Vertical stabilizer accident damage (Courtesy of FAA)**

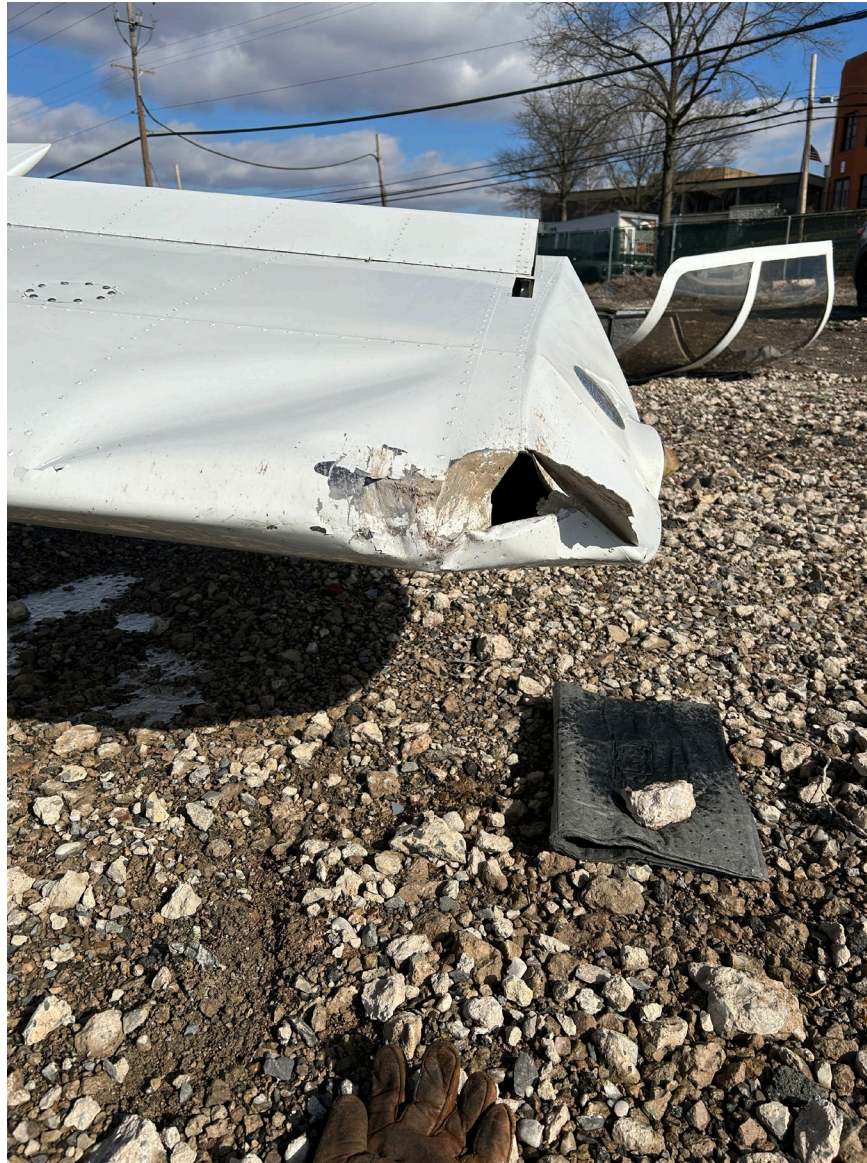
**Photograph 3 - Right wing accident damage (Courtesy of FAA)**

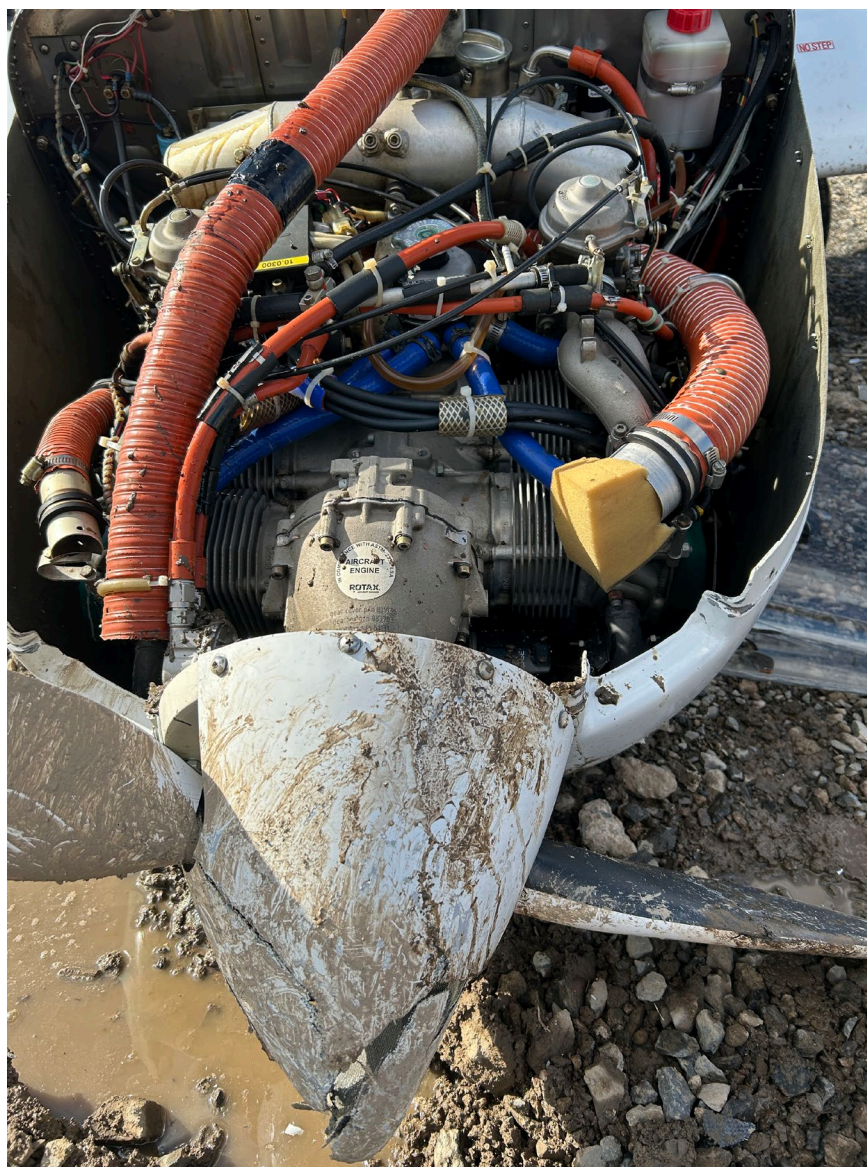
**Photograph 4 - Engine postaccident (Courtesy of FAA)**
