ERA25LA123

## INVESTIGATION PHOTOGRAPHS

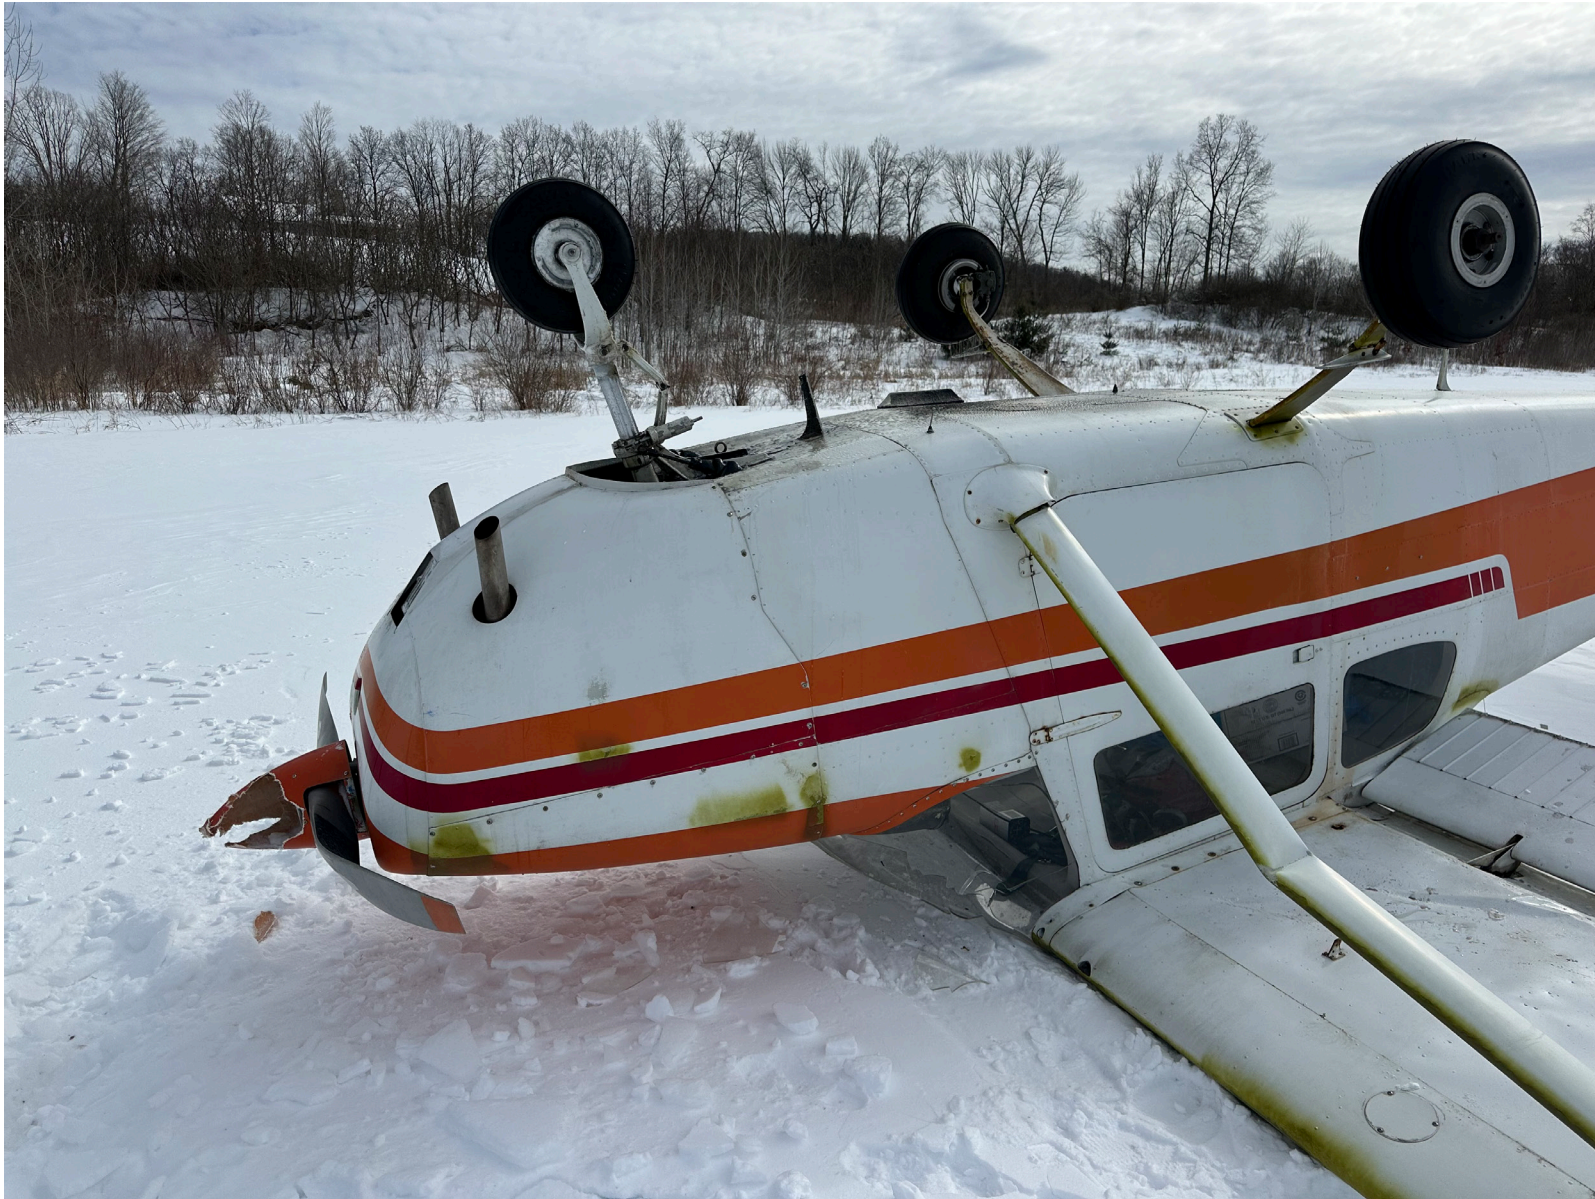
**Photograph 1 - Accident airplane inverted (Courtesy of Owner/Pilot)**

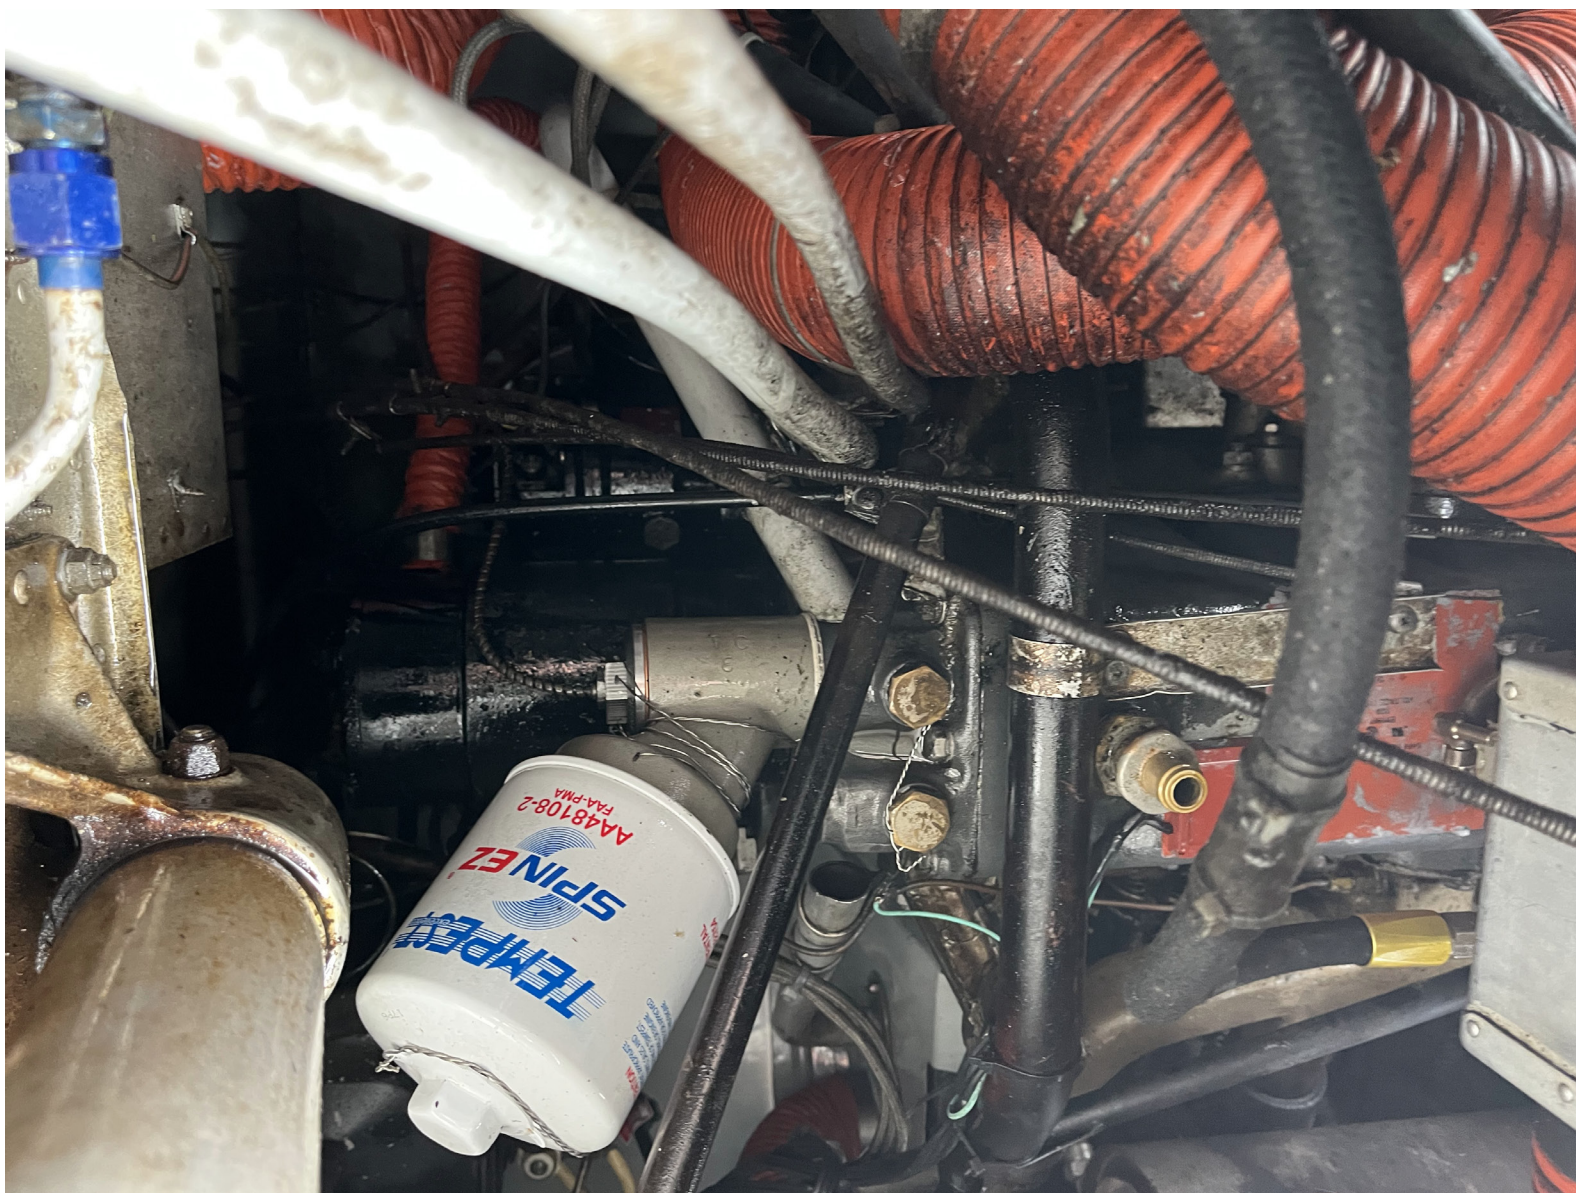
**Photograph 2 - Oil filter and adapter (Courtesy of FAA)**

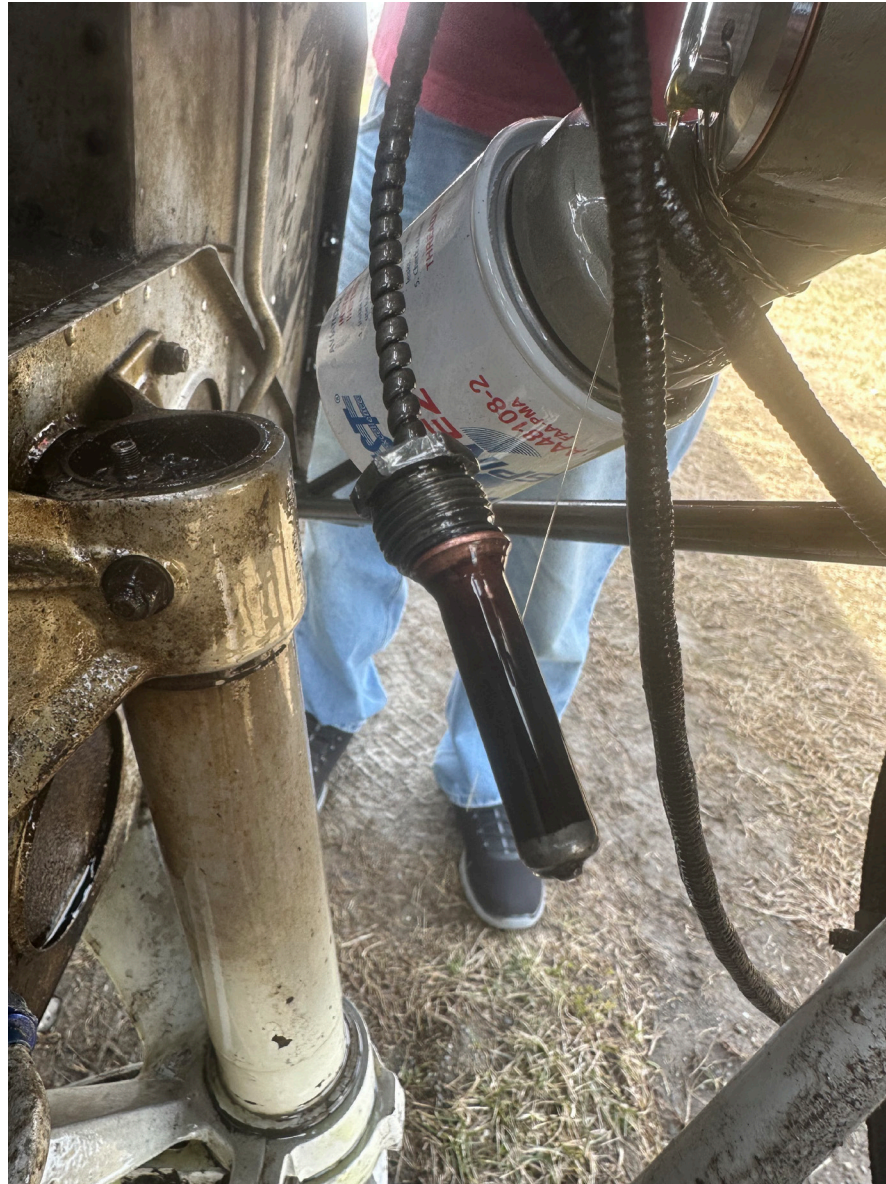
**Photograph 3 - Oil temperature probe (Courtesy of Owner/Pilot)**

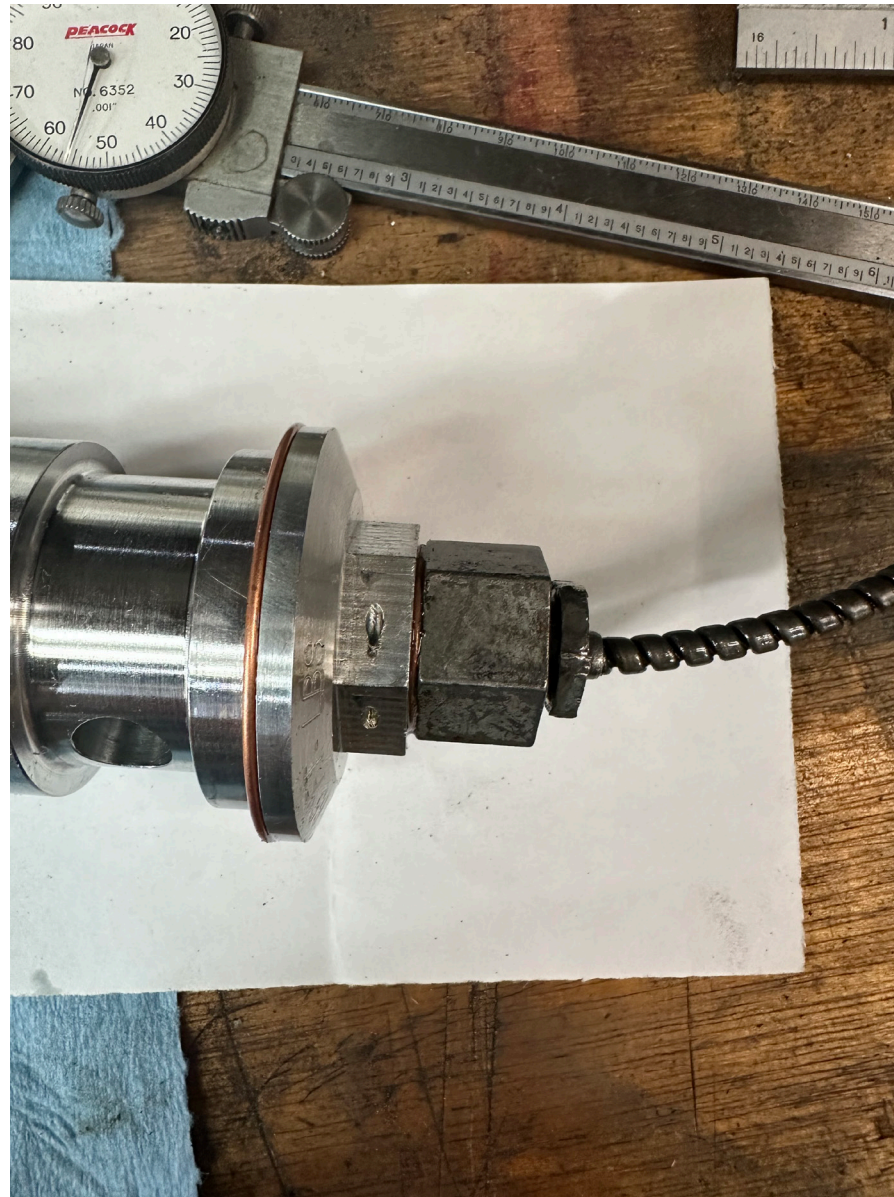
**Photograph 4 - Oil temperature probe (Courtesy of Owner/Pilot)**

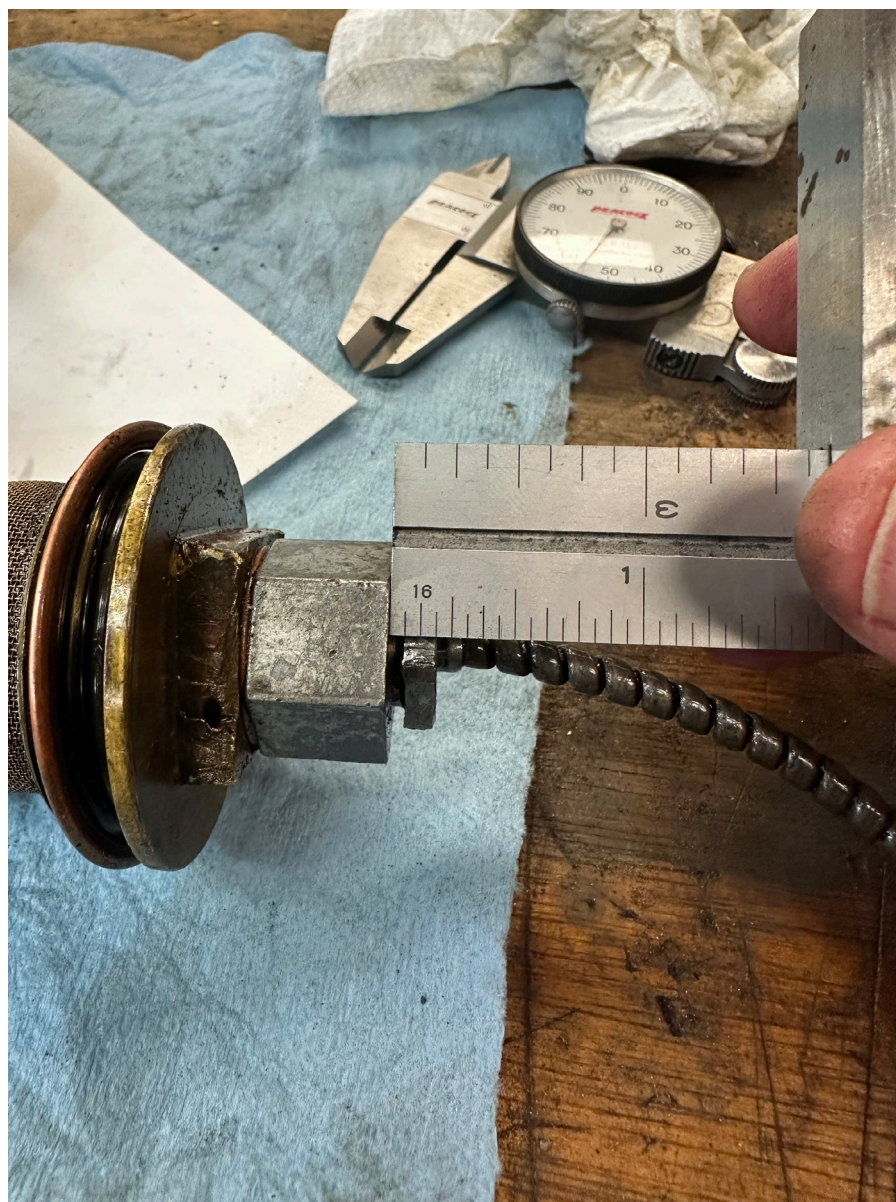
**Photograph 5 - Oil temperature probe (Courtesy of Owner/Pilot)**
