Damian Galbraith  
Aviation Accident Investigator  
OAS-ERA

**Subject:** ERA25LA123 Engine Examination Summary

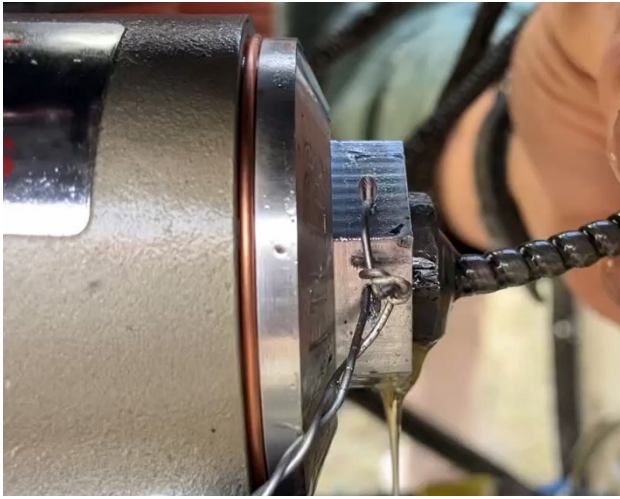
On March 20, 2025, the IIC coordinated with a local aircraft mechanic, Mr. Richard Bovey, to examine the engine for oil leaks. Mr. Bovey reported to the IIC that he straightened the propeller, added oil, and performed an engine run. The engine started and ran smoothly through the RPM range. During the engine run, an oil leak was observed at the oil temperature probe that was attached to the recently installed Tempest Model CO-300 oil filter adaptor (see figure 1). Further examination revealed that, although the oil temperature probe nut threaded into the Tempest oil filter housing, the probe was not seated after securing the attachment nut and could not be seated without utilization of the Textron 0750139 adaptor fitting which was installed on the original oil screen housing. After installation of the Textron adaptor fitting on to the Tempest oil filter adaptor, the oil temperature probe seated (see figure 2).

During a phone conversation on March 20, 2025, the pilot, Mr. Robert Mapes, stated that the Tempest Model CO-300 oil filter adaptor was installed during the last Annual Inspection. He further stated that a post-installation engine run to check for oil leaks was not performed.

Figure 1: Oil temp probe installed without Textron adaptor fitting.

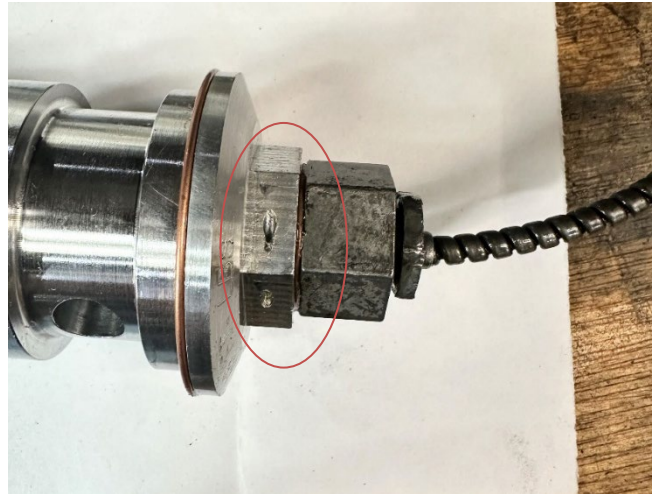
Figure 2: Oil temp probe installed with Textron adaptor fitting.
