ERA25LA124

## INVESTIGATION PHOTOGRAPHS

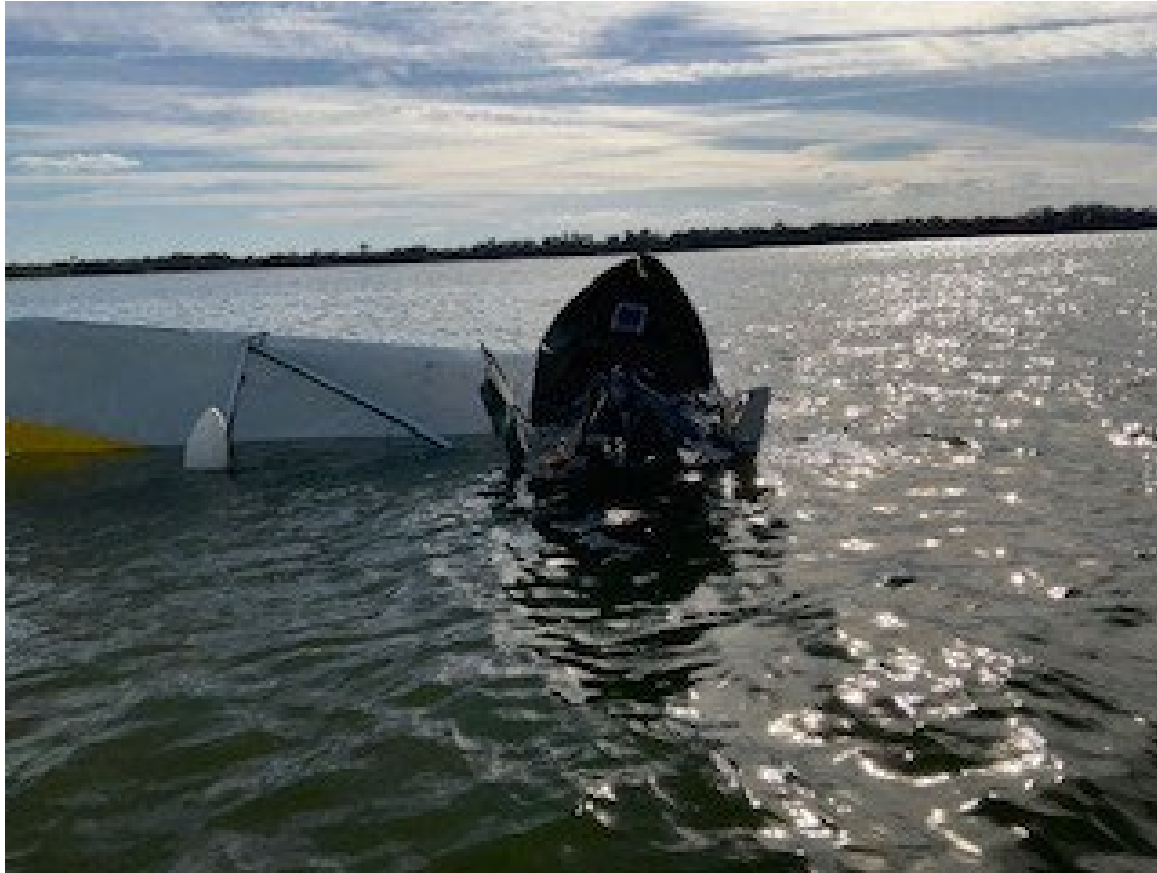
**Photograph 1 - Main Wreckage (Courtesy of Sea Tow)**

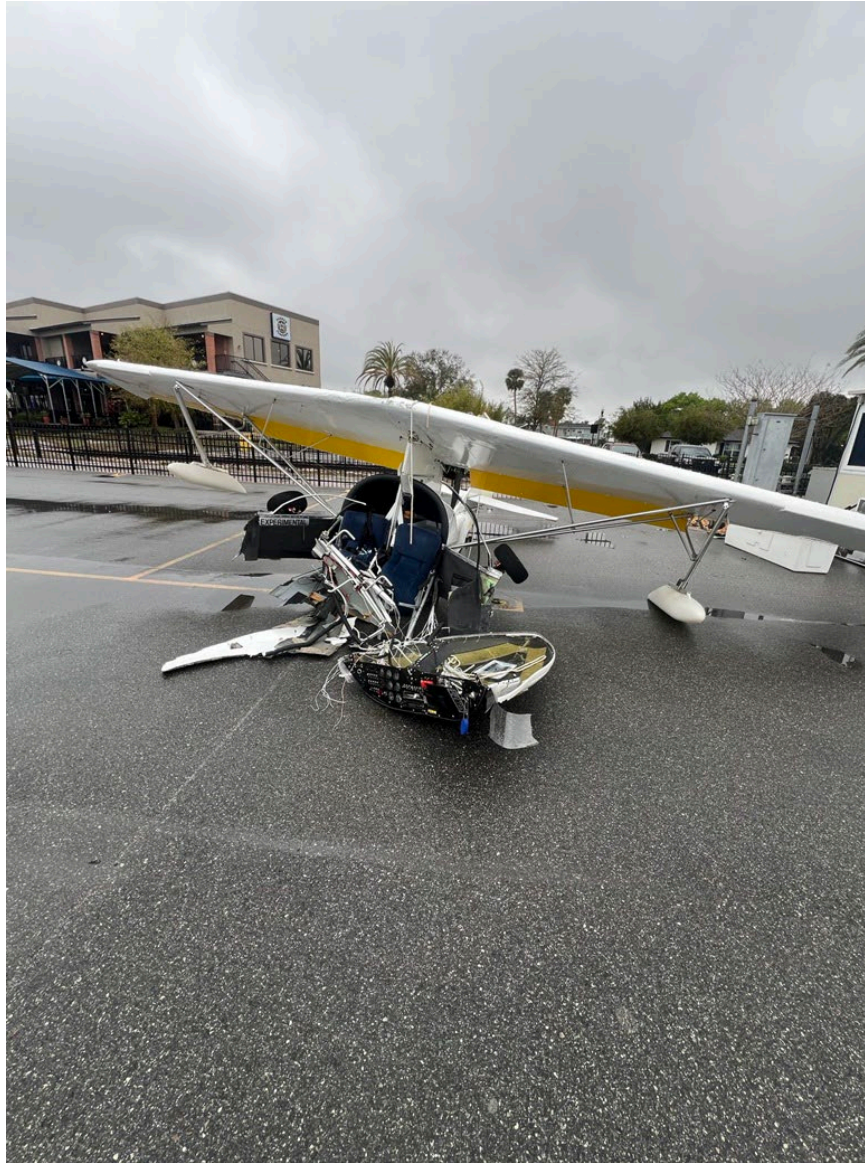
**Photograph 2 - Main Wreckage Recovered (Courtesy of WaterFront Operations Manager)**
