ERA25LA125

## INVESTIGATION PHOTOGRAPHS

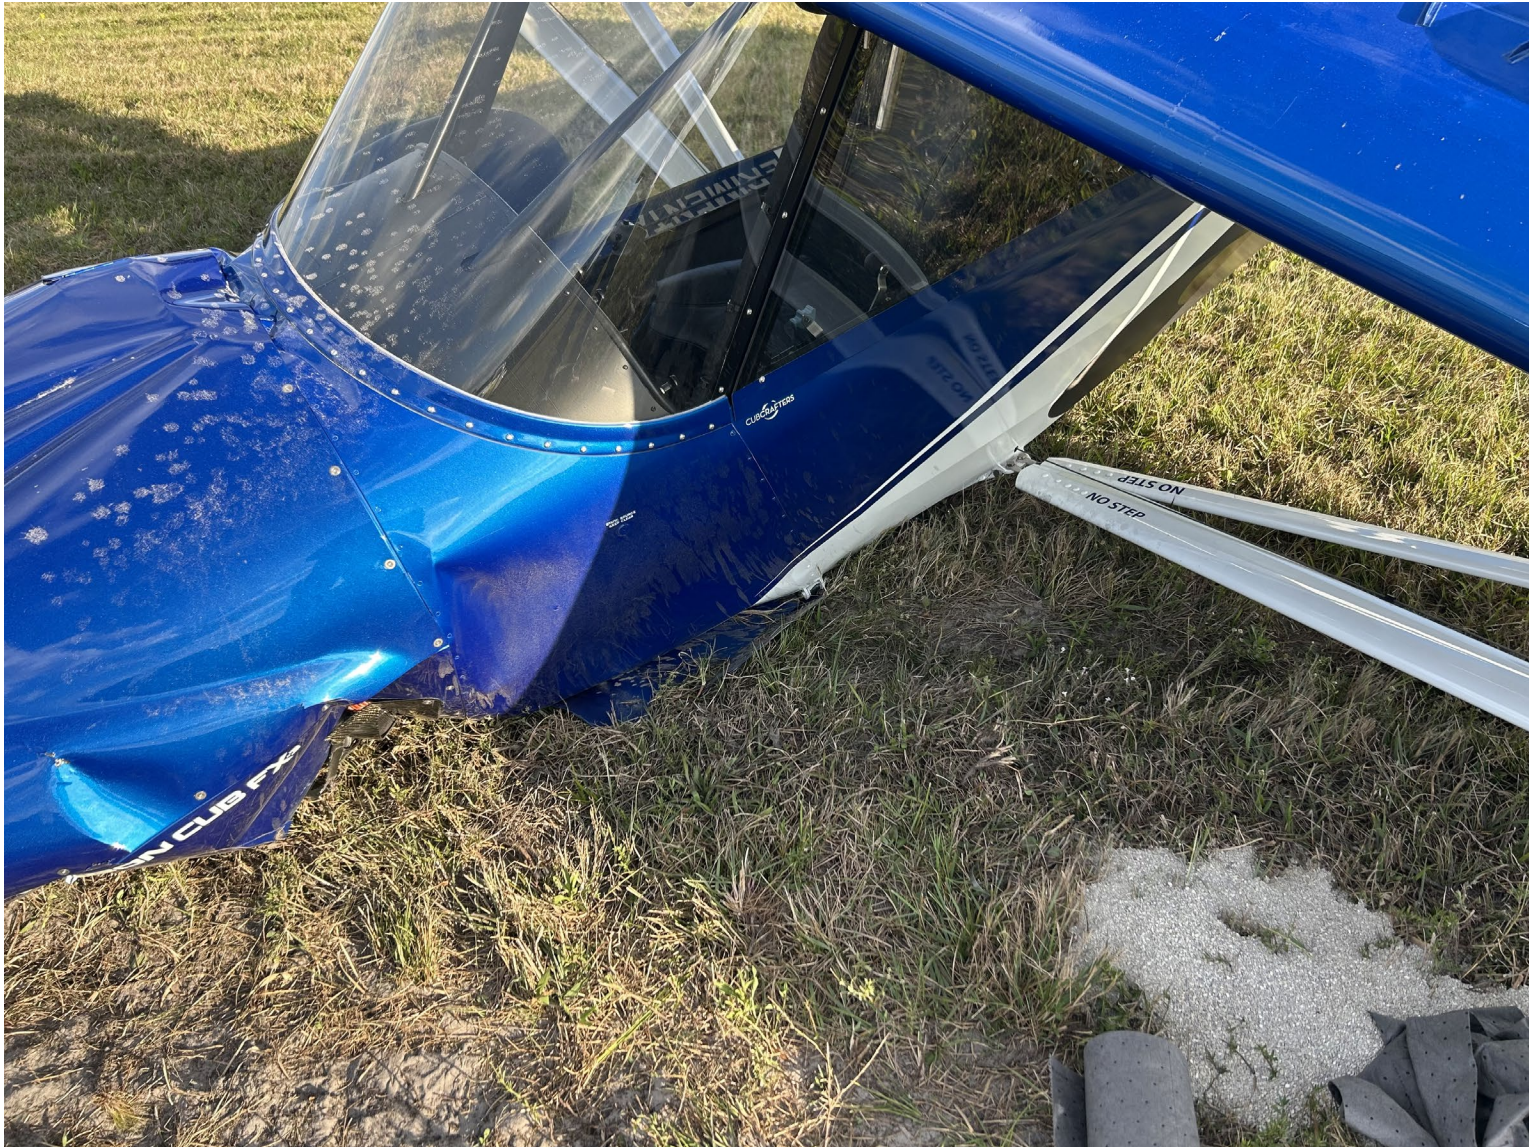
**Photograph 1 - Left gear collapsed, folded under fuselage (Courtesy of Owner)**

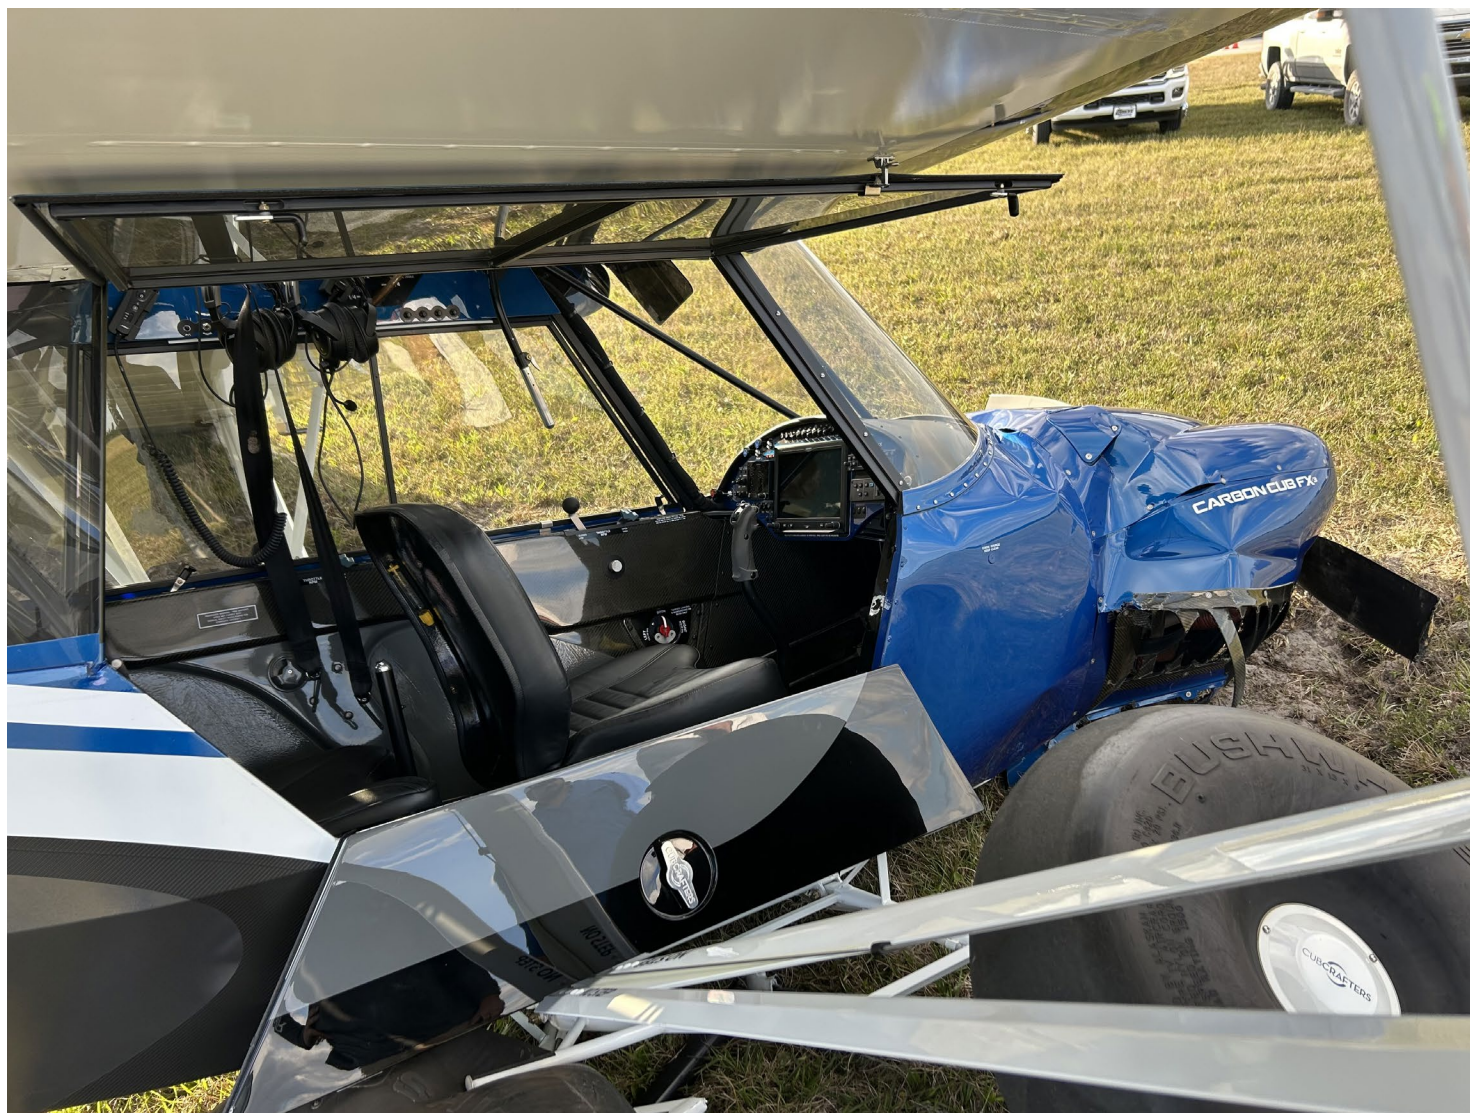
**Photograph 2 - Main wreckage, right wing view (Courtesy of Owner)**

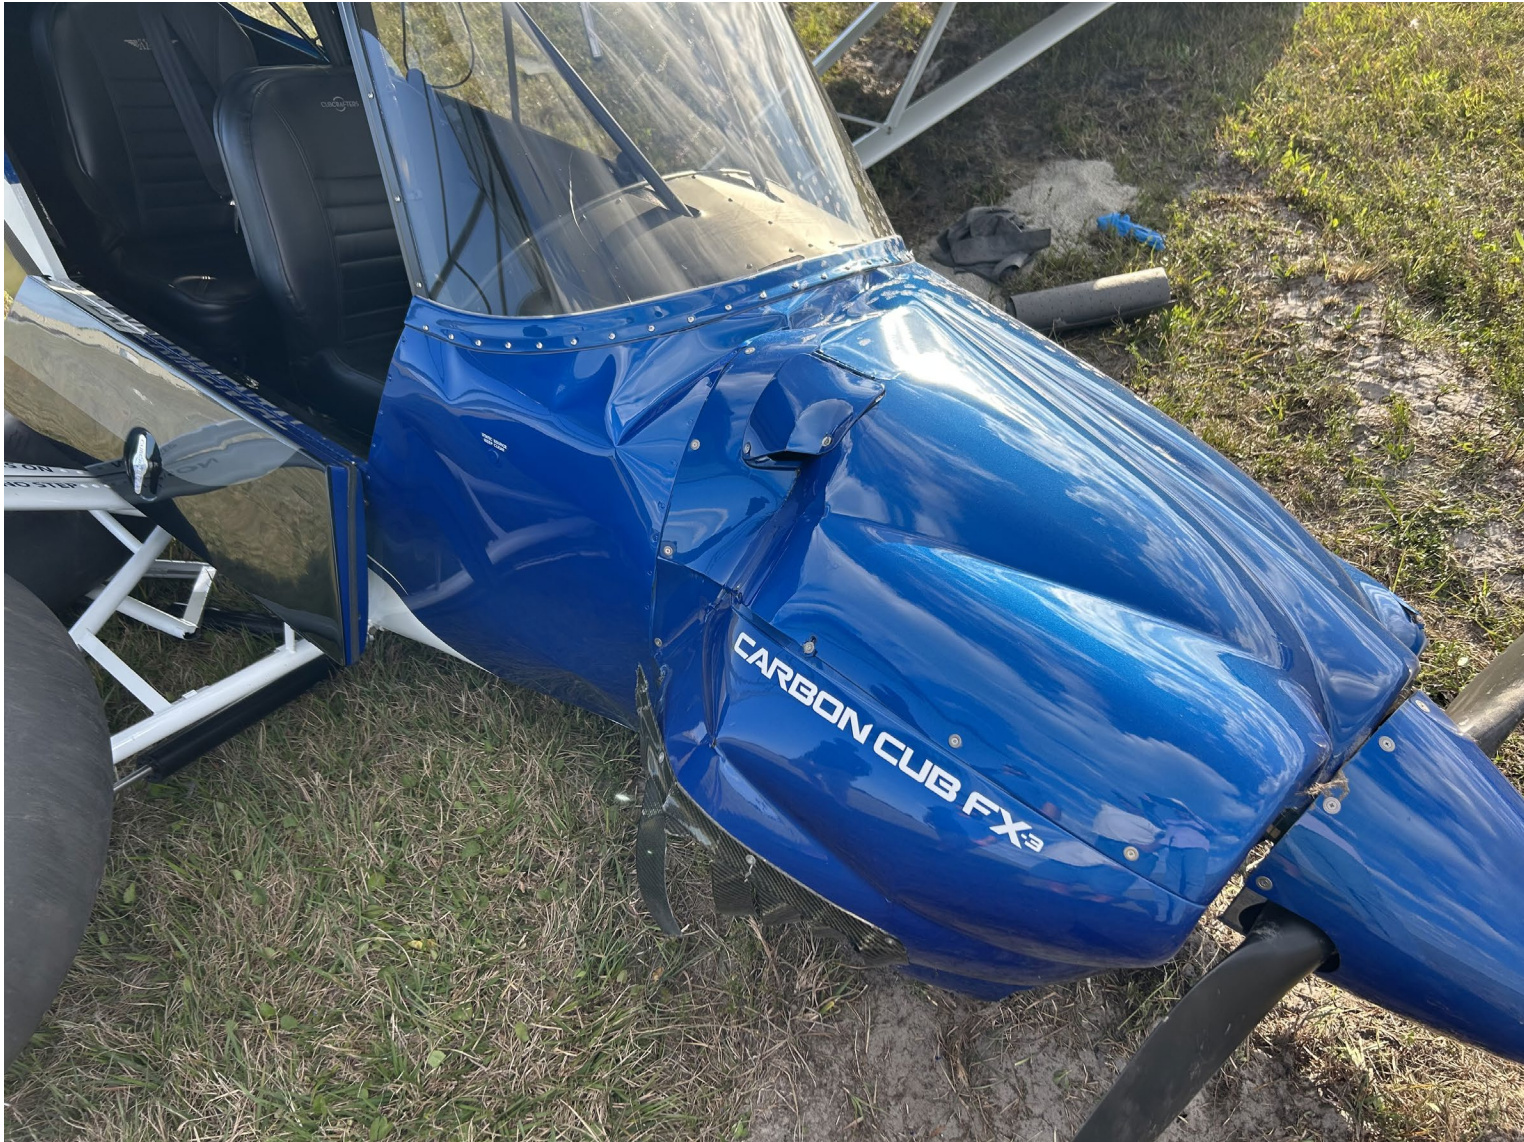
**Photograph 3 - Front of aircraft and firewall damage (Courtesy of Owner)**

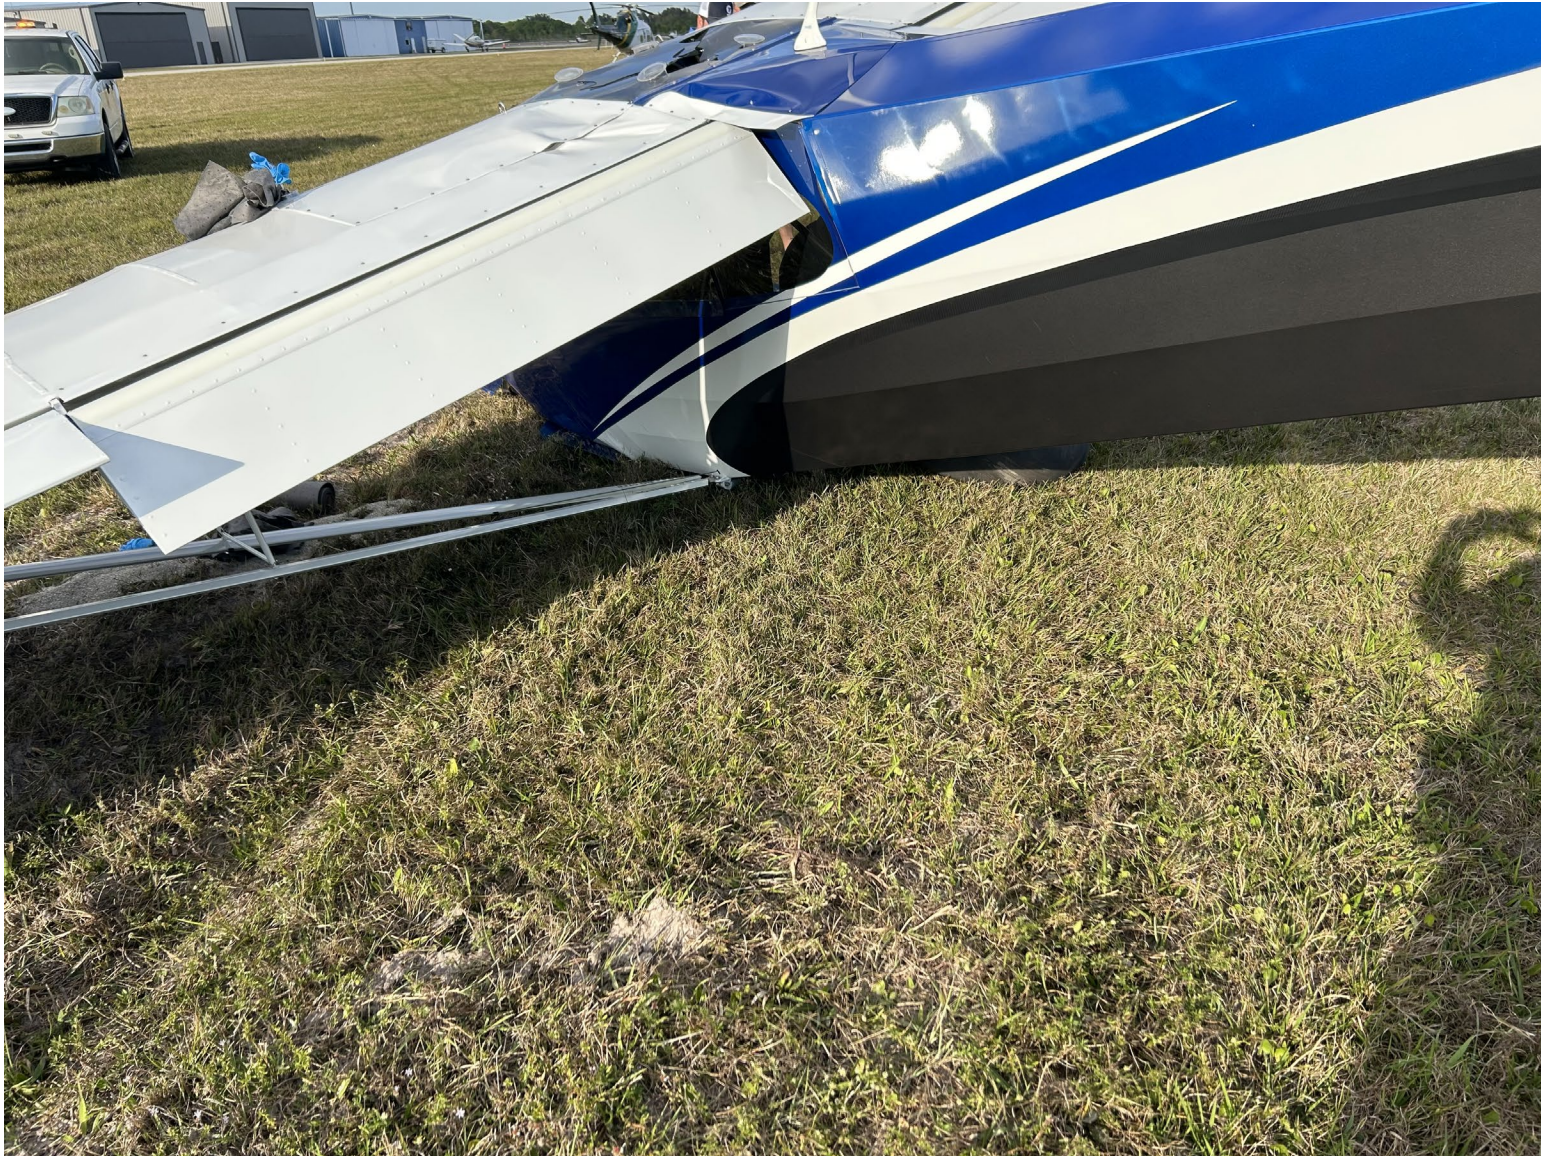
**Photograph 4 - Main wreckage, left wing view, gear collapsed (Courtesy of Owner)**
