ERA25LA135

## INVESTIGATION PHOTOGRAPHS

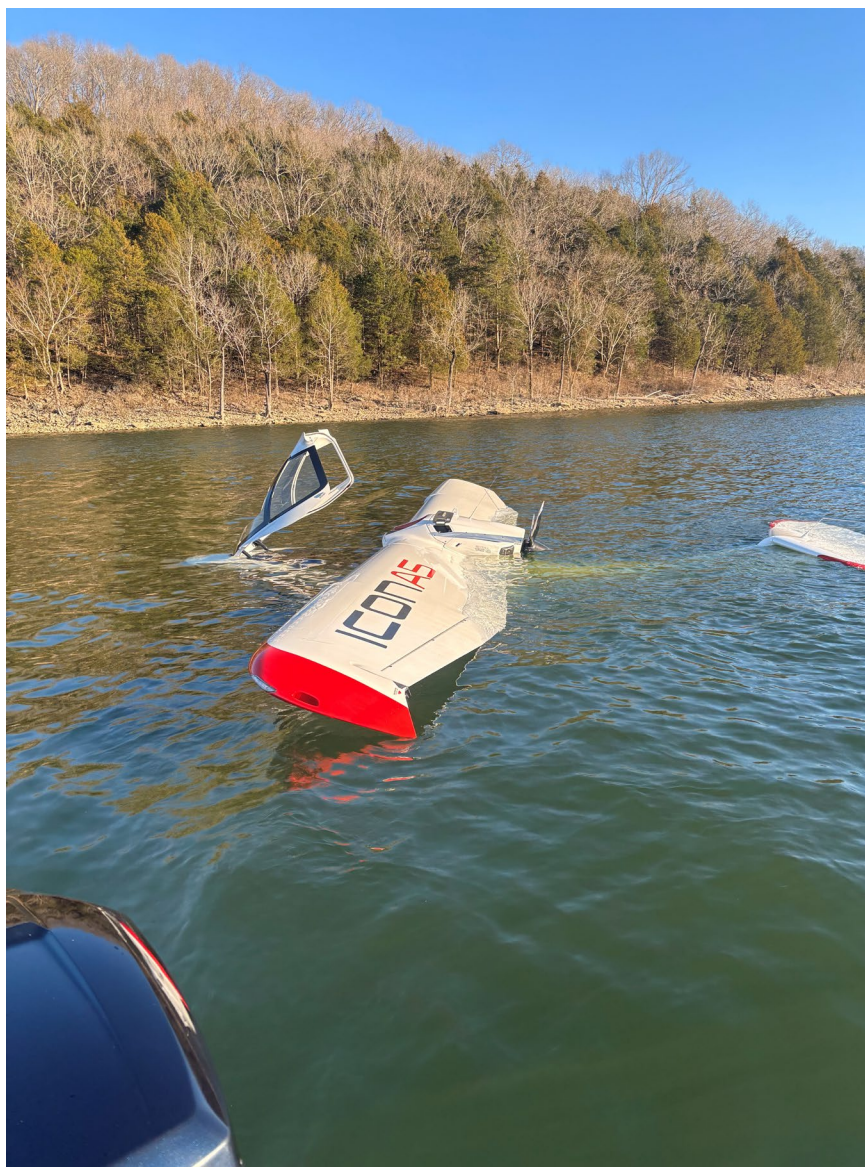
**Photograph 1 - Airplane postaccident (Courtesy of Recovery Company)**

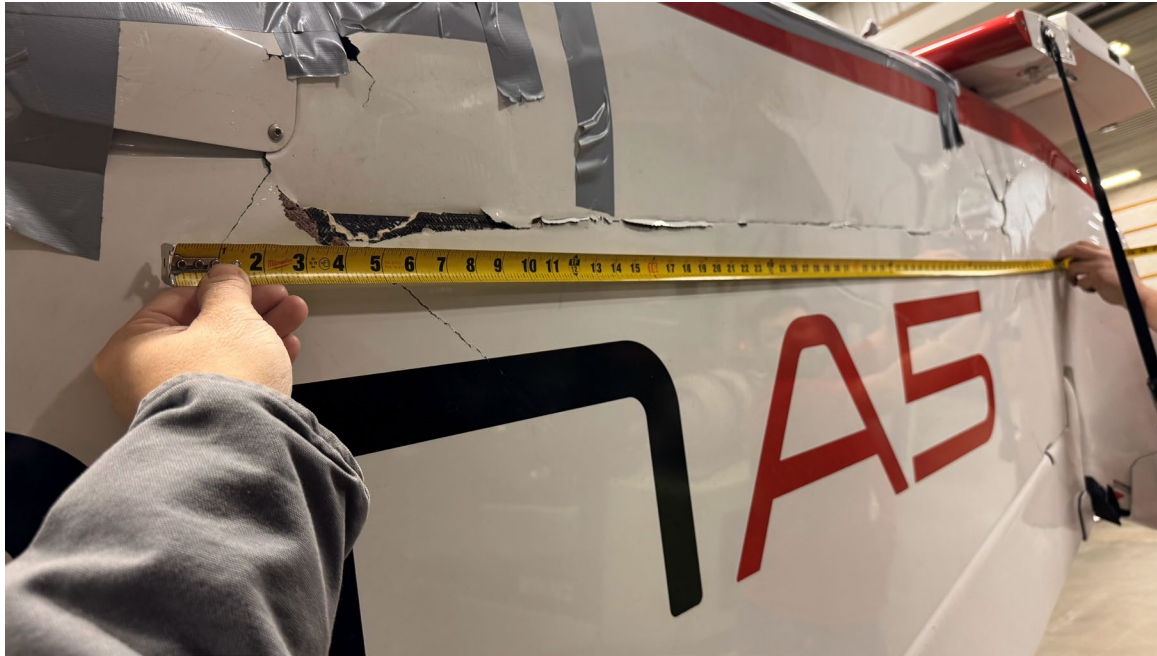
**Photograph 2 - Right side fuselage accident damage (Courtesy of maintenance)**

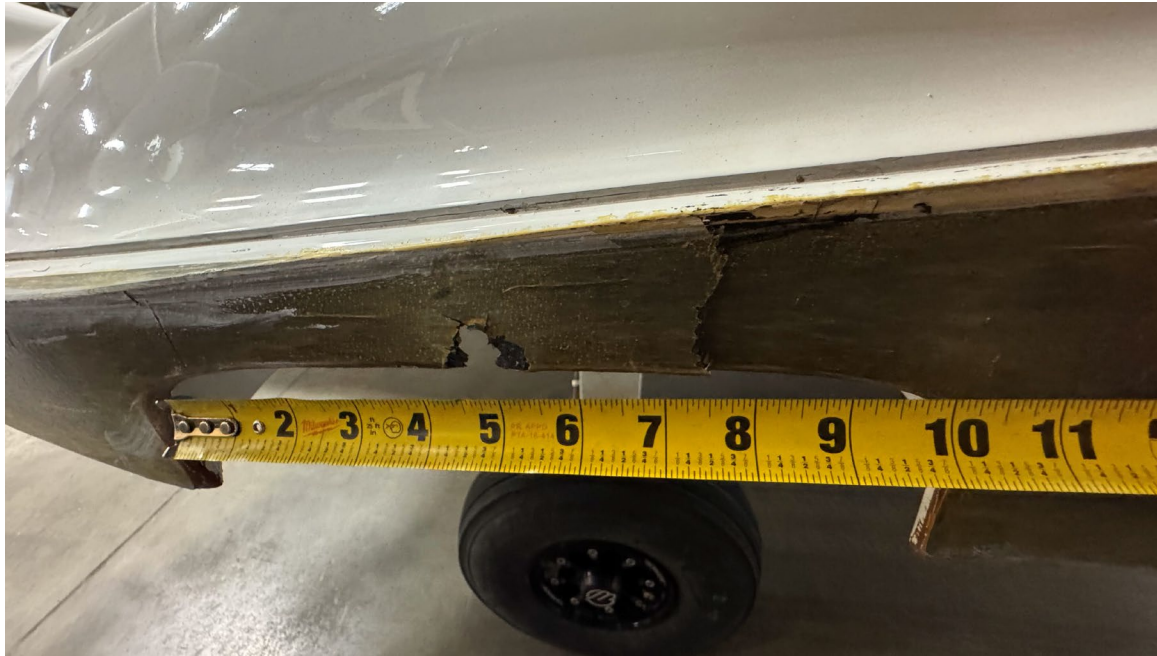
**Photograph 3 - Right main landing gear pylon accident damage (Courtesy of maintenance)**

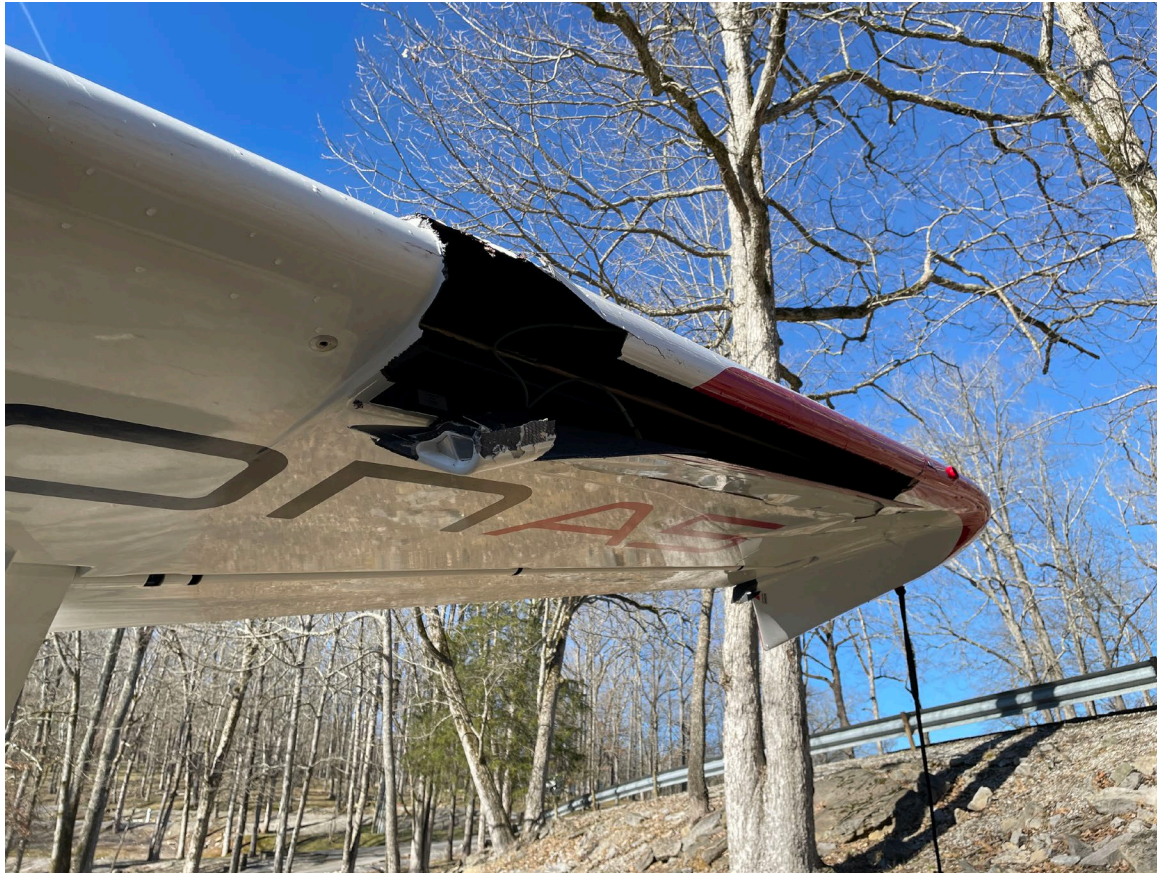
**Photograph 4 - Left wing accident damage (Courtesy of FAA)**
