ERA25LA138

## INVESTIGATION PHOTOGRAPHS

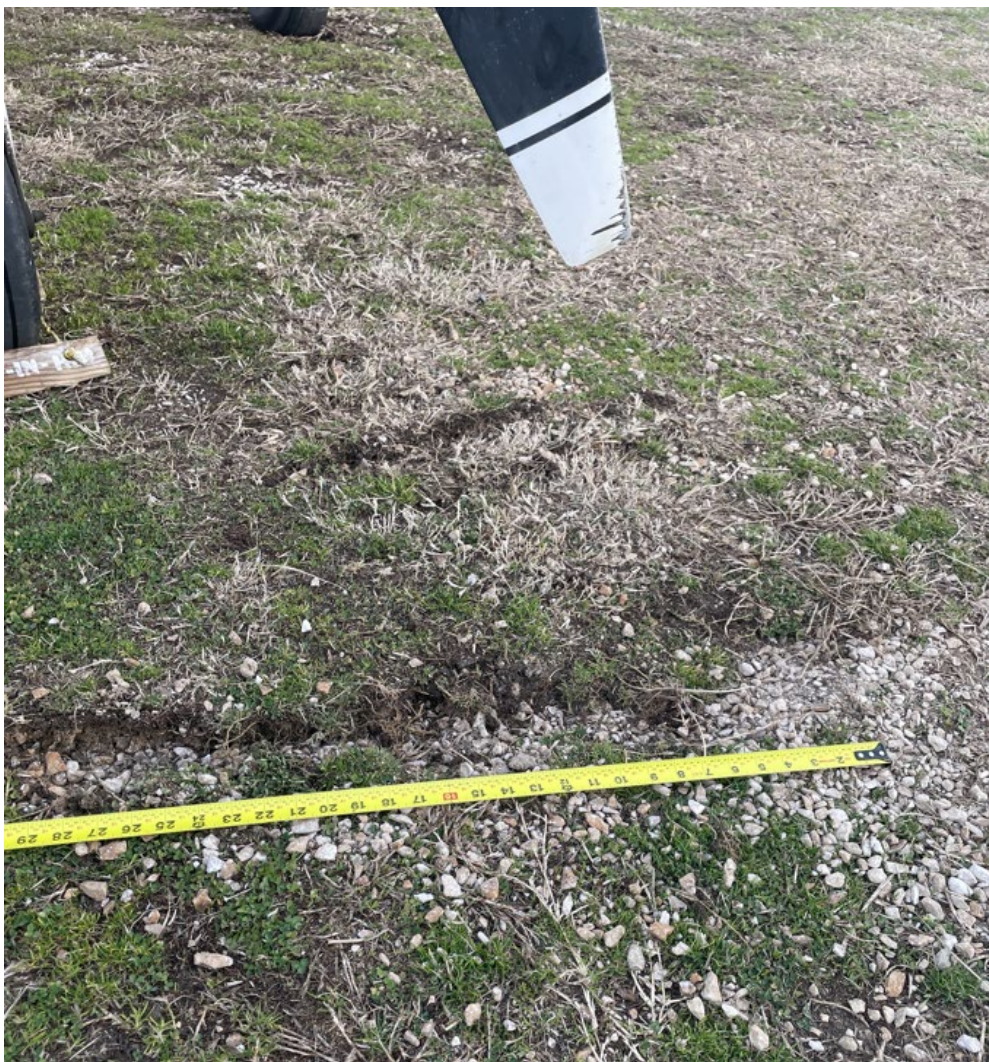
**Photograph 7 - Propeller Strike (Courtesy of FAA)**
