# National Transportation Safety Board

Office of Research and Engineering

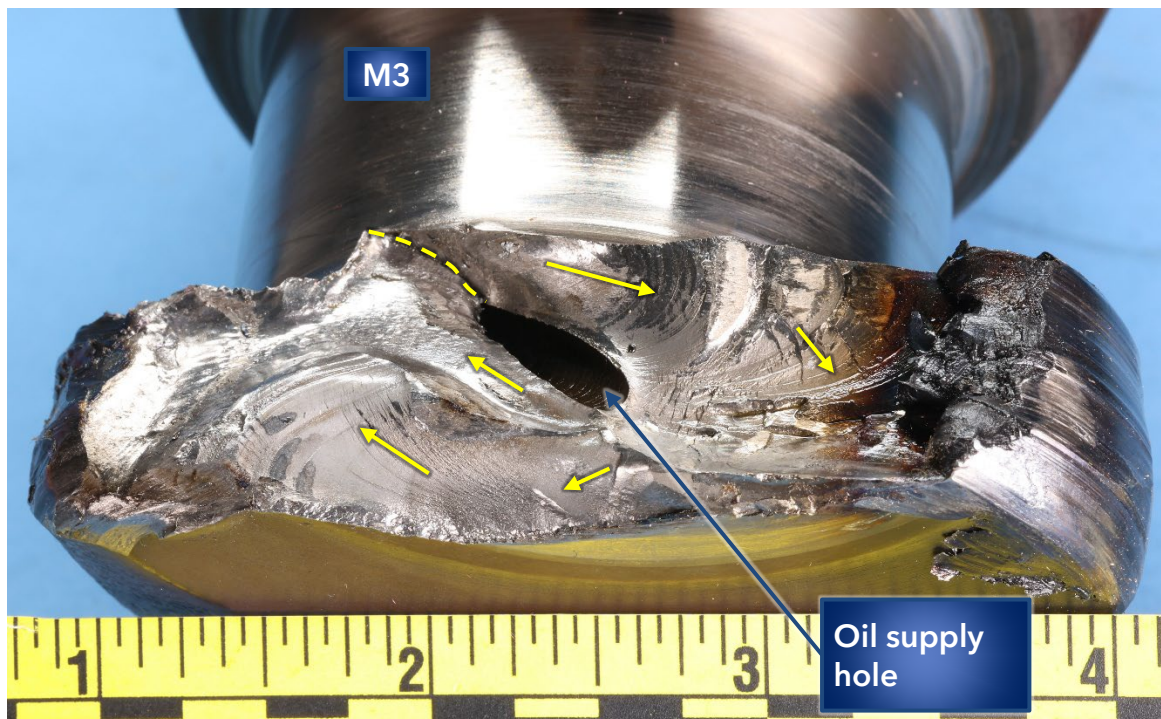
**Figure 2.** Close view of the fracture through the cheek at the aft side of the M3 journal. Unlabeled arrows indicate local directions of fatigue crack propagation, and a dashed line indicates the location where the fracture intersected the crack propagating along the oil supply hole for the C3 journal.

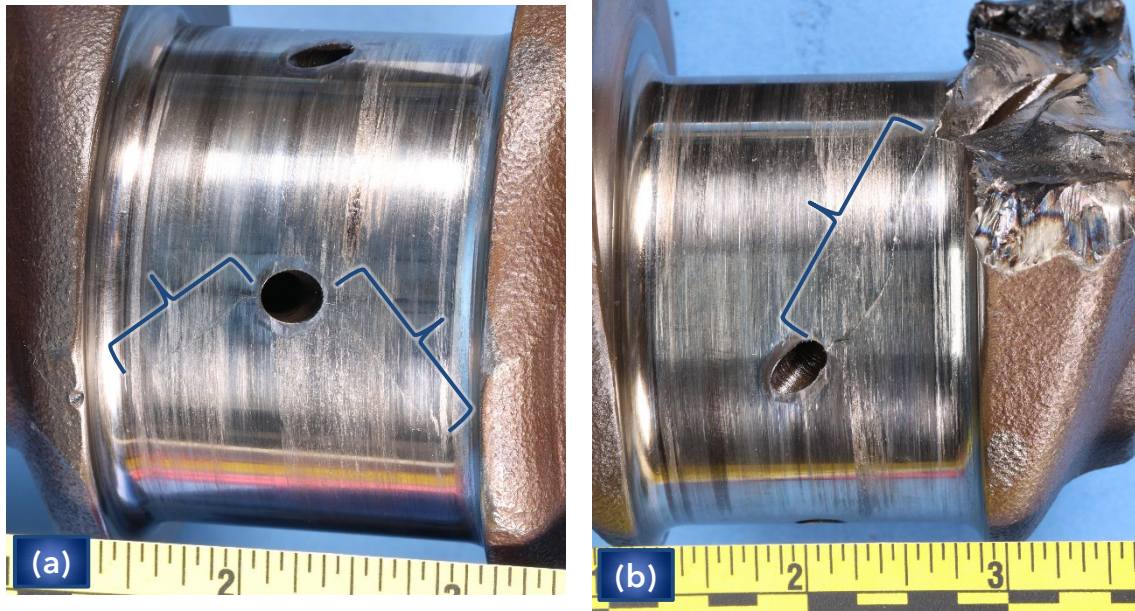
**Figure 3.** Views of cracks emanating from oil supply holes in the M3 journal as indicated with unlabeled brackets. (a) Cracks emanating from the forward and aft sides of the hole for the C2 journal. (b) Crack emanating from the aft side of the hole supplying the C3 journal.

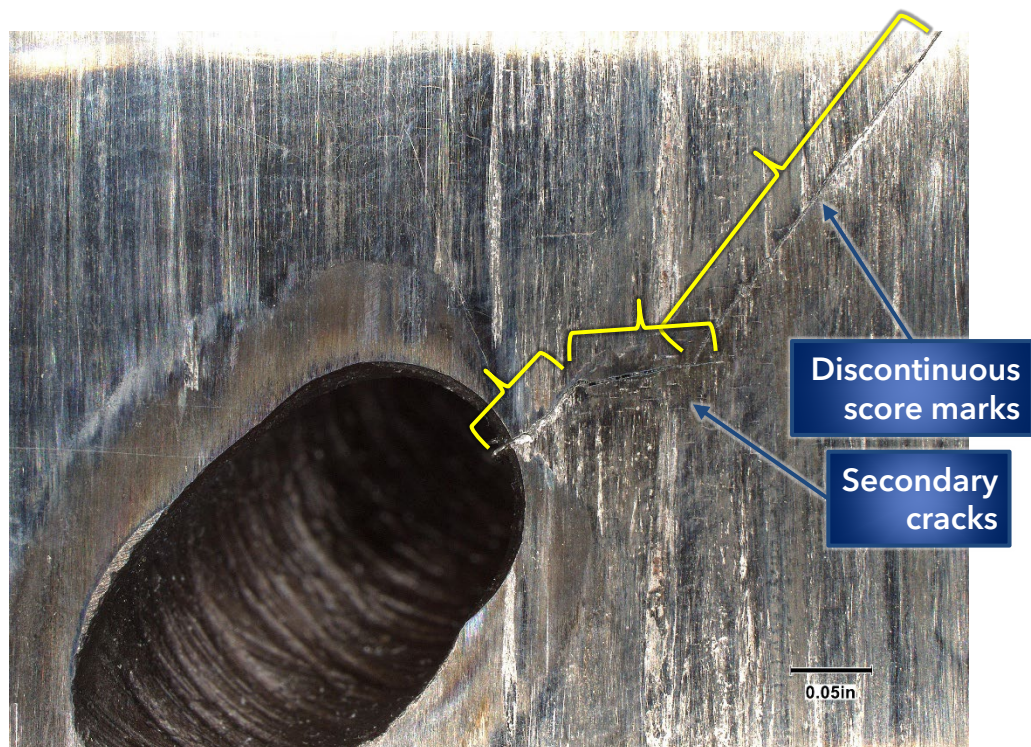
**Figure 4.** Closer view of the crack in the M3 journal at the C3 oil supply hole. Brackets indicate crack propagation angled between the circumferential and longitudinal directions separated by a nearly longitudinal segment.

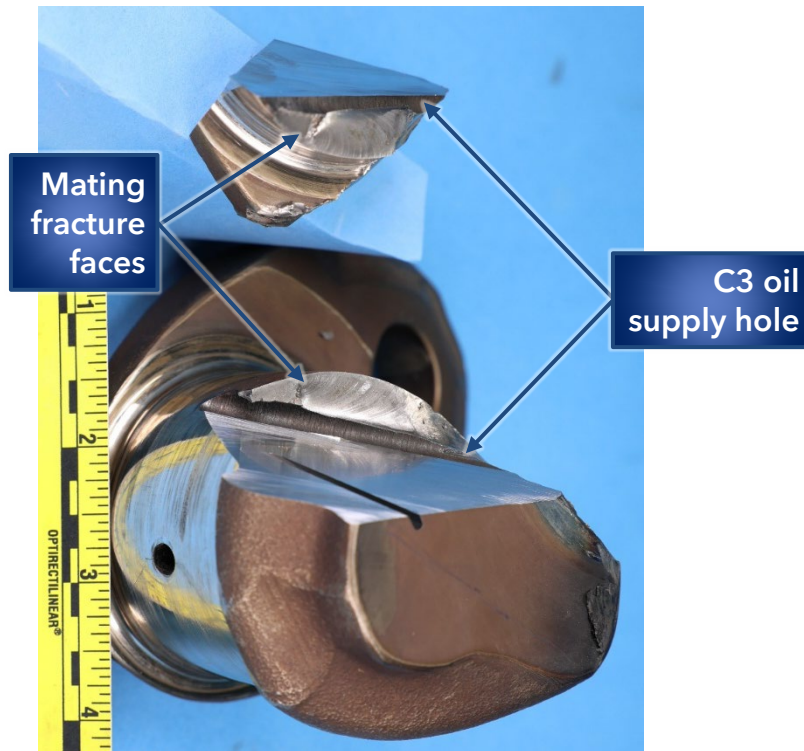
**Figure 5.** Mating sides of the crack in the M3 journal emanating from the C3 oil supply hole after sectioning.

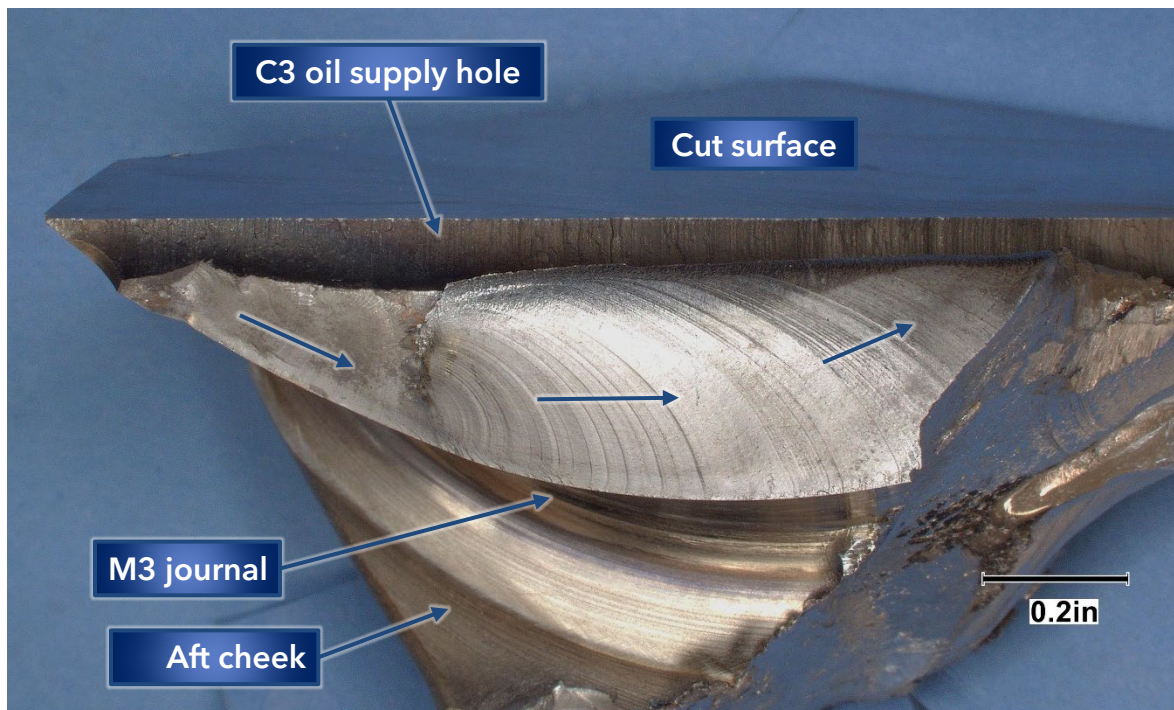
**Figure 6.** Close view of the opened crack on the smaller piece shown in figure 5. Unlabeled arrows indicate local directions of fatigue propagation.

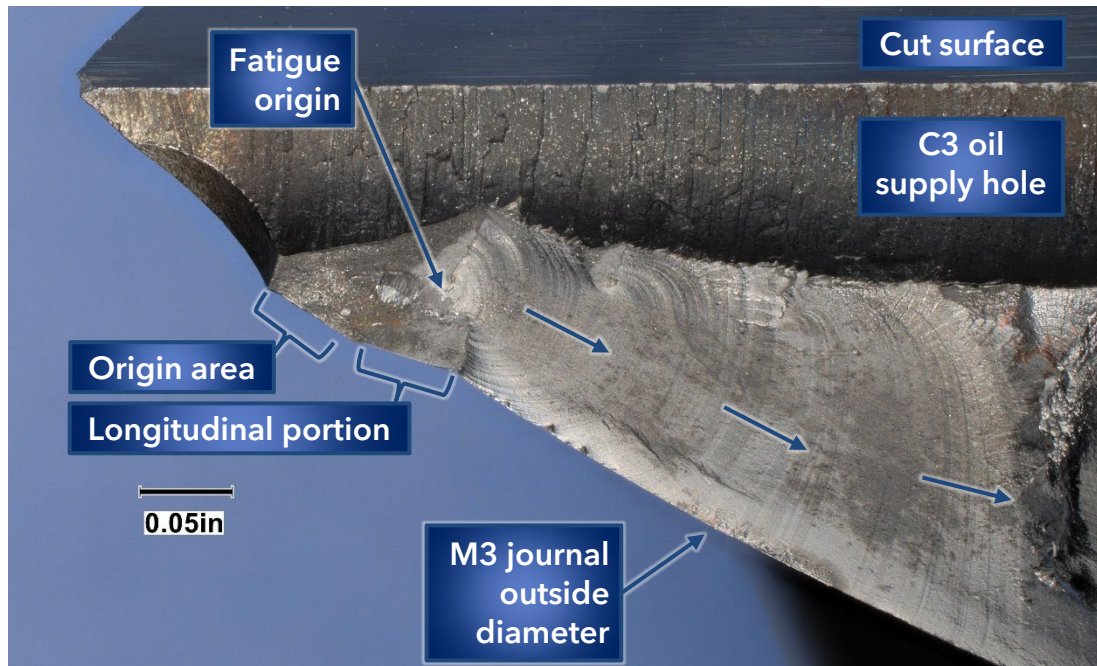
**Figure 7.** Closer view of the origin area on the opened crack. Unlabeled arrows indicate local directions of fatigue propagation.

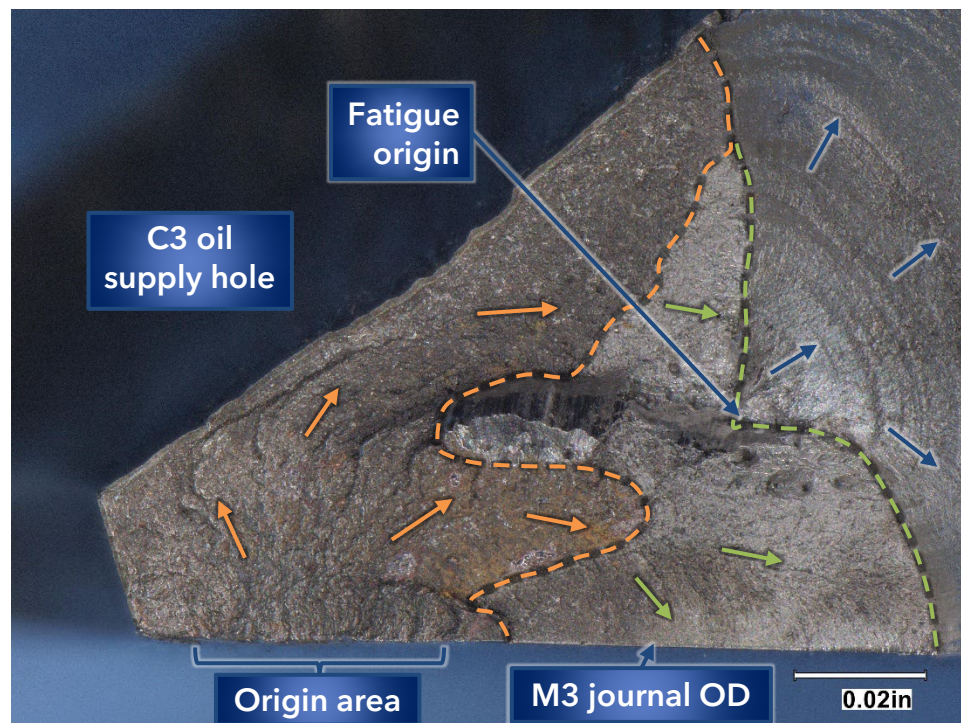
**Figure 8.** Origin area located at the M3 journal surface adjacent to the C3 supply hole. Orange arrows indicate local intergranular crack propagation within an oxidized region bounded by an orange dashed line. Green arrows indicate directions of overstress fracture with limited oxidation bounded by the dashed green line. Blue arrows indicate local directions of fatigue crack propagation from the indicated fatigue origin.

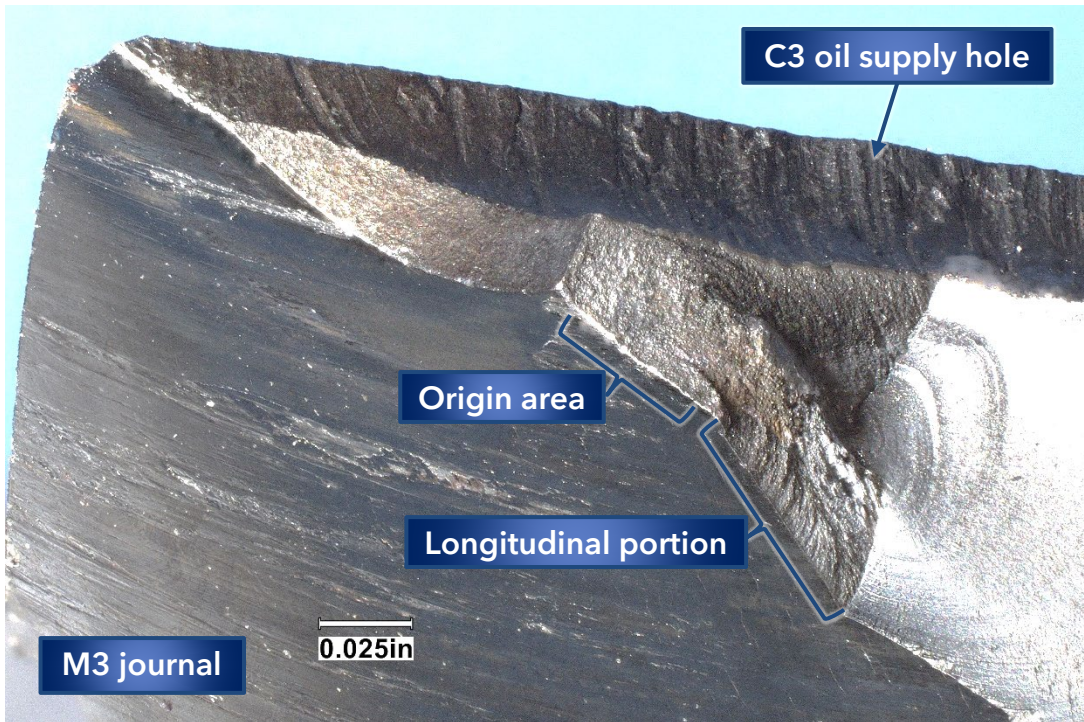
**Figure 9.** Angled view of the origin area showing the adjacent M3 journal surface.

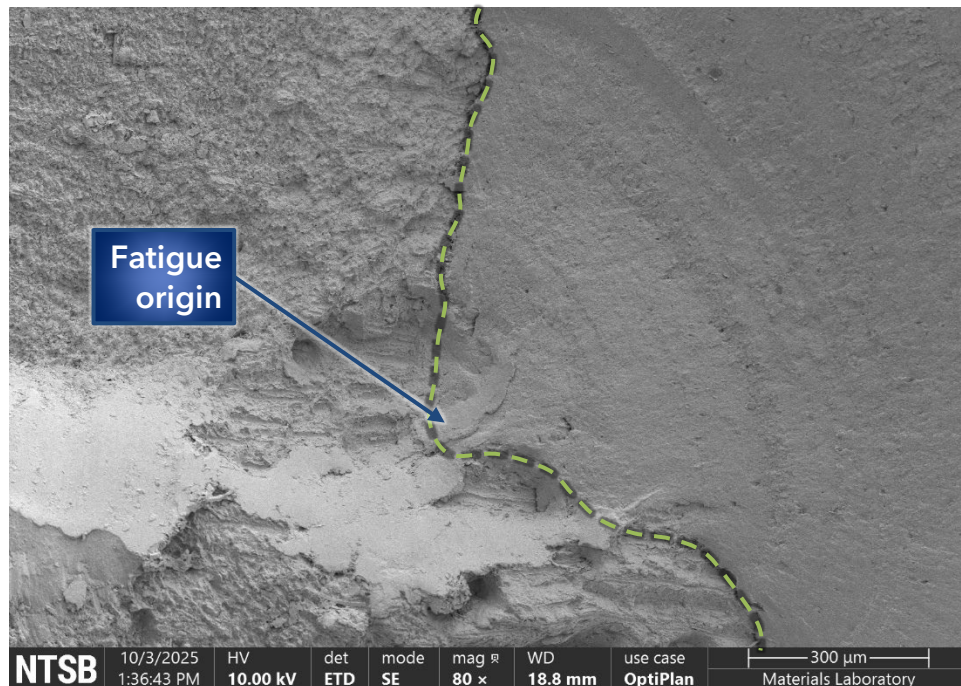
**Figure 12.** SEM image of the transition to fatigue crack propagation at the fatigue origin area. A green dashed line indicates the overstress fracture boundary.

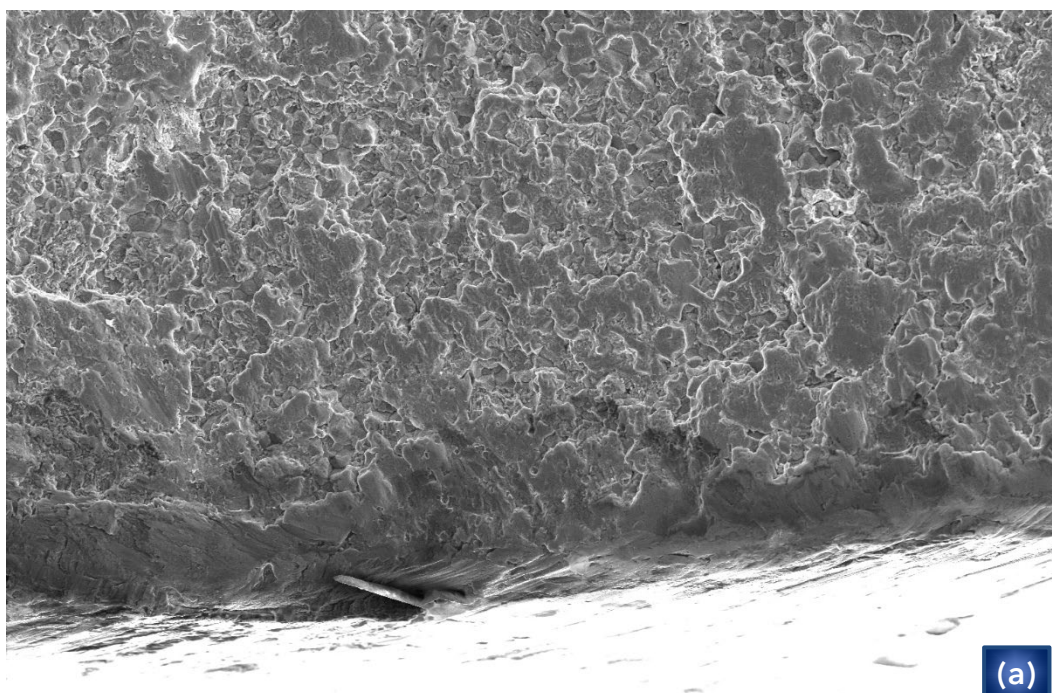
| NTSB | 10/3/2025<br>3:22:04 PM | HV<br>20.00 kV | det<br>ETD | mode<br>SE | mag ×<br>250 × | WD<br>14.8 mm | use case<br>OptiPlan | 100 μm | |

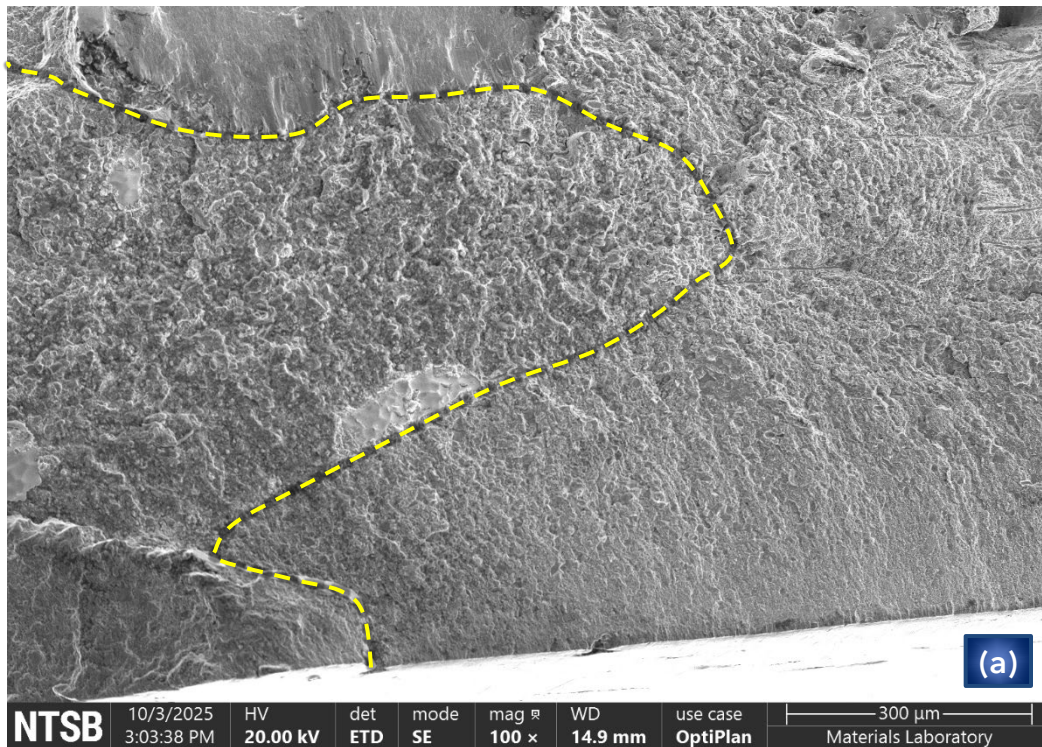
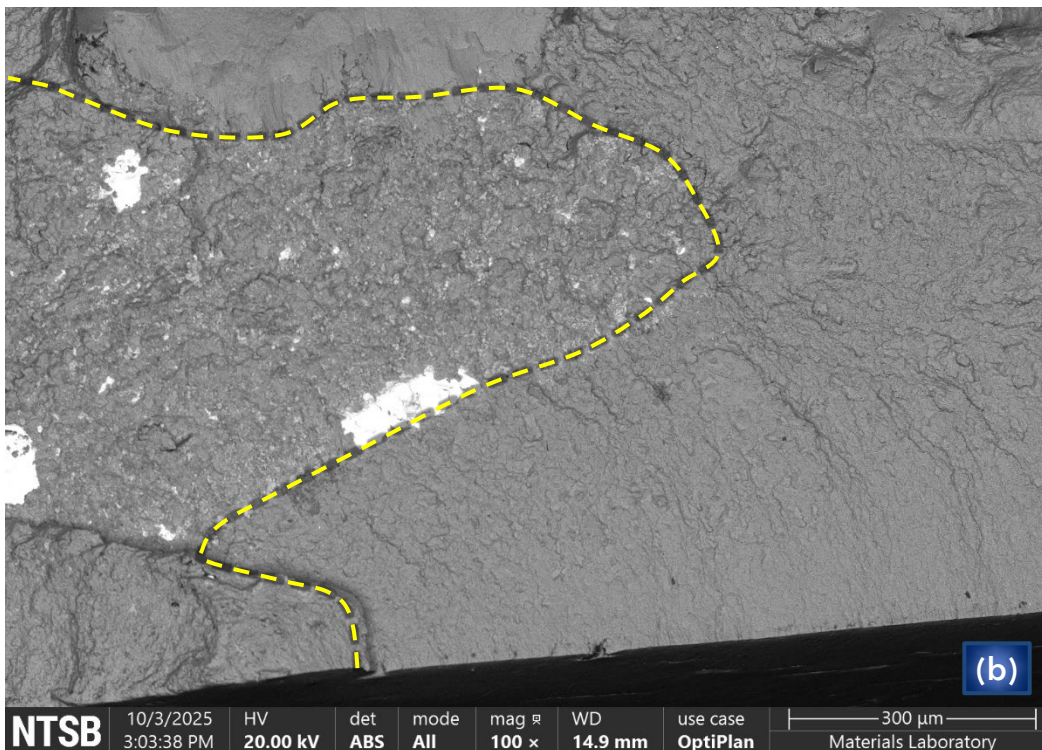
**Figure 14.** (a) SEM image of the boundary between the oxidized intergranular region bounded by a dashed line and the adjacent overstress fracture region, and (b) the same area viewed using a backscattered electron detector in composition mode. In the backscattered electron image, white areas had relatively high levels of lead as analyzed using EDS.

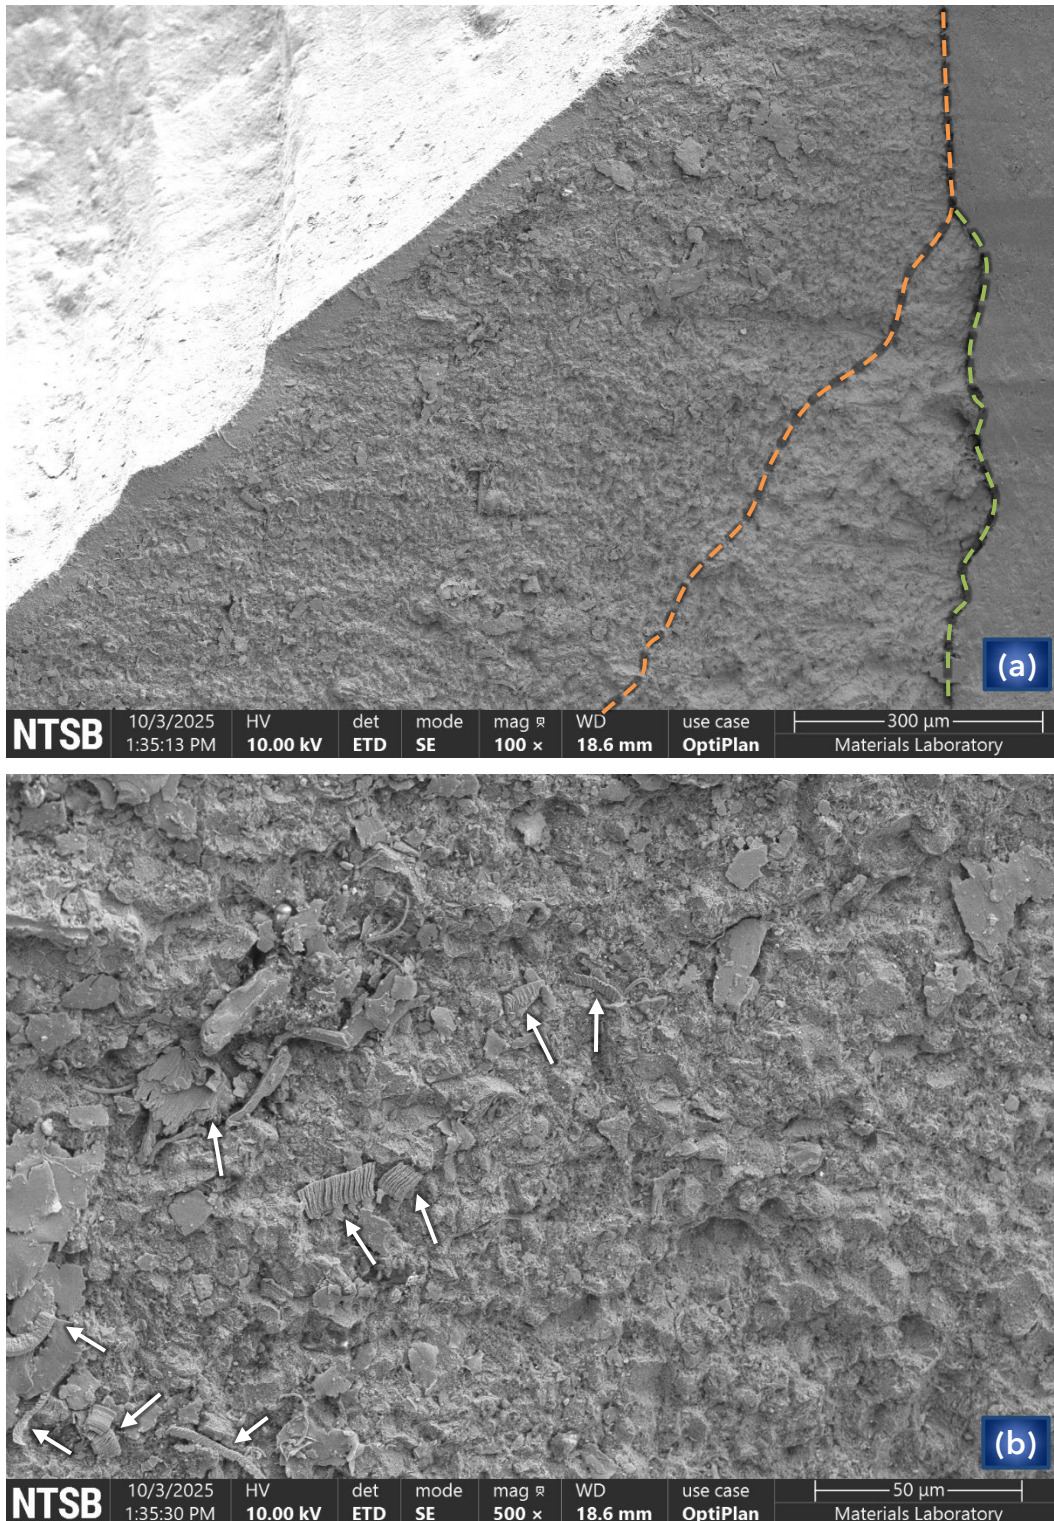
**Figure 15.** (a) SEM image of the oxidized region adjacent to the C3 oil supply hole at the region boundary indicated with an orange dashed line. A green dashed line indicates the boundary between the overstress and fatigue regions. (b) Higher magnification view of fracture features near the middle of image (a) showing debris on the surface consistent with machining debris.

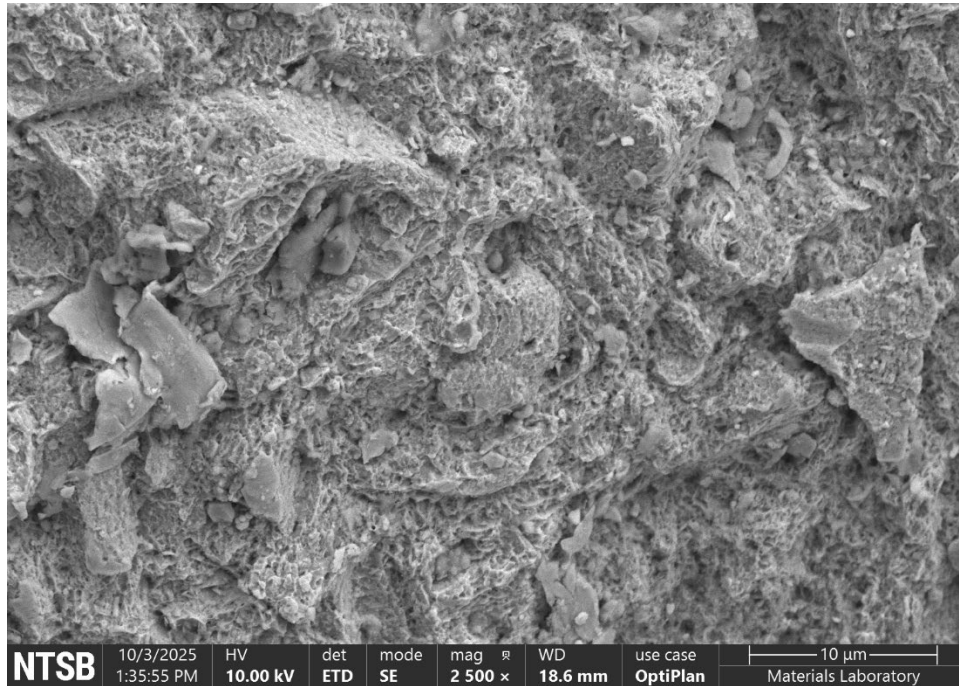
**Figure 16.** Closer view of fracture features in the area shown in the previous figure showing dimples on intergranular features.

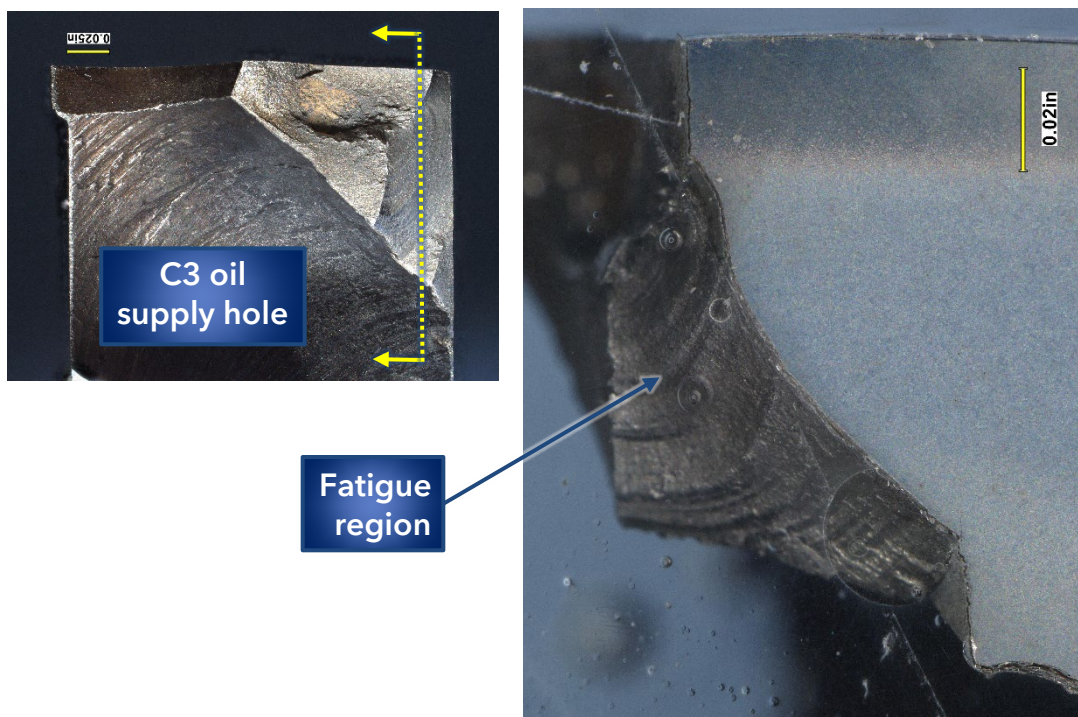
**Figure 17.** Polished and etched cross-section in the plane indicated in the upper left image. (2% nital etch)

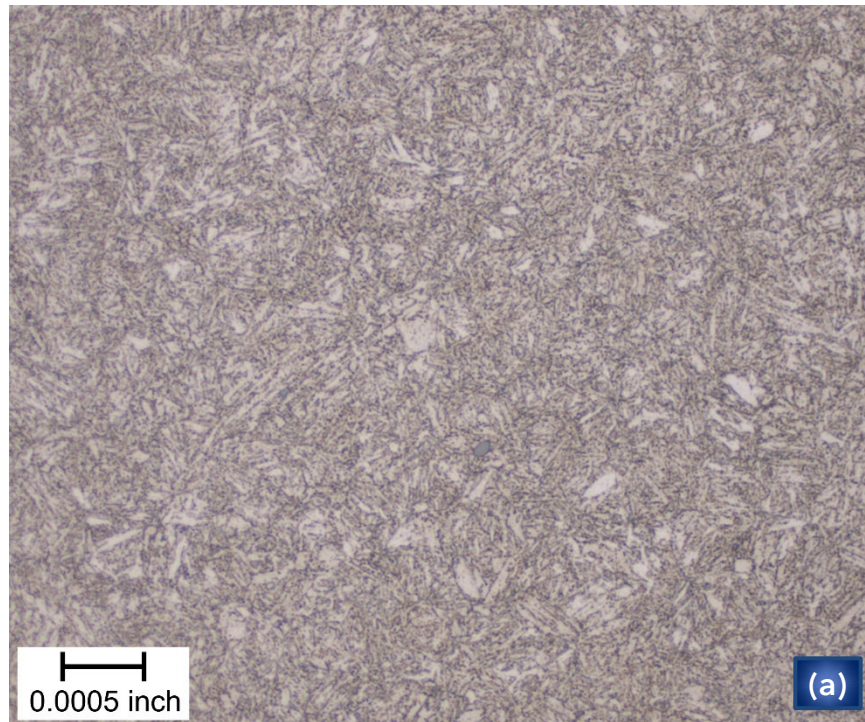
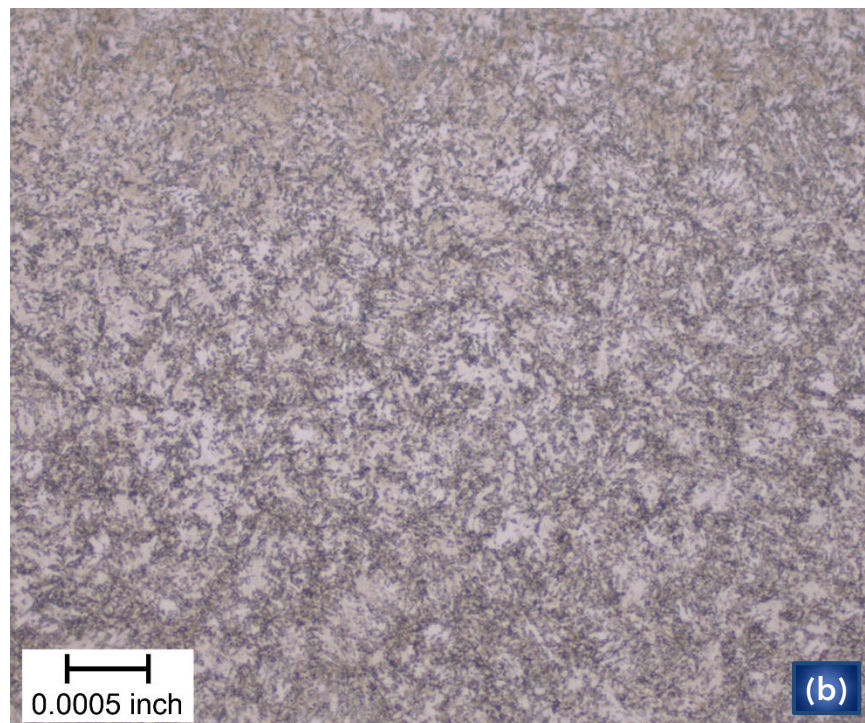
**Figure 21.** Metallographic images of typical features for the polished and etched sample. (a) microstructure at the core (b) microstructure near the journal surface. (Etchant: 2% nital)

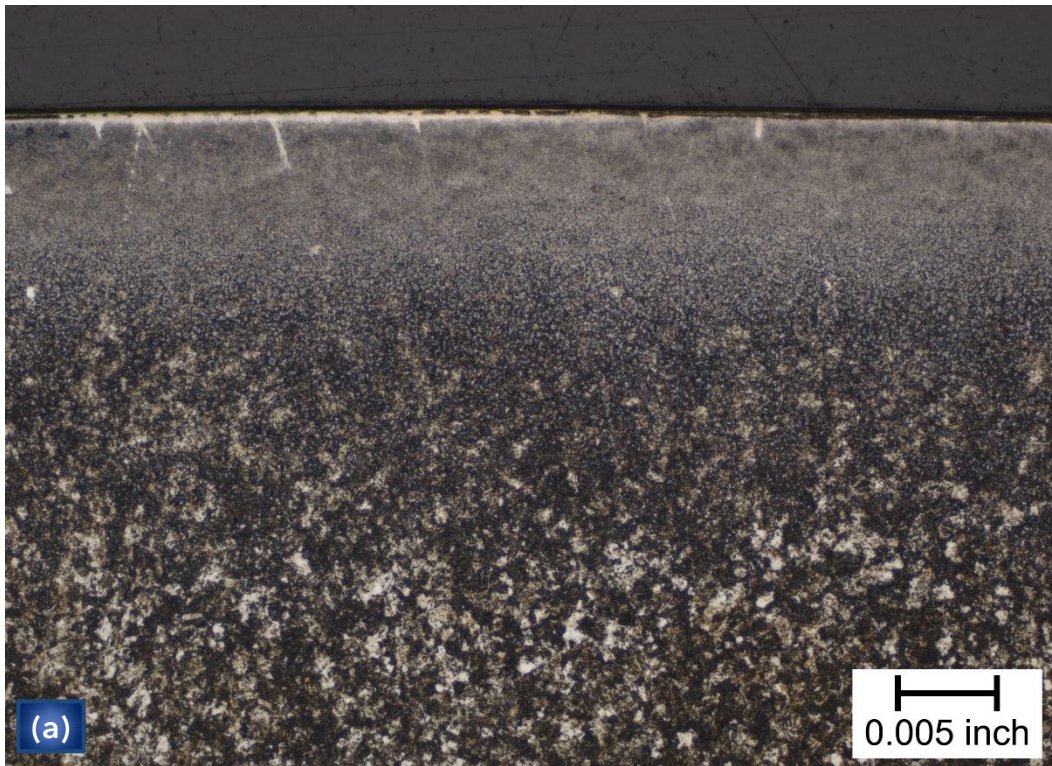
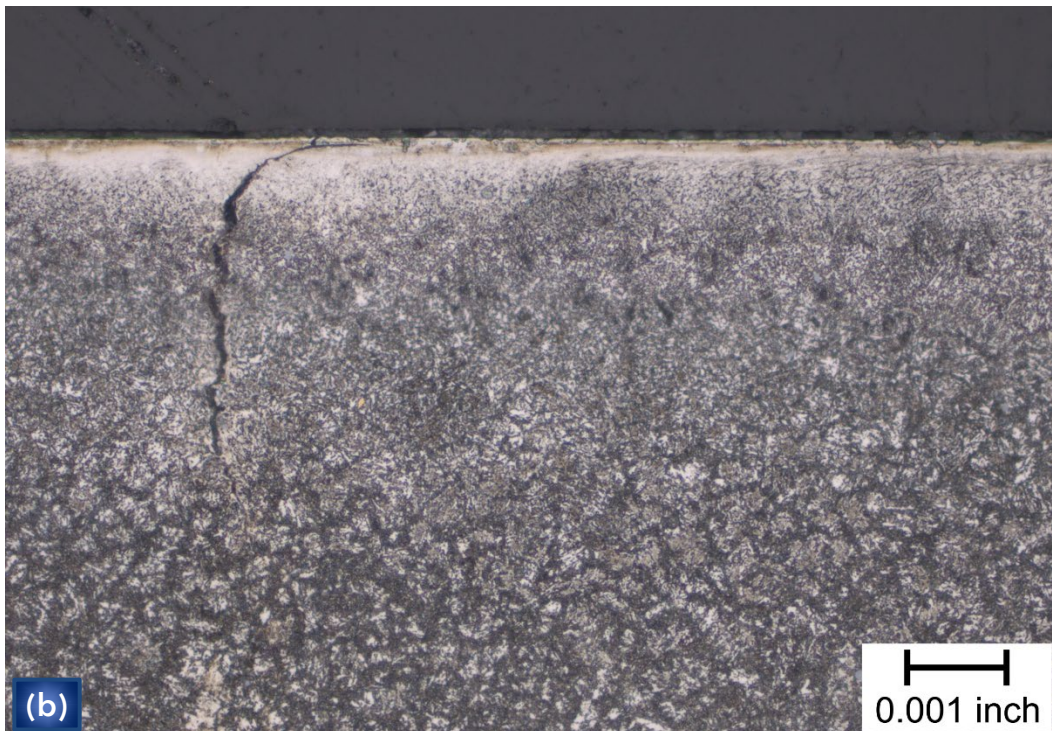
**Figure 22.** Metallographic images at the M3 journal surface. (Etchant: Marble's reagent)
