ERA25LA141

## INVESTIGATION PHOTOGRAPHS

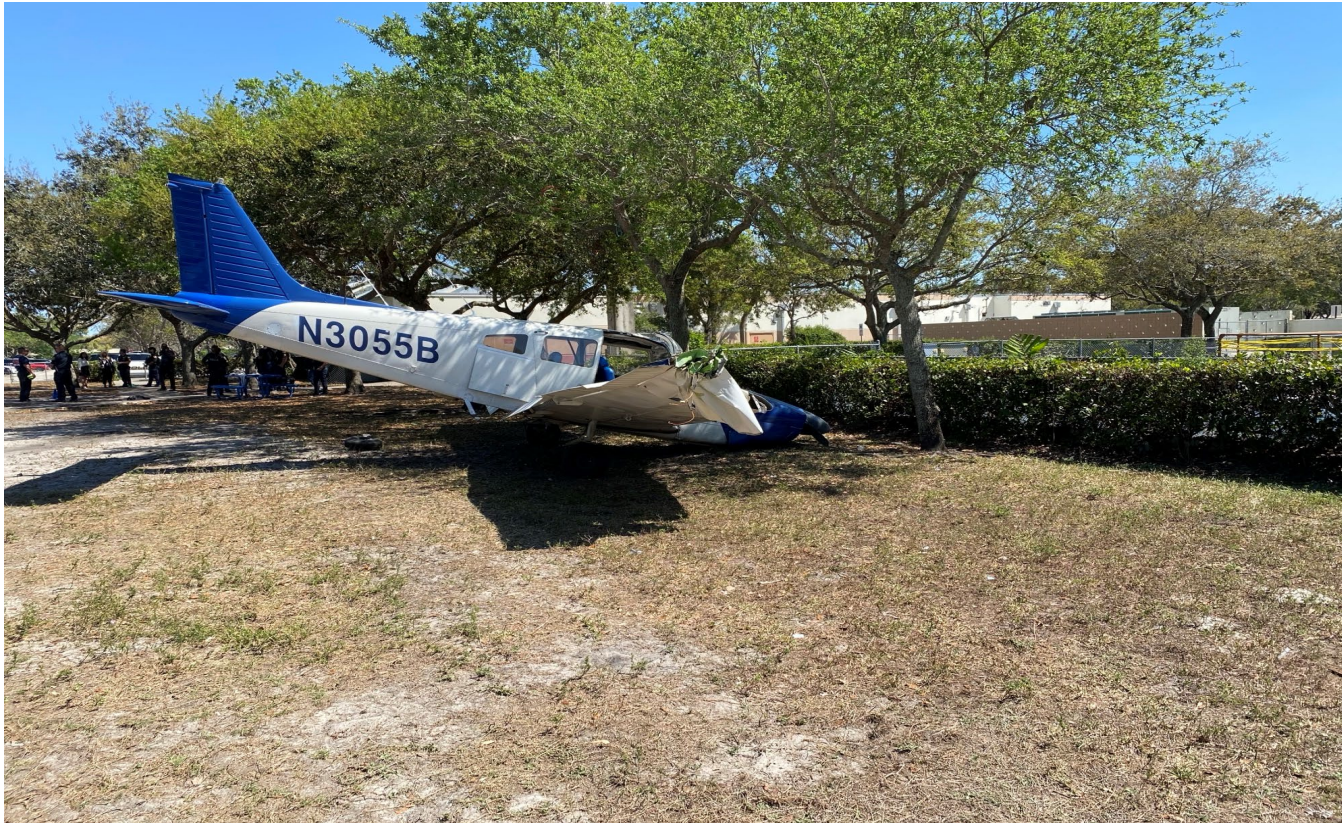
**Photograph 1 - View of right side of airplane showing damaged right wing.  
(Courtesy of FAA)**

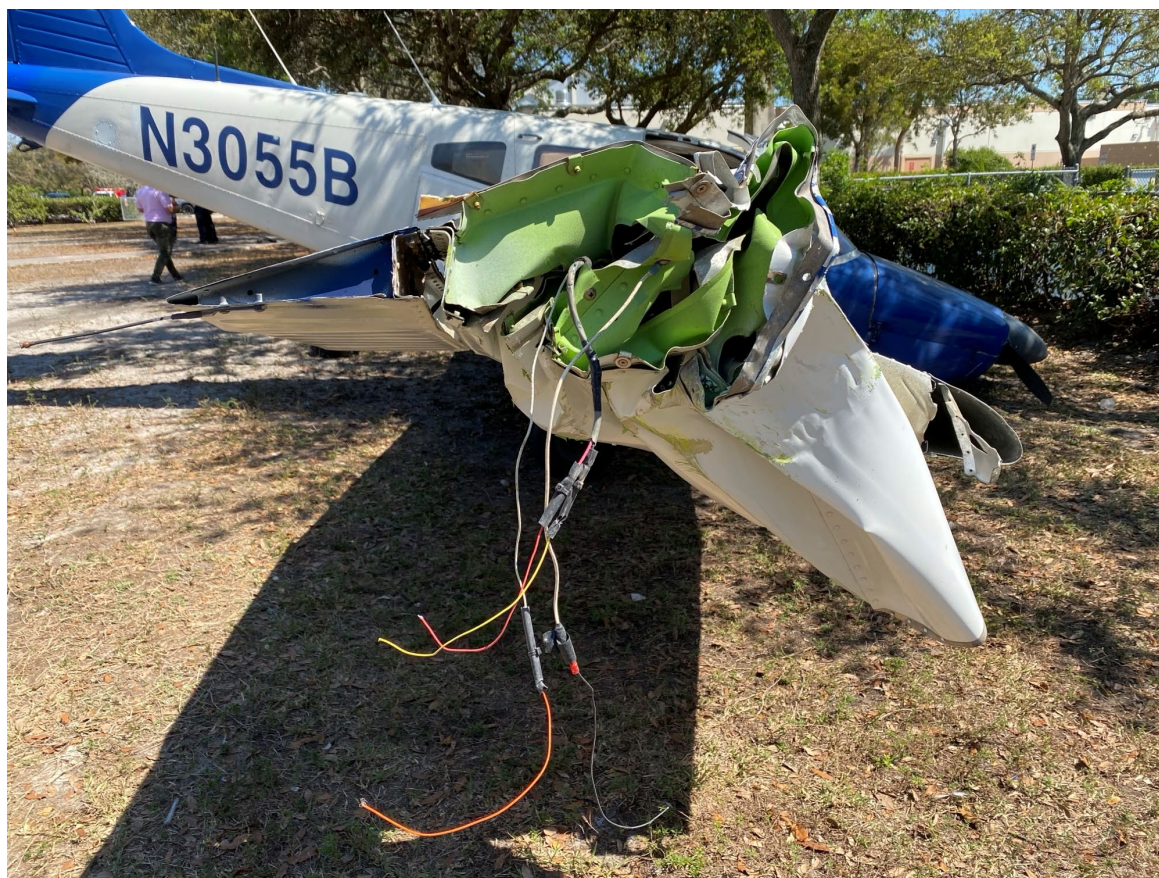
**Photograph 2 - Close up view of damaged right wing.  
(Courtesy of FAA)**
