## Air Safety Investigations Aircraft Incident/Accident Technical Report

| Aircraft Incident/<br>Accident Information | Year: 1977 | Make: Cessna | Model: TU206G |
| | Serial number: U20604105 | | Registration: N27GP |
| Senior Air Safety Investigator: Ernest C. Hall | | Report #: ASI-25-BB-T | Report date: 08-19-25 |

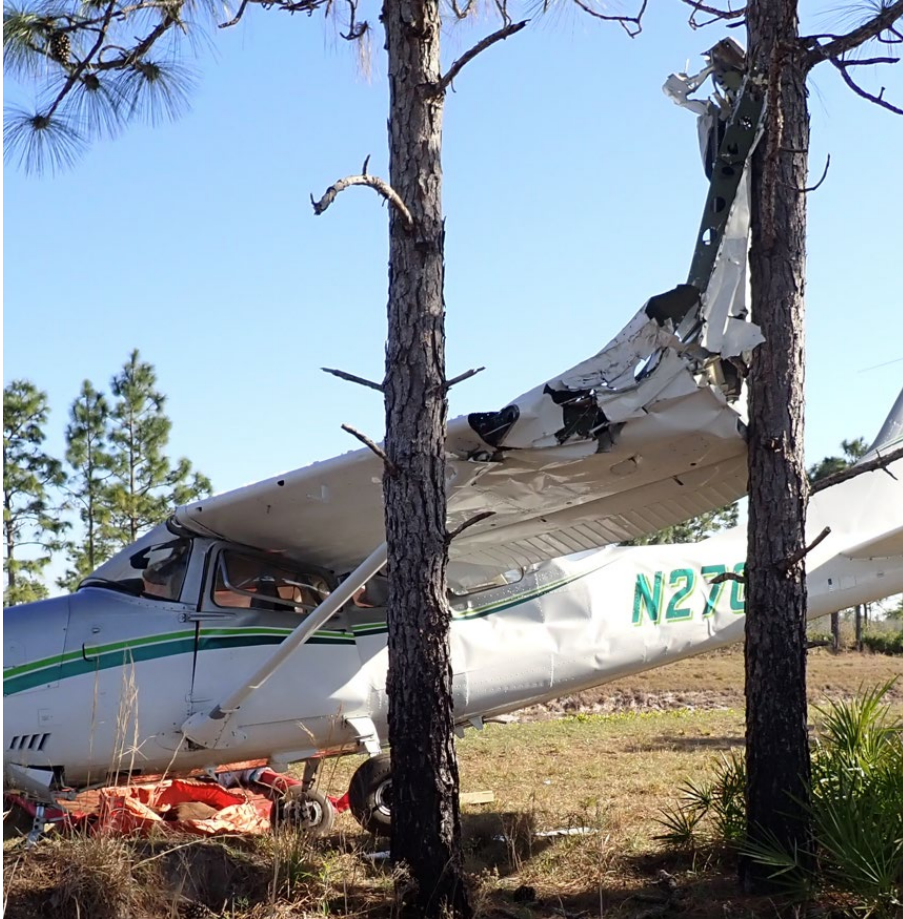
Reviewing the FAA onsite photographs, the left wing outboard of the wing strut to the wing tip exhibited leading edge aft and up crush damage. Between the flap and aileron to the wing tip, the wing was partially impact separated. The left wing remained attached to the fuselage attachment points. The left-wing strut remained attached to the wing and the fuselage. The left wing from the leading edge aft to the trailing edge was canted down impinging the left cockpit door and the wing trailing edge was pushed into the cabin area at the left cockpit aft door post. The fuselage skin from the left cockpit door to about the rear cabin window down to the cabin floor was buckled into the cabin area.

Cropped – Courtesy of the FAA – Left Wing

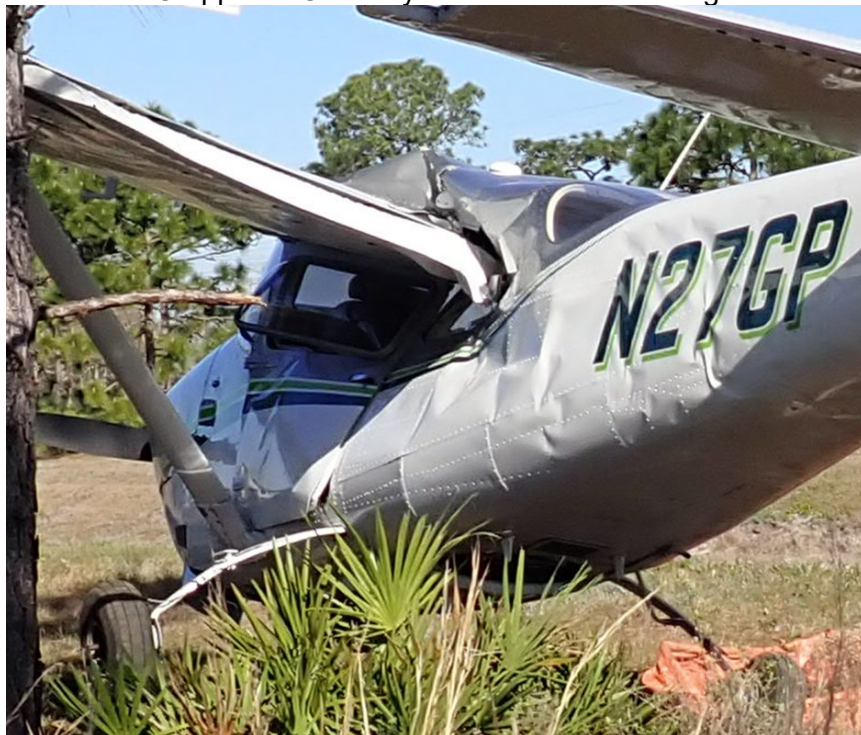
Cropped – Courtesy of the FAA – Left Wing, Left Fuselage

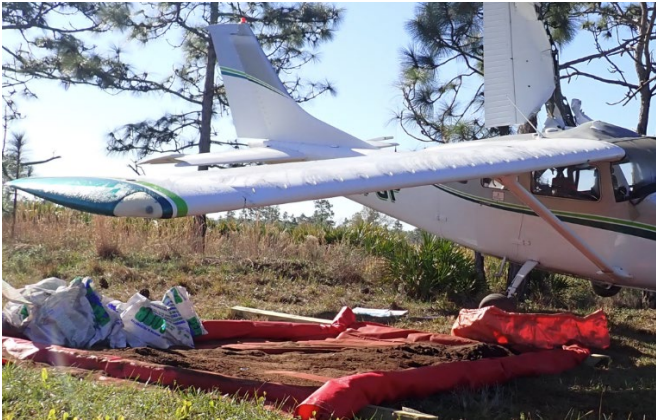
The right wing and wing strut remained attached to the fuselage attachment points and exhibited minimal damage. The vertical stabilizer and the left and right horizontal stabilizers remained attached to their respective fuselage attachment points and exhibited minimal damage.

Cropped – Courtesy of the FAA – Right Wing, Vertical Stabilizer and Right Horizontal Stabilizer

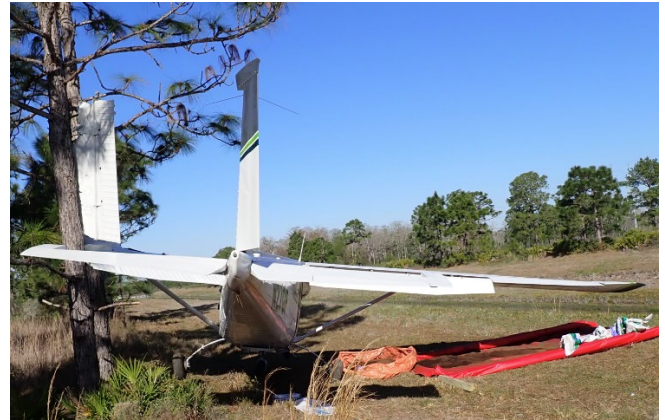
Cropped – Courtesy of the FAA – Left and Right Horizontal Stabilizer and Vertical Stabilizer

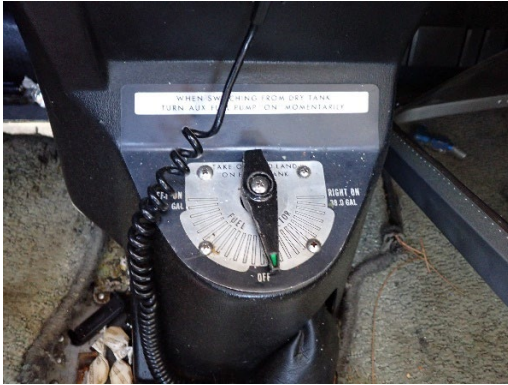
The fuel selector handle, after recovery, was found in the approximate OFF position.

ASI-25-BB-032 – Fuel Selector Handle After Recovery

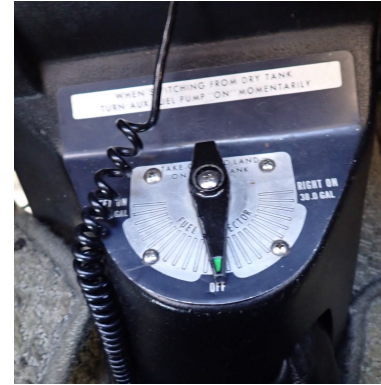
Courtesy of the FAA – Fuel Selector Handle Onsite

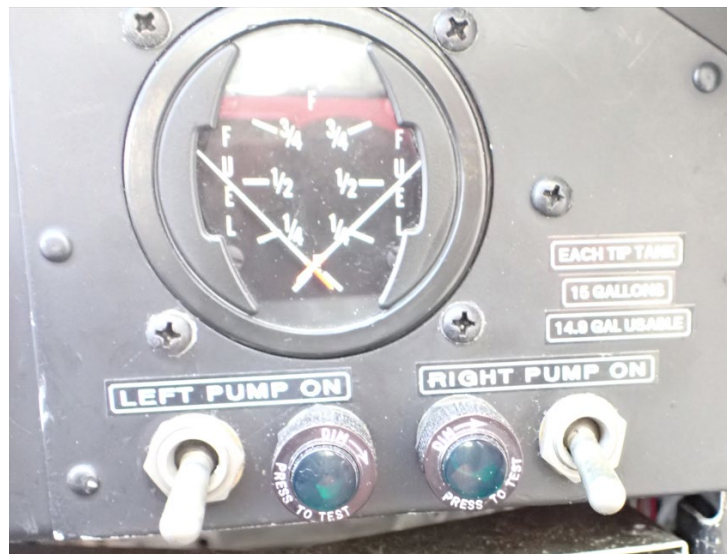
The STC tip tanks (15 gallons/14.9 gallons useable) fuel indicators both read empty/0. The left and right tip tank fuel pump switches were found in the OFF position.

Cropped – ASI-25-BB-064 – STC Wing Tip Fuel Tank Indicators and Pump Switches

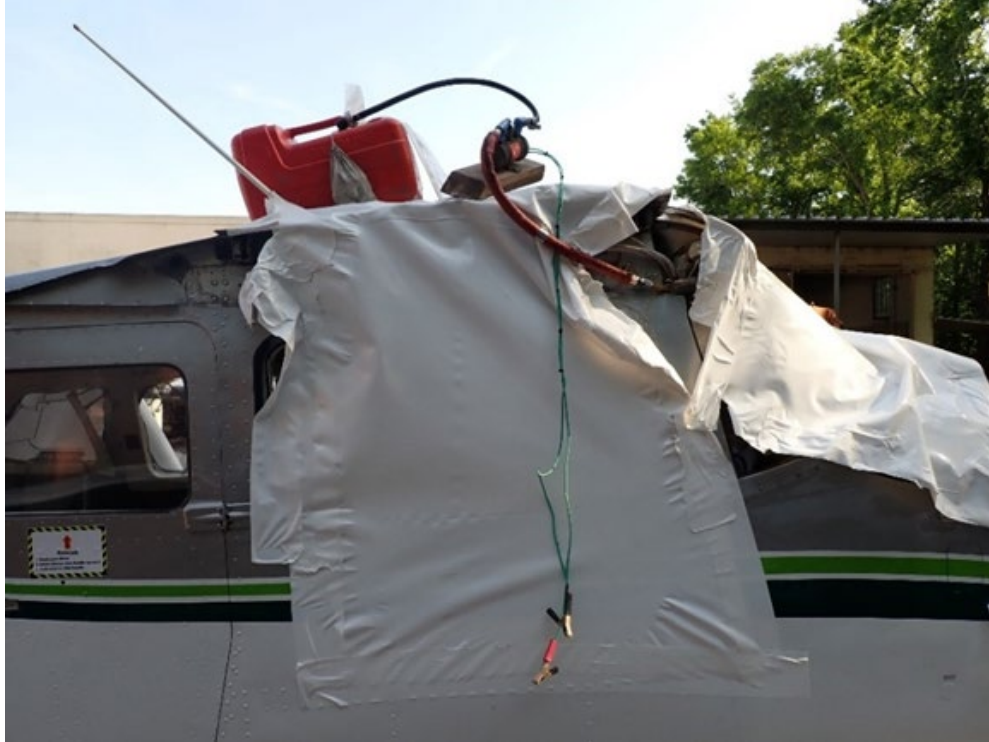
A small fuel container of aviation fuel 100LL was plumbed into the right-wing root main fuel feed line. The system was primed, and the engine started and operated up to about 1,700 RPM. The bent propeller blade created enough vibration to shake the aircraft which prevented safely operating the engine at a higher RPM.

ASI-25-BB-081 – Small Fuel Container with Aviation Gasoline 100LL Plumbed to Right Wing Root

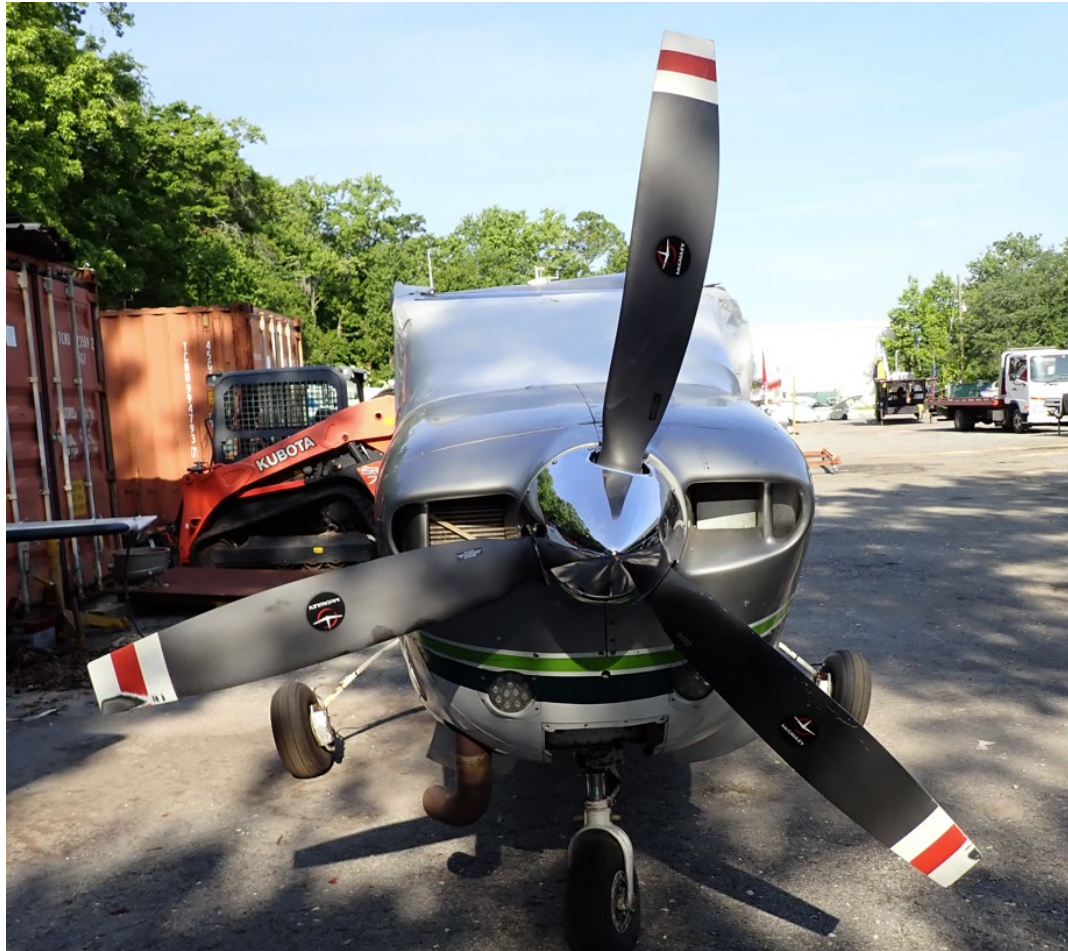
All three blades were unmarkable, but one of the three blades was slightly bent toward the non-camber side. Two of the blades exhibited tip leading edge polishing.

ASI-25-BB-006 – 3-Blade Propeller
