ERA25LA153

## INVESTIGATION PHOTOGRAPHS

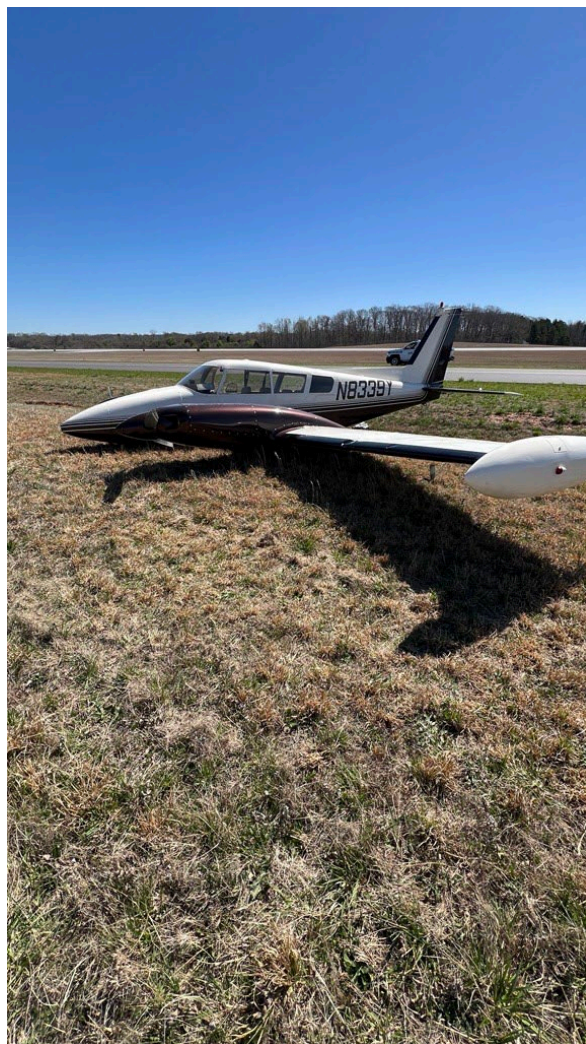
**Photograph 1 - View of left side of airplane on site. (Courtesy of FAA)**

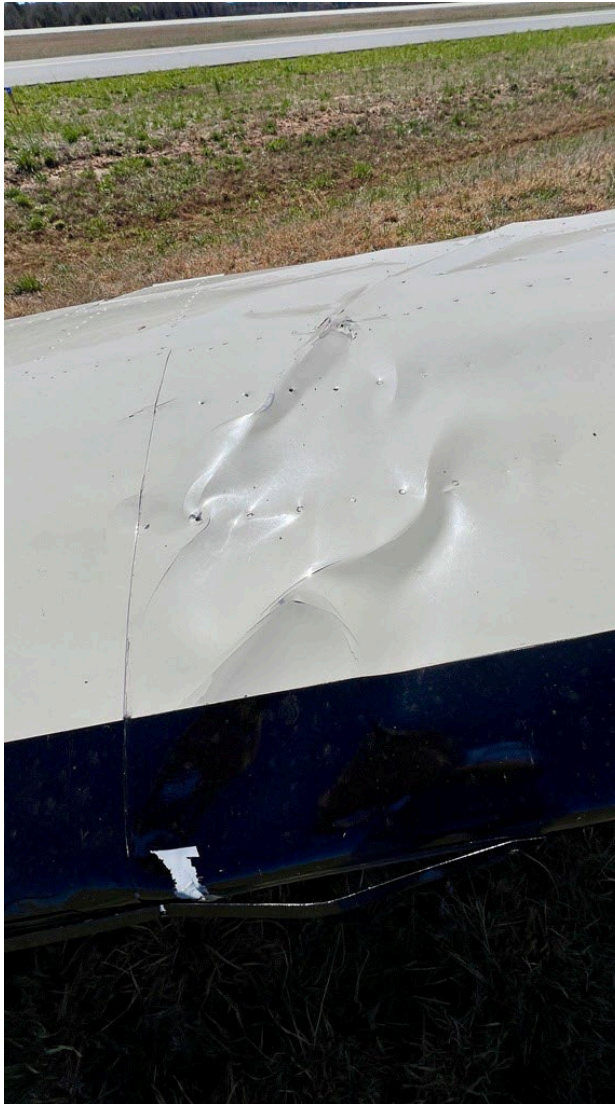
**Photograph 2 - View of wing damage. (Courtesy of FAA)**

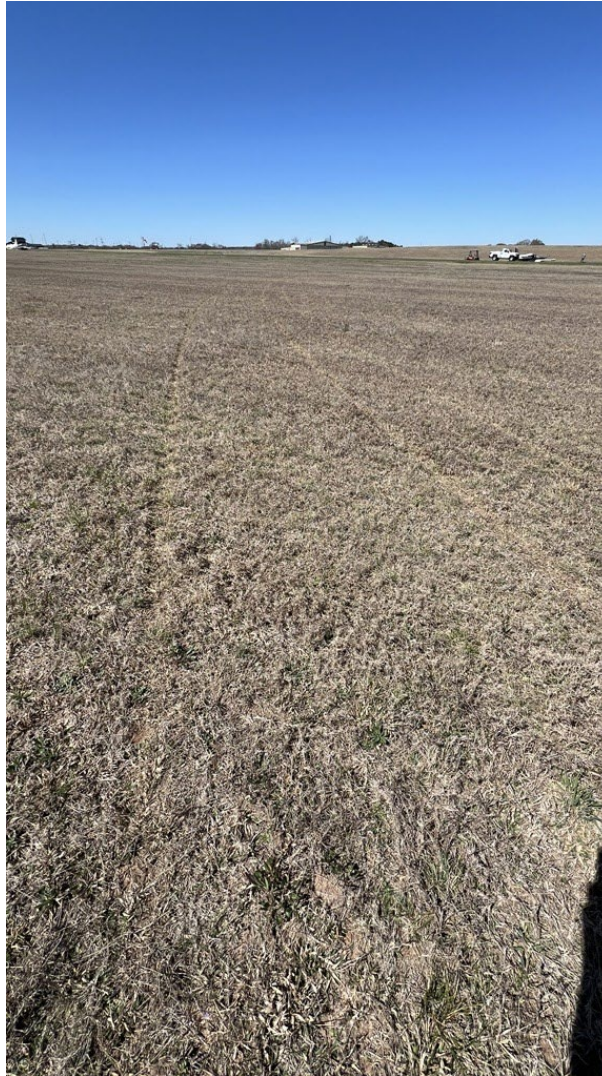
**Photograph 3 - View of landing gear ground tracks leading up to airplane. (Courtesy of FAA)**
