ERA25LA157

## INVESTIGATION PHOTOGRAPHS

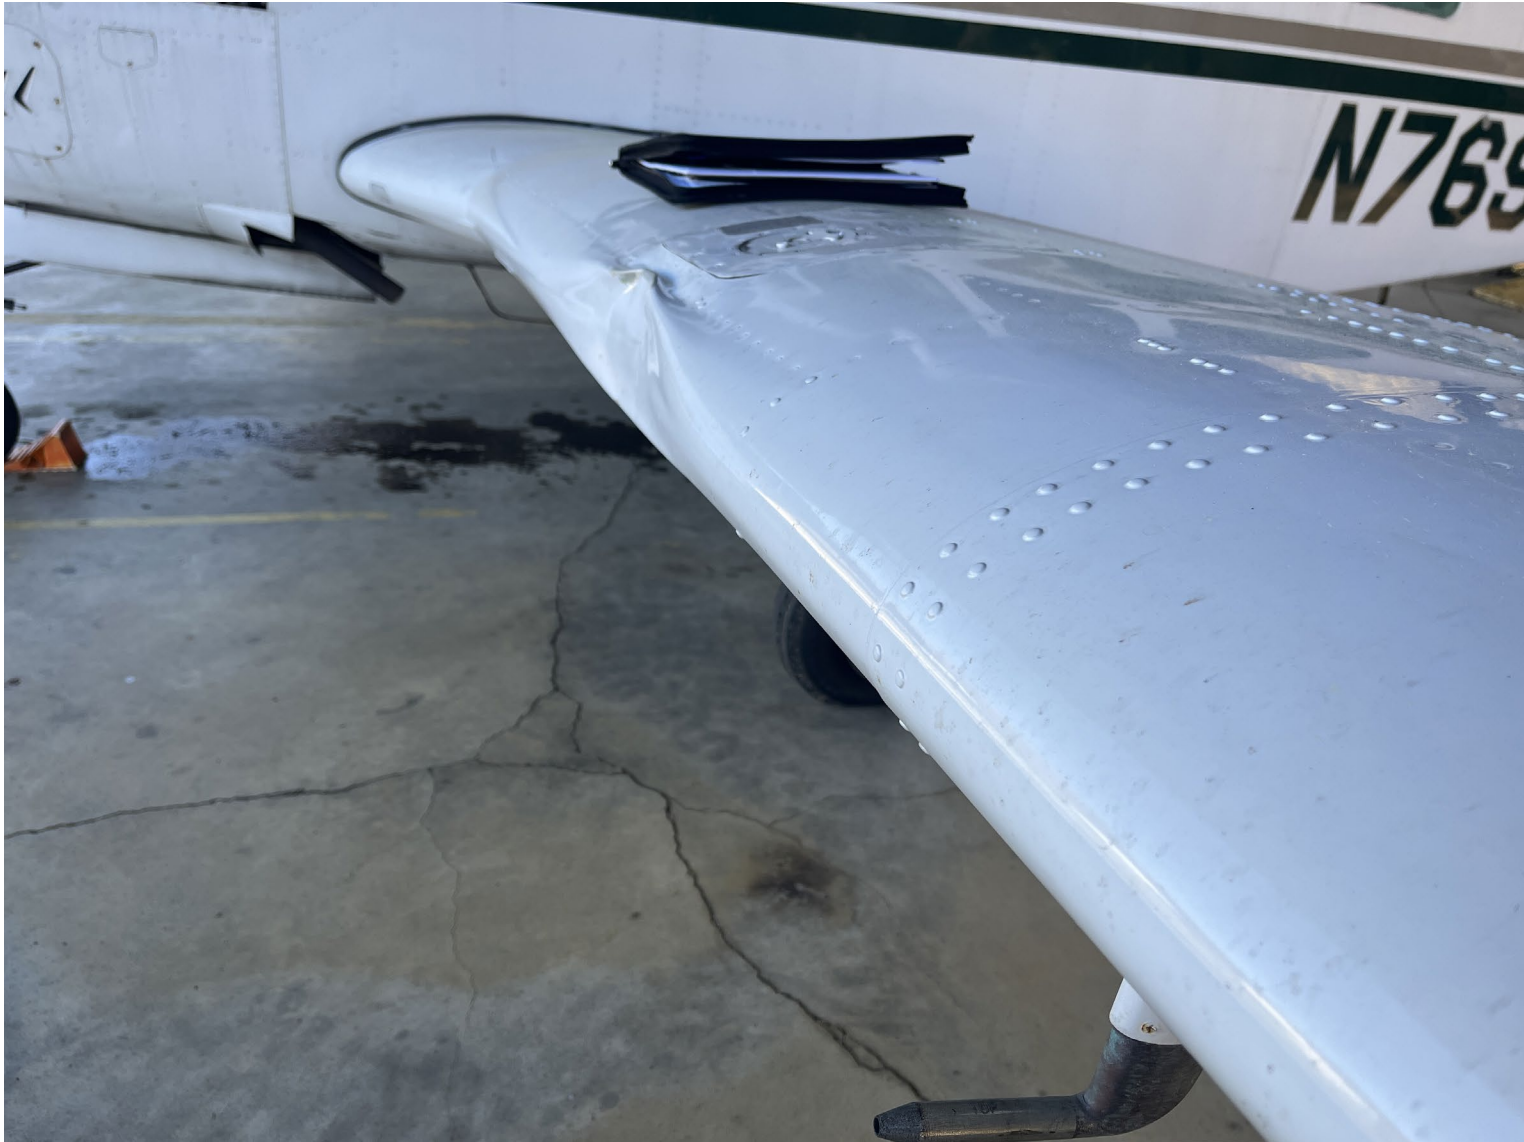
**Photograph 1 - Left-Wing Leading-Edge Damage (Courtesy of FAA)**

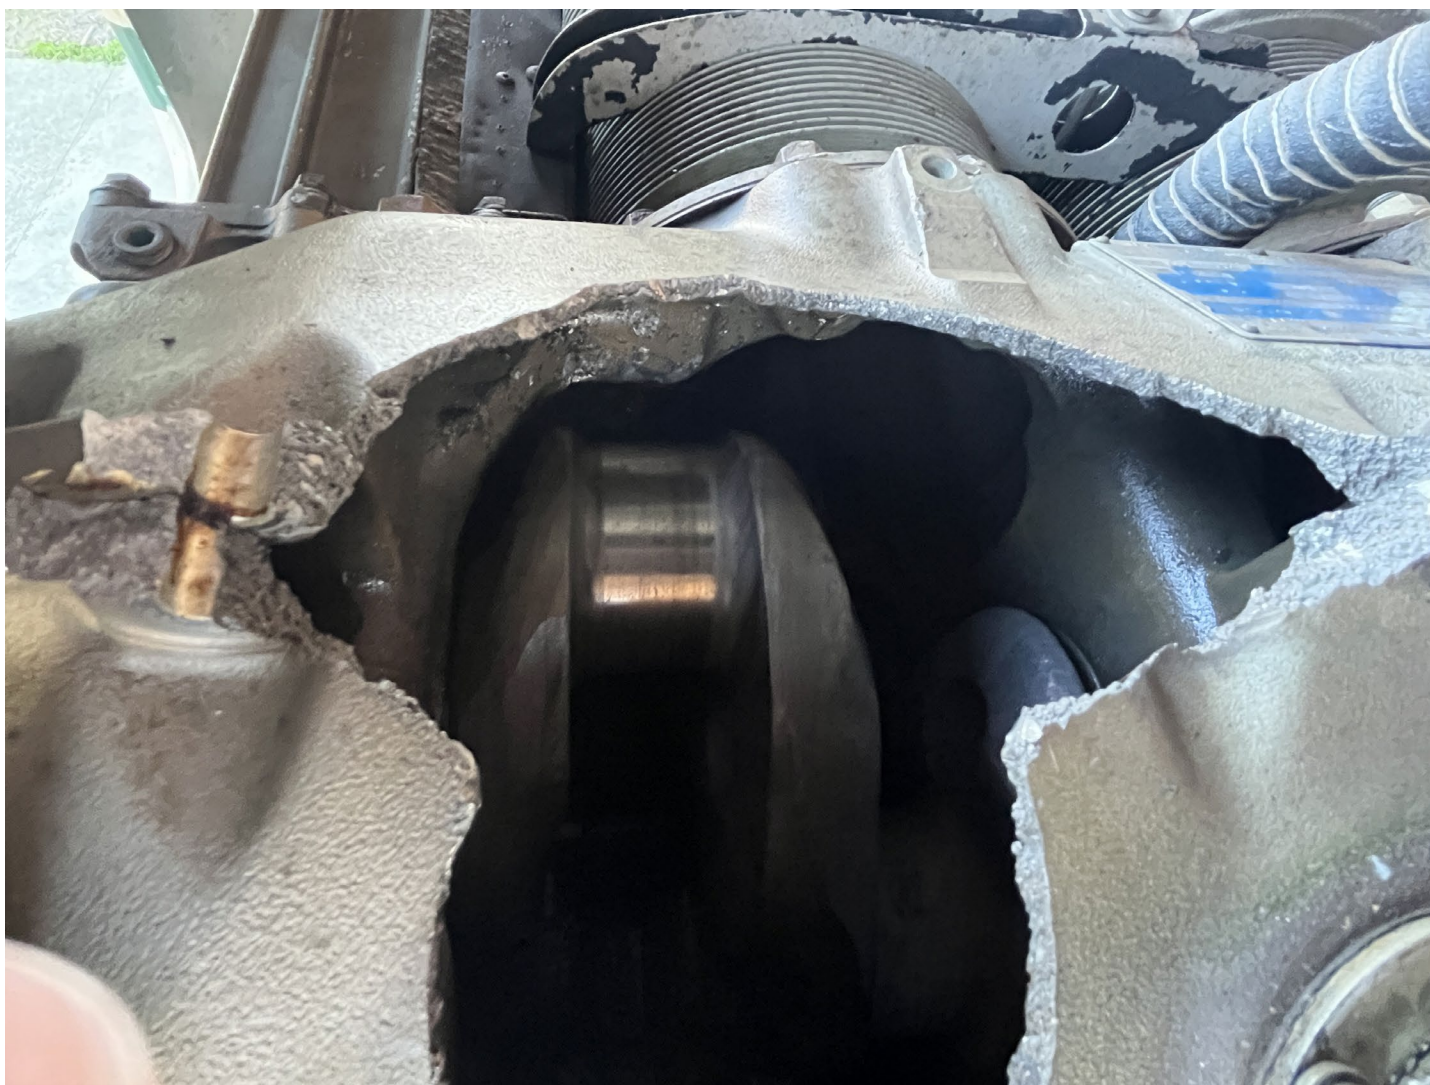
**Photograph 2 - Hole in engine case (Courtesy of FAA)**

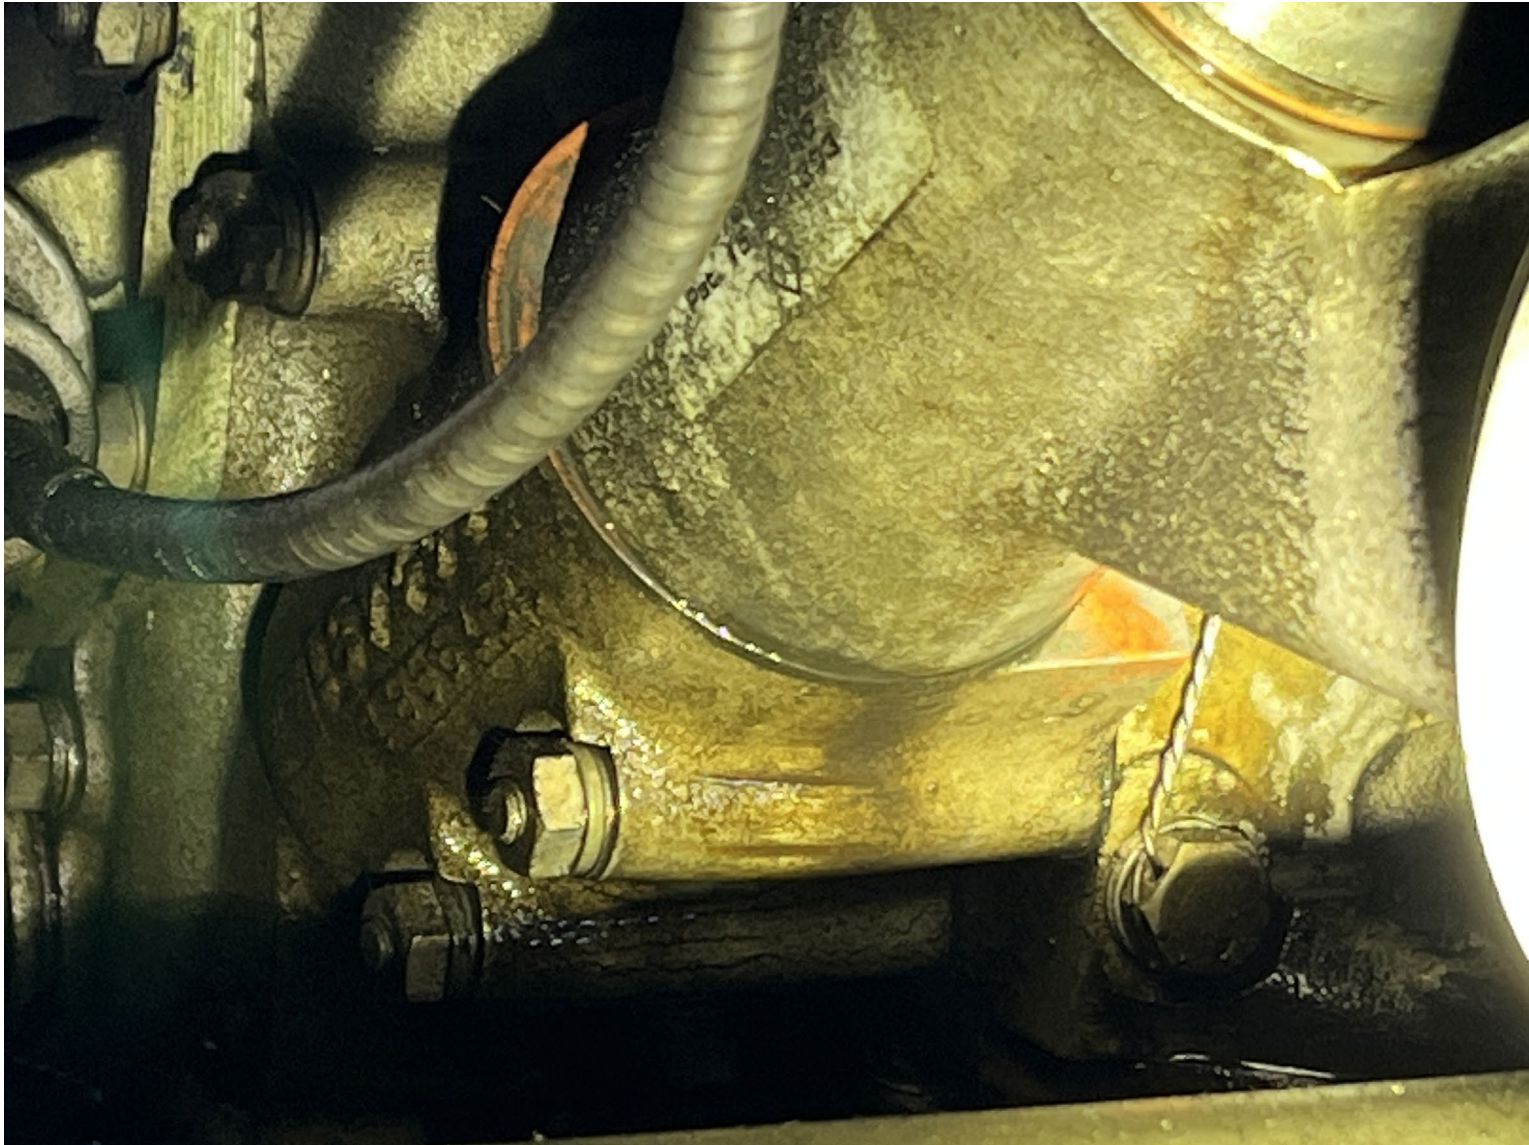
**Photograph 3 - Oil filter adapter, Note: gasket protruding and leaking oil (Courtesy of FAA)**

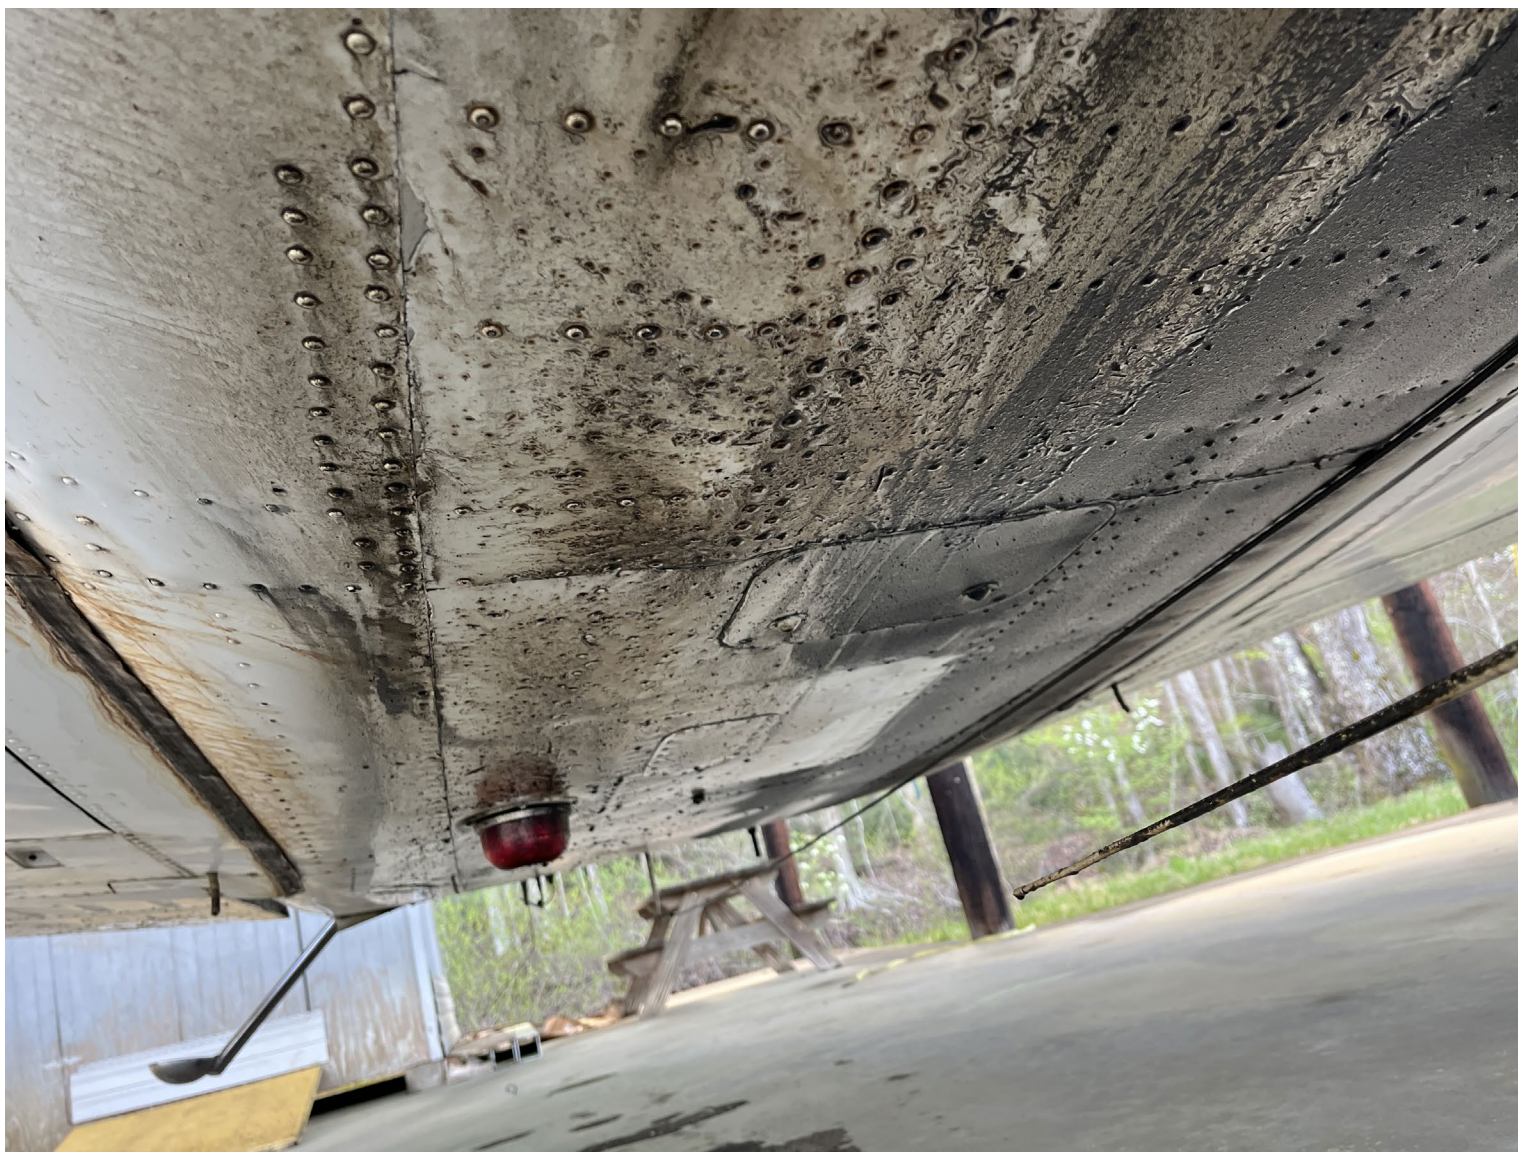
**Photograph 4 - Bottom of fuselage covered in oil (Courtesy of FAA)**
