ERA25LA160

## INVESTIGATION PHOTOGRAPHS

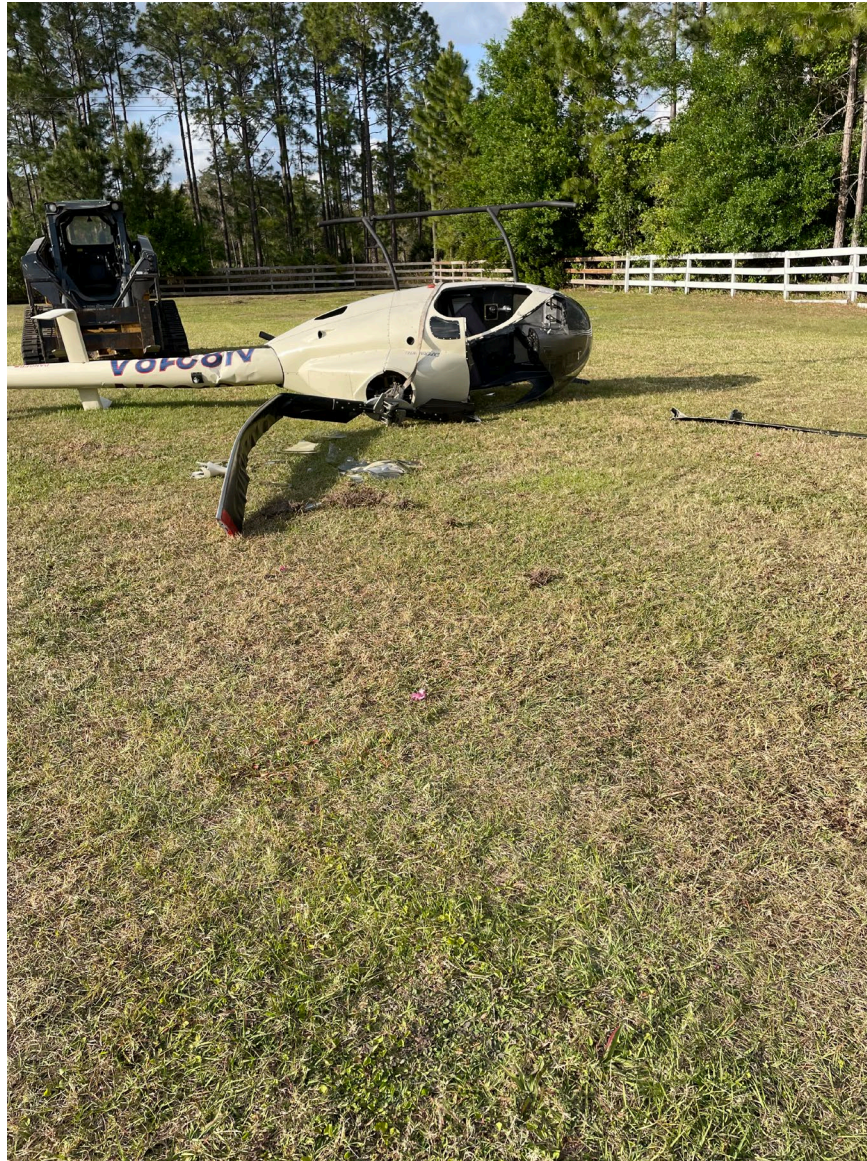
**Photograph 1 - Deformation noted to main rotor blades (Courtesy of FAA)**

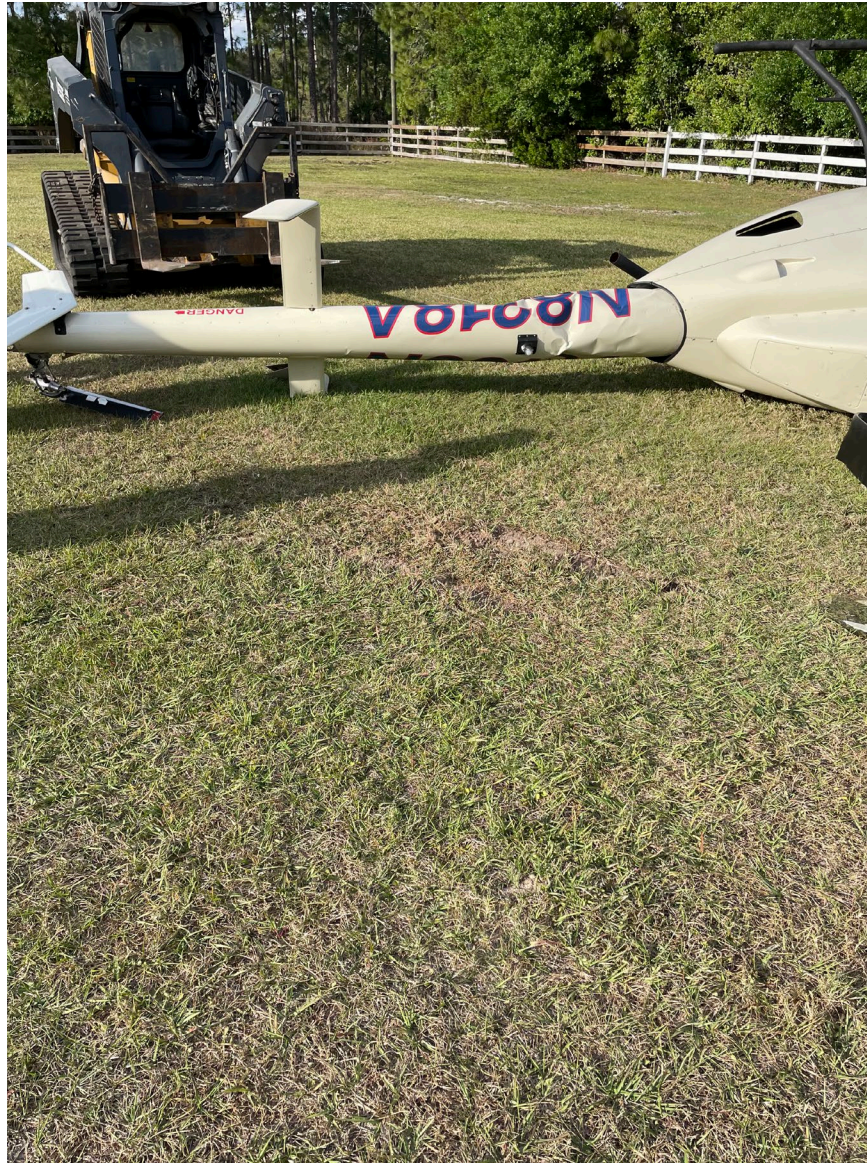
**Photograph 2 - Deformation noted to tail boom (Courtesy of FAA)**
