**Federal Aviation  
Administration**

N8EV S/N: 80568

March 28, 2025 – Marlboro Co Jetport (BBP)

Engine stoppage in cruise flight– Subsequent ditching

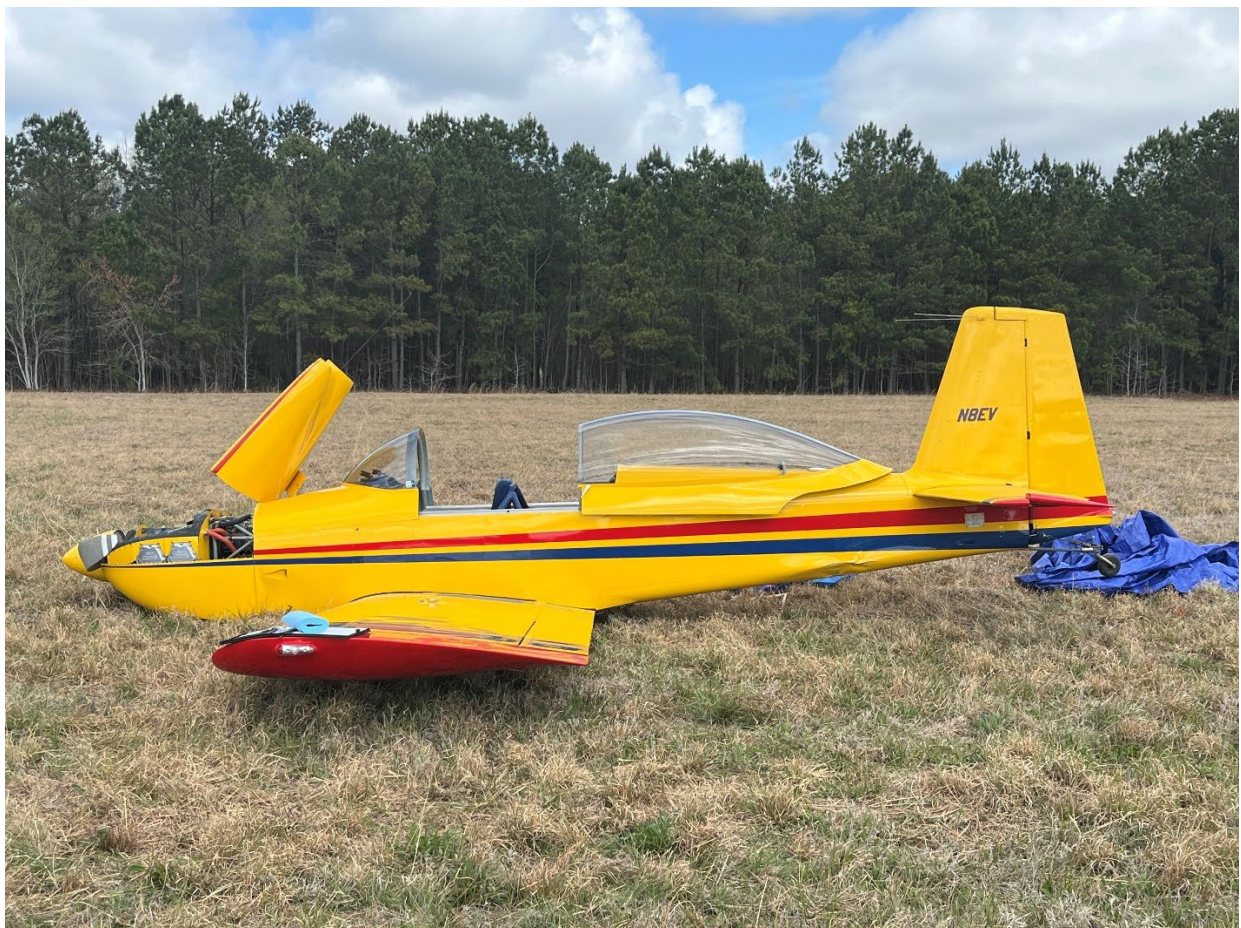
Aircraft departed Chesapeake, VA (CPK) Friday March 28<sup>th</sup> 2025 for Camden, SC (CDN). Approximately 1.5 hours into the flight near Bennettsville, SC, the engine stopped abruptly and without warning. An attempt to land at Marlboro Co jetport was unsuccessful. Pilot ditched the aircraft in a field one-quarter mile off the end of Runway 25. Initial impact with the ground tore both left and right main landing gear from the fuselage. Aircraft then slid to a stop in the open field. The fuselage, wings and propeller suffered substantial damage. No post crash fire or emergency situation resulted from the ditching.

Upon inspection, engine oil level was in the normal operating range. All sparkplugs were installed with wires connected securely. Externally, the fuel pump and magnetos visually appeared in good condition. No other external engine features appeared abnormal or out of place. When the wing fuel filler caps were removed, no fuel was visible in either wing tanks. Recovery team attempted to drain fuel for a sample without success (no fuel).
