ERA25LA180

## INVESTIGATION PHOTOGRAPHS

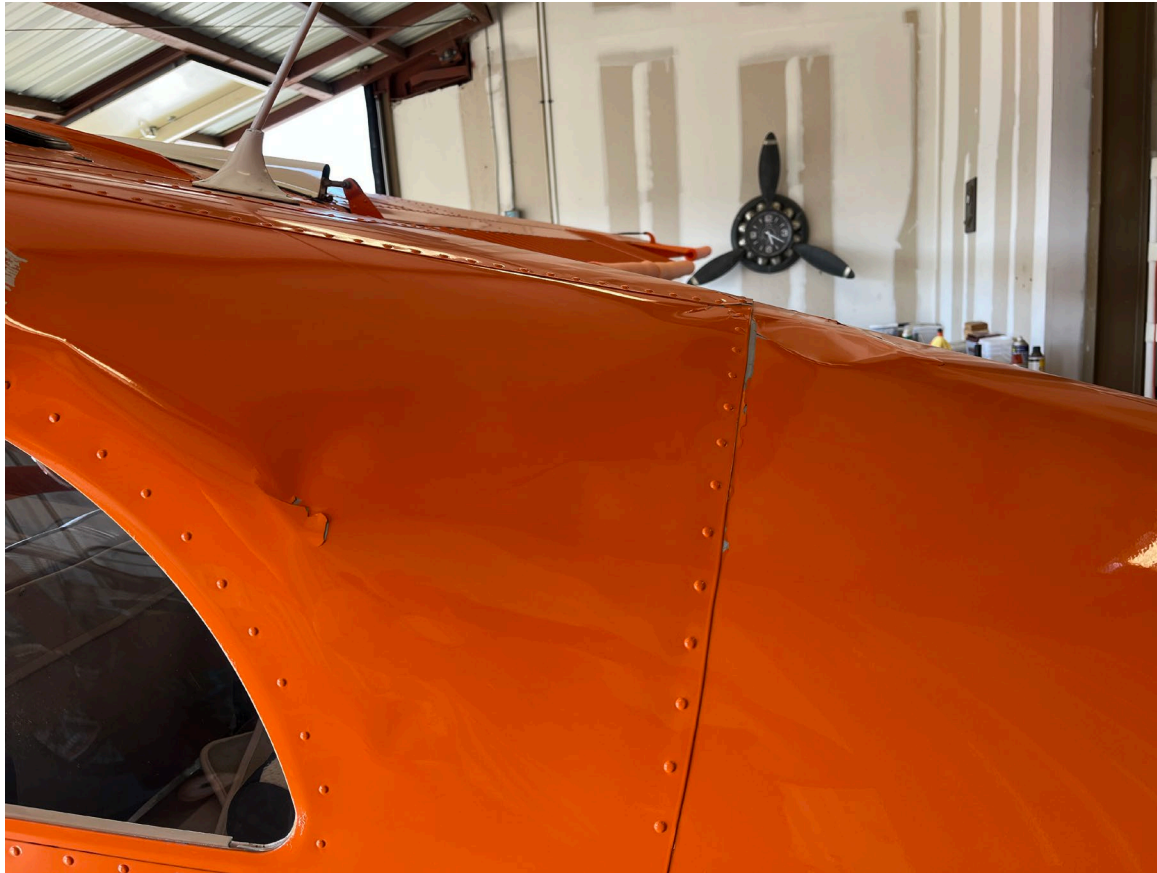
**Photograph 1 - Upper fuselage accident damage (Courtesy of Pilot)**

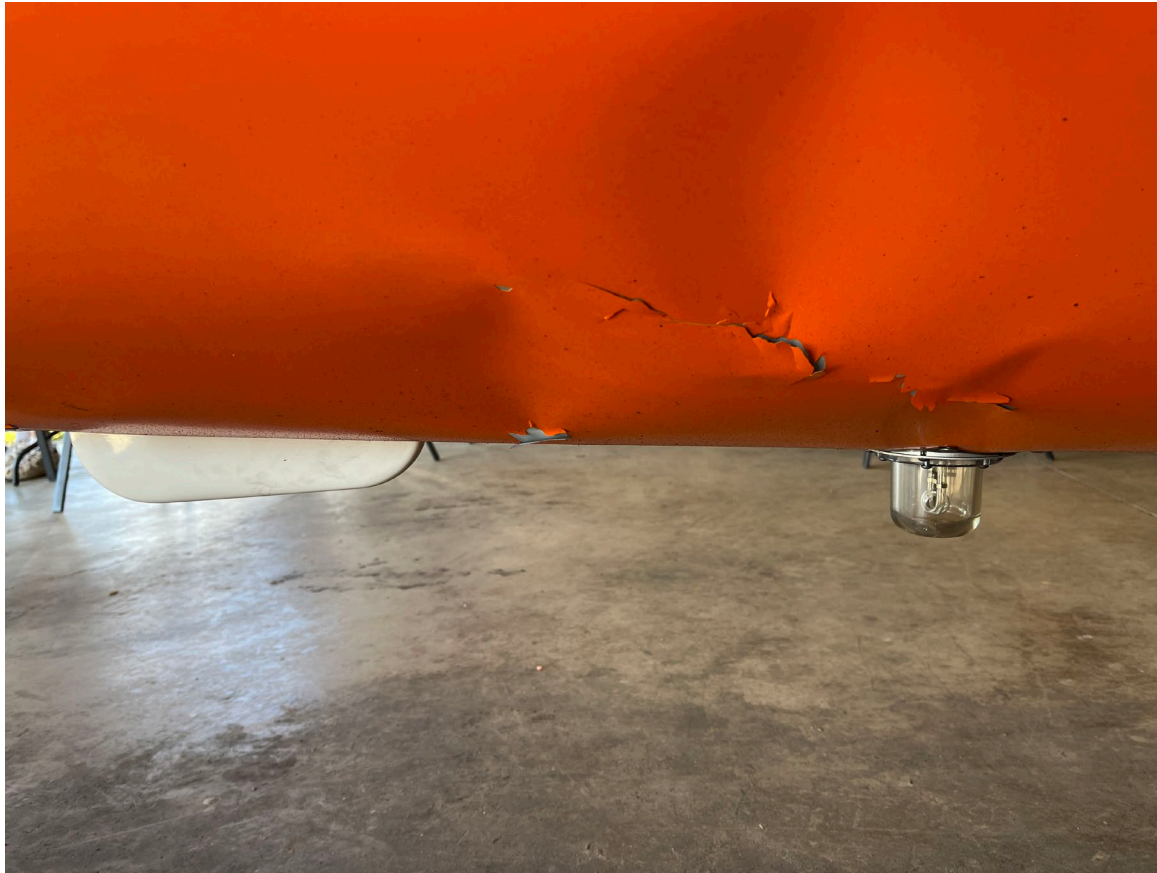
**Photograph 2 - Lower fuselage accident damage (Courtesy of Pilot)**

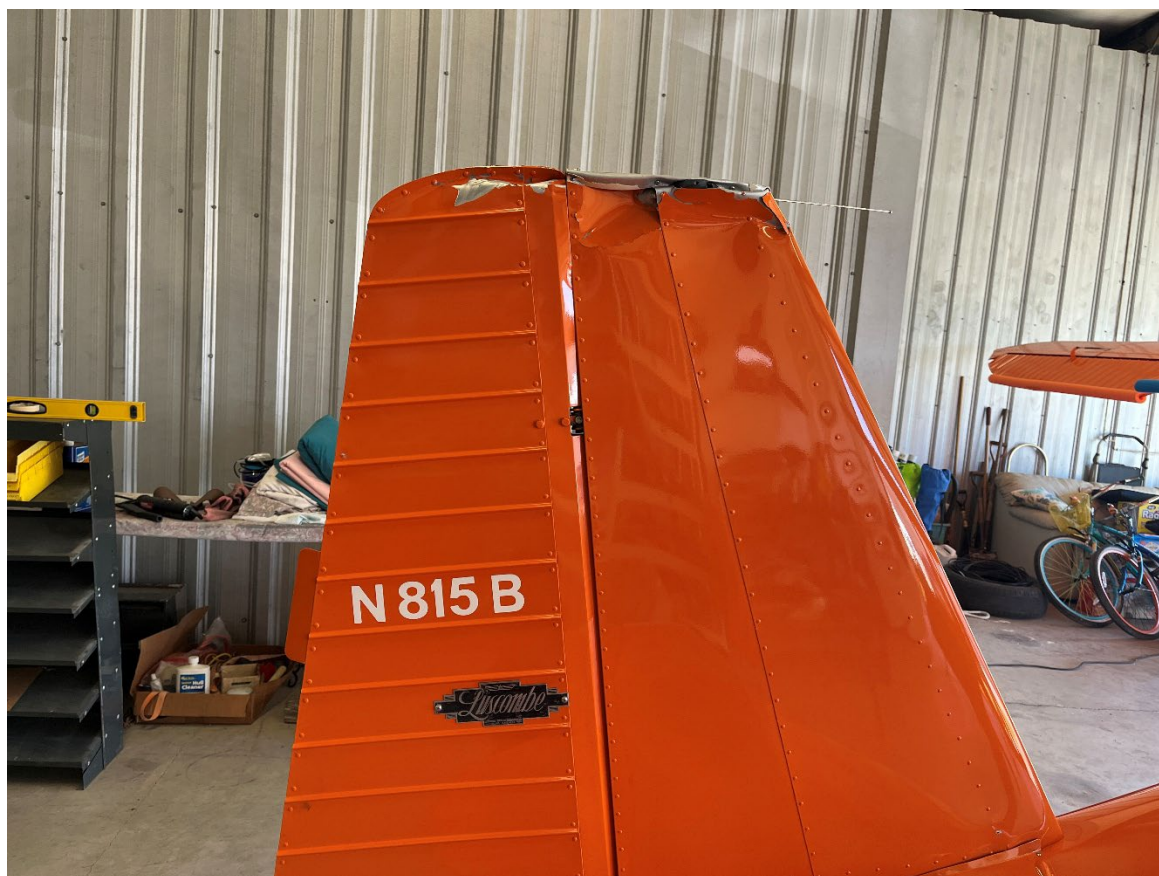
**Photograph 3 - Vertical stabilizer and rudder accident damage (Courtesy of Pilot)**

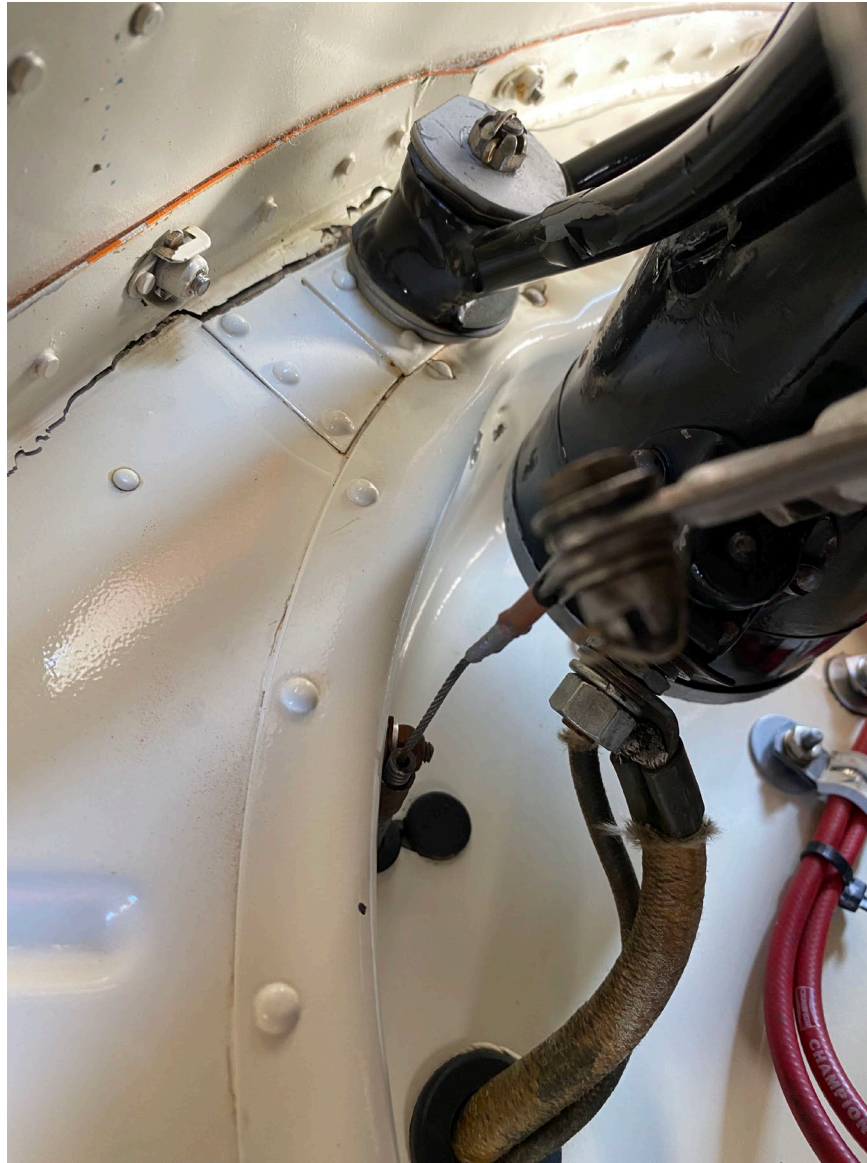
**Photograph 4 - Engine mount and firewall structure accident damage (Courtesy of Pilot)**
