ERA25LA181

## INVESTIGATION PHOTOGRAPHS

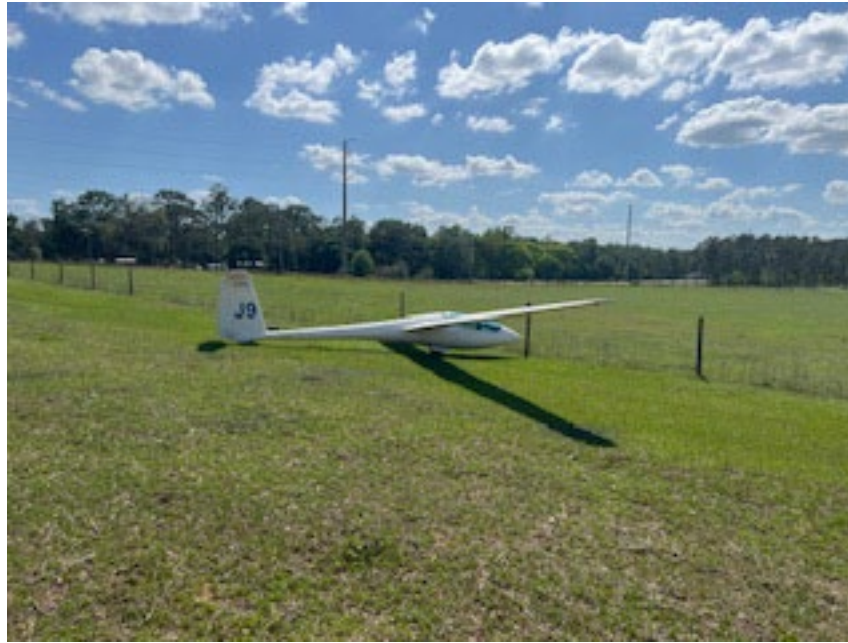
**Photograph 1 - Glider at accident site (Source: Pilot)**

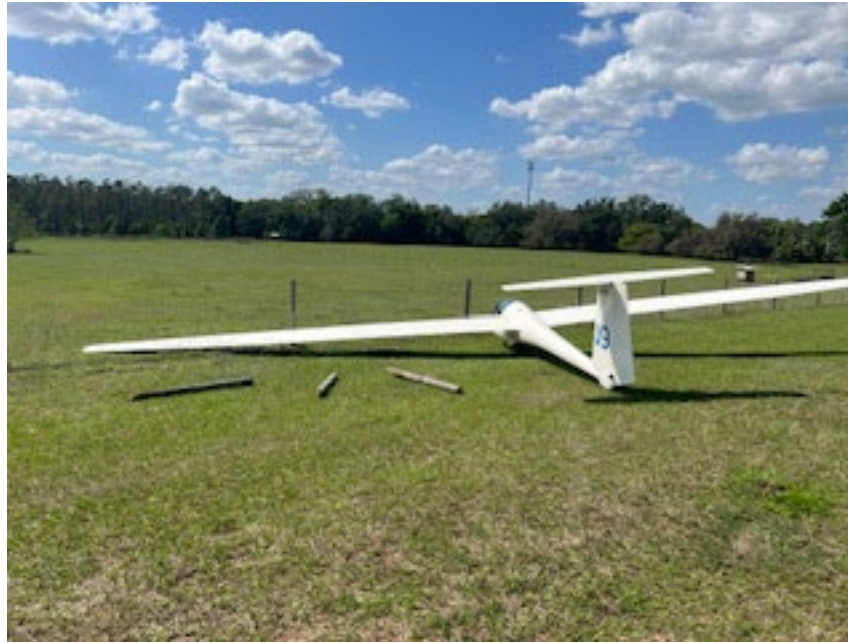
**Photograph 2 - Glider at accident site (Source: Pilot)**

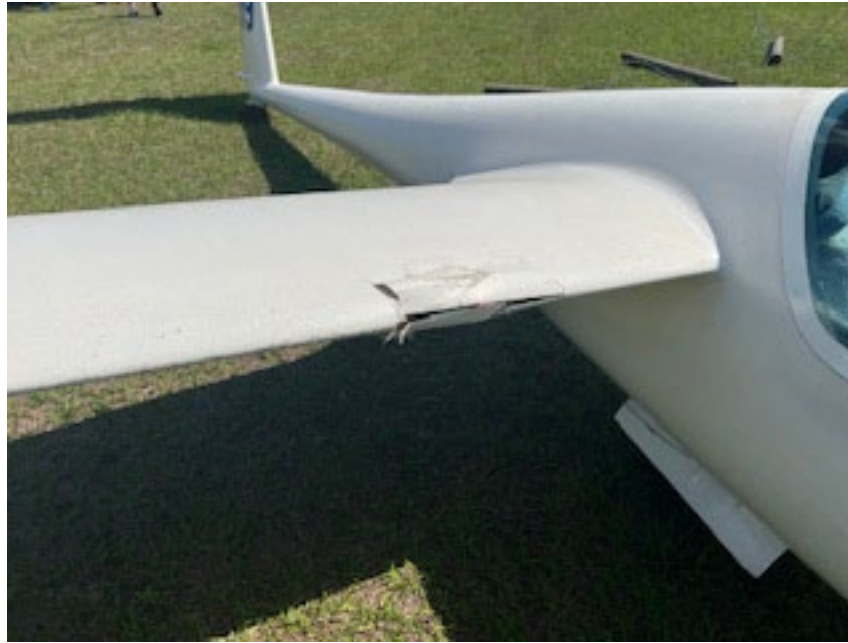
**Photograph 3 - Damage to right wing (Source: Pilot)**

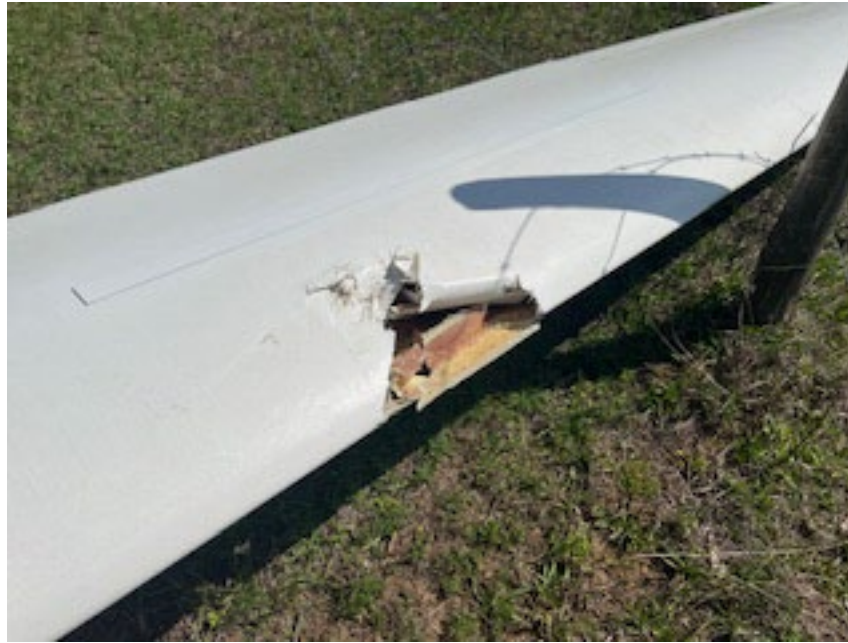
**Photograph 4 - Damage to left wing (Source: Pilot)**

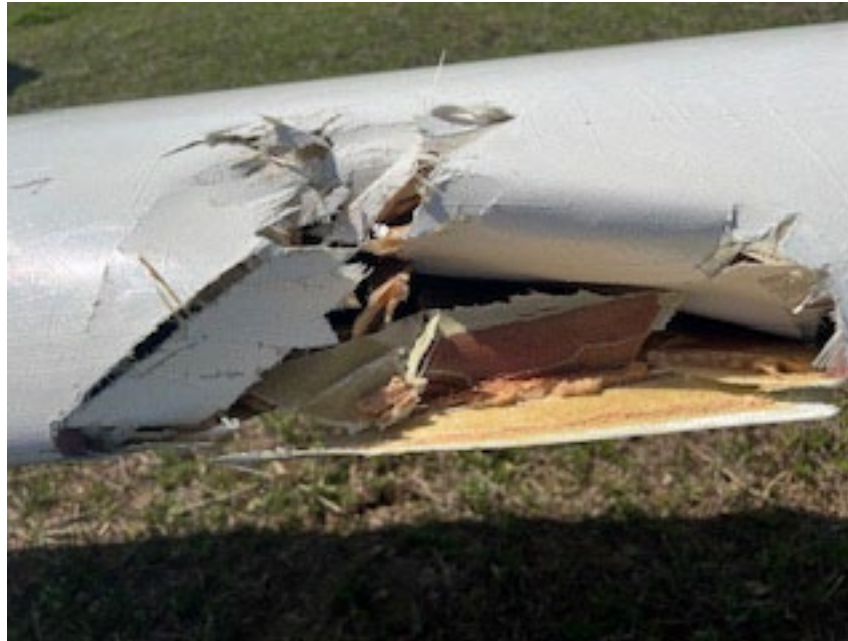
**Photograph 5 - Damage to left wing (Source: Pilot)**
