ERA25LA194

## INVESTIGATION PHOTOGRAPHS

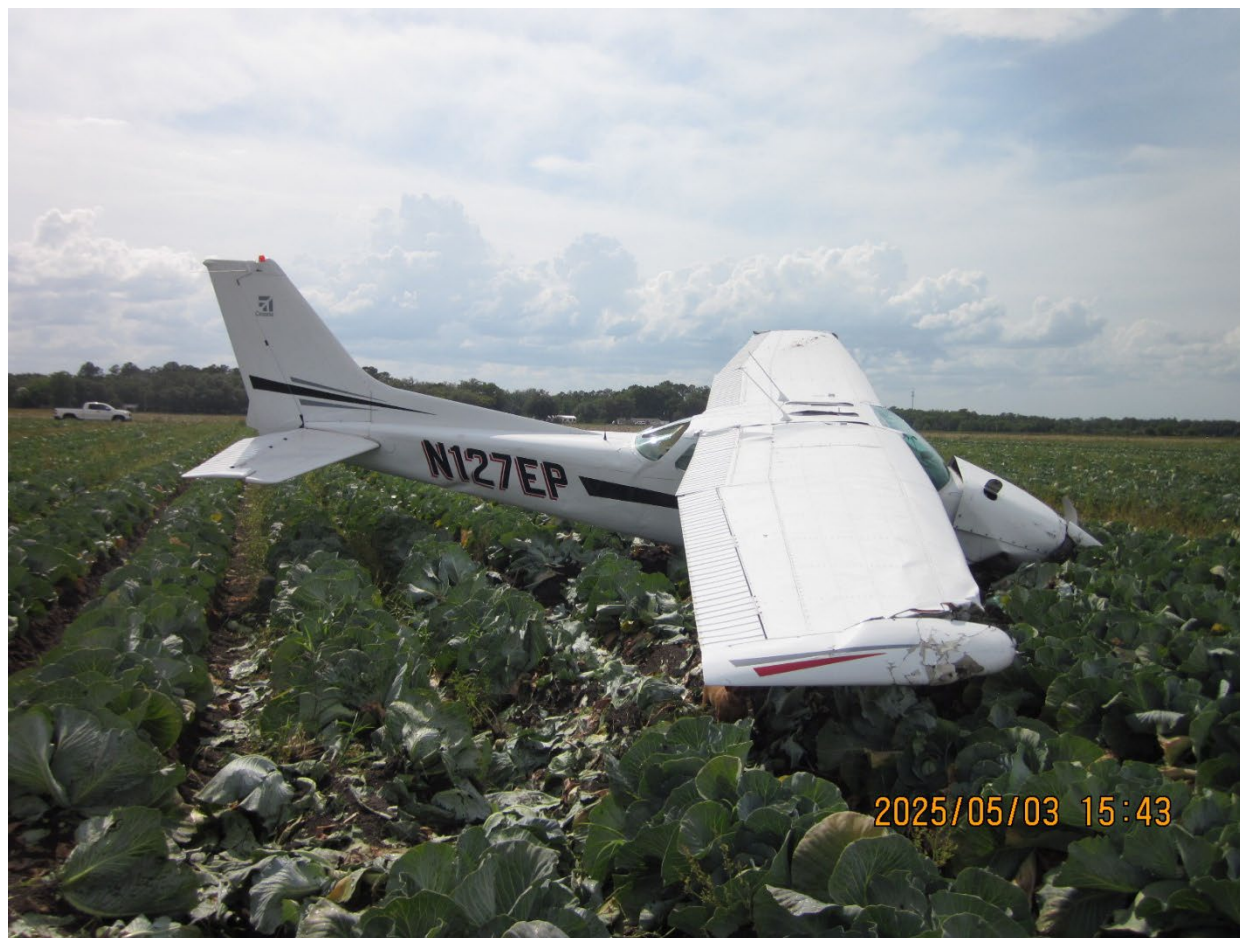
**Photograph 1 - Right profile view of airplane at accident site. Note damage to right wing and engine compartment. (Courtesy of FAA)**

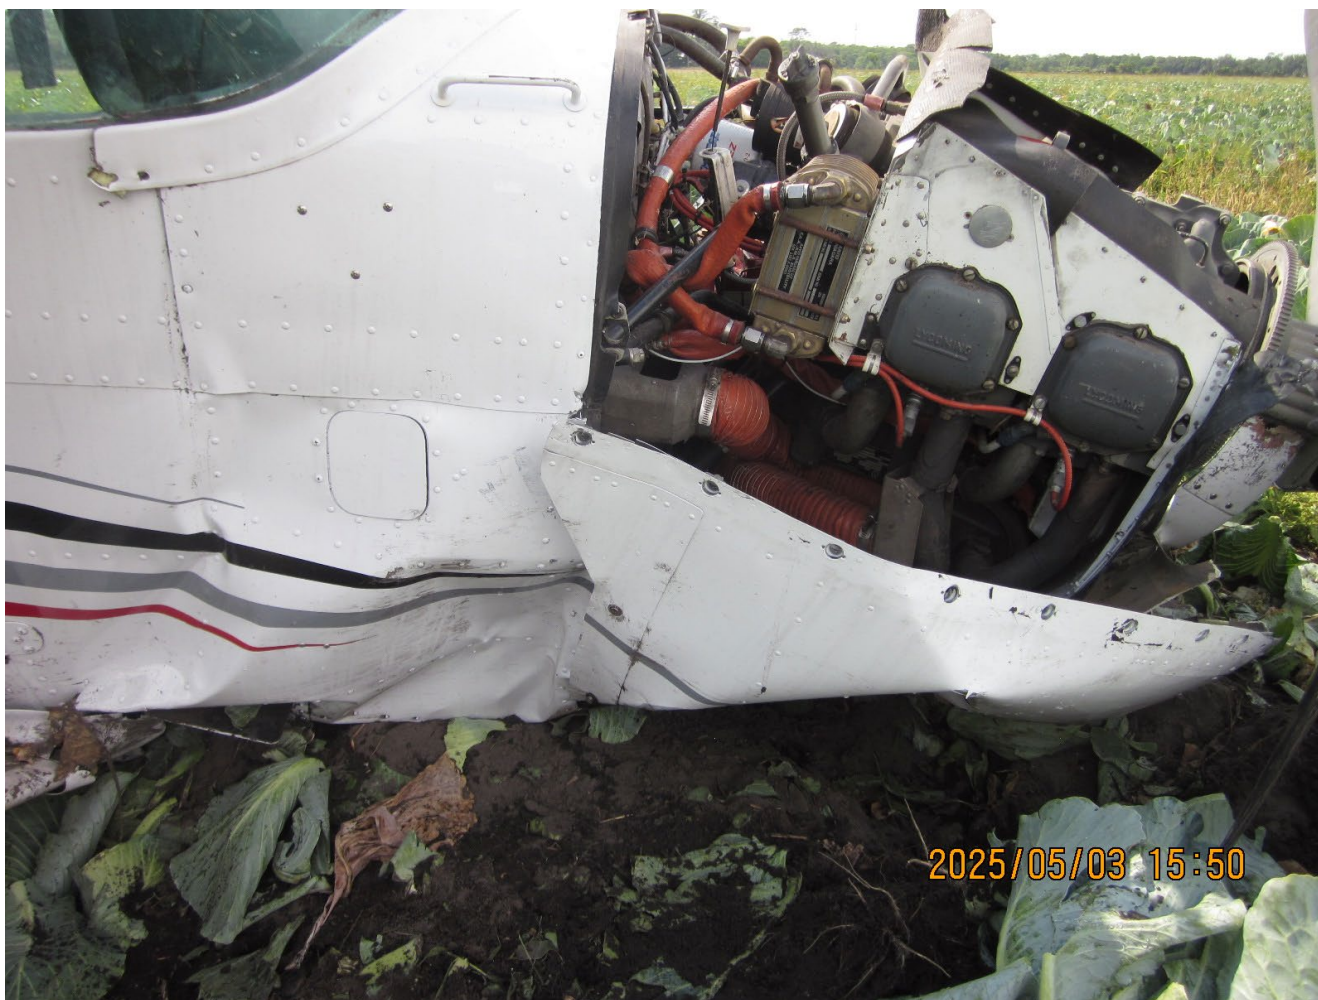
**Photograph 3 - View of airframe and engine compartment damage. (Courtesy of FAA)**
