ERA25LA198

## INVESTIGATION PHOTOGRAPHS

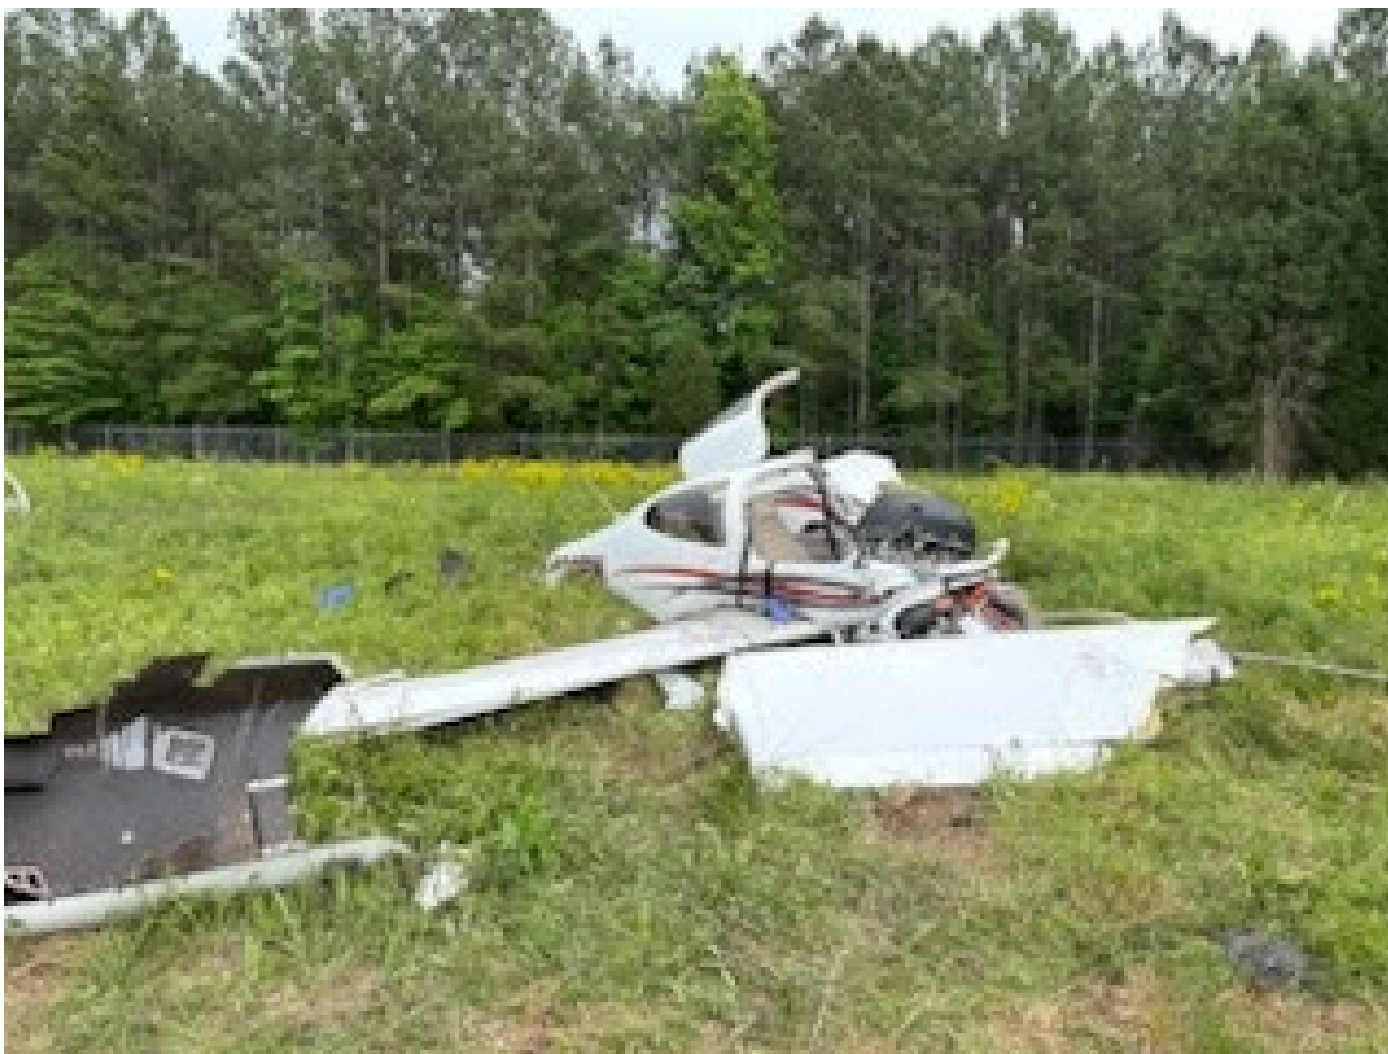
**Photograph 1 - main wreckage (Courtesy of FAA)**

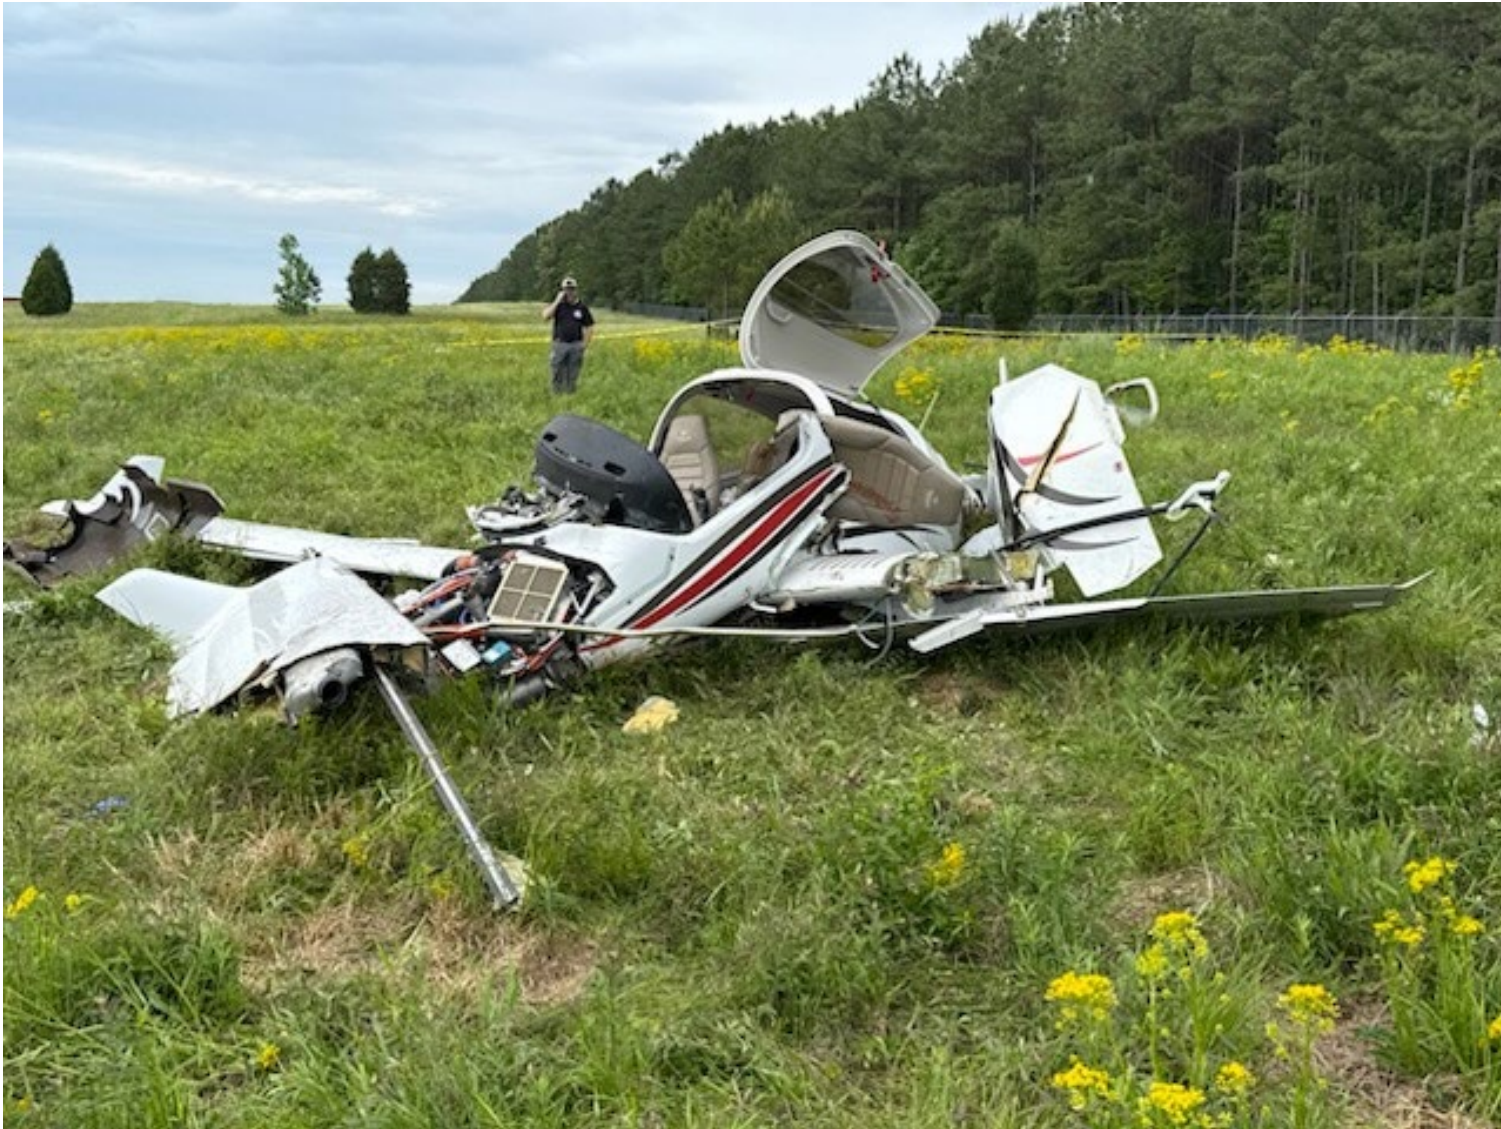
**Photograph 2 - Main wreckage (Courtesy of FAA)**

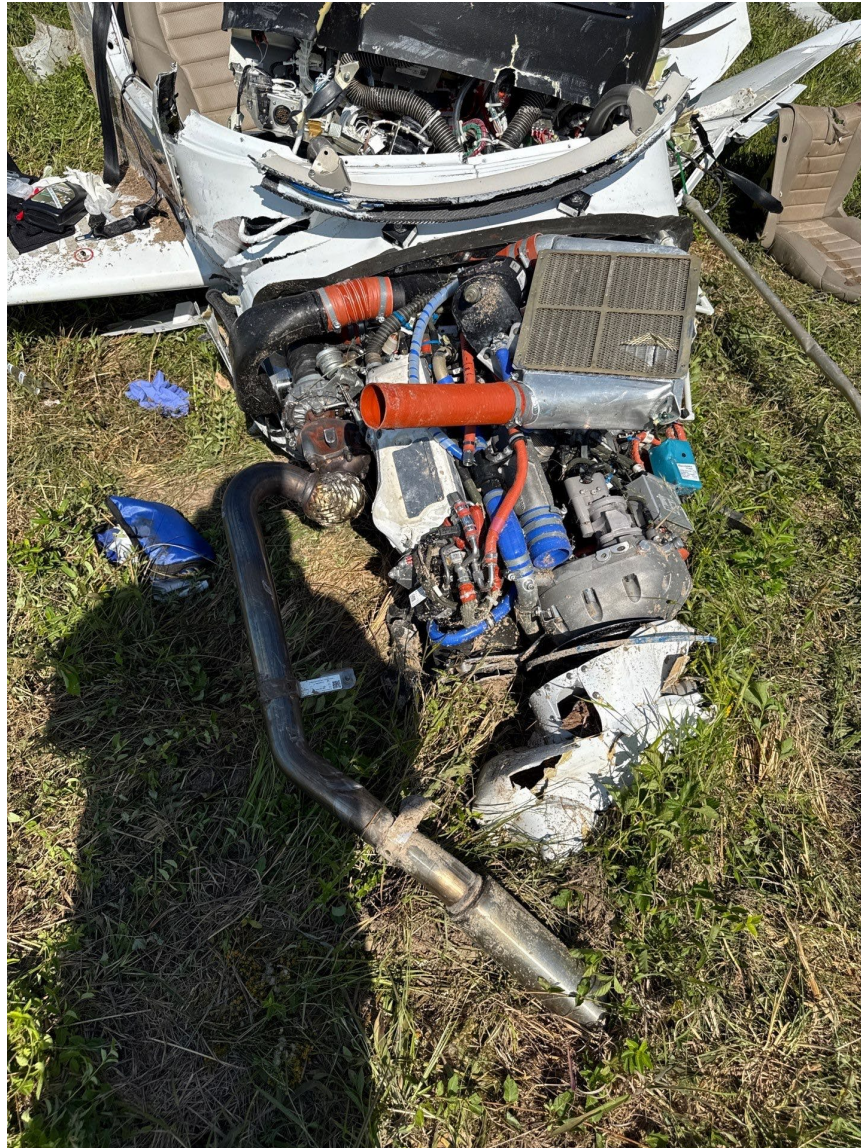
**Photograph 3 - Engine, note: Air discharge duct missing. (Courtesy of FAA)**
