# National Transportation Safety Board

ERA25LA198

## WRECKAGE EXAMINATION

Location: Sanford, North Carolina  
Date: 5/7/2025  
Time: 1600  
Airplane: Diamond DA40 NG

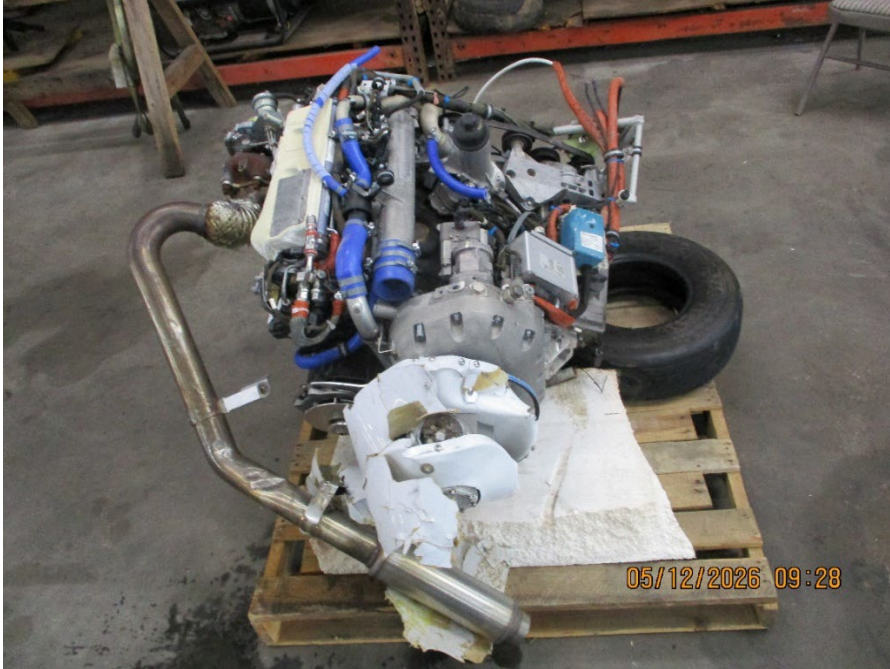
Fig 1. Engine as recieved

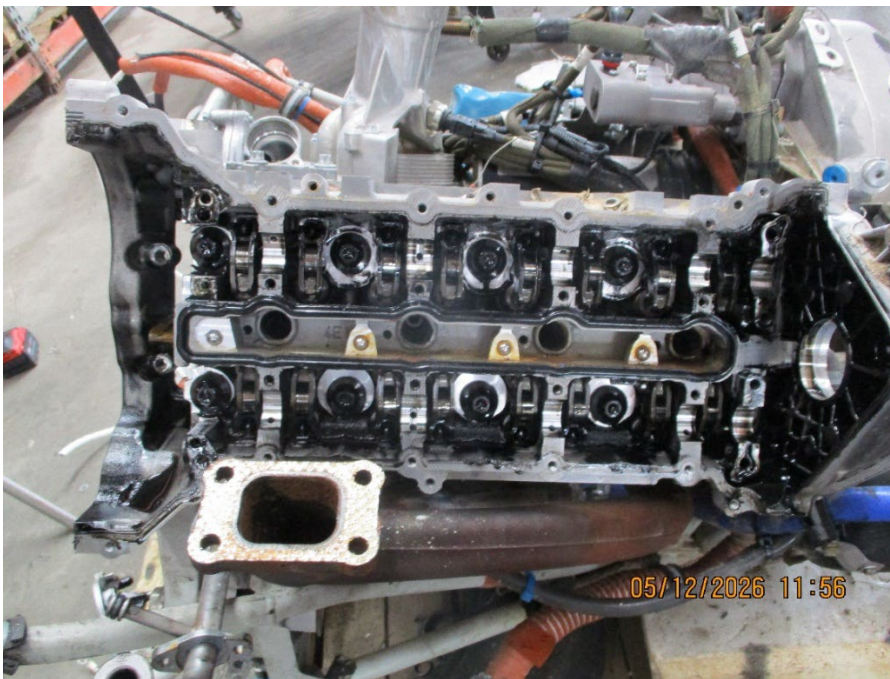
The engine was examined at the aircraft recovery facility located in Giffin GA. The glow plugs were removed and the propeller was rotated by hand. Thumb compression was obtained on all cylinders. Engine continuity was established through the engine. The fuel injectors revealed normal wear. The timing chain cover was removed and the engine timing was verified by visual examination. The turbo charger did not rotated due to sitting in the rain for months and rusted all the components. The camshafts were removed and showed normal wear. The head was removed and the pistons, and valves showed normal wear. The rocker arms were removed and showed normal wear.

Fig 2. Rocket arms

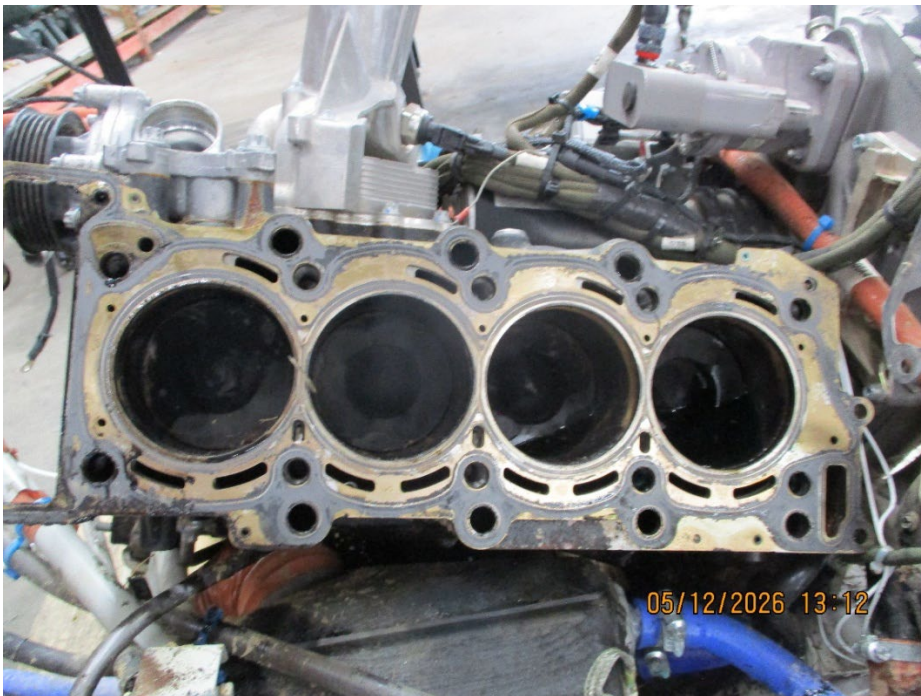
Fig. 4 pistons and head.

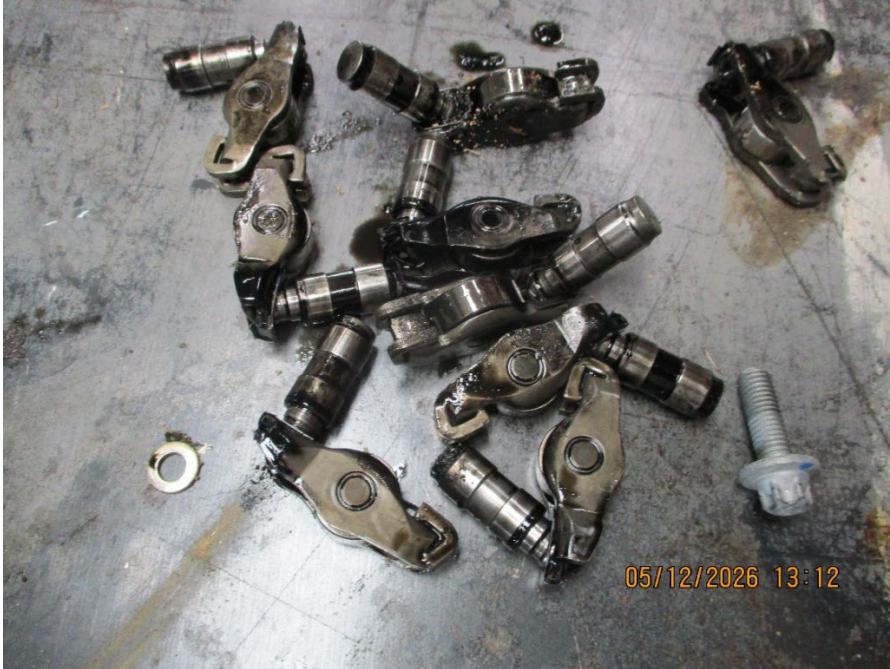
Fig. 5. Rocket arms and lifters

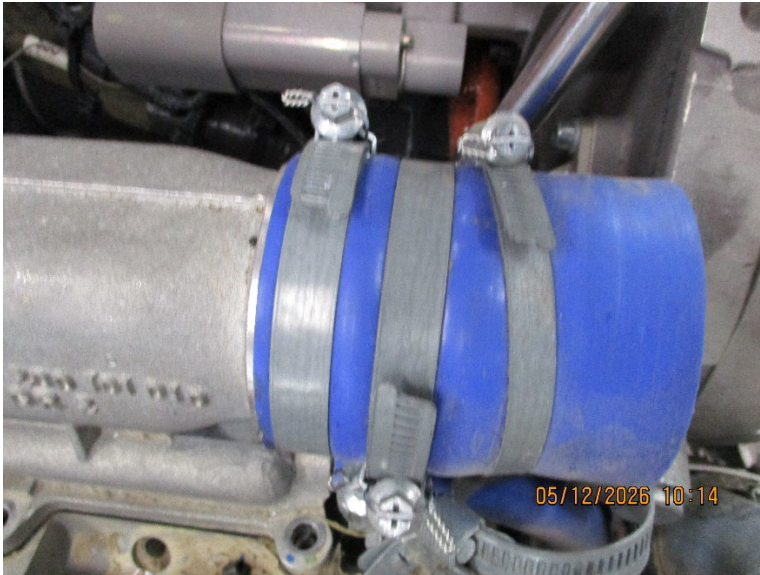
One worm clamp was found under the intake ductwork. The clamp safety wire was dislodged from the screw head. The screw was loose and the drive thread was worn in the clamp housing. (see Figure 8) Three of the four required clamps were still on the hose connecting to the intake. Two clamps were positioned correctly and securely holding the hose to the intake. One clamp was in the middle of the hose and secured with safety wire. It did not appear to be on the correct side of the bead the helps hold the plenum. (see figure 7)

Fig. 7. Induction clamps, NOTE: right clamp in middle of the hose secured and safety wired.

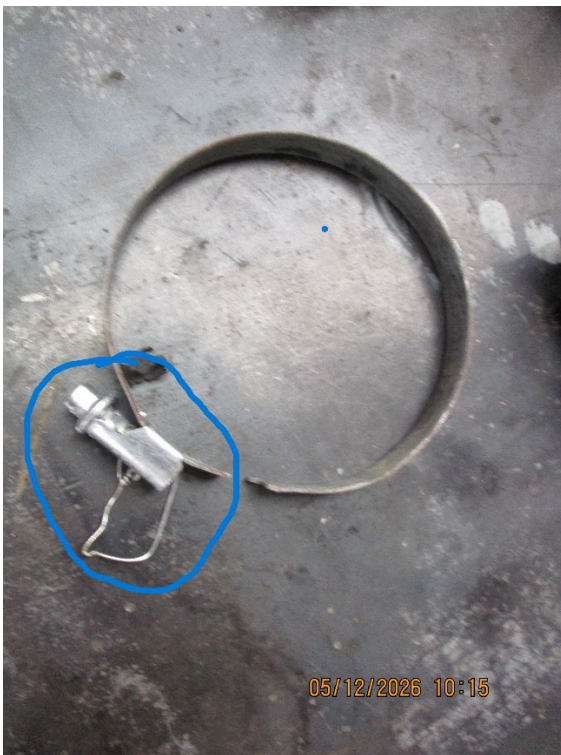
Fig. 8. Disconnected clamp found under intake ductwork. NOTE: screw is worn and loose in clamp housing.
