ERA25LA200

## INVESTIGATION PHOTOGRAPHS

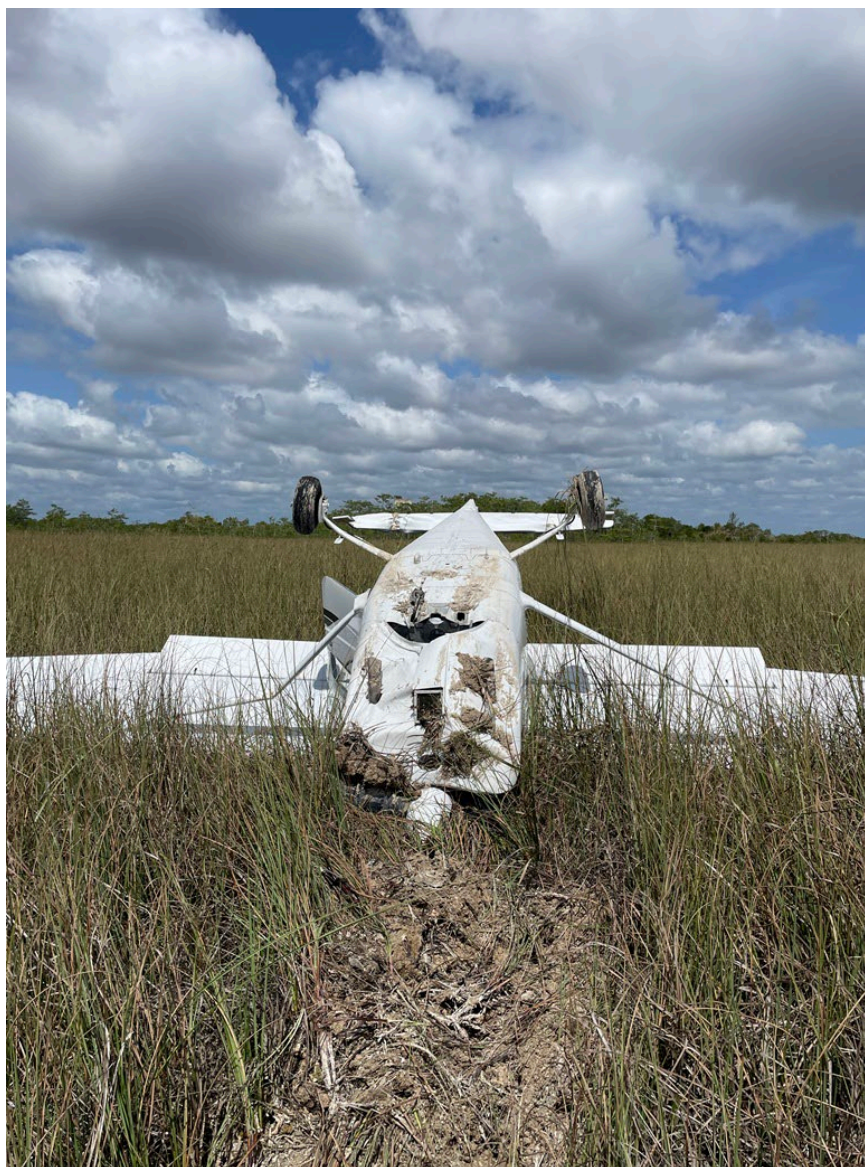
**Photograph 1 - Main Wreckage (Courtesy of FAA)**

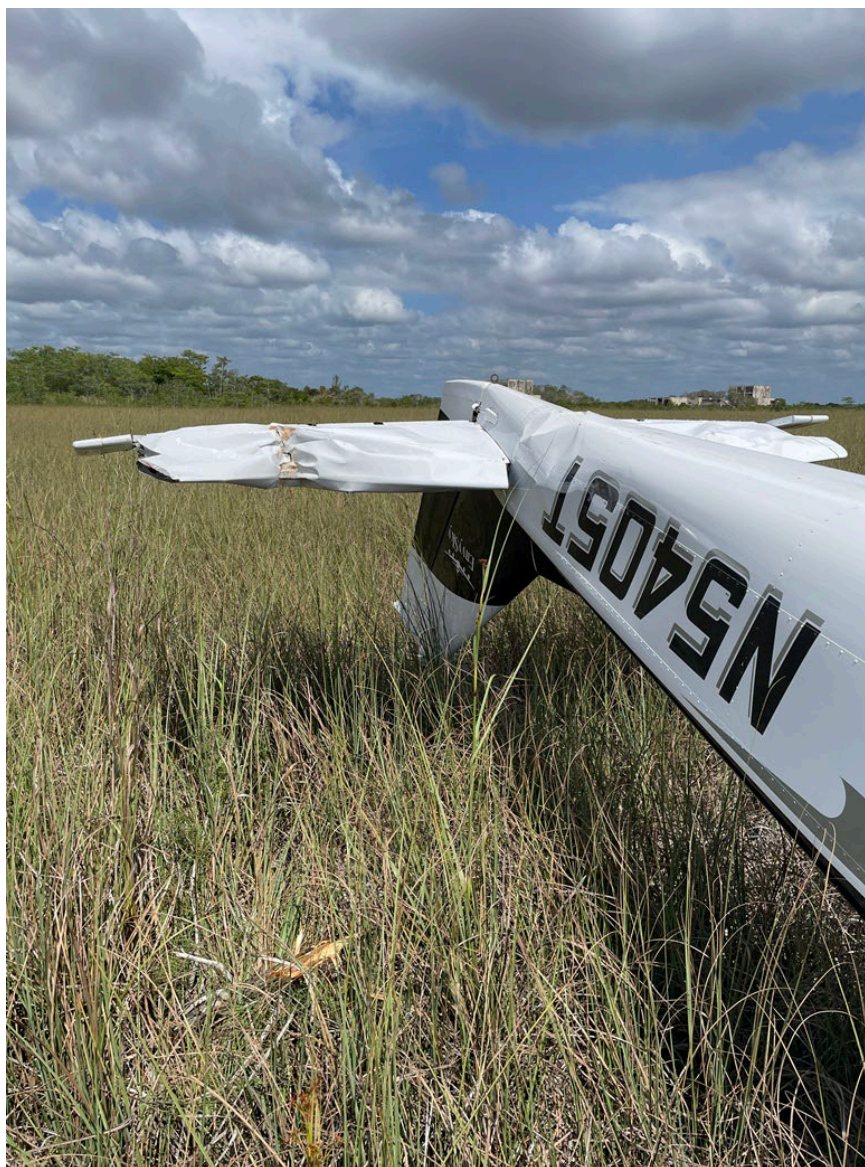
**Photograph 2 - Left Side Empennage Damage (Courtesy of FAA)**

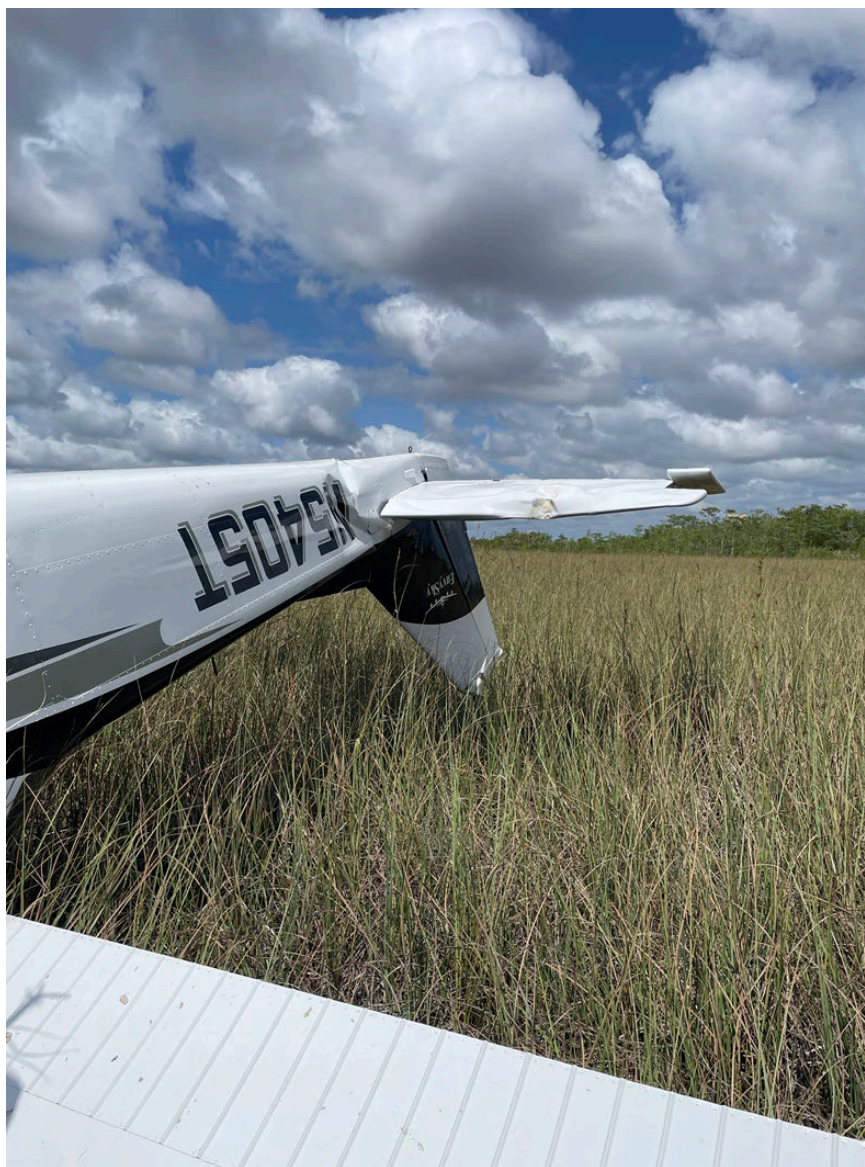
**Photograph 3 - Left Side Empennage Damage (Courtesy of FAA)**
