ERA25LA203

## INVESTIGATION PHOTOGRAPHS

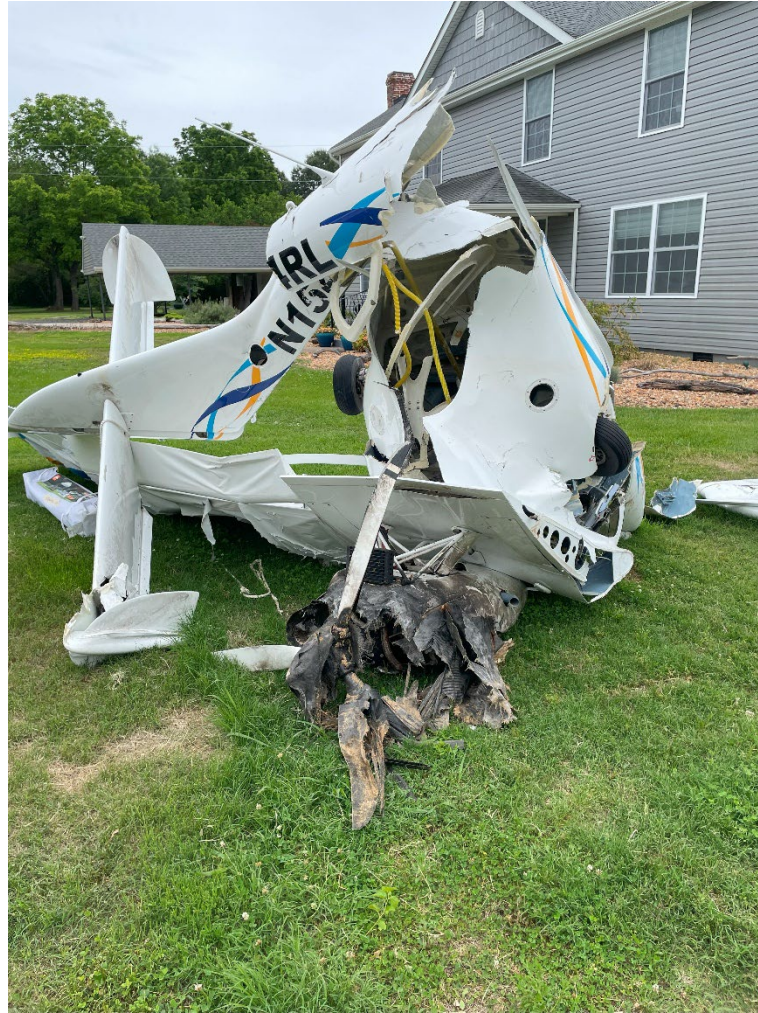
**Photograph 1 - Overall view of airframe and engine wreckage. (NTSB)**

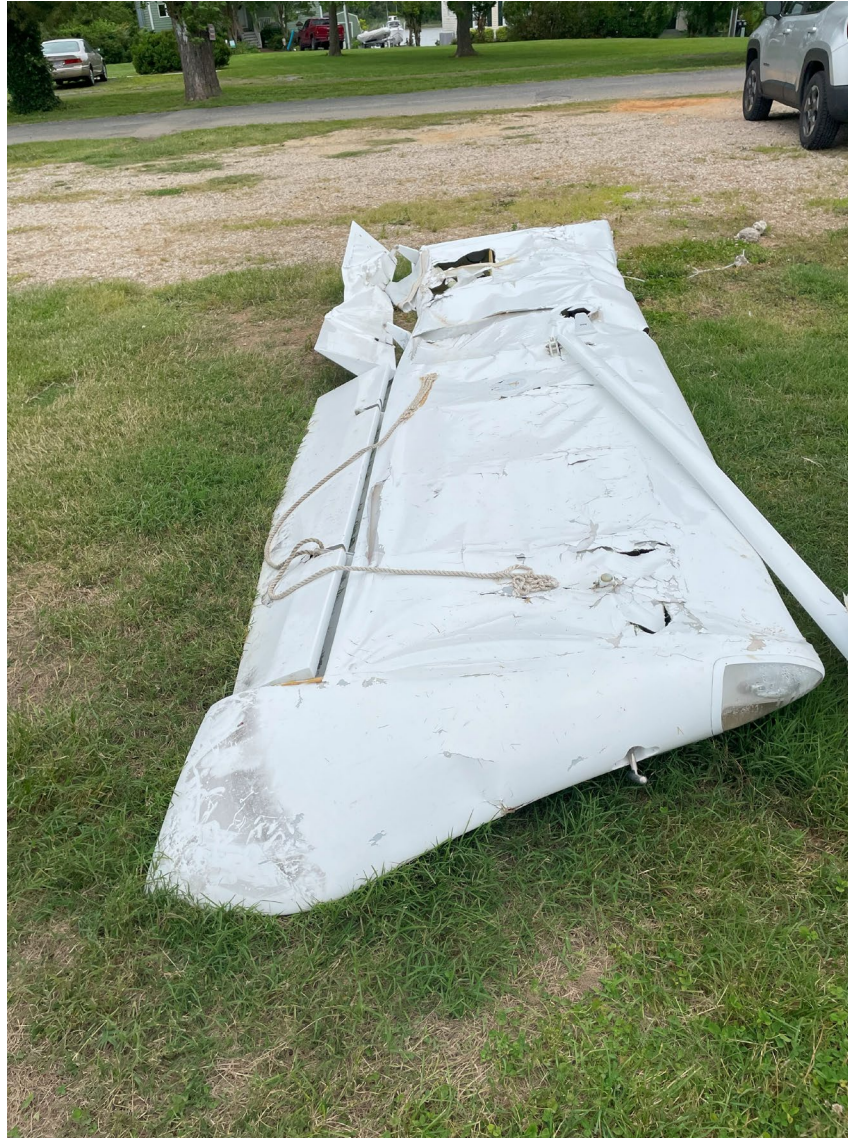
**Photograph 2 - Left wing damage. (NTSB)**

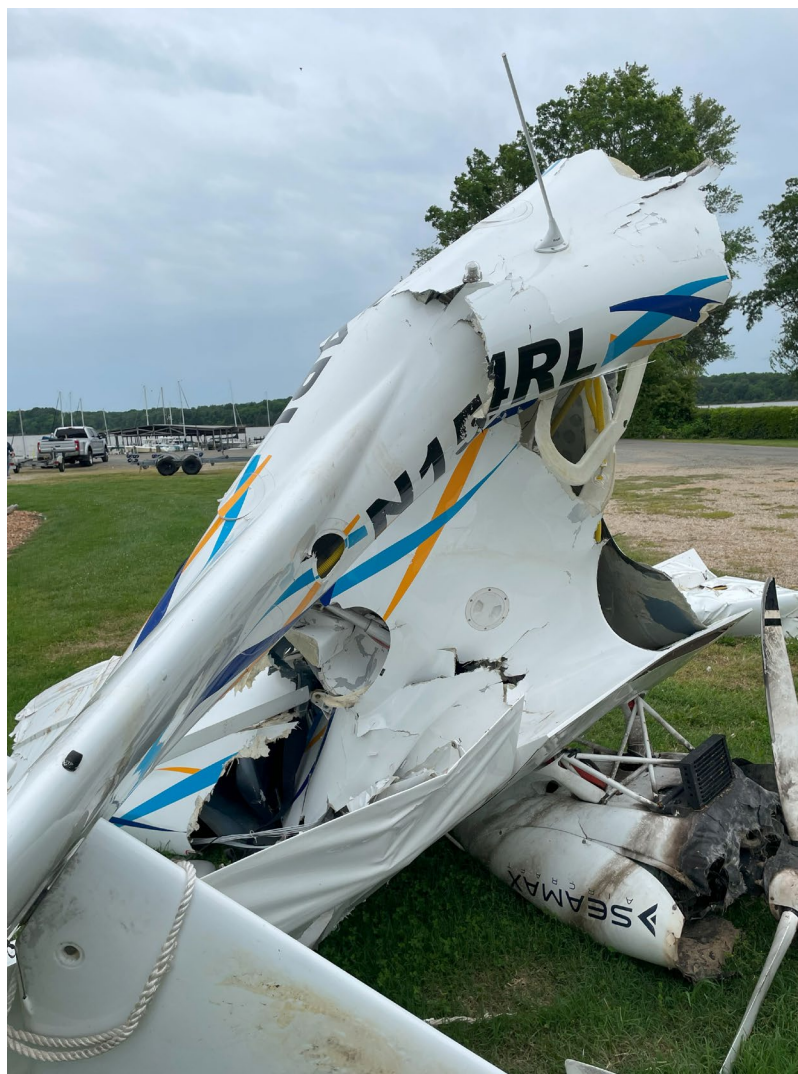
**Photograph 3 - View of engine and airframe wreckage. (NTSB)**

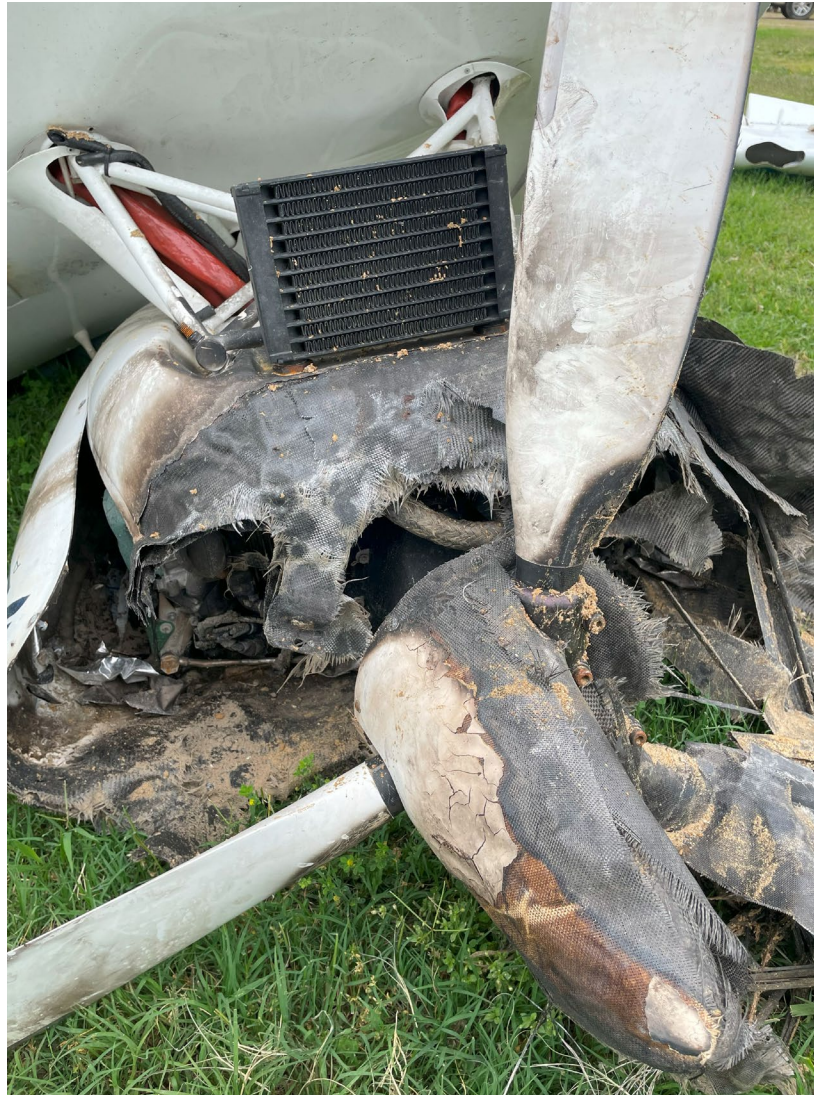
**Photograph 4 - Closeup view of propeller damage. (NTSB)**

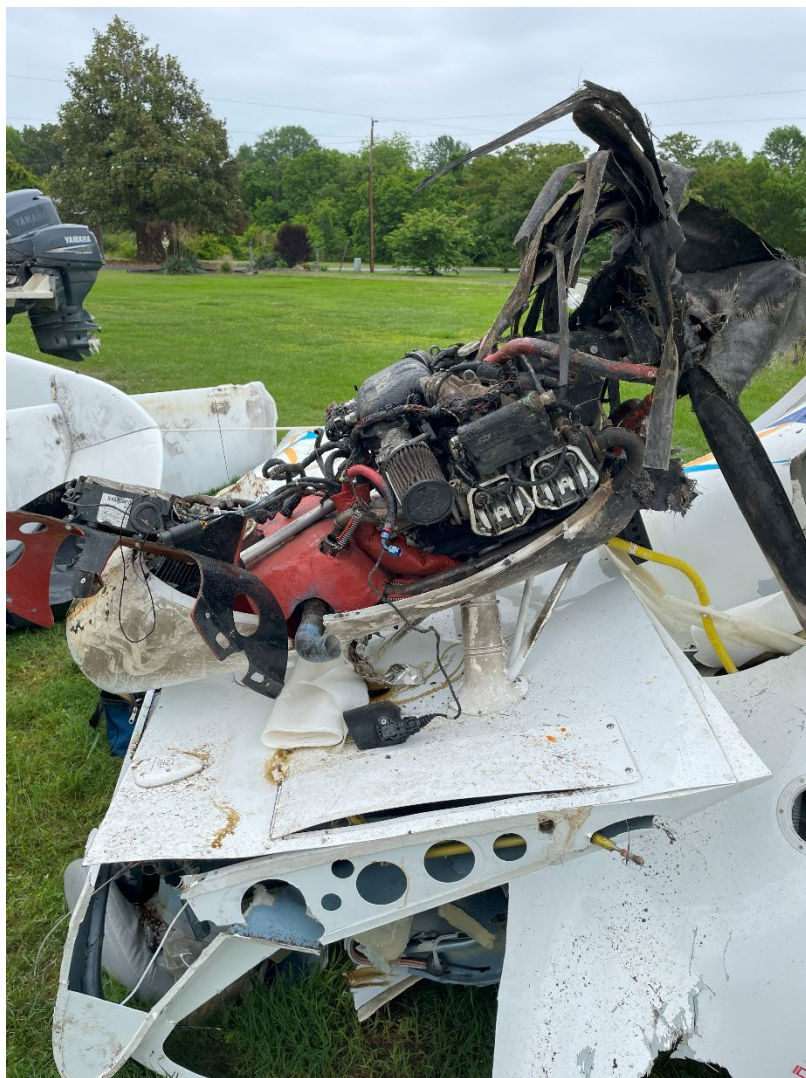
**Photograph 5 - Entire profile view of engine with cowling removed. (NTSB)**
