# National Transportation Safety Board

ERA25LA203

## ACCIDENT INVESTIGATION EXAMINATION REPORT

Location: Dahlgren, Virginia  
Date: May 17, 2025 (Date of Examination: May 26, 2025)  
Time: 1600 EDT  
2000 UTC  
Airplane: Seamax M-22, N154RL

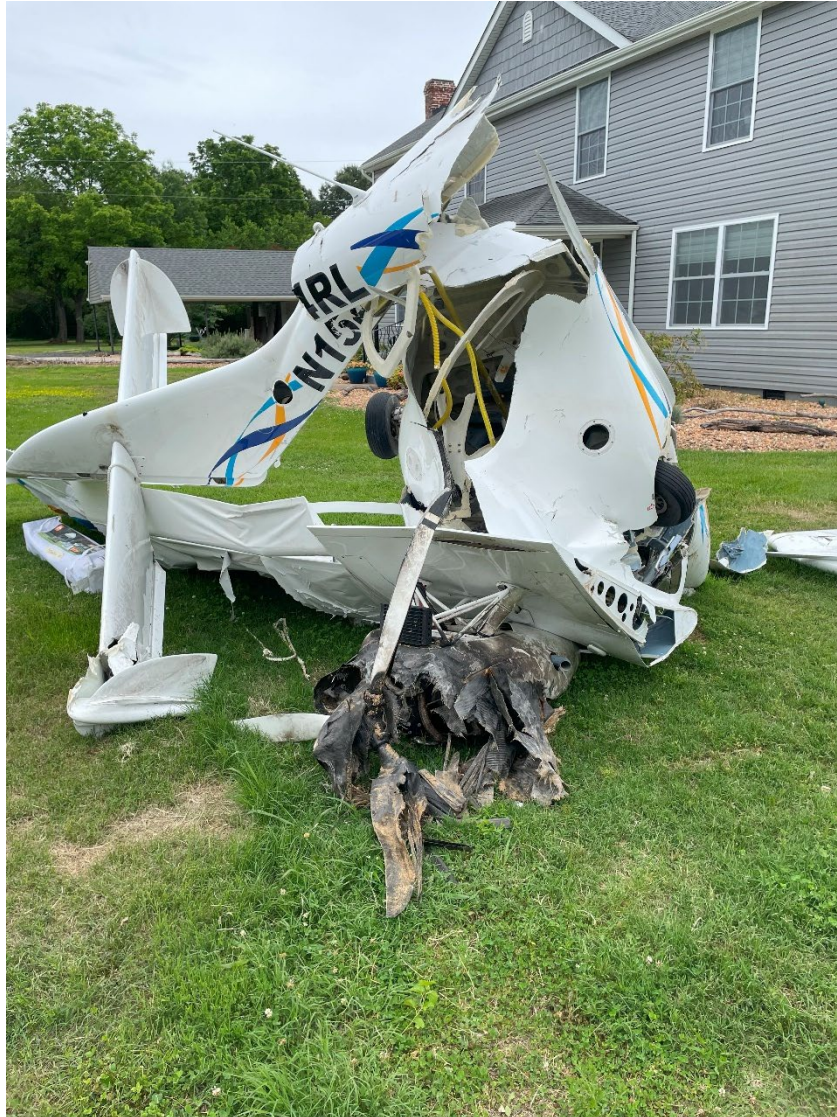
There was substantial damage to the airframe; the left wing was impact separated; the cockpit and fuselage were fractured and crushed in multiple locations. The empennage remained attached by control rods and cables. All fractures in the flight control cables had a “broomstraw” appearance indicative of overload. All flight control surfaces, and critical components were discovered at the location of the wreckage.

**Figure 1, Overall view of wreckage.**

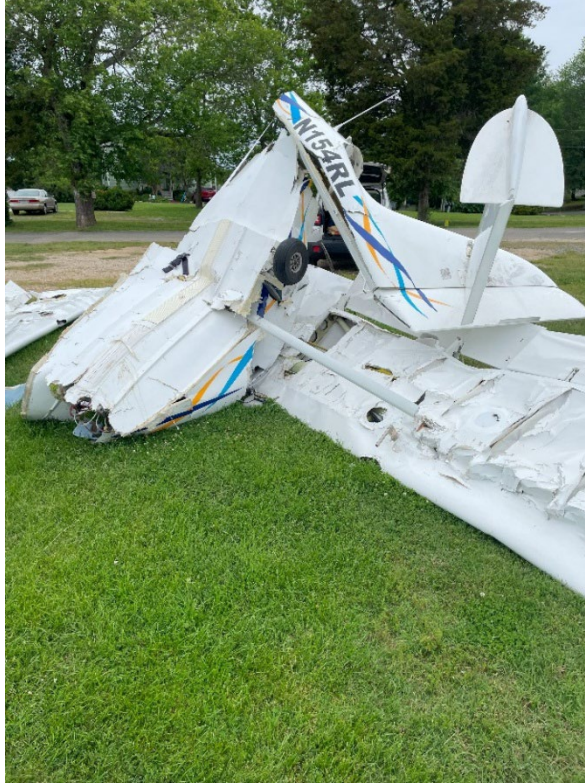
All flight control surfaces remained attached to their respective positions and were manually manipulated with corresponding cable movement. The left wing was separated. The right wing remained partially attached to the airframe. The empennage remained attached. The rudder and stabilator remained attached and functioned as designed.

**Figure 2, View of right wing, elevator, rudder and bottom of hull.**

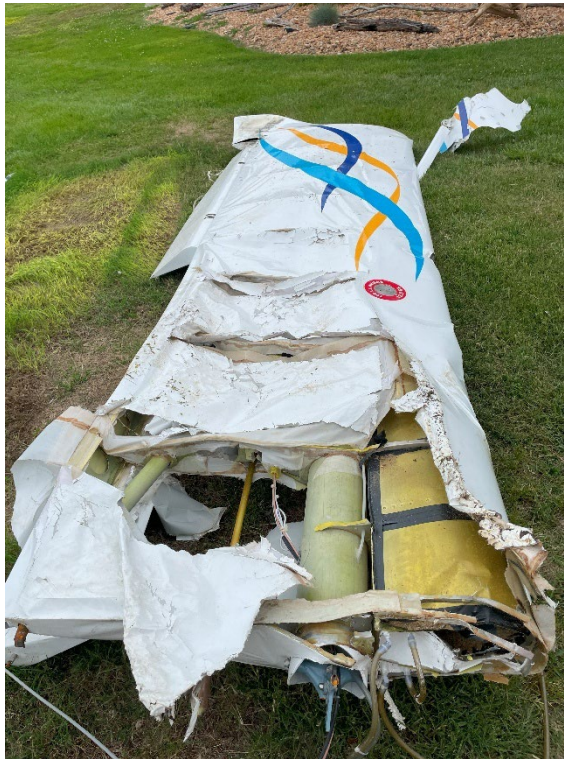
**Figure 3, View of impact separated left wing.**

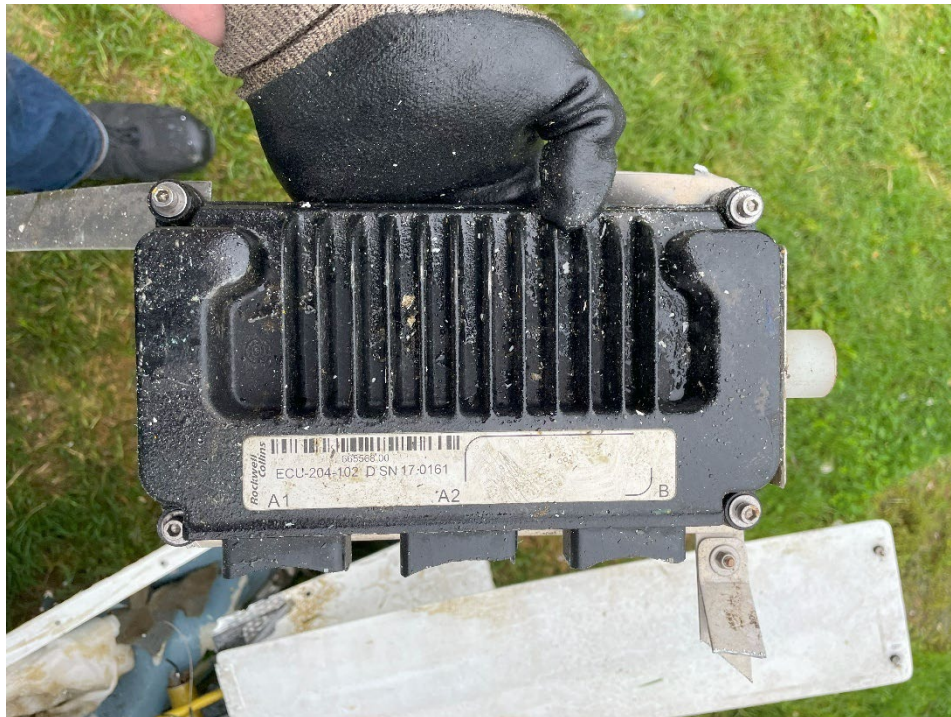
Figure 4, ECU .

A Rockwell Collins ECU-204-102 was removed and will be delivered to the NTSB Vehicle Recorder Division for examination and download of engine health and performance data.

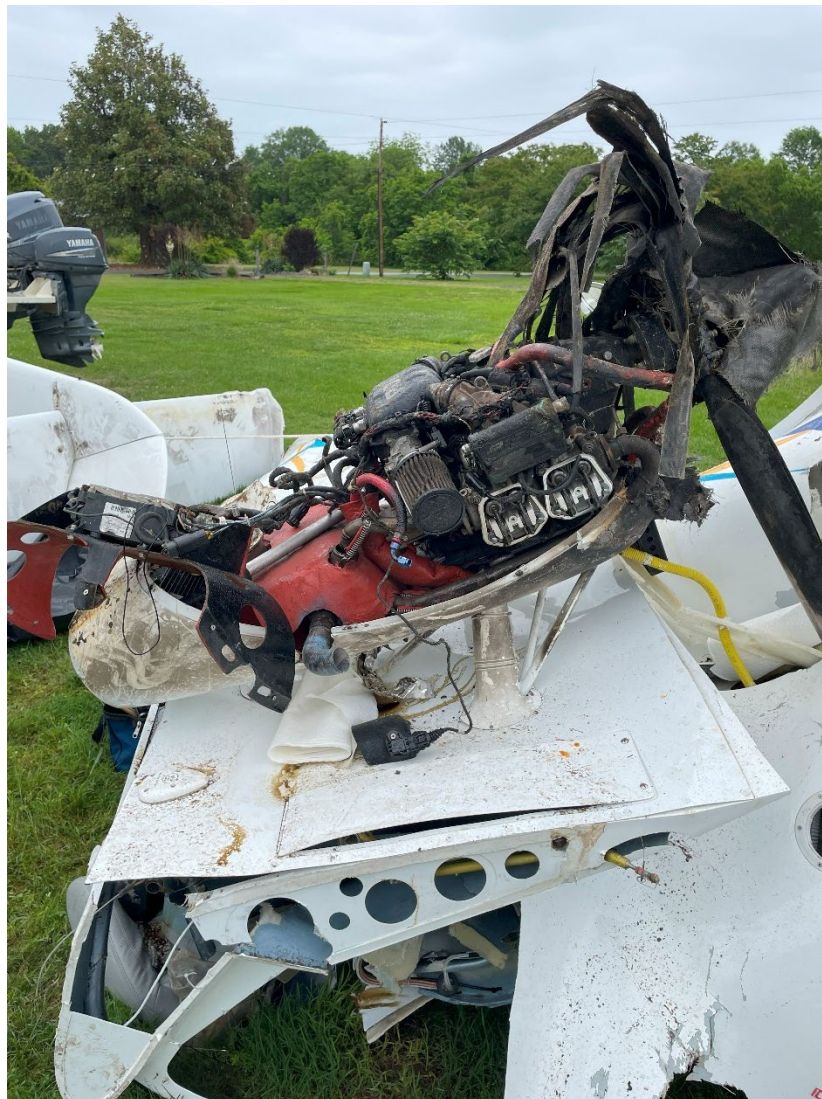
Engine crankshaft and valvetrain continuity was established when the propeller was manually rotated. The spark plugs showed normal wear when compared to the Champion Aviation Check-A-Plug AV-27 chart.

The engine appears well lubricated, and the oil tank (dry sump forced lubrication system) was intact and full of oil. The oil looks new and has a dark almond color.

**Figure 5, View of engine with engine cowl removed.**

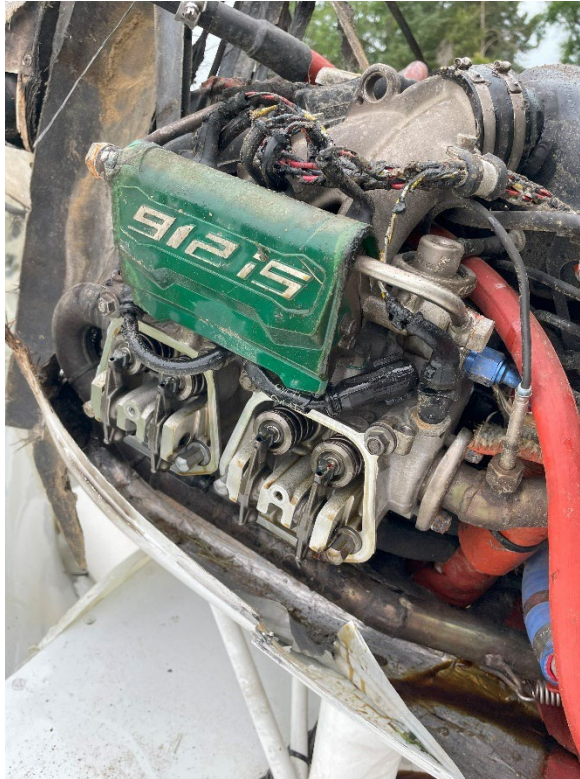
**Figure 6, Right side view of engine.**

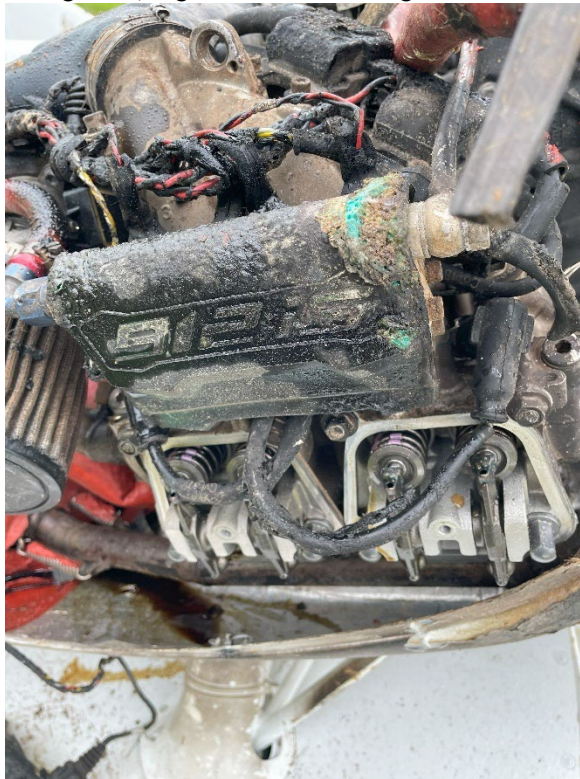
The engine was mounted on top of the airframe in a pusher configuration and was exposed to fire near the propeller side of the engine. The fire was limited to the top of the engine and compartment, and the source appears to be a fuel line that was impact separated. Thermal damage was mostly limited to plastics and wiring insulation.

There was no evidence of a preimpact engine or airframe fire. Soot on the top of the tail was not in a slipstream formation and video of the flight showed no evidence of an inflight fire.

**Figure 7, Left side view of engine and thermal damage.**

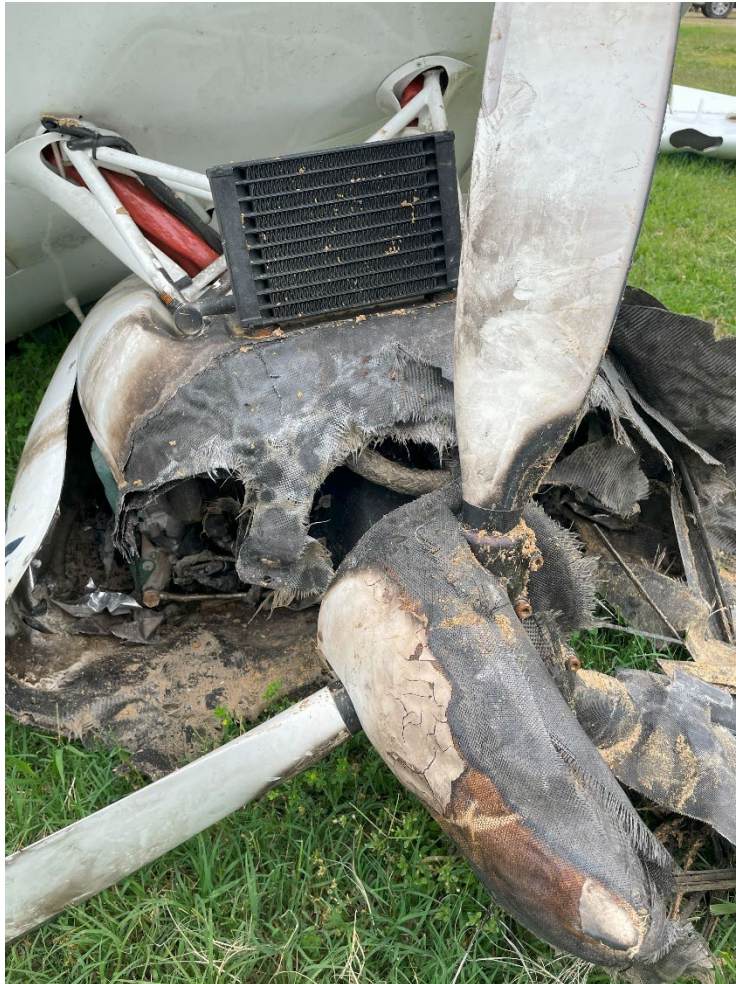
The 3-bladed composite propeller remained attached to the hub and reduction gearbox assembly, and it was manually rotated without any hinderance or noises.

One of the blades was destroyed by fire. The opposing blades remained relatively intact with minor surface damage.

During manual operation of the propeller, bay water was forced out of the cylinders and the air filter assembly.

Figure 8, View of propeller showing damage.
