ERA25LA204

## INVESTIGATION PHOTOGRAPHS

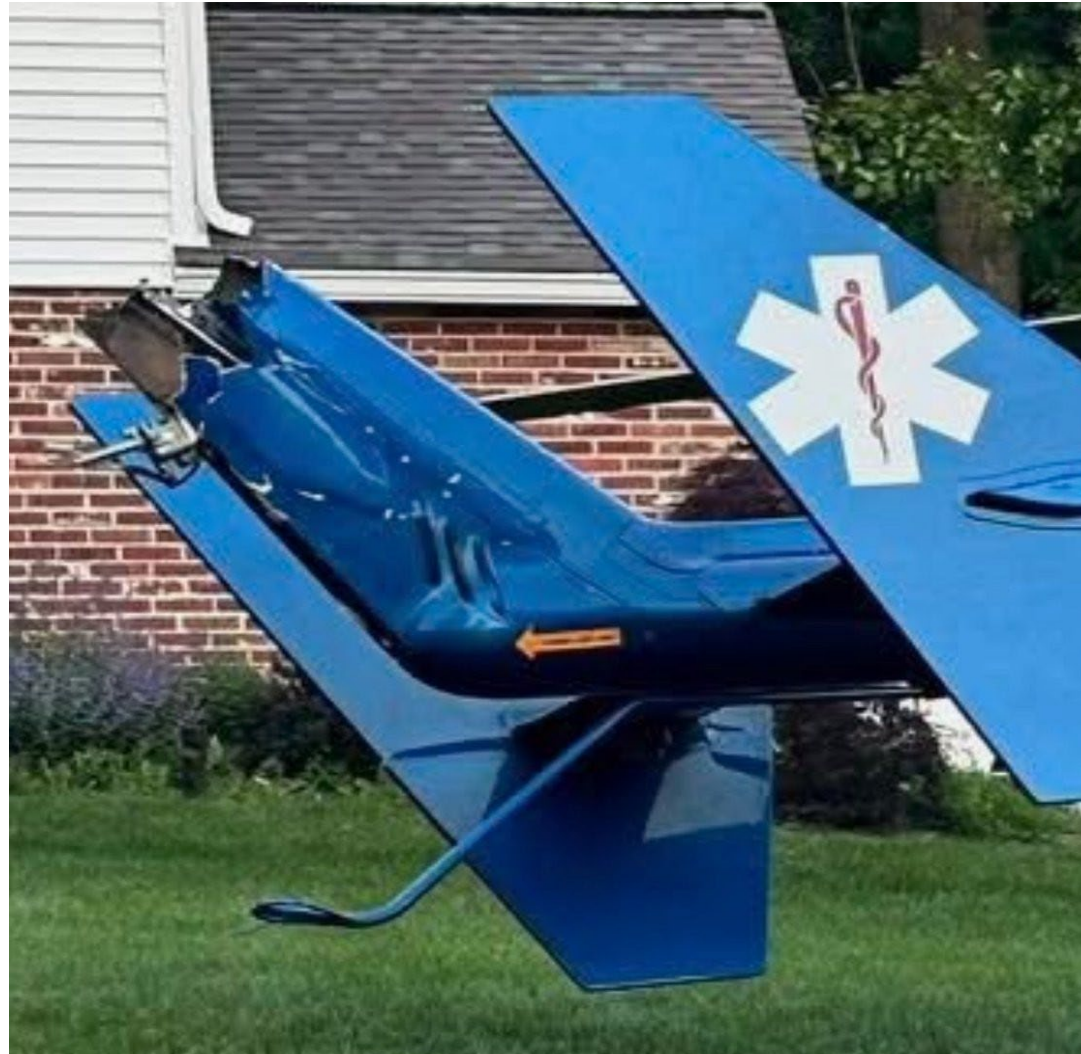
**Photograph 1 - View of tail rotor separated from helicopter  
(Courtesy of FAA)**

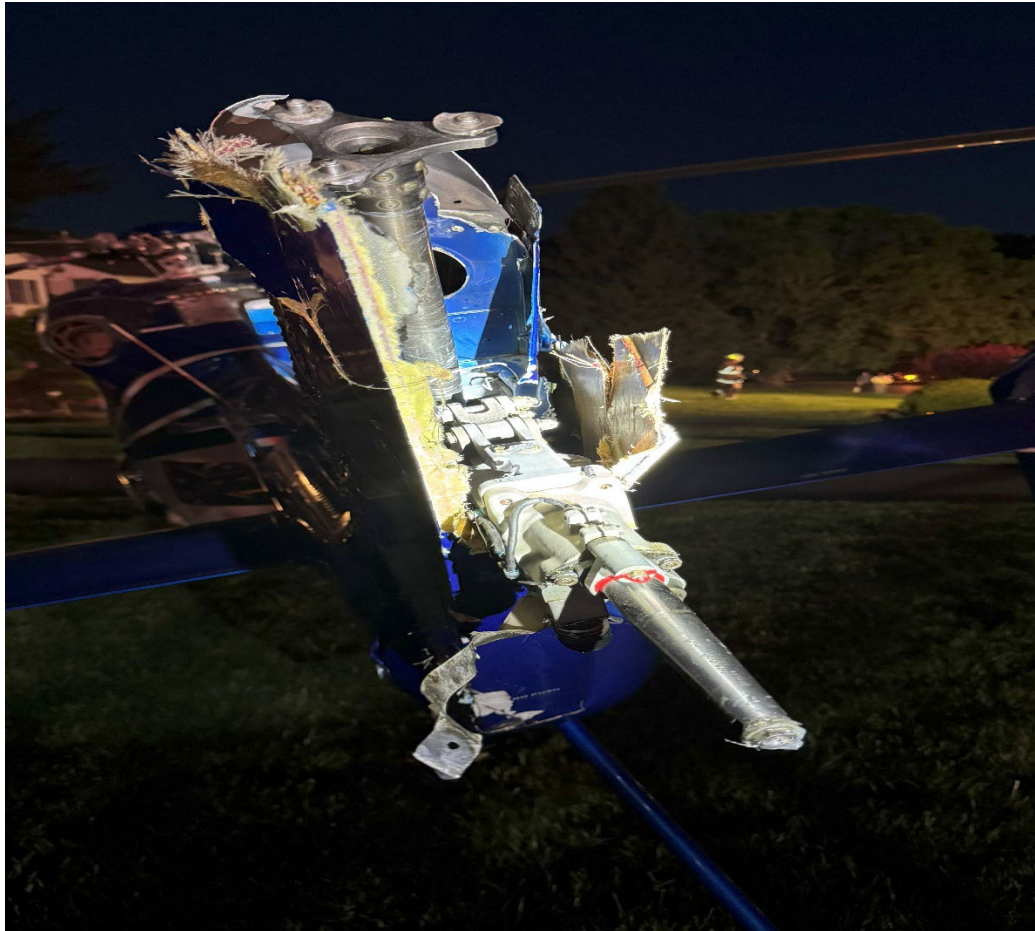
**Photograph 2 - View of missing tail rotor assembly and damage airframe  
(Courtesy of FAA)**

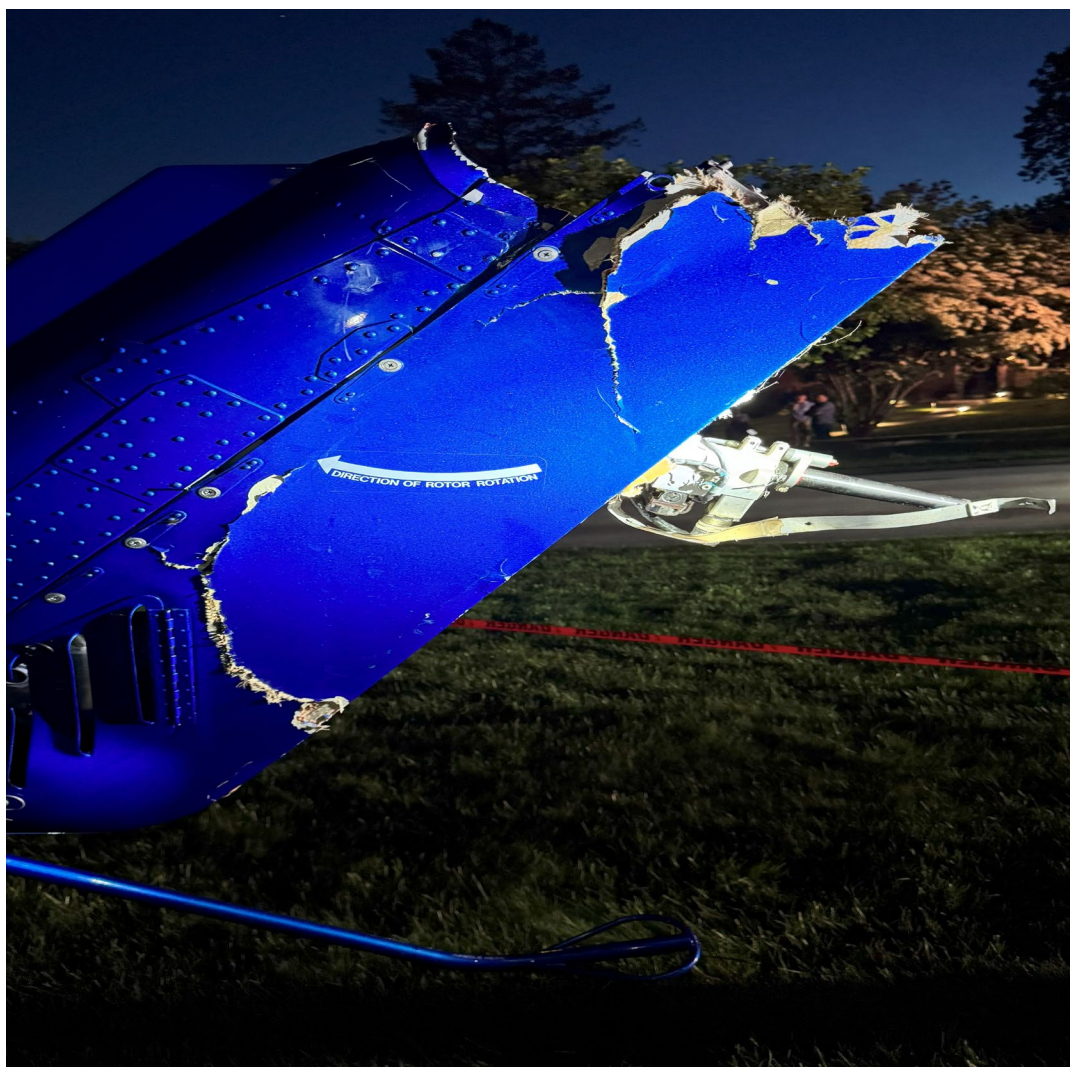
**Photograph 3 - Left side view of damaged vertical stabilizer  
(Courtesy of FAA)**

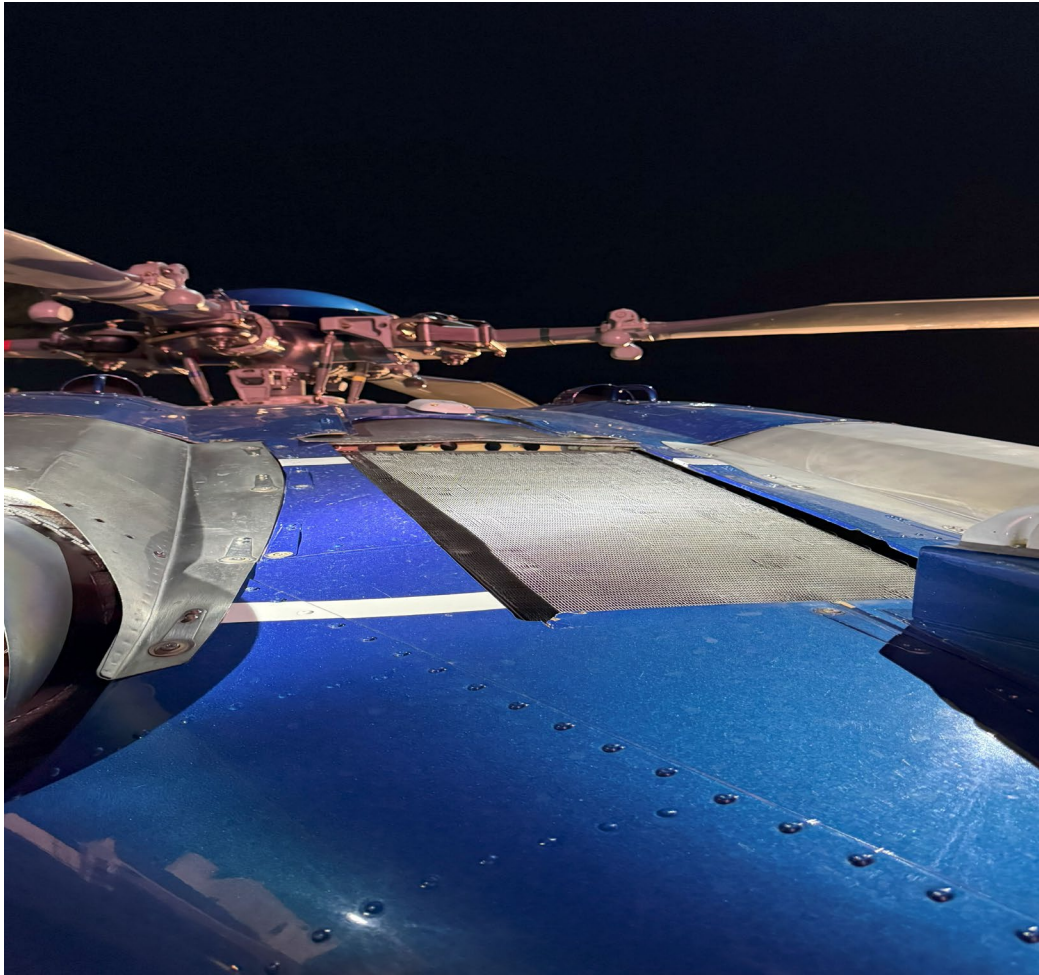
**Photograph 4 - View of missing A/C panel  
(Courtesy of FAA)**

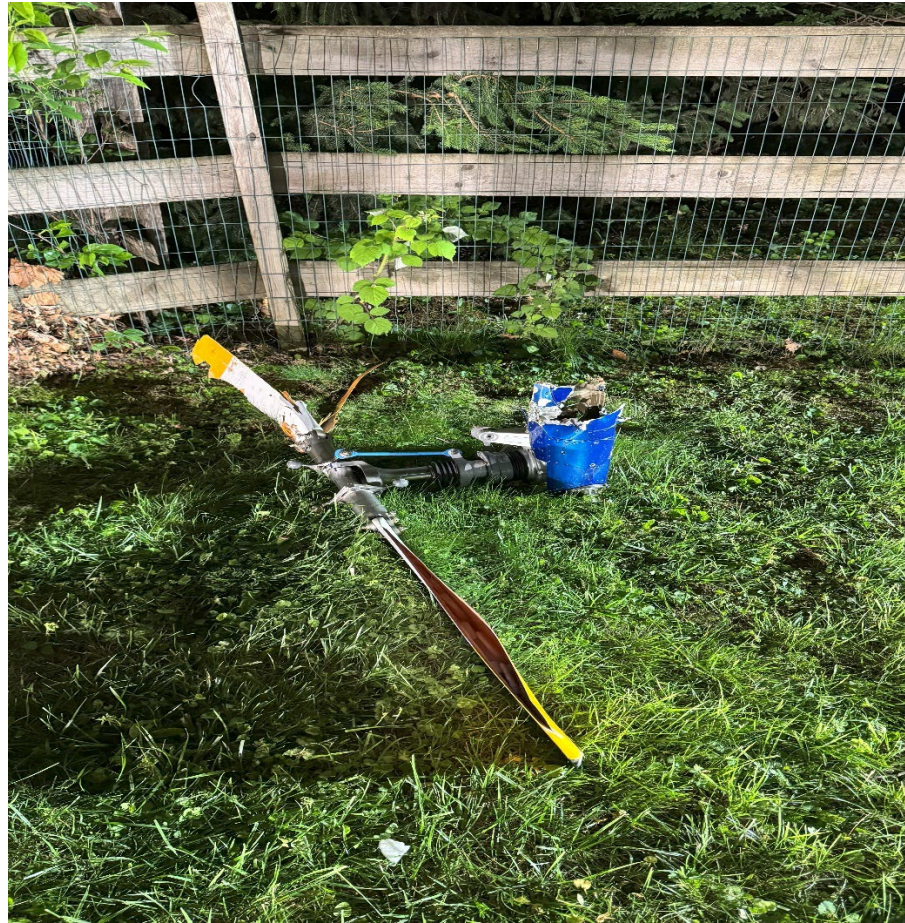
**Photograph 5 - View of tail rotor assembly  
(Courtesy of FAA)**

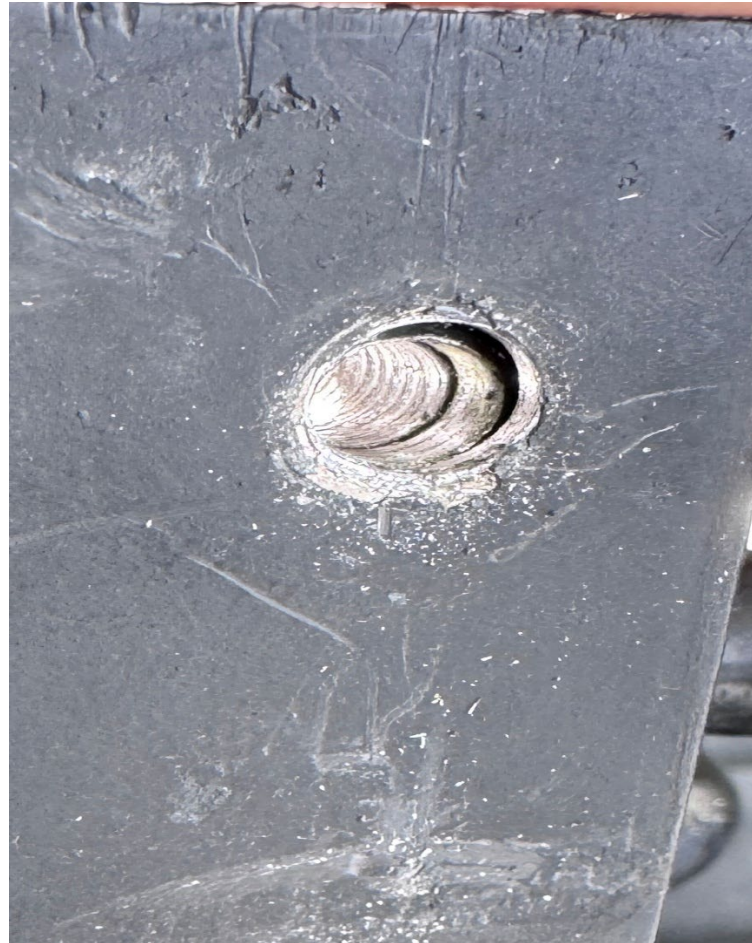
**Photograph 6 - View of striped rivnut thread  
(Courtesy of FAA)**

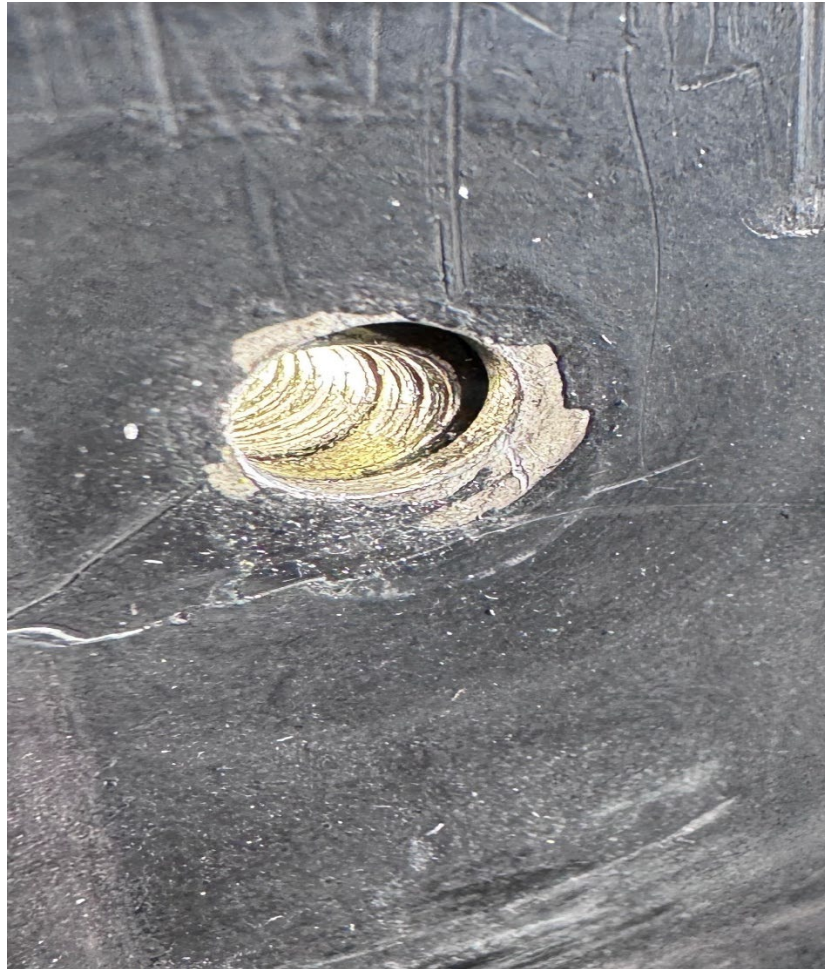
**Photograph 7 - View of striped rivnut threads  
(Courtesy of FAA)**
